Site visit 18 October 2025:

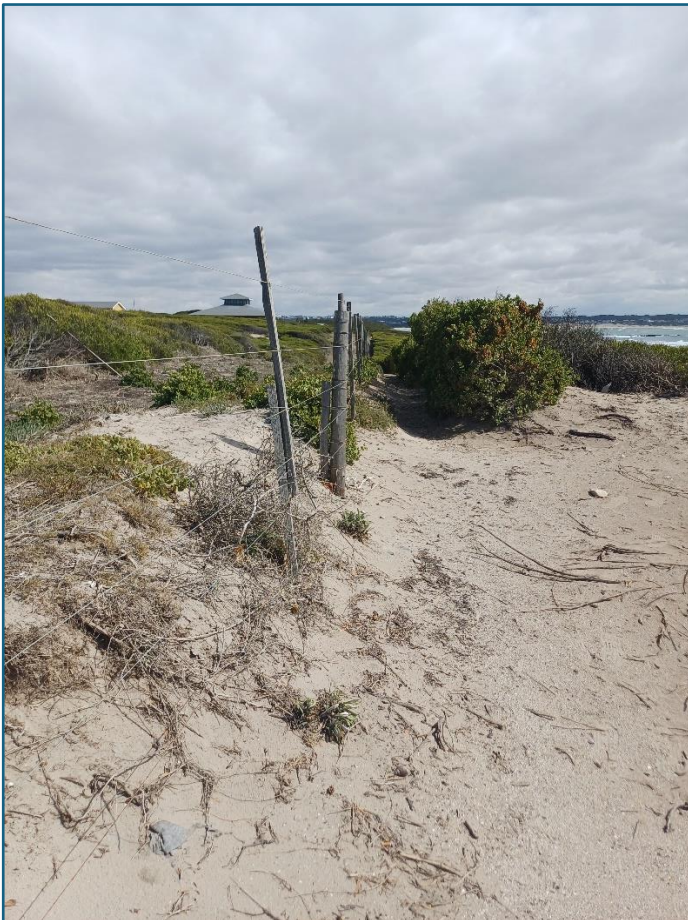
Photo 1: Southeast corner of site looking North – note walkway seaward side of perimeter fence

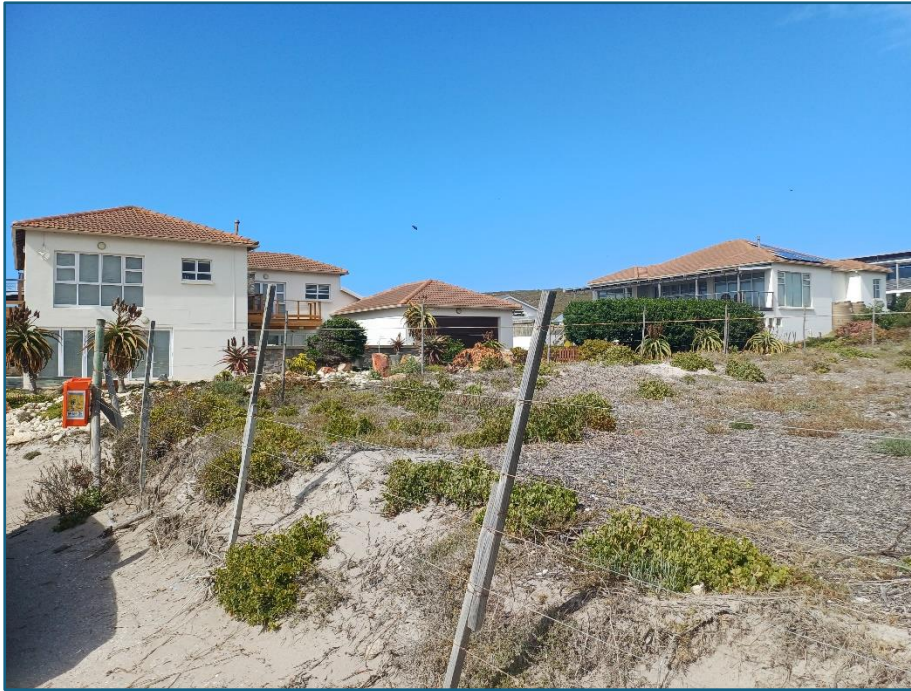
Photo 2: Southeast corner of site looking South – houses on Hoekstreet

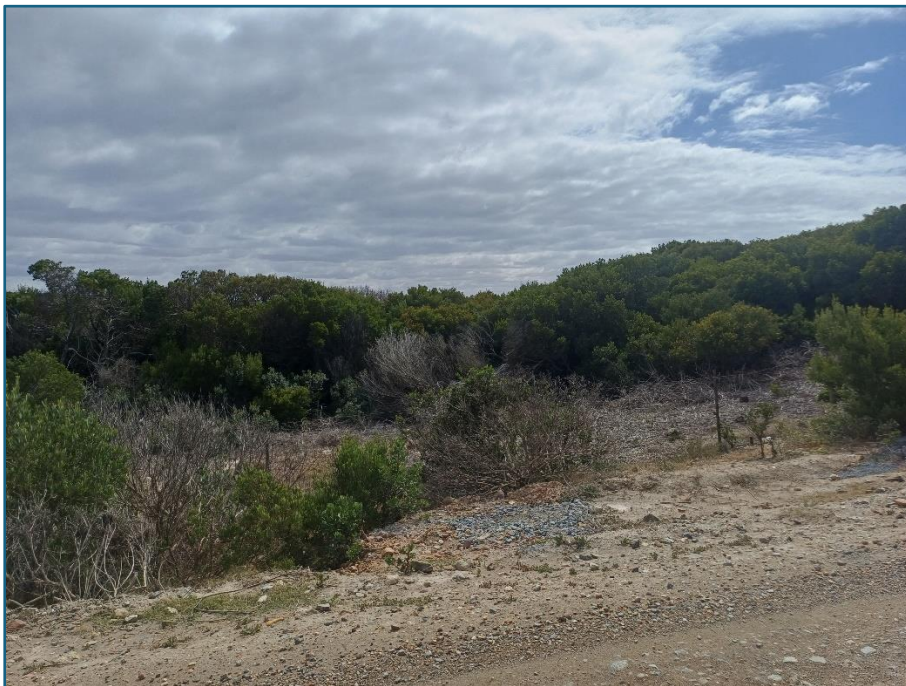
Photo 3: Drainage line taken on Infanta Road (facing East)

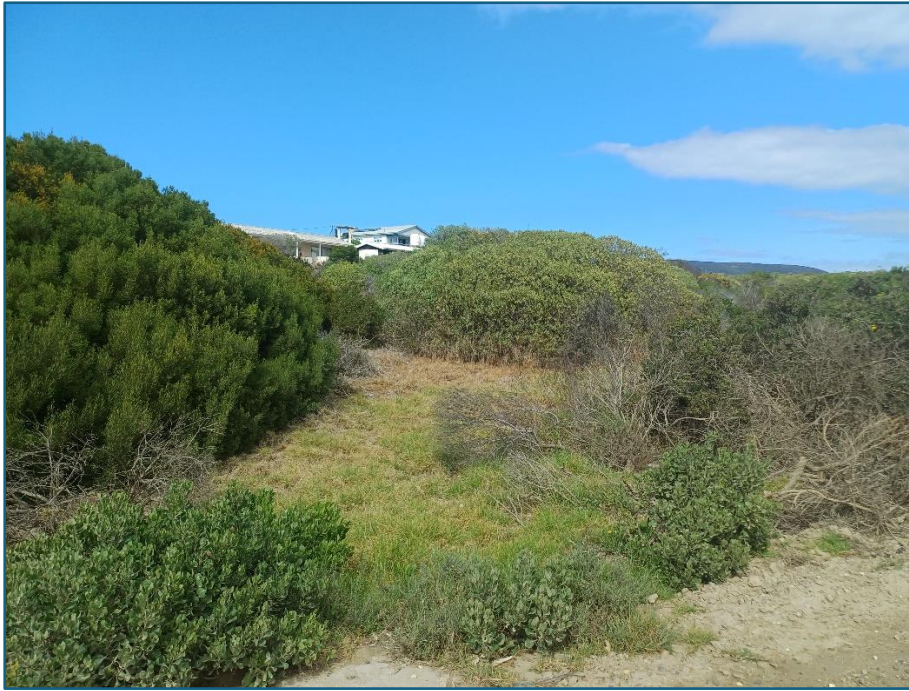
Photo 4: Drainage line taken on Infanta Road (facing West)

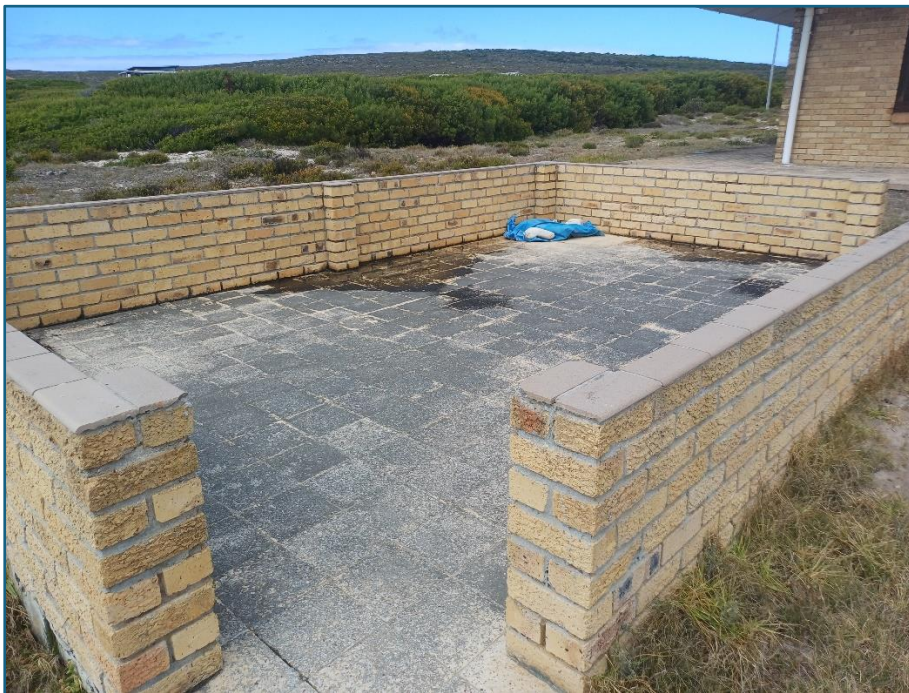
Photo 5: Existing platform on site (seaward side of house)

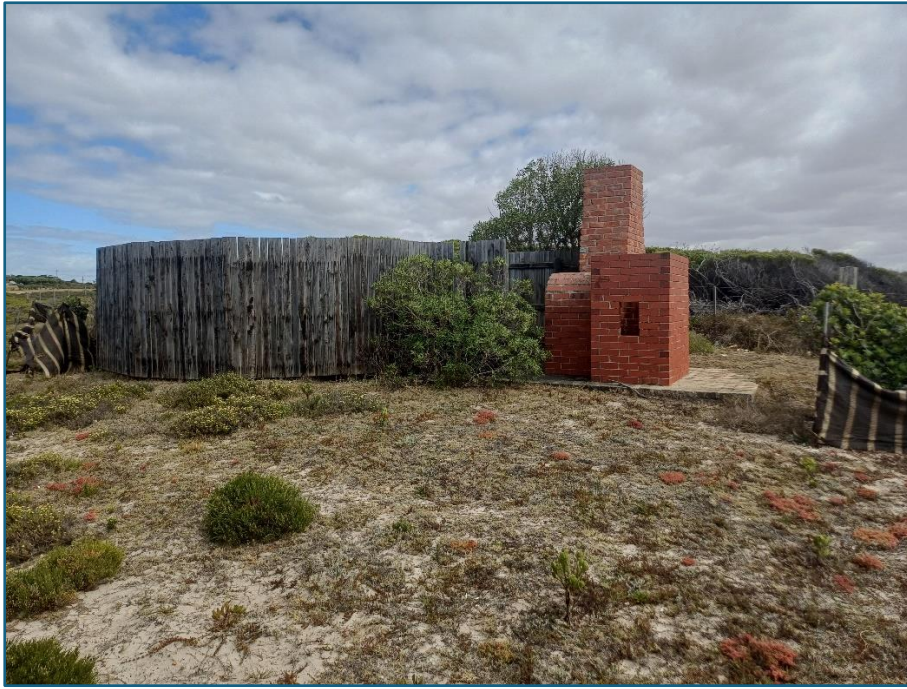
Photo 6: Existing braai and washing line area

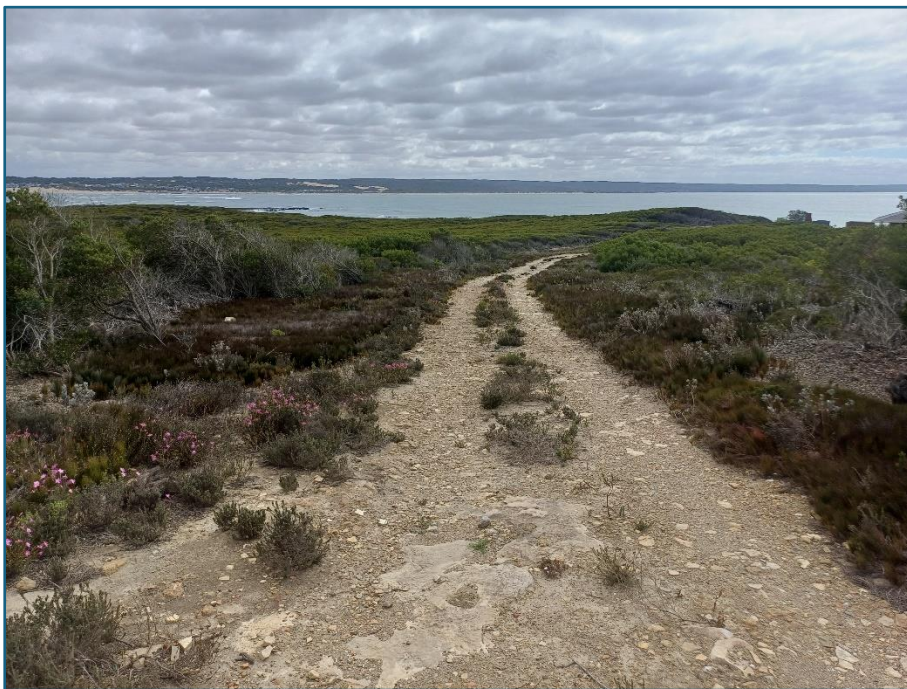
Photo 7: View from existing access gate along existing access roads (looking East)

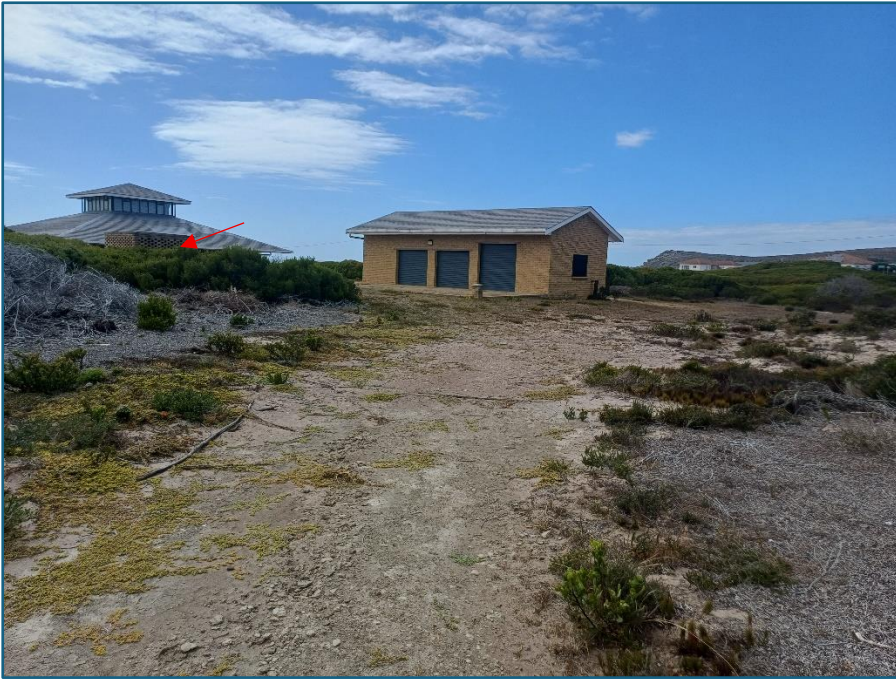
Photo 8: Existing Garage and House (red arrow points to existing storeroom)

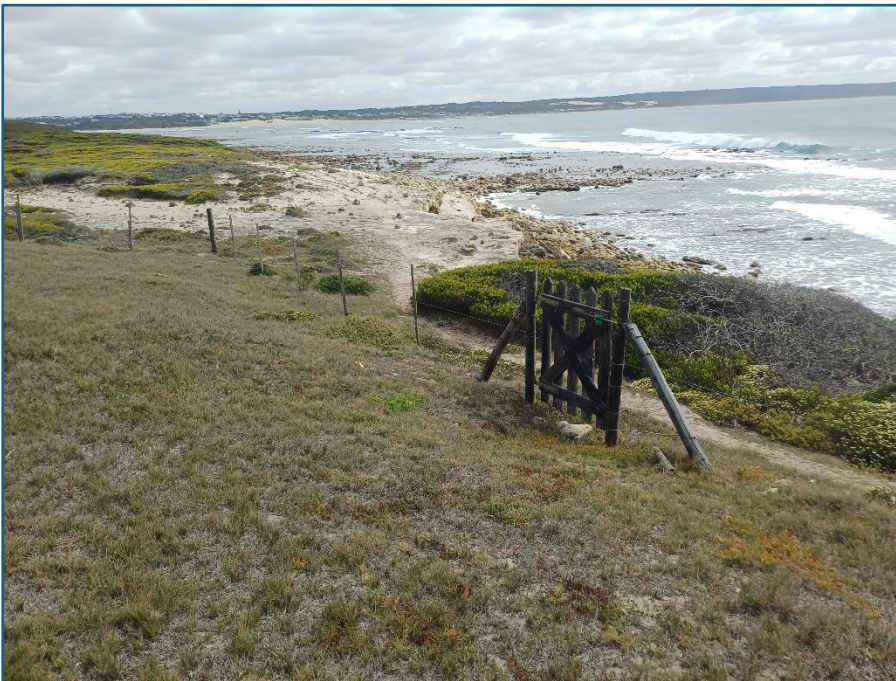
Photo 9: Existing beach access gate

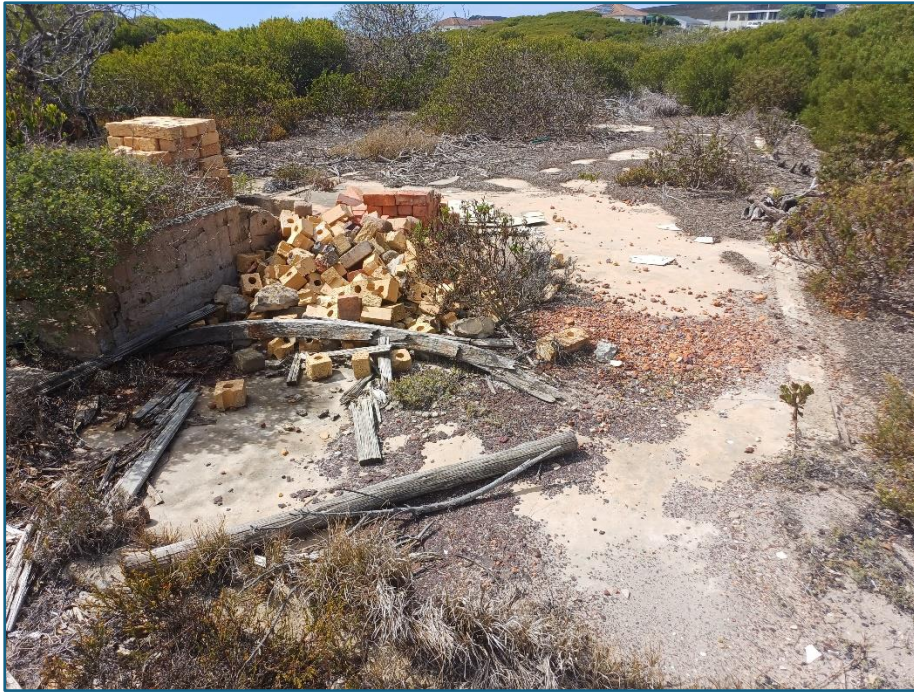
Photo 10: Existing derelict concrete slab (looking South)

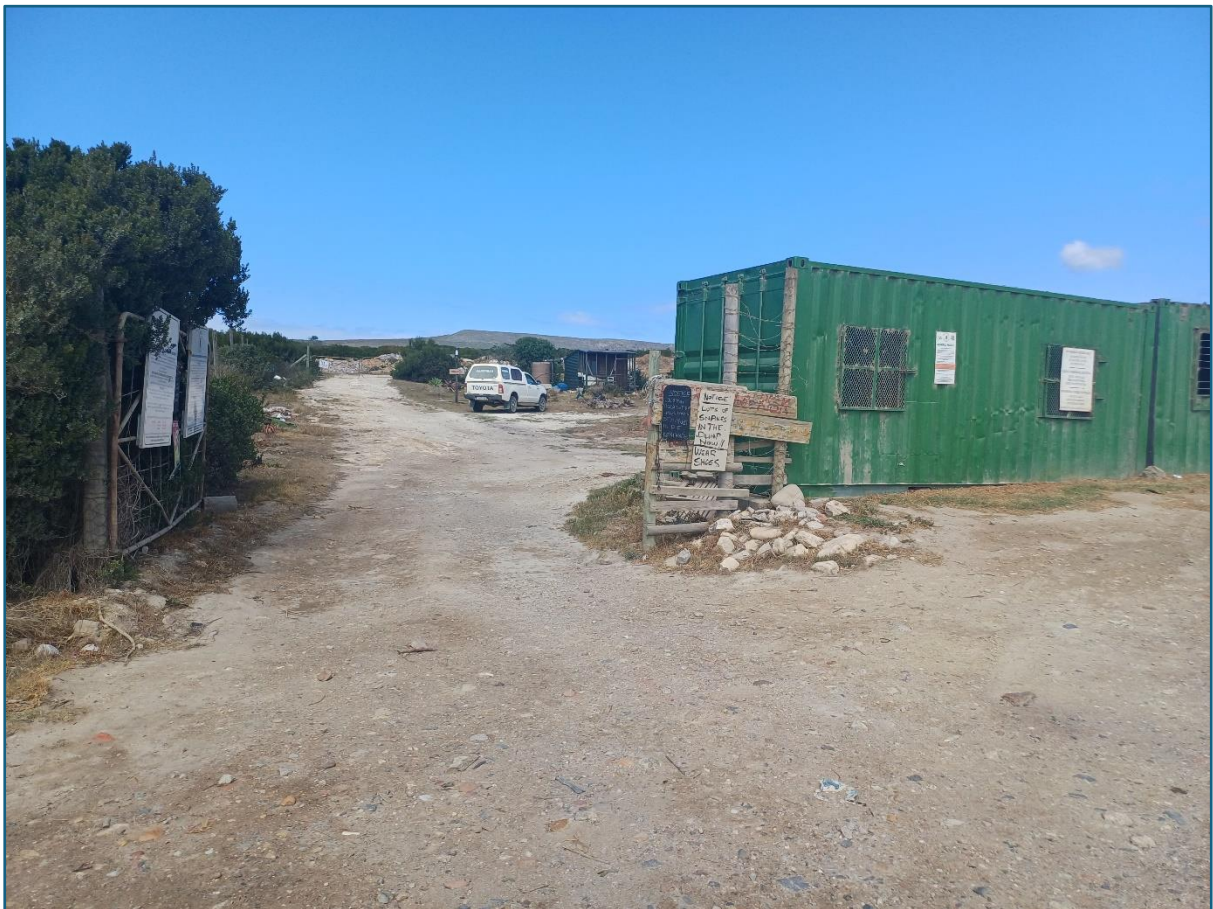
Photo 11: General waste collection area for Infanta (on Infanta to Malgas Road)
