## **APPENDIX D – PHOTO REPORT**

Prepared by: PHS Consulting

Photo report for site visit conducted on 12 August 2025:

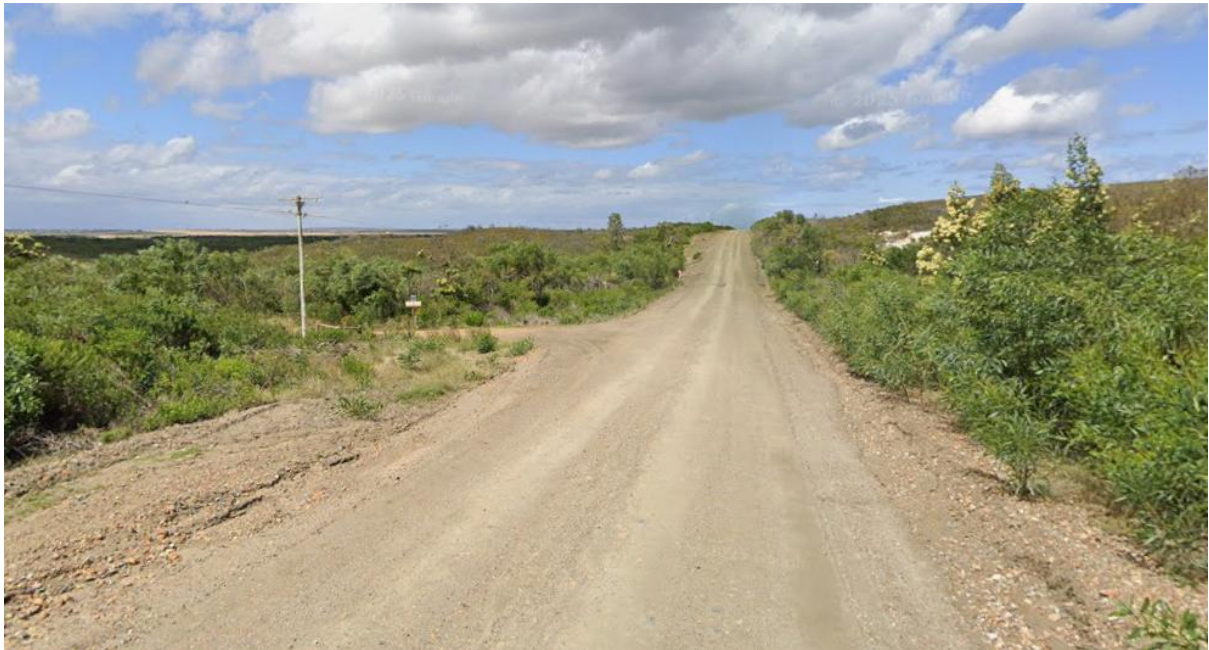
Photo 1: View of the turnoff from the Malgas-Infanta Road onto the access road that leads to the farm.

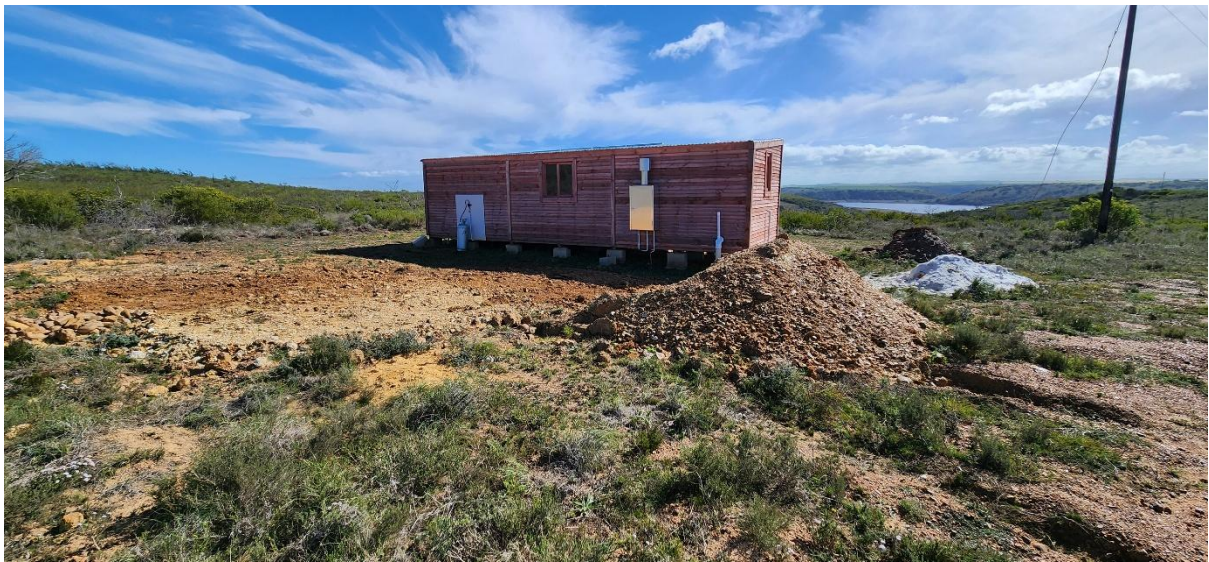
Photo 4: View of the cleared area around the new caretakers cottage located in the southern portion of the property, adjacent to the farms internal access road (facing north)

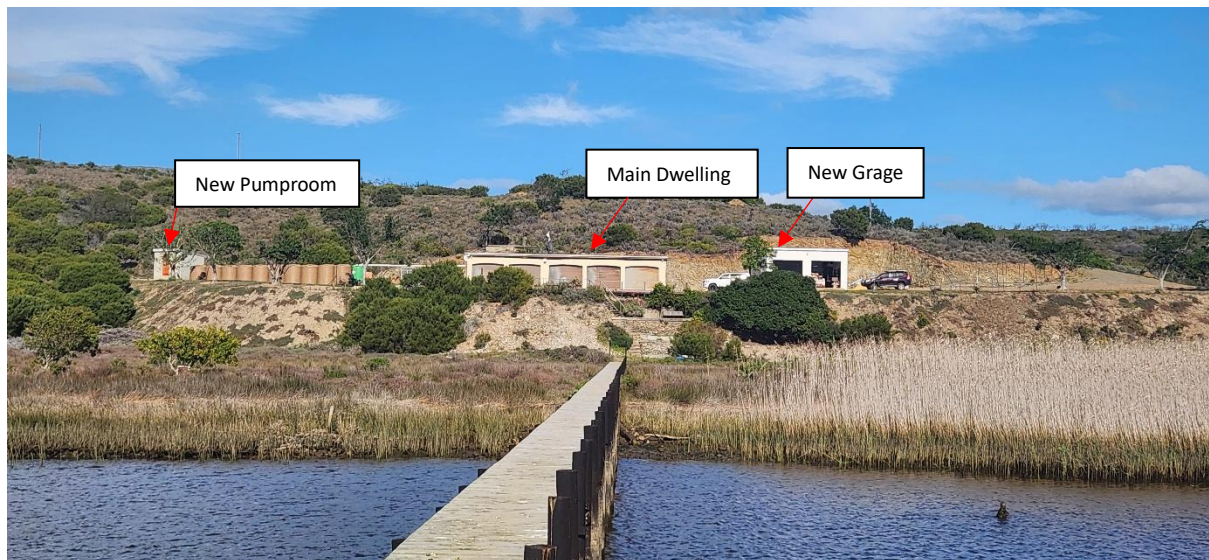
Photo 5: Overview of the cleared area around the main dwelling, viewed from the existing jetty

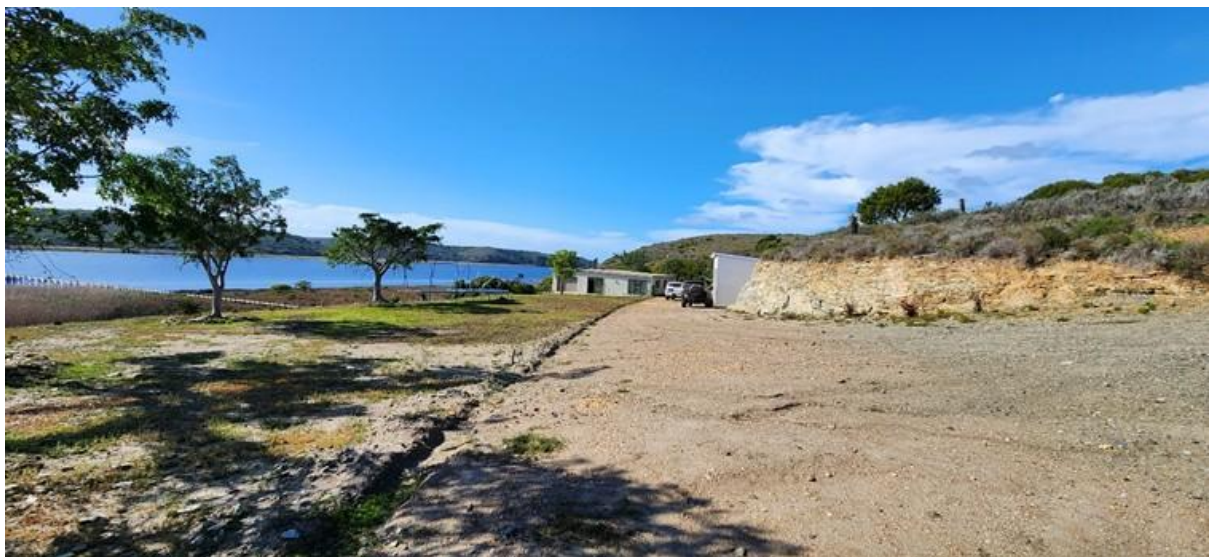
Photo 6: View of a portion of the cleared area around the main dwelling (facing east)

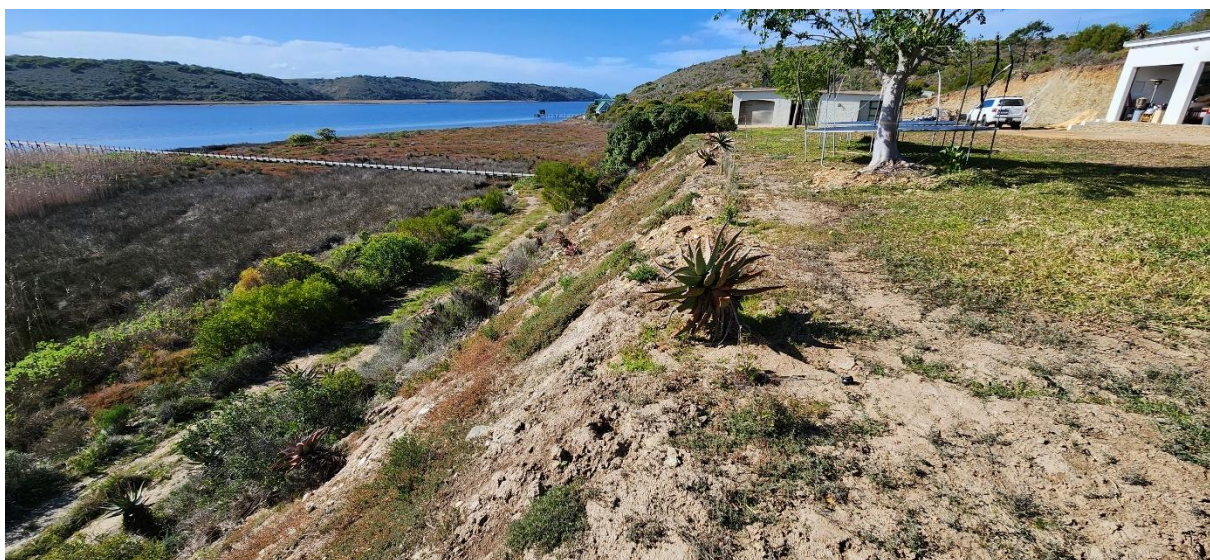
Photo 7: View of a portion of the cleared area around the main dwelling (facing southeast)
