## **APPENDIX A – PHOTO REPORT**

Prepared by: PHS Consulting

Photo report for site visit conducted on 12 August 2025:

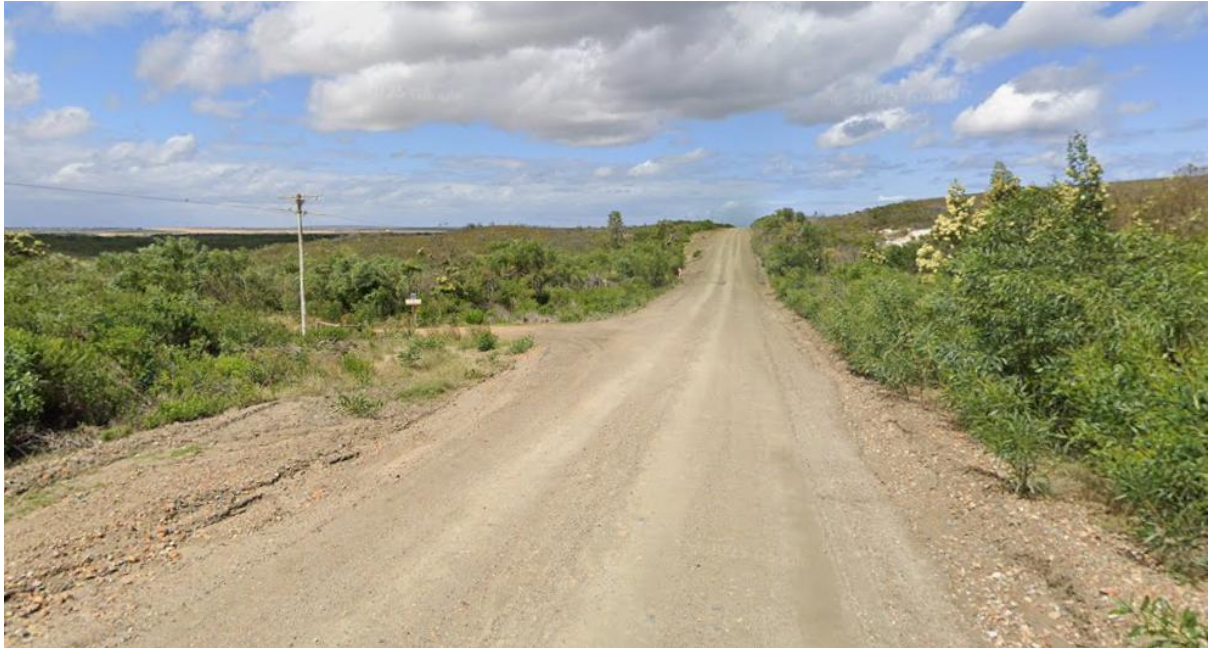
Photo 1: View of the turnoff from the Malgas-Infanta Road onto the access road that leads to the farm.

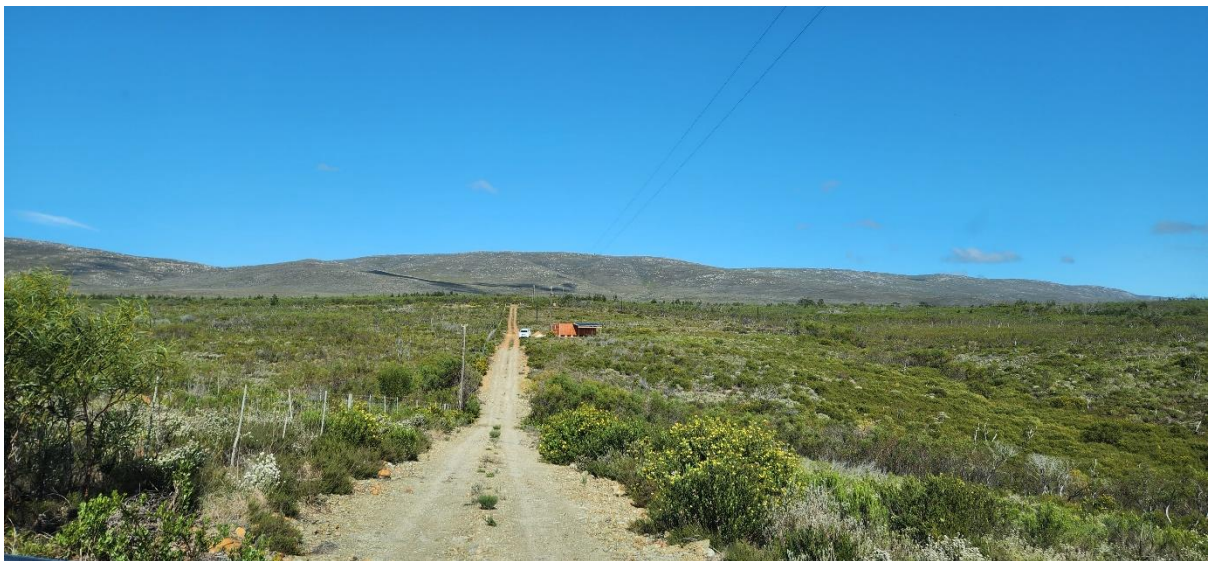
Photo 2: View along internal farm access road, facing southwest (towards the Malgas-Infanta road). The caretakers cottage can be seen in the middle of the photo to the right of the road.

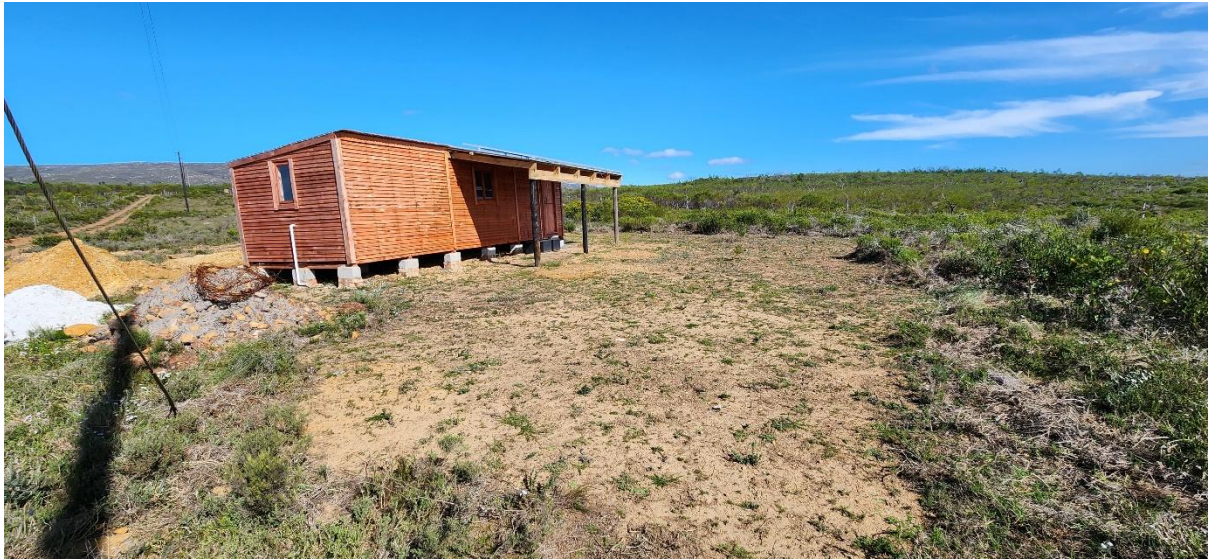
Photo 3: View of the cleared area around the new caretakers cottage located in the southern portion of the property, adjacent to the farms internal access road (facing south)

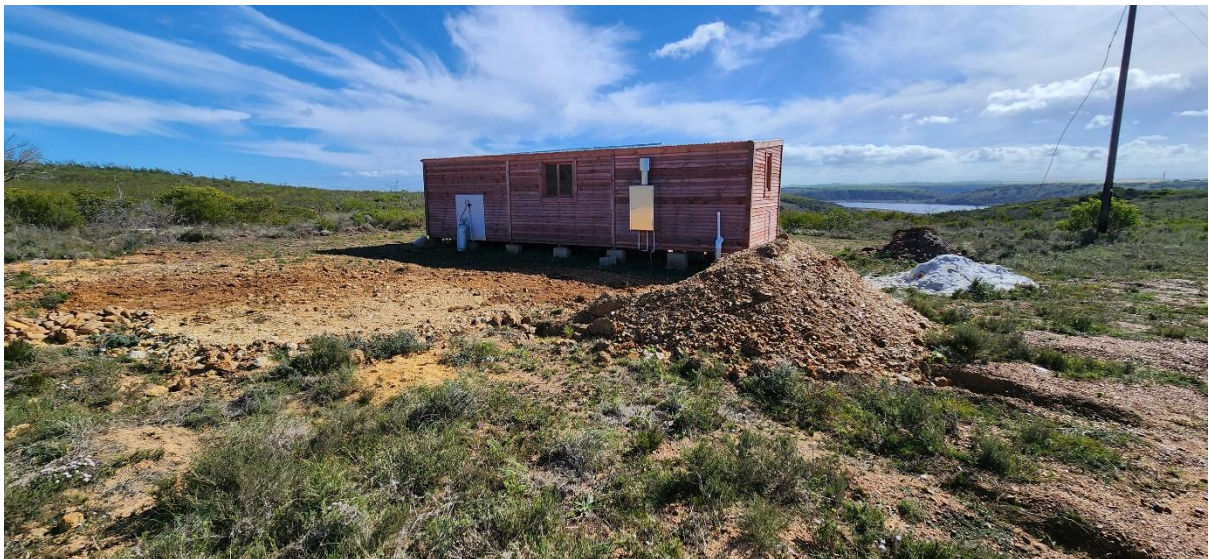
Photo 4: View of the cleared area around the new caretakers cottage located in the southern portion of the property, adjacent to the farms internal access road (facing north)

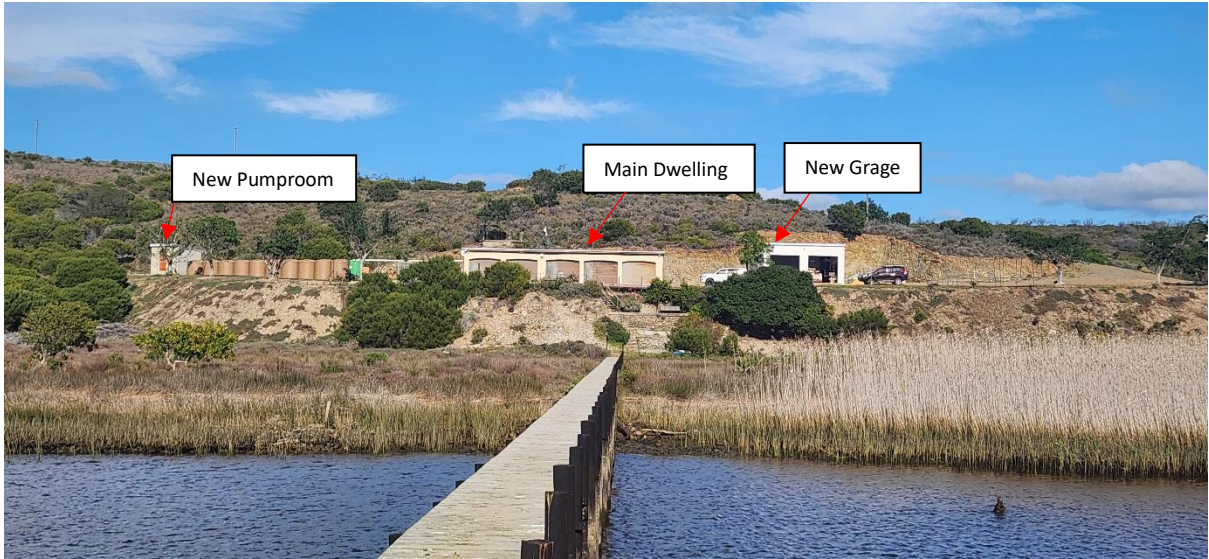
Photo 5: Overview of the cleared area around the main dwelling, viewed from the existing jetty

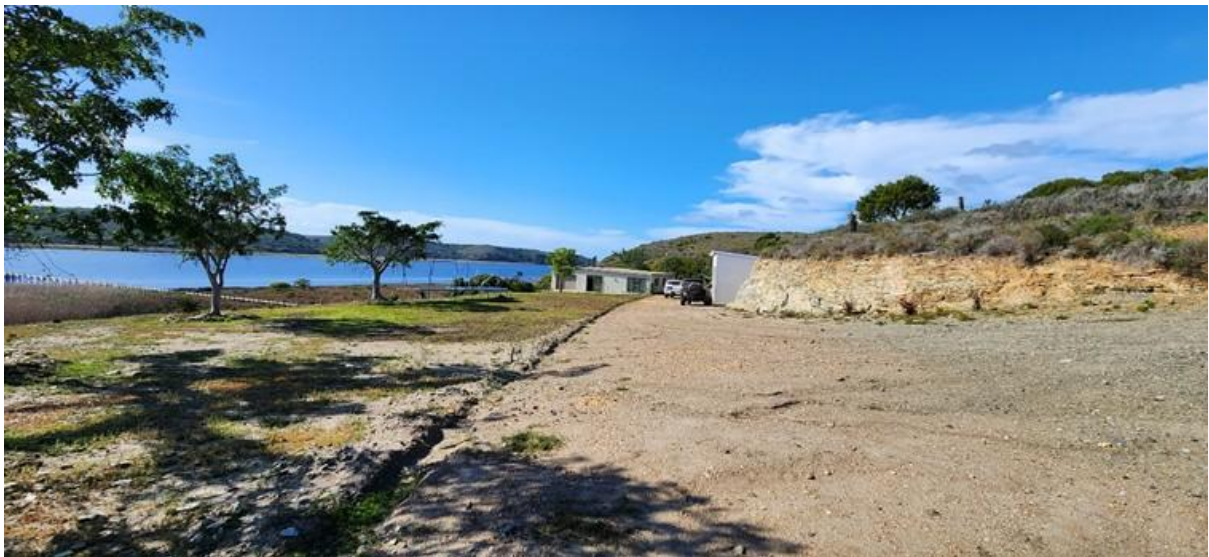
Photo 6: View of a portion of the cleared area around the main dwelling (facing east)

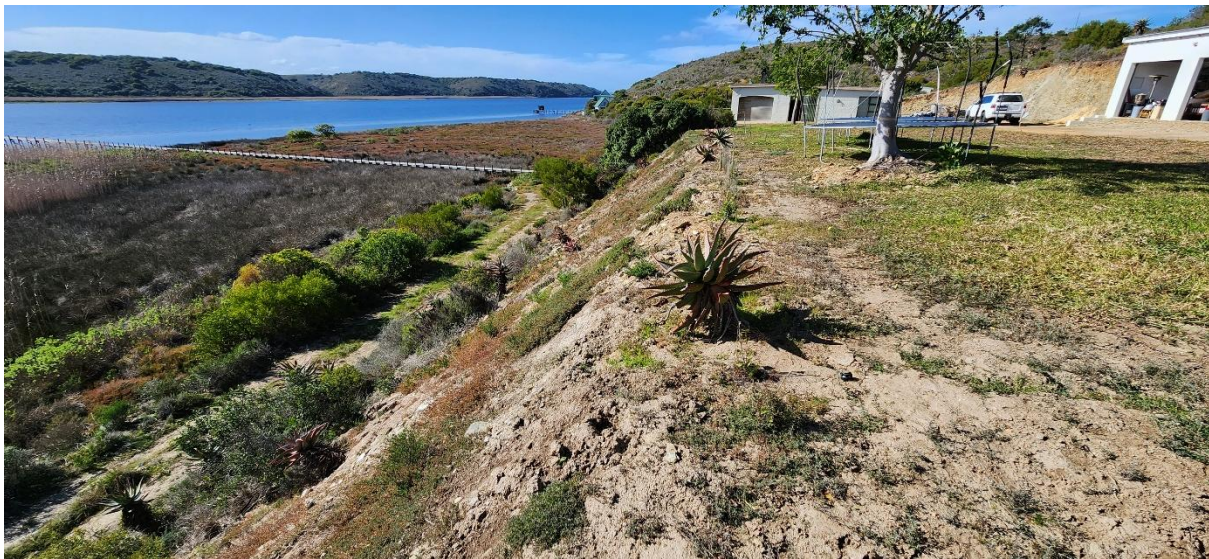
Photo 7: View of a portion of the cleared area around the main dwelling (facing southeast)

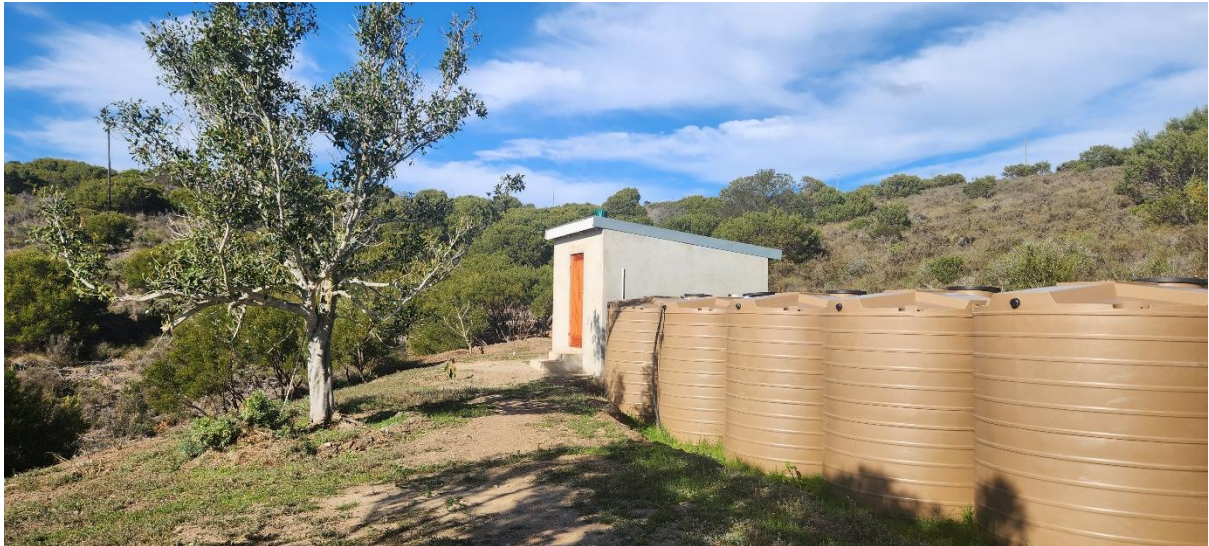
Photo 8: View of a portion of the cleared area around the main dwelling where a new pumproom has been constructed and additional water tanks have been installed.

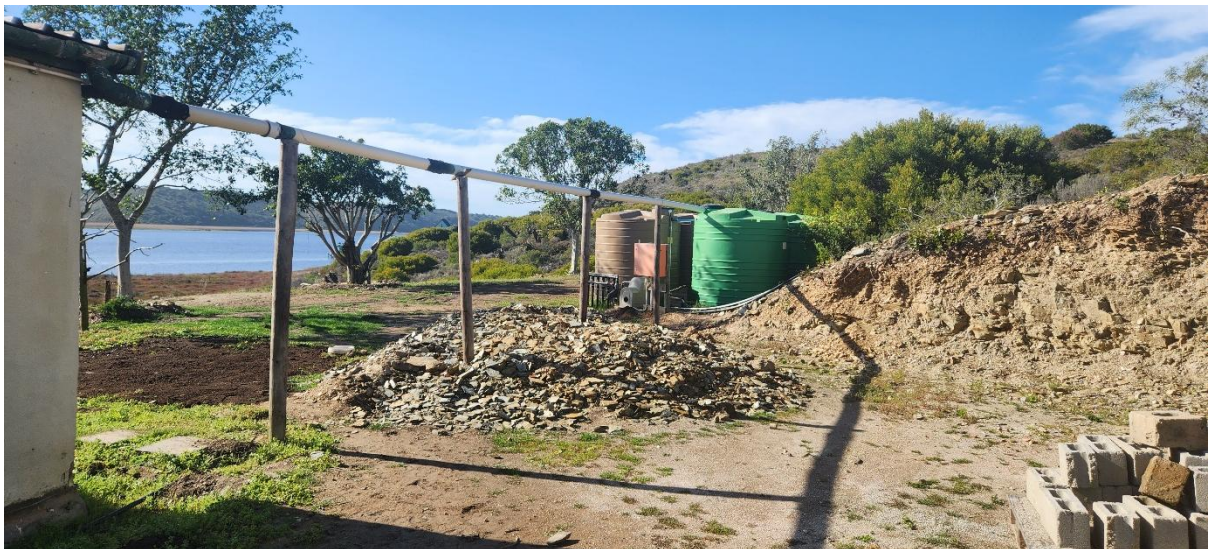
Photo 9: View of a portion of existing cleared area around the main dwelling

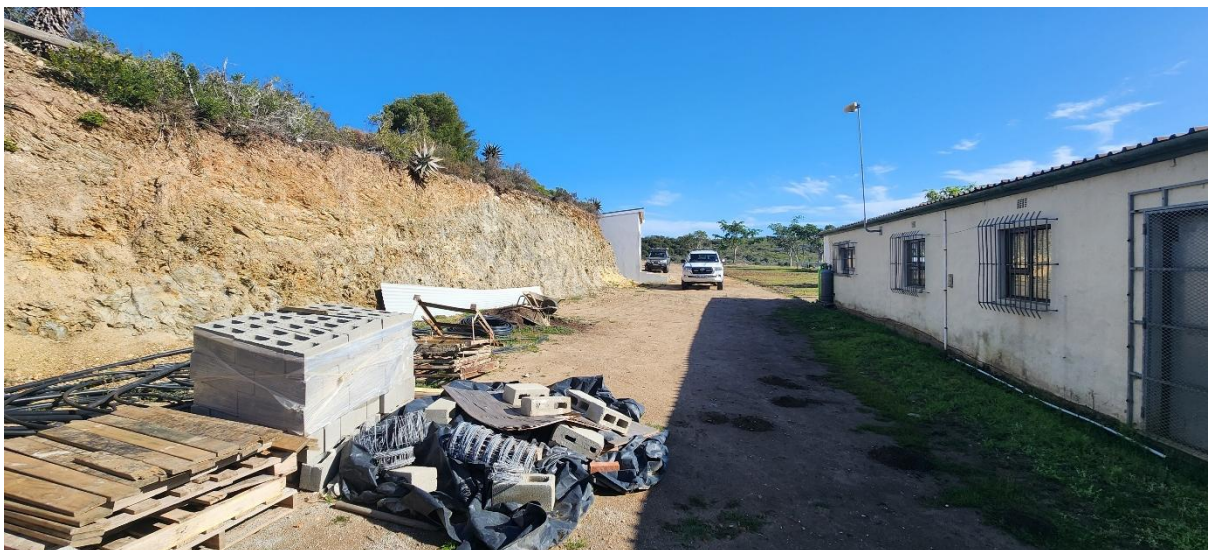
Photo 10: View of a portion of existing cleared area behind the main dwelling.

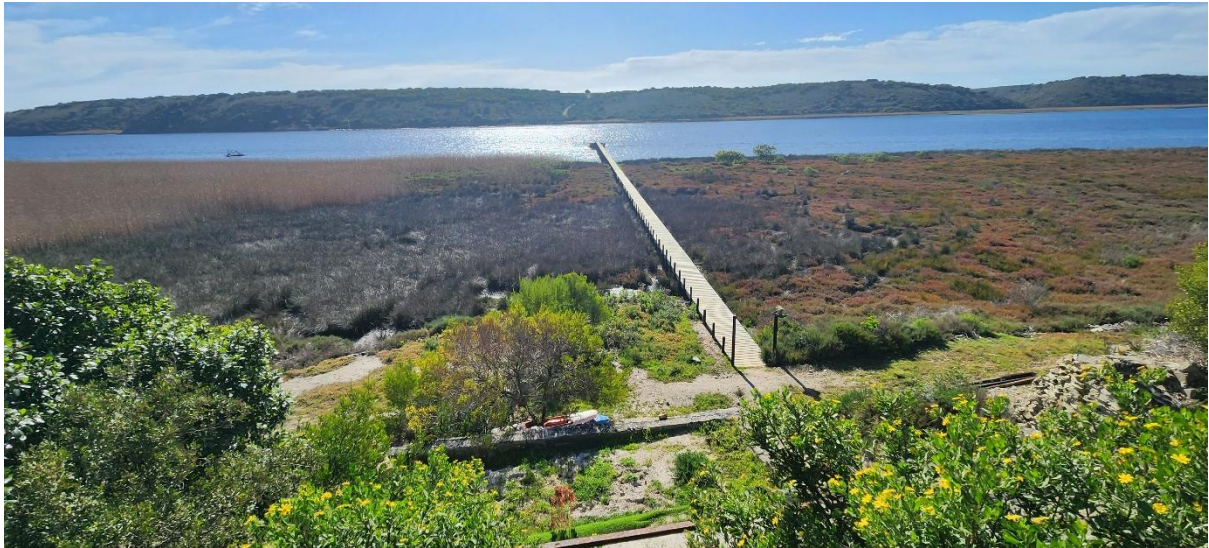
Photo 11: Existing jetty leading to the Breede River

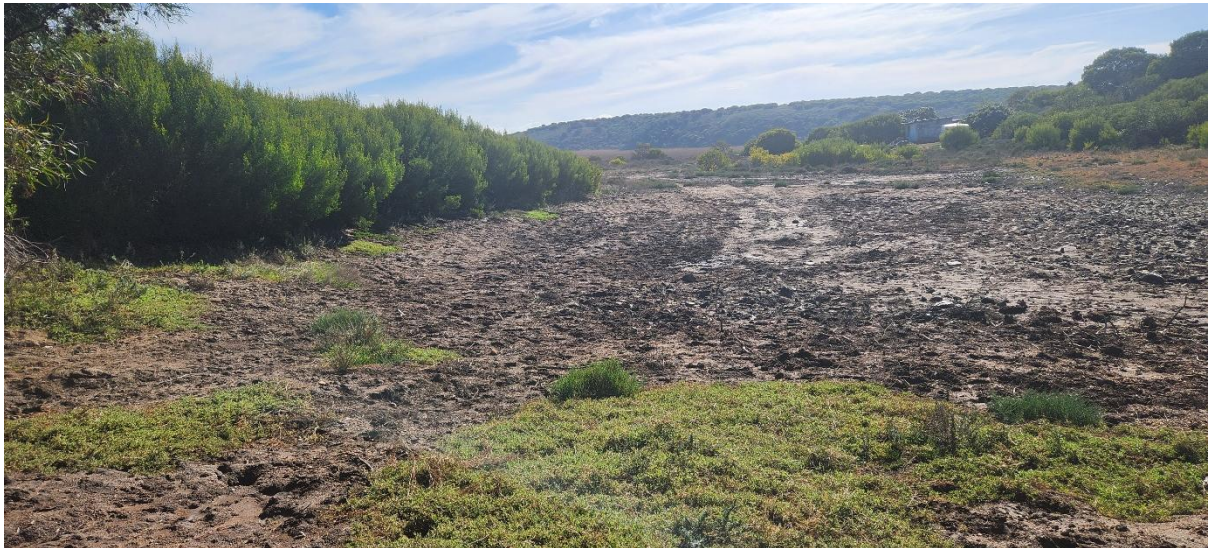
Photo 12: View of a portion of the cleared area within the floodplain saltmarsh (facing north)

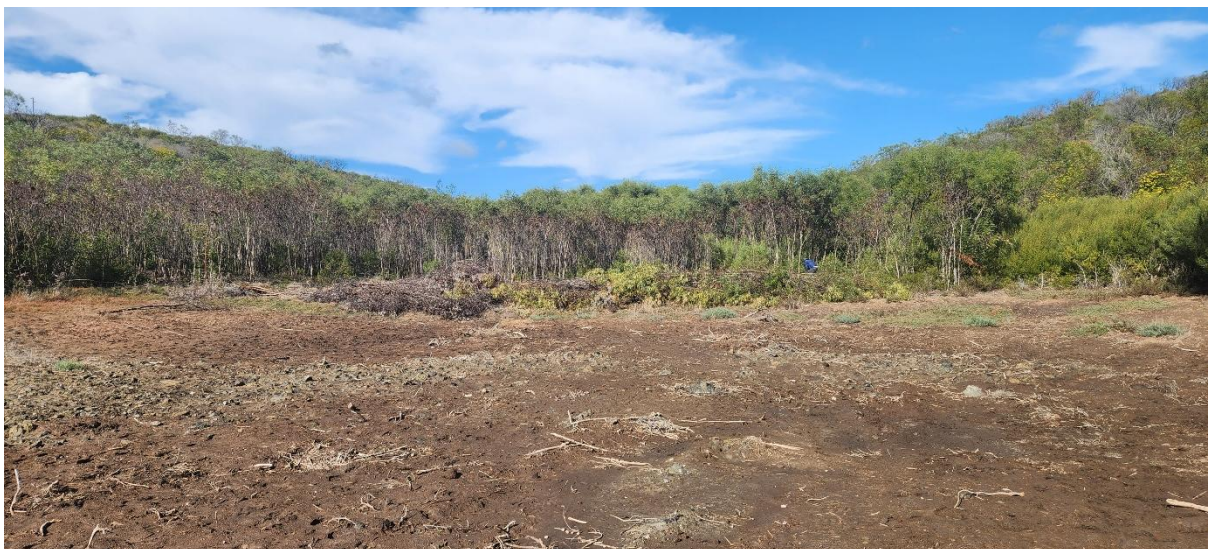
Photo 13: View of a portion of the cleared area within the floodplain saltmarsh (facing south)

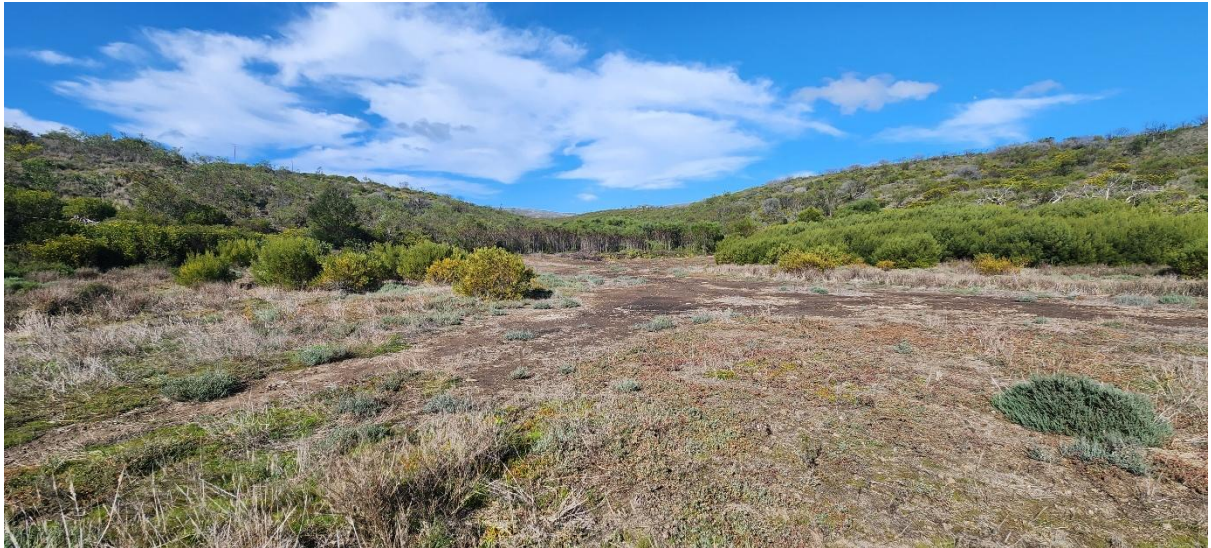
Photo 14: View of a portion of the cleared area within the floodplain saltmarsh (facing south)
