## **APPENDIX D – PHOTO REPORT**

Prepared by: PHS Consulting

Photo report for site visit conducted on 10 June 2026:

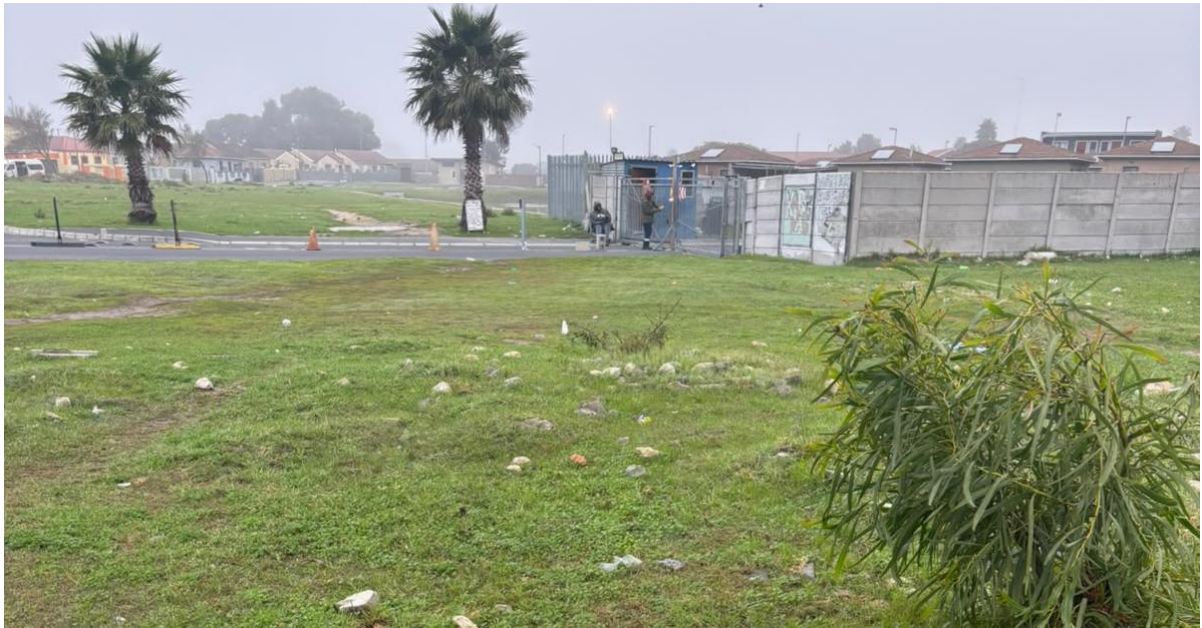
Photo 1: View of the southeastern corner of Erf 3733, facing southwest, where Wetland 7 was unlawfully piped. A portion of the residential development authorised under the 2011 Environmental Authorisation is visible in the top right of the photograph. The stormwater pond, which serves as the designated offset area for Wetland 7, is located behind the palm tree in the top centre of the photograph (refer photo 12 & 13 below).

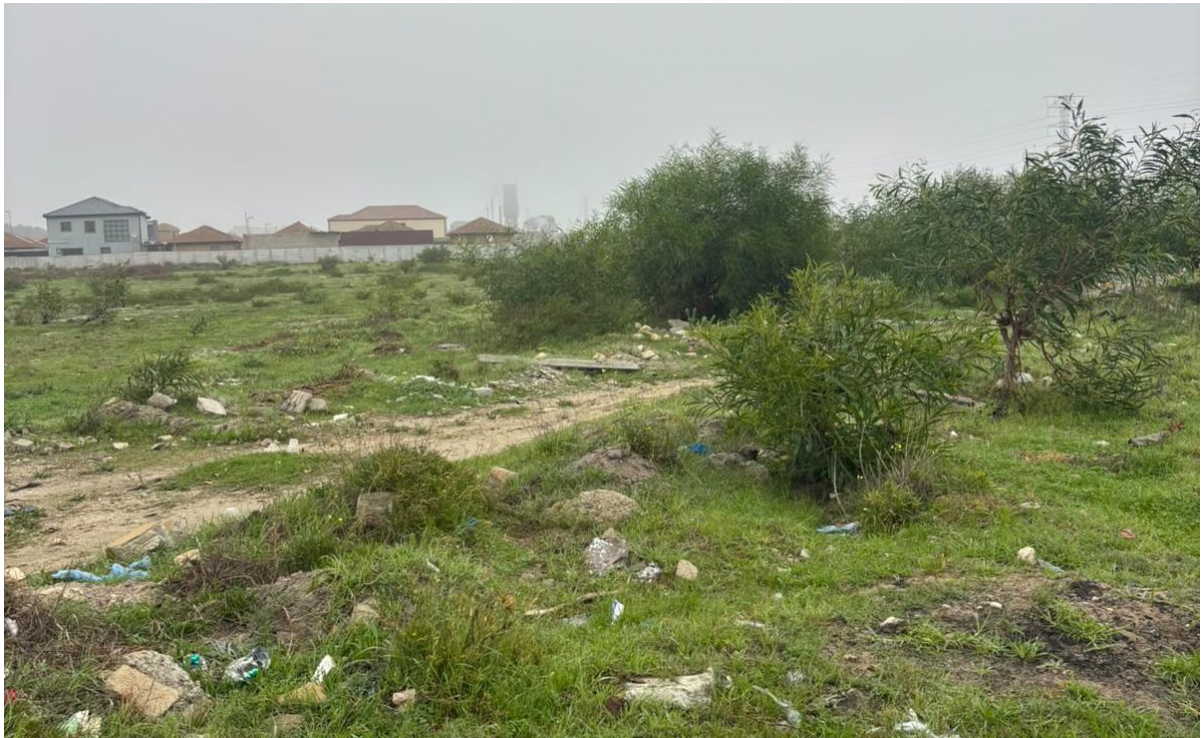
Photo 2: View of Erf 3733 where Wetland 7 was unlawfully piped. The vegetation on site is dominated by *Pennisetum clandestinum* (kikuyu grass) and *Acacia saligna* (Port Jackson), both of which are alien invasive species. Litter and evidence of general anthropogenic disturbance are also visible.

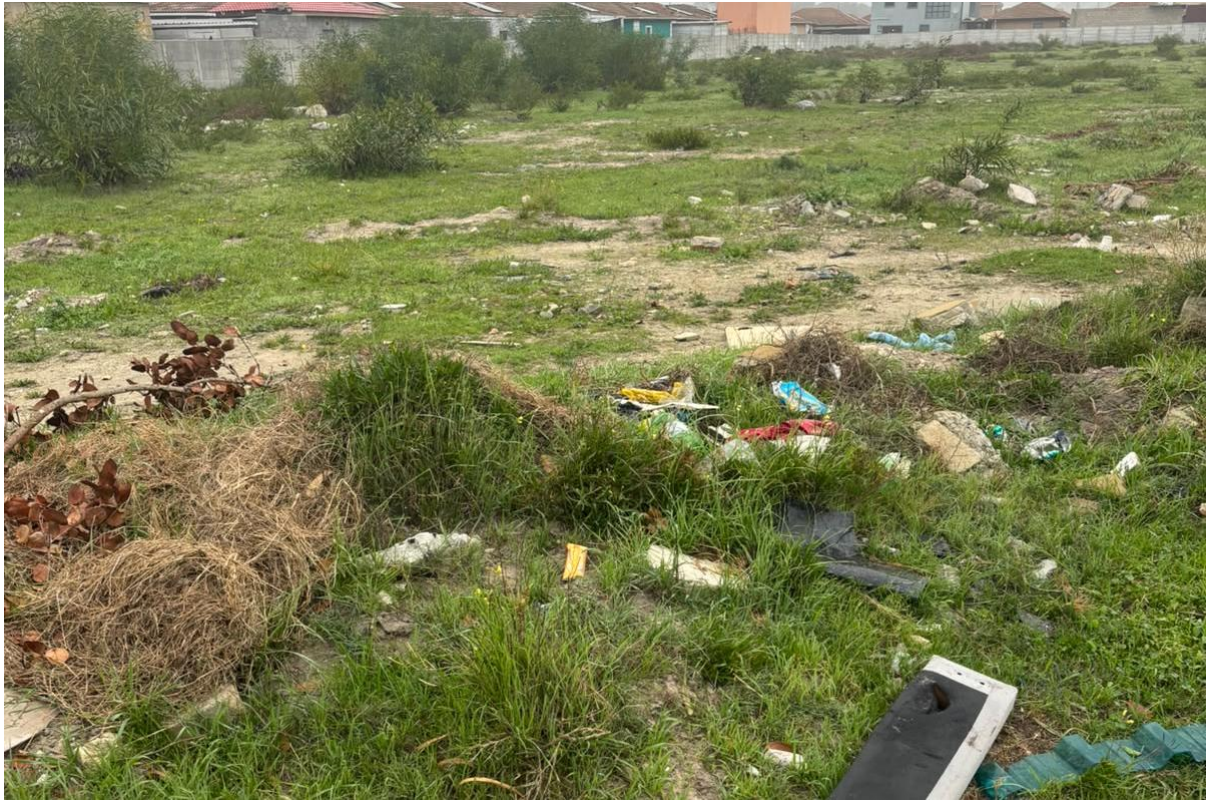
Photo 3 View of Erf 3733 where Wetland 7 was unlawfully piped. A portion of the residential development authorised under the 2011 Environmental Authorisation is visible in the top of the photograph. The vegetation on site is dominated by *Pennisetum clandestinum* (kikuyu grass) and *Acacia saligna* (Port Jackson), both of which are alien invasive species. Litter and evidence of general anthropogenic disturbance are also visible.

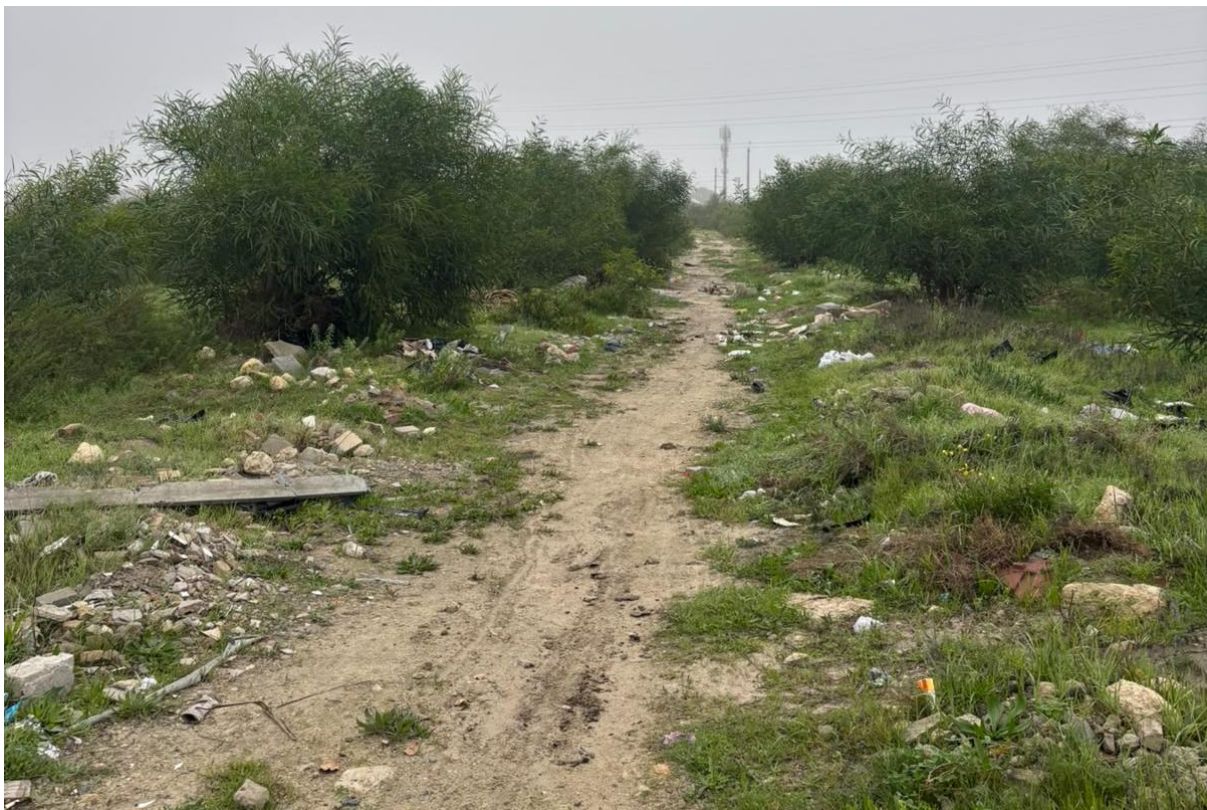
Photo 4: View of Erf 3733 where Wetland 7 was unlawfully piped. The vegetation on site is dominated by *Pennisetum clandestinum* (kikuyu grass) and *Acacia saligna* (Port Jackson), both of which are alien invasive species. Litter and evidence of general anthropogenic disturbance are also visible.

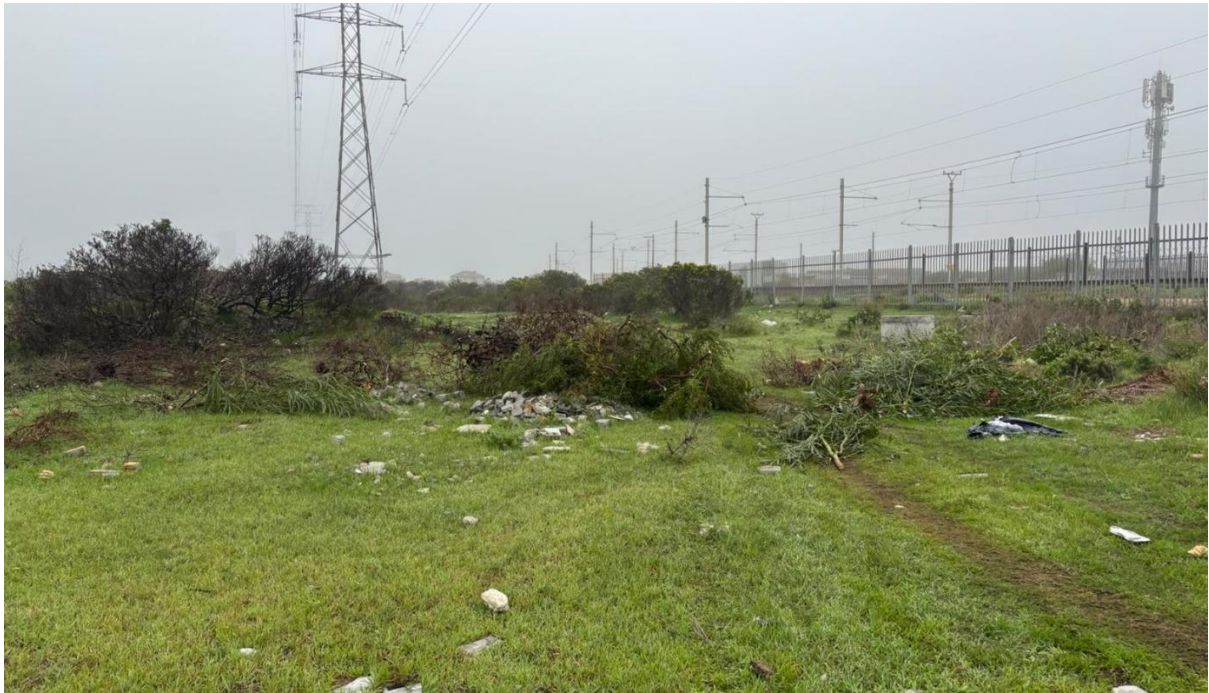
Photo 5: View of the open space area north of Erf 3733 and south of the railway line, where Wetland 7 was unlawfully piped. The Eskom powerlines, for which the servitude was retained as open space, are visible overhead. Evidence of attempted alien vegetation clearing, as well as litter and rubble dumping, can also be seen.

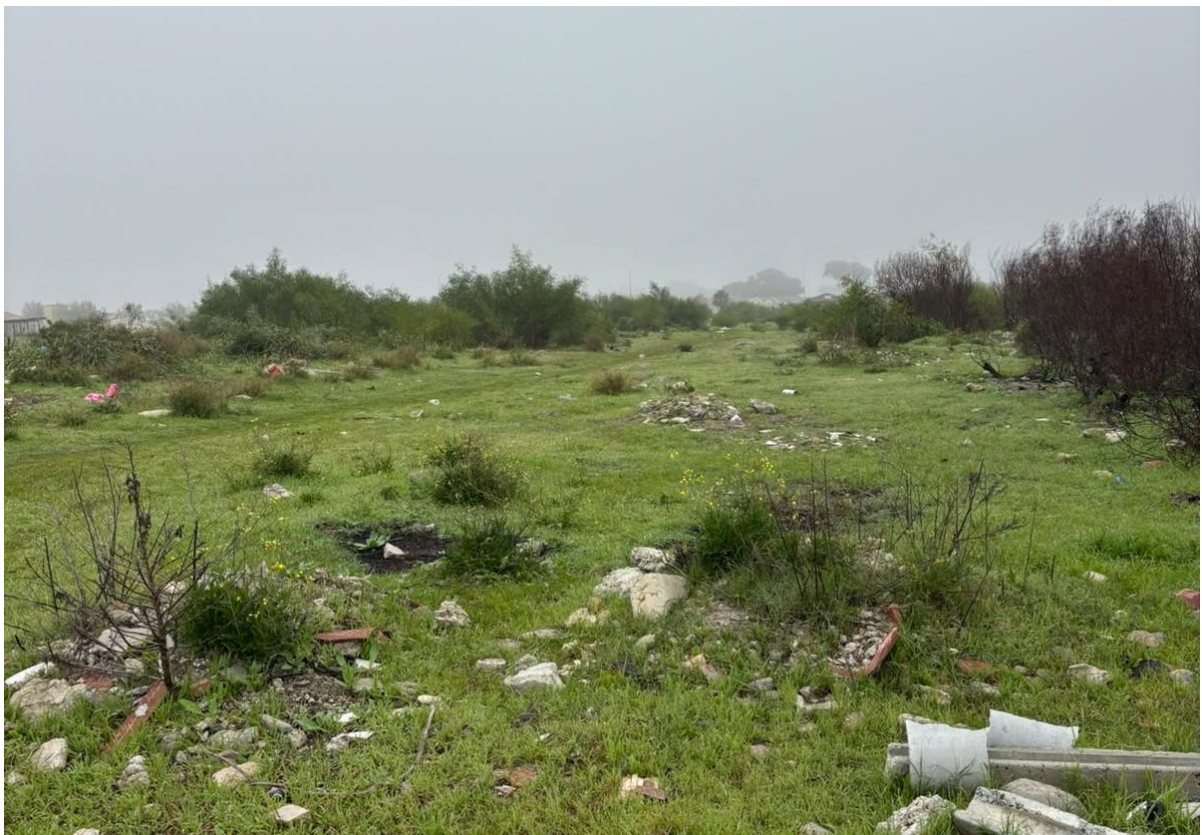
Photo 6: View of the open space area north of Erf 3733 and south of the railway line. Alien invasive vegetation and litter are present throughout the area.

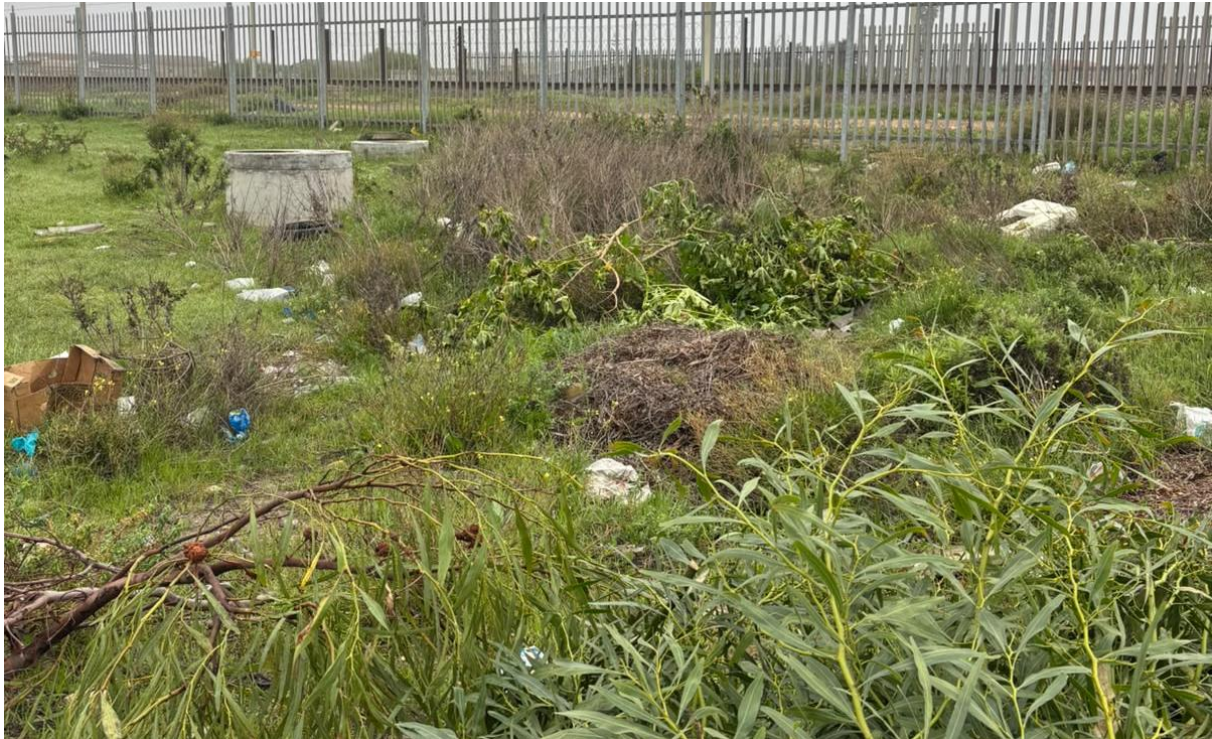
Photo 7: View of the open space area north of Erf 3733 and south of the railway line, where Wetland 7 was unlawfully piped. Evidence of attempted alien vegetation clearing, as well as litter and rubble dumping, can also be seen.

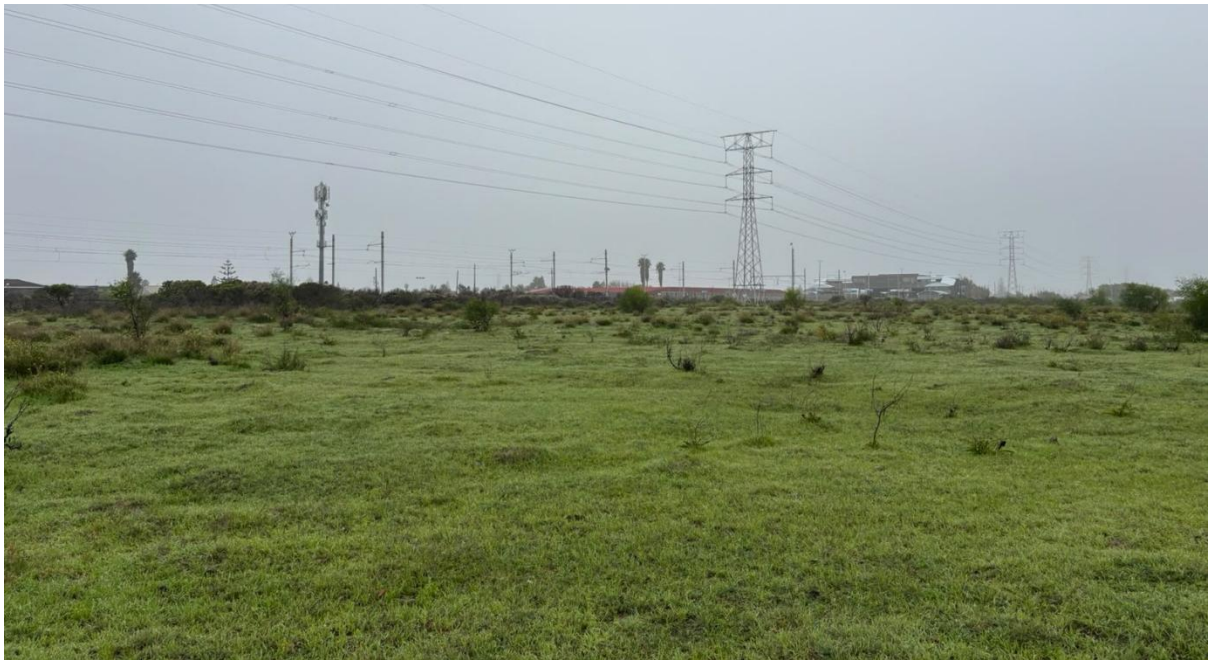
Photo 8: Representative view of Erf 3733. Alien invasive vegetation is present throughout the area. The Mandalay Railway station can be seen in the background of the photograph.

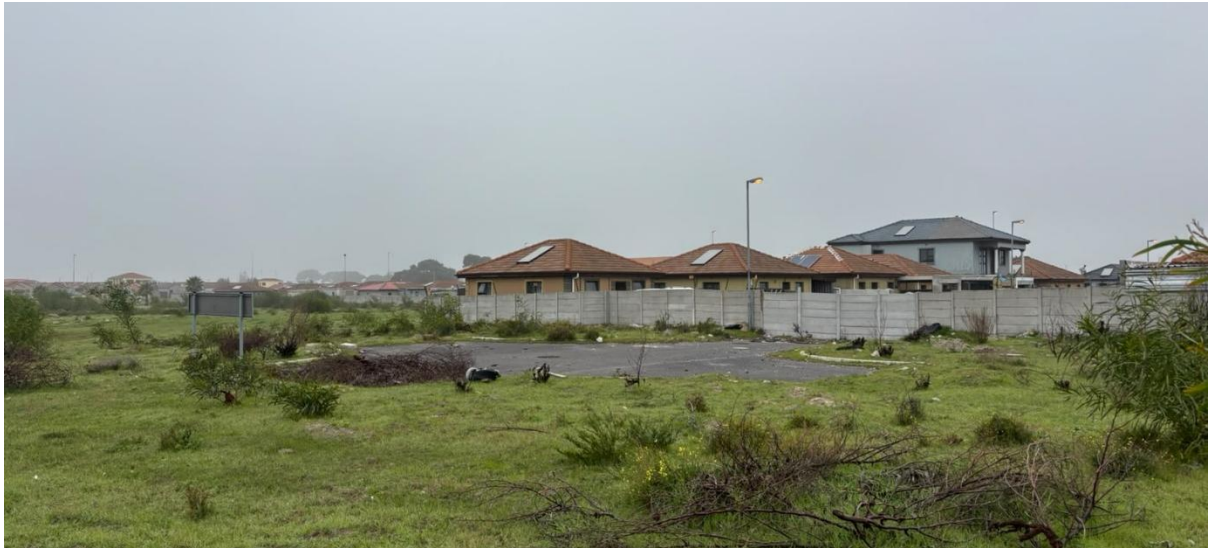
Photo 9: View of the southern boundary of Erf 3733 looking towards the residential development authorised under the 2011 Environmental Authorisation.

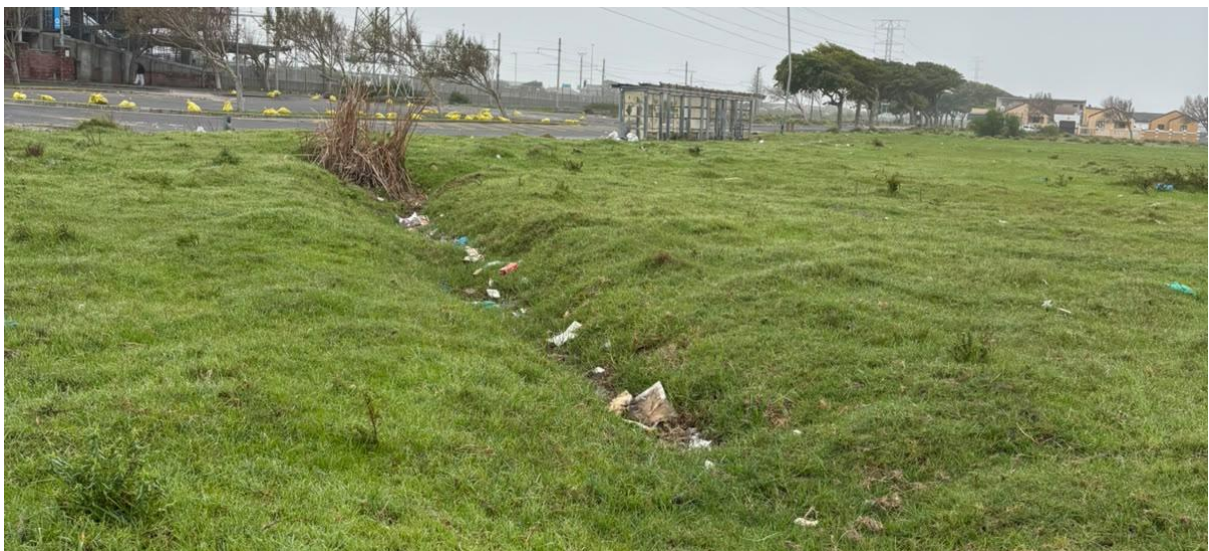
Photo 10: Artificial stormwater channel in the northeastern portion of Erf 3733, south of Mandalay Railway Station.

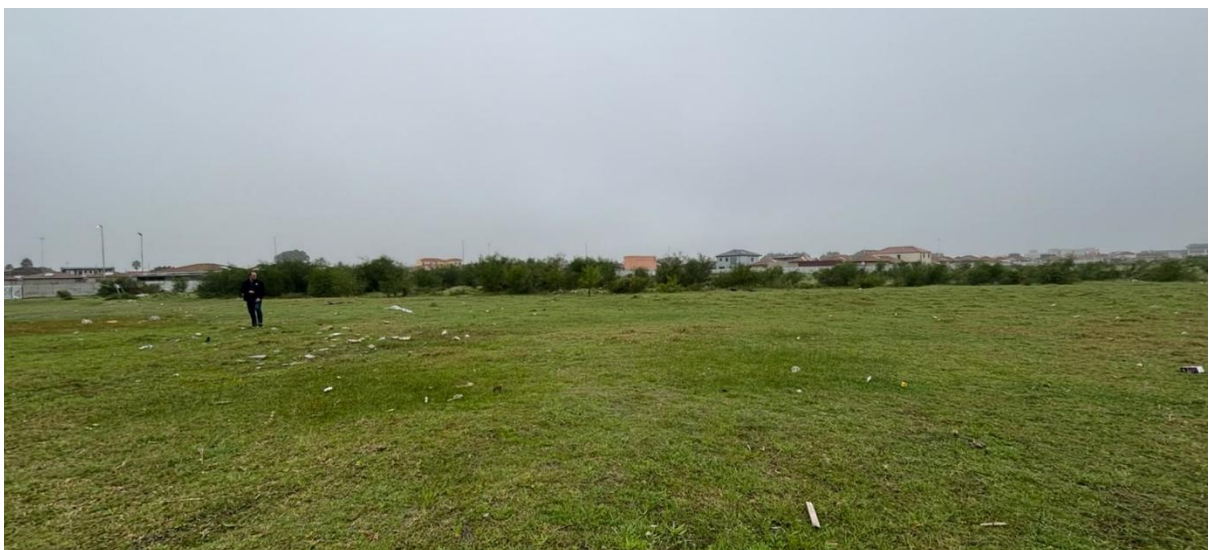
Photo 11: Representative view of the eastern portion of Erf 3733. The area is dominated by *Pennisetum clandestinum* (kikuyu grass), with the adjacent residential development visible in the background.

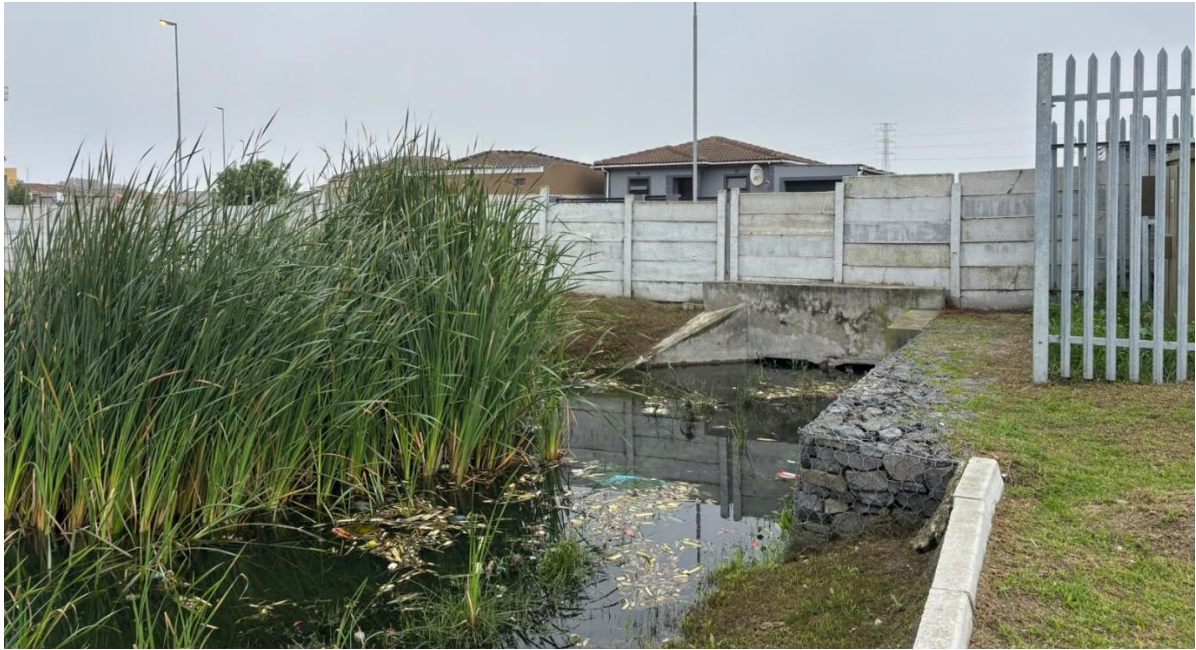
Photo 12: Stormwater pond that serves as the designated wetland offset area to compensate for impacts on Wetland 7. The inlet from the underground piped section of Wetland 7 is visible on the left-hand side of the pond.

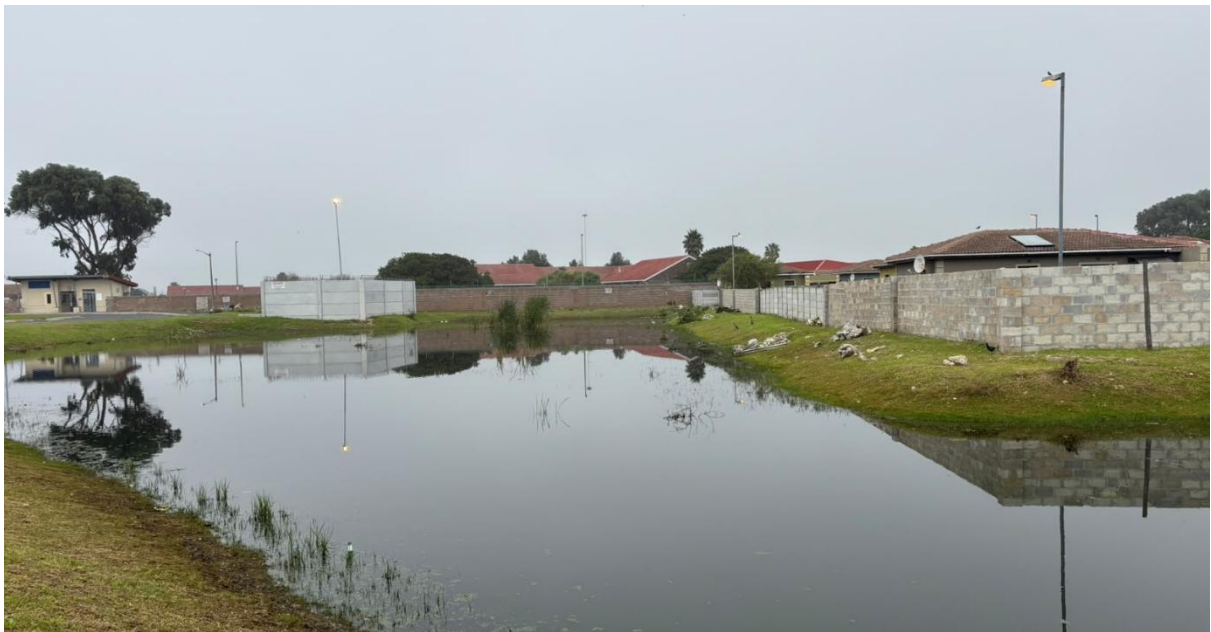
Photo 13: Stormwater pond that serves as the designated wetland offset area to compensate for impacts on Wetland 7. The residential development established as part of the 2011 Environmental Authorisation can be seen in the background of the photograph.
