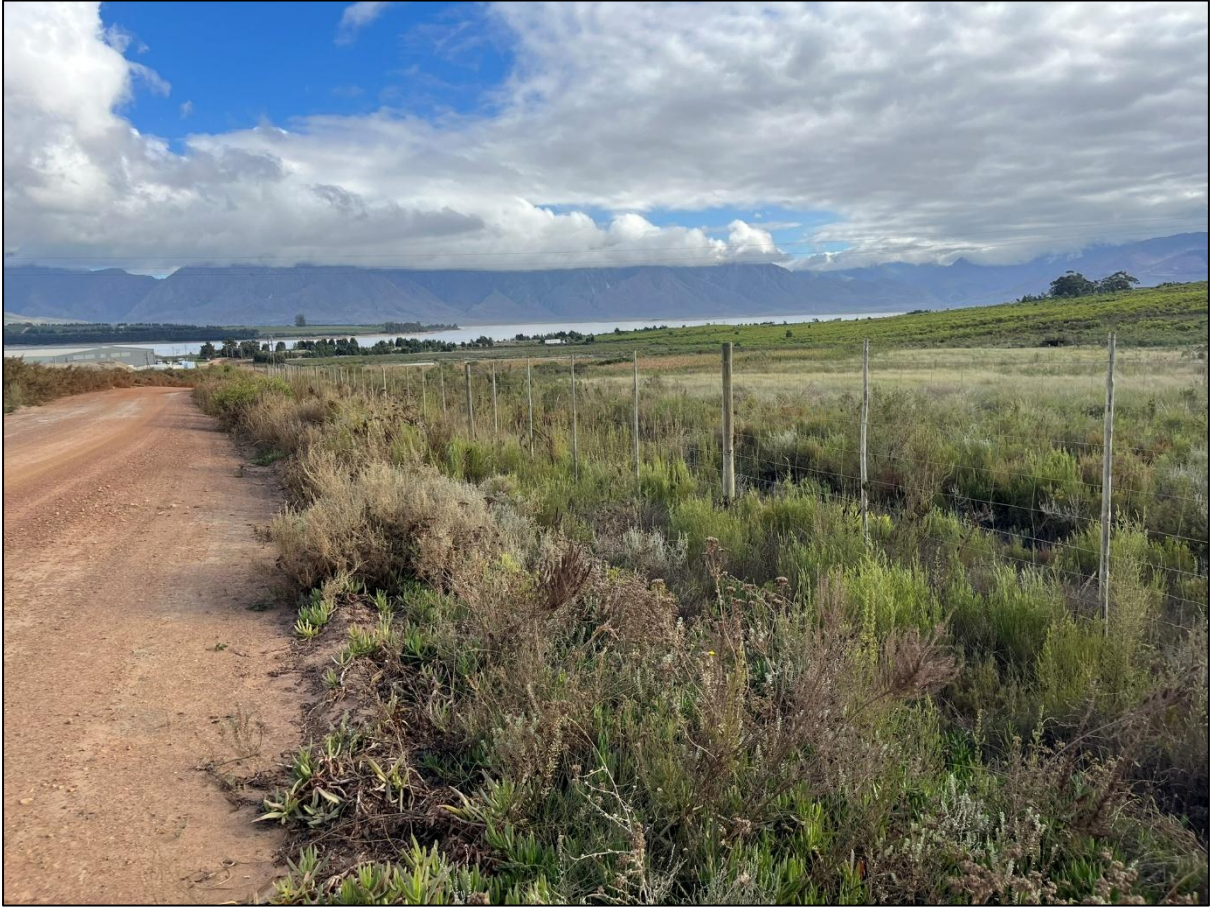
*Photo A: View from the gravel road along the south-west boundary of the property showing the remaining natural vegetation and the gentle sloping of the area looking down towards the Theewaterskloof Dam.*

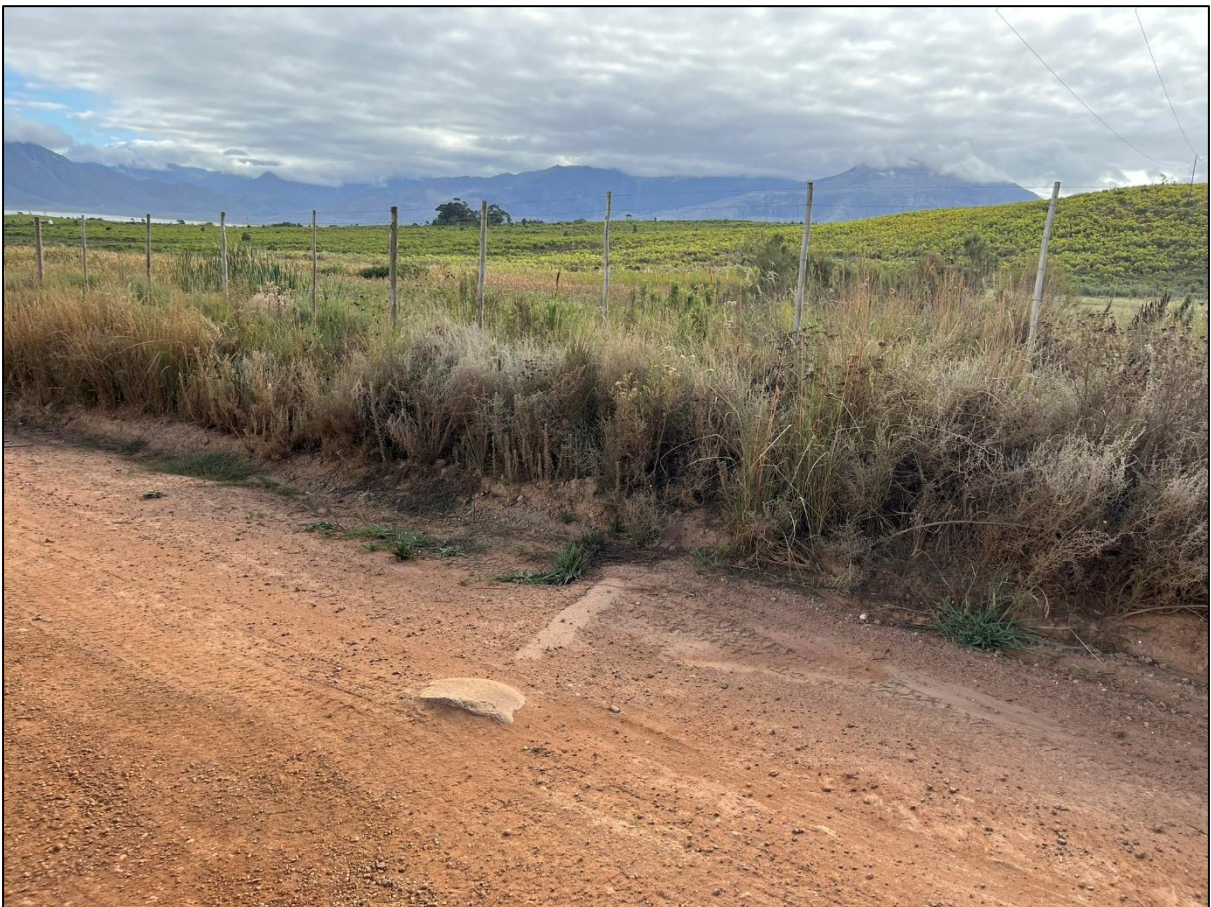
*Photo B: View from the gravel road on the south-western boundary showing the point where the off-site drainage line flows underneath the road and into the property (culvert). One can see in the background the indigenous vegetation that is lightly invaded by alien species. Note the powerline servitude running overhead.*

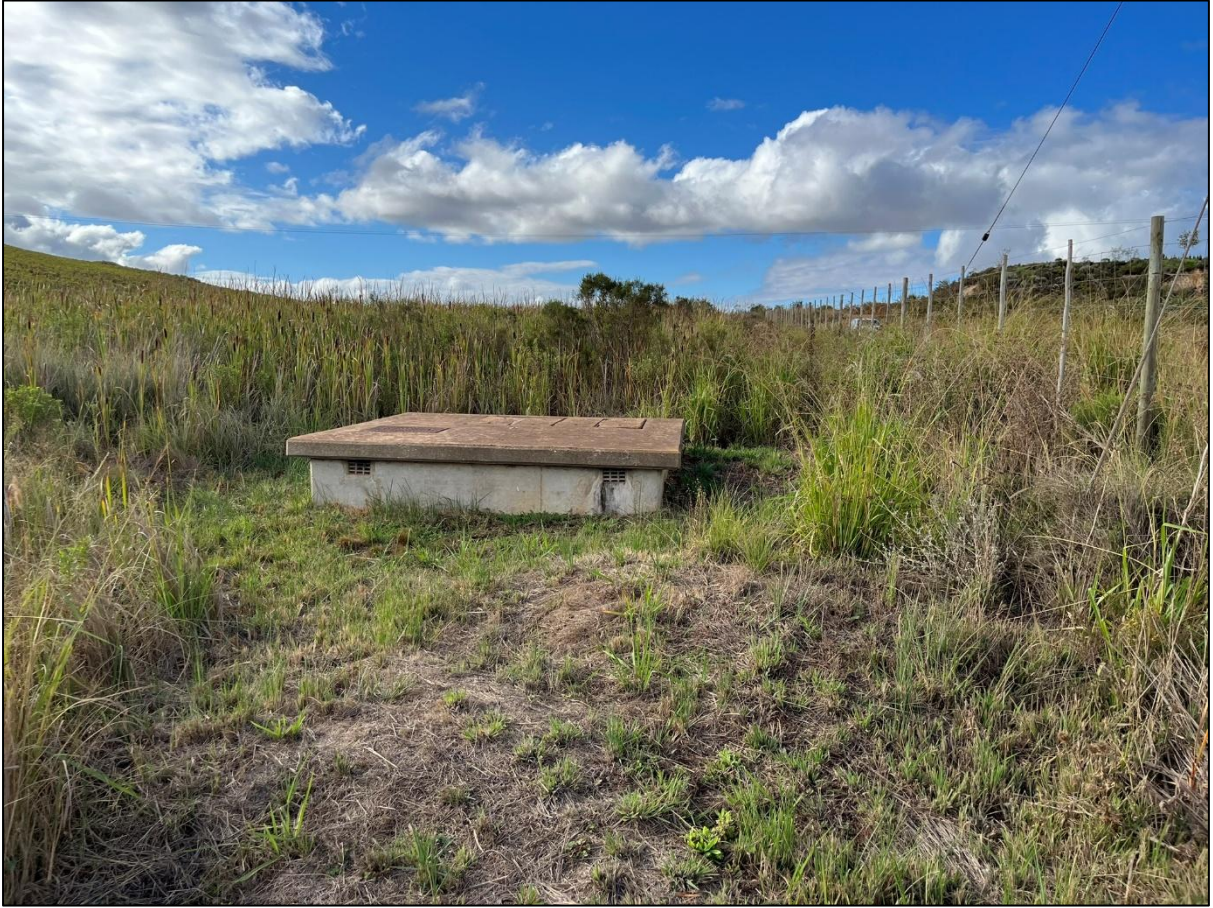
*Photo C: Drainage sump, down slope of the culvert within the property boundary on the edge of the demarcated wetland. Image was taken looking south/upslope.*

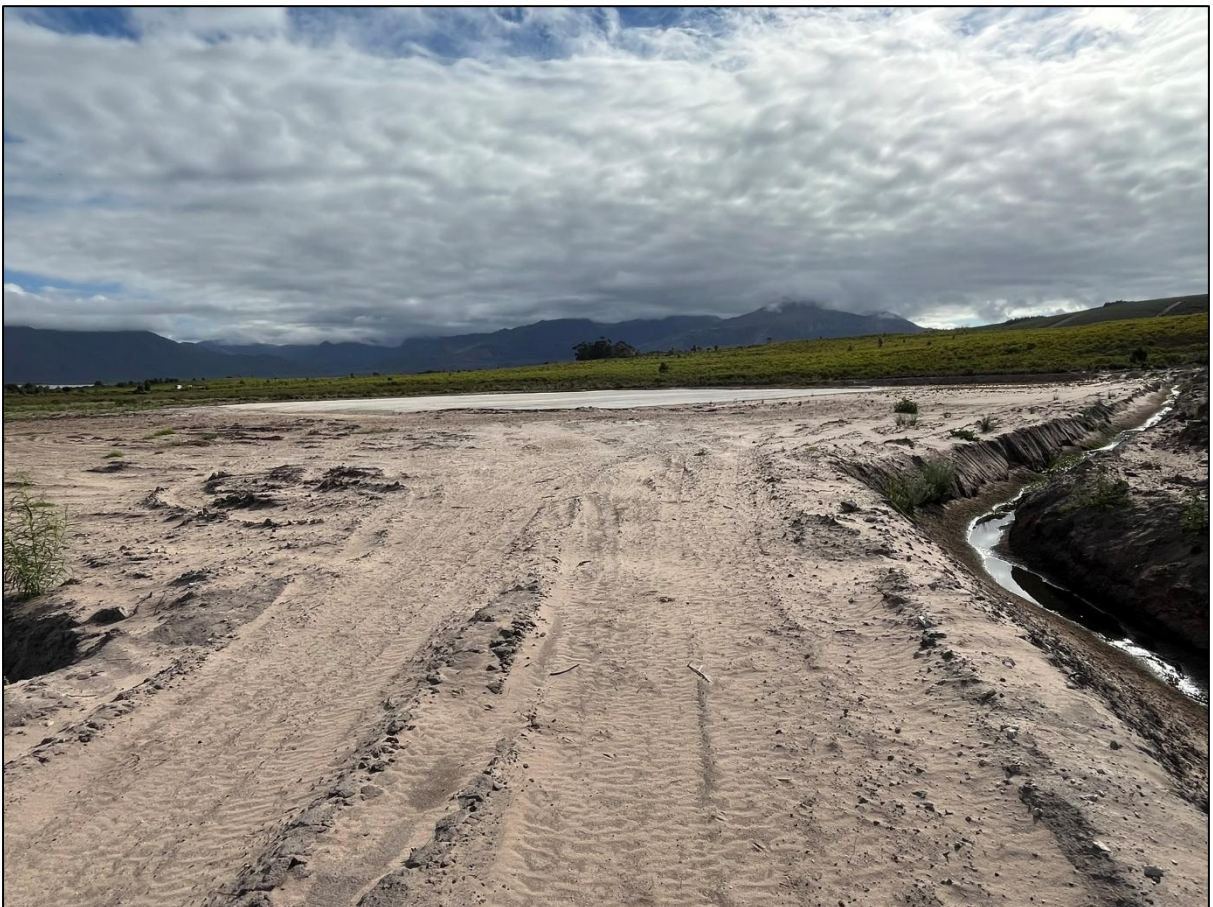
*Photo D: View from the edge of the cleared area on the western property boundary, looking northeast showing the portion of the platform already constructed. The central trench runs along the right of the photo.*

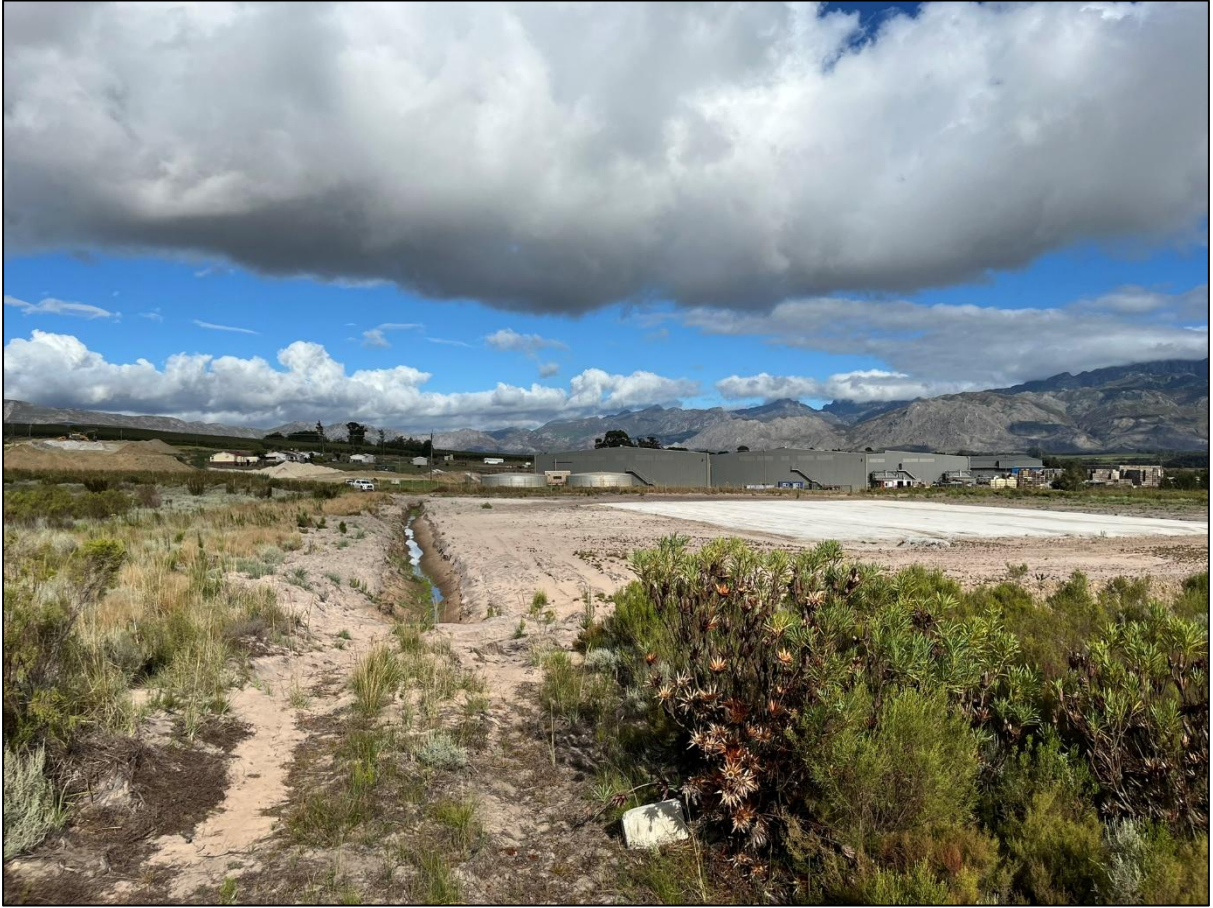
*Photo E: View from the eastern edge of the cleared area. The central drainage trench is visible with IdeaFruit pack shed and its crate storage prominent in the background with the cleared area and concrete platform visible in the foreground.*

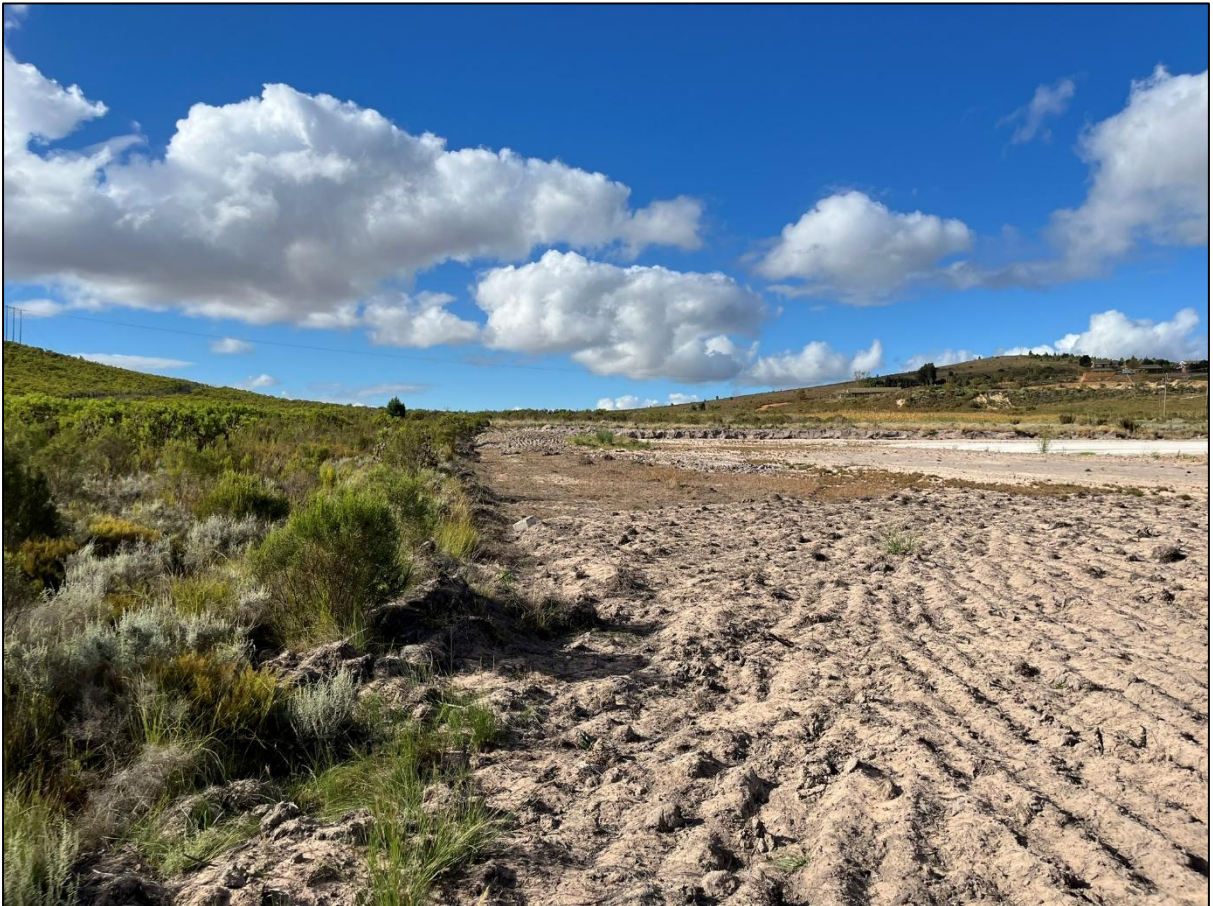
*Photo F: View from the north-east edge of the cleared area. On the left one can see the indigenous vegetation. The gentle slope of the property is evident from this image.*

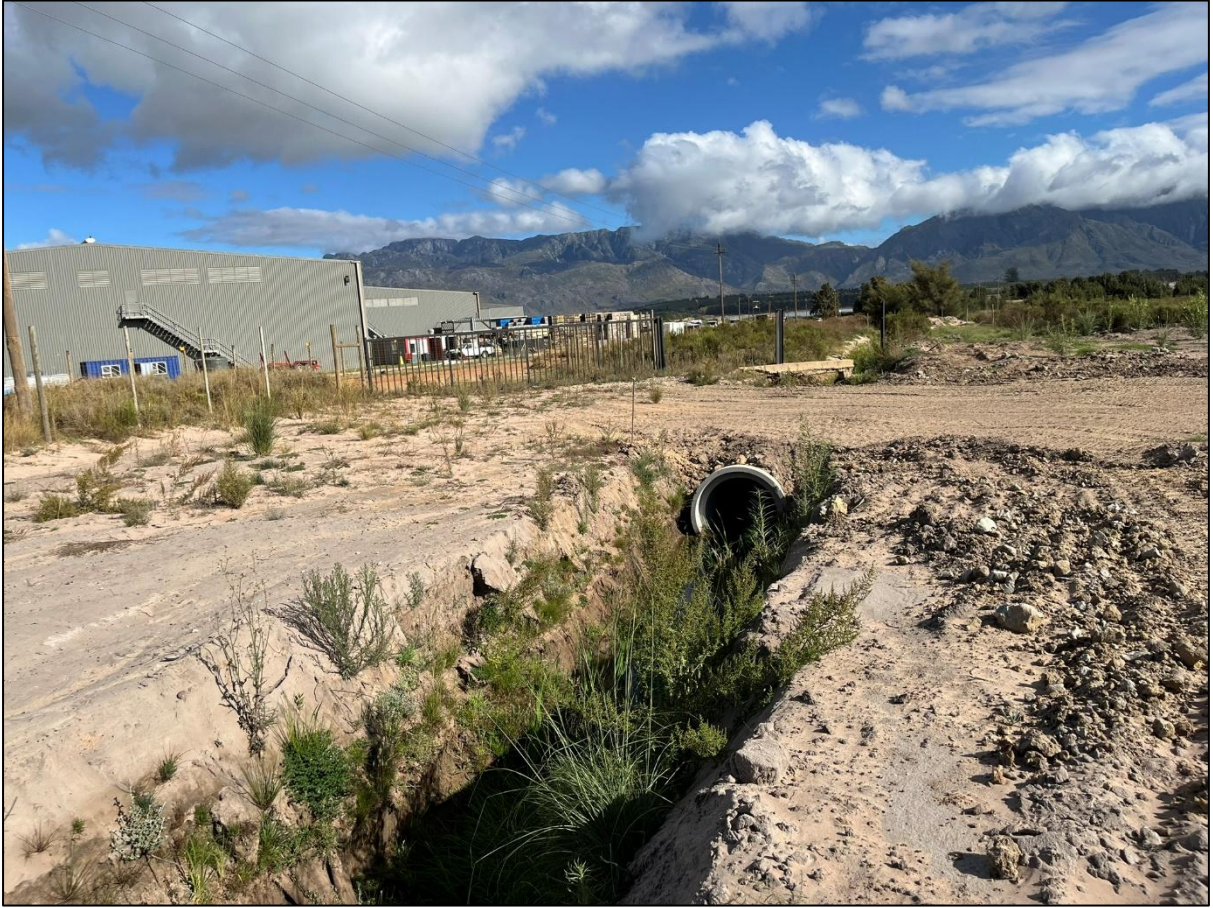
*Photo G: View the north-west corner of the cleared area looking north. In the foreground is the historical trench, with a new culvert and crossing, and, in the background (left), the IdeaFruit pack shed.*
