## PHOTO REPORT

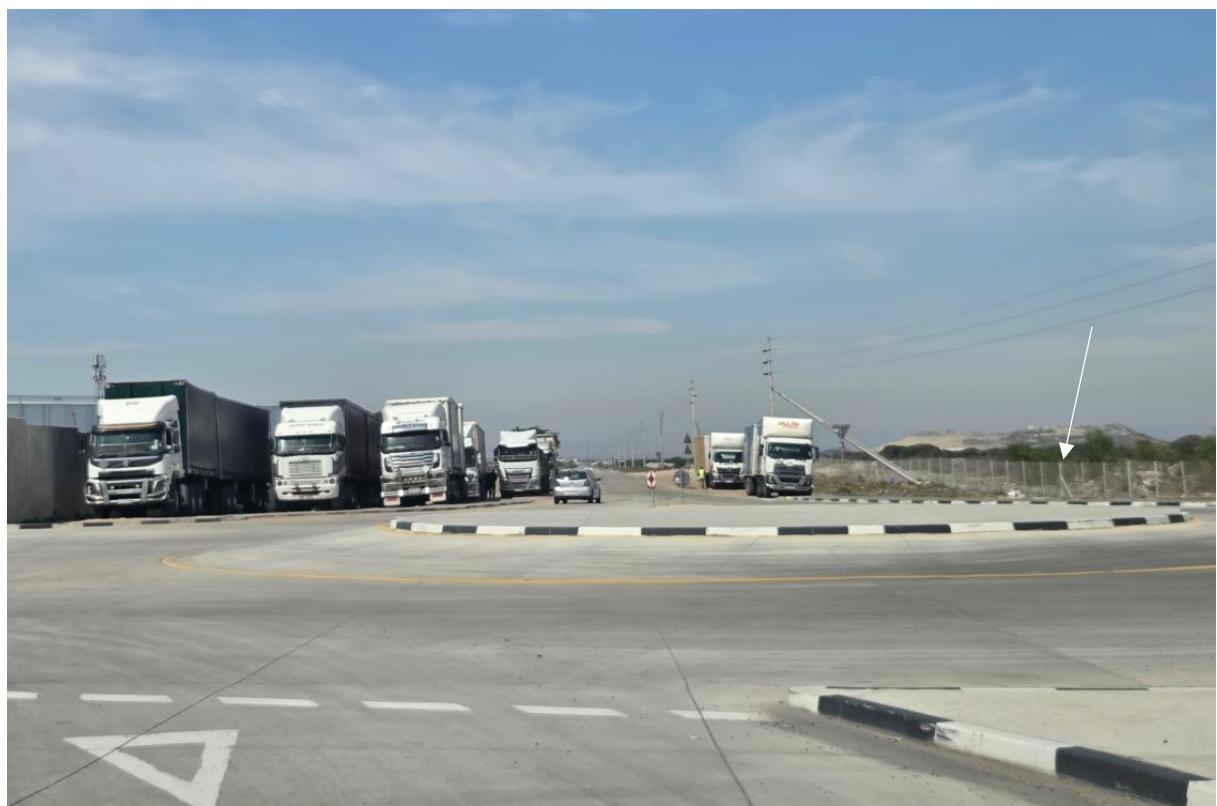
Photo 1: R 102 view towards the south, site on right pointed by arrow.

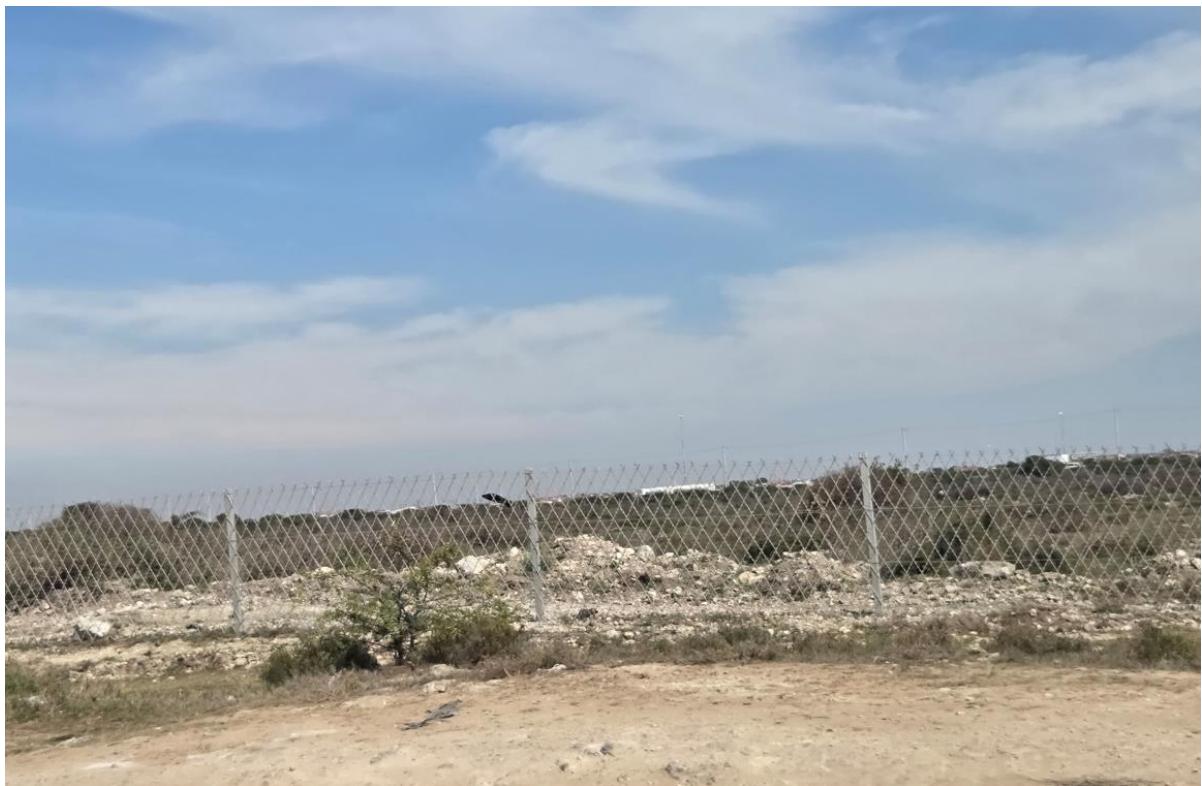
**Photo 2:** Taken from R 102, view towards the west, site is fenced with razor wire to attempt to stop illegal dumping.

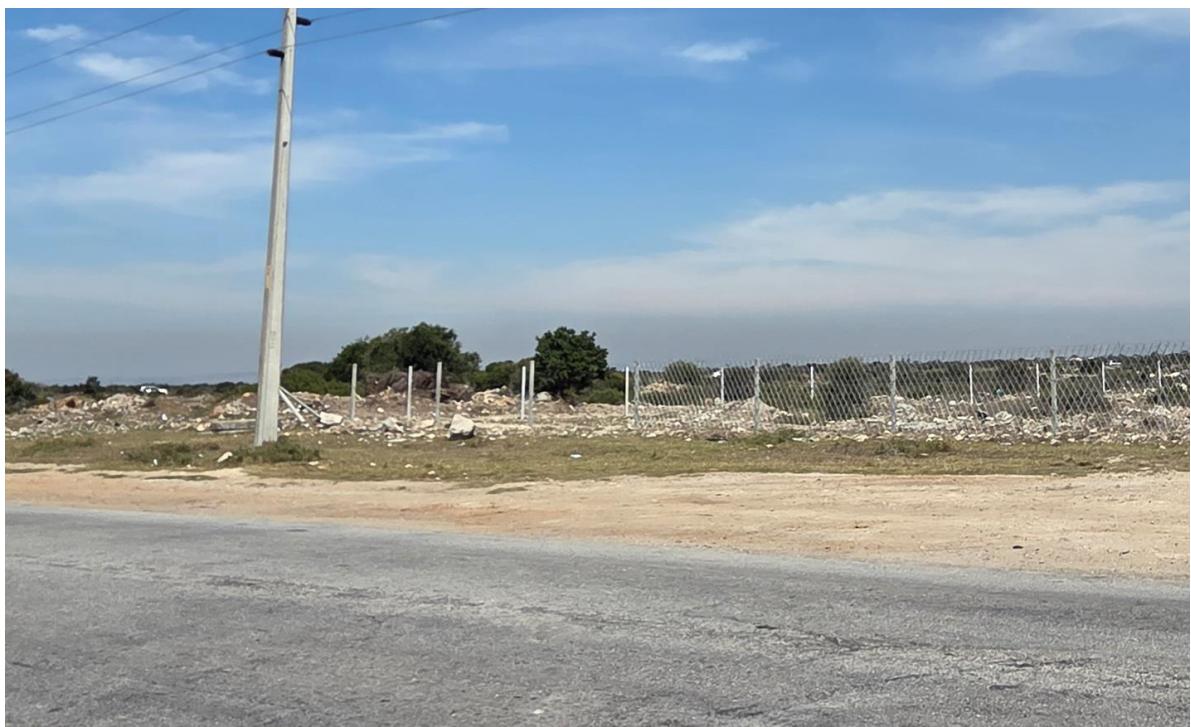
**Photo 3:** Taken from R 102 view towards the west, most southern corner of site, fence stolen by neighboring squatters.

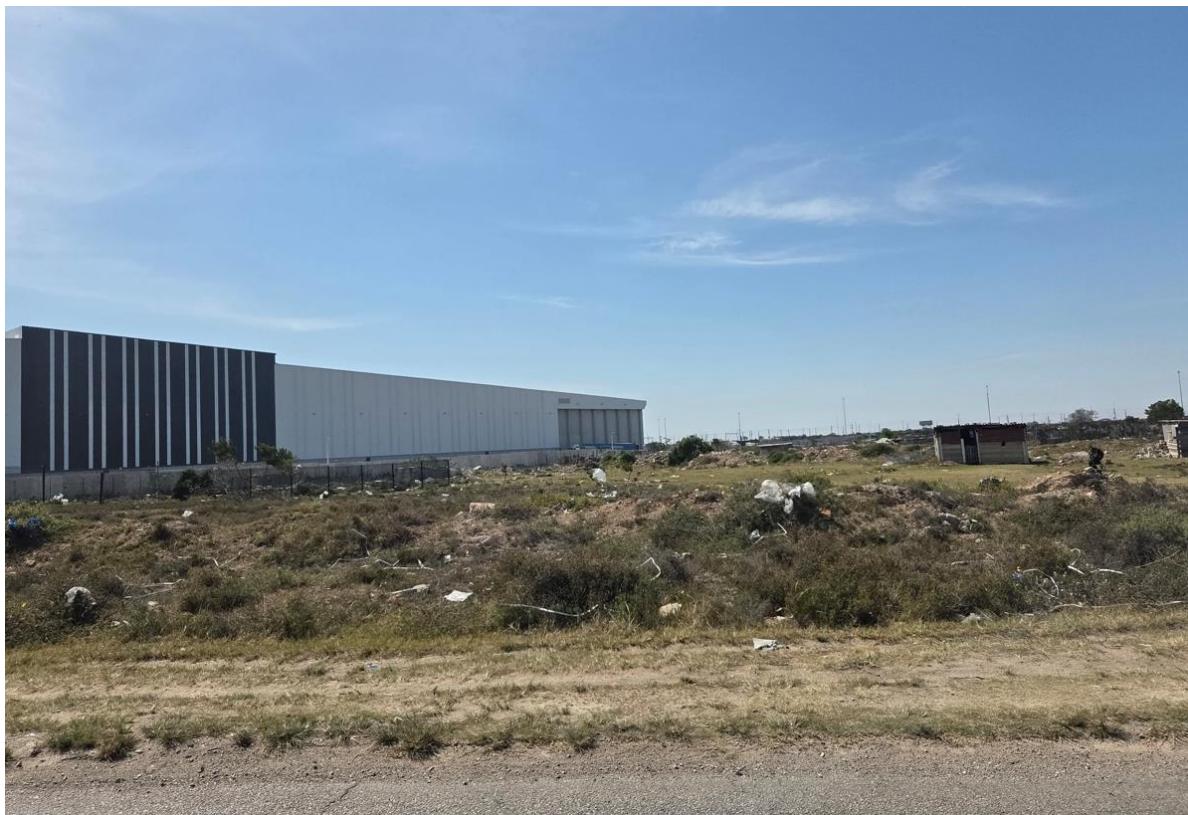
**Photo 4:** Taken from R 102, view towards the east, Shoprite Eastern Cape Distribution Centre (DC) and the squatter settlement in view.

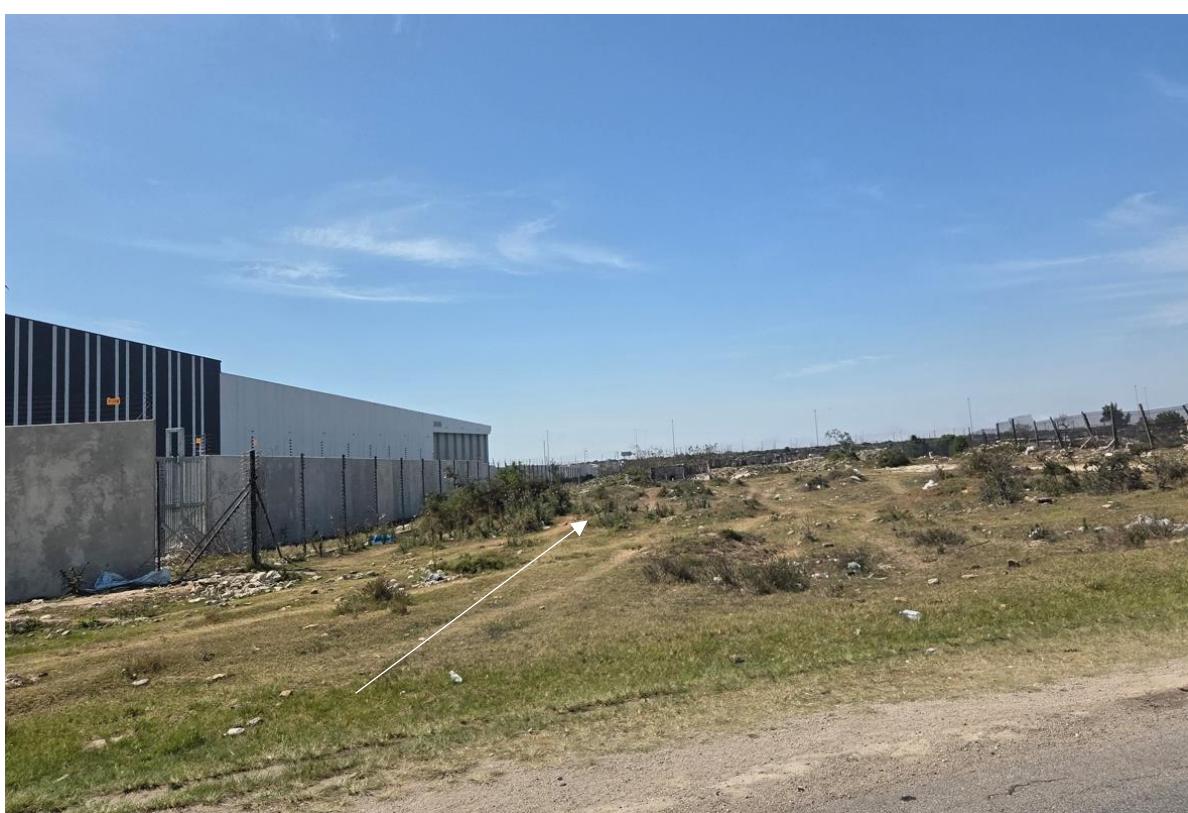
**Photo 5:** Municipal owned property on the right of the DC fence where the Municipal stormwater culvert will be located as per arrow.

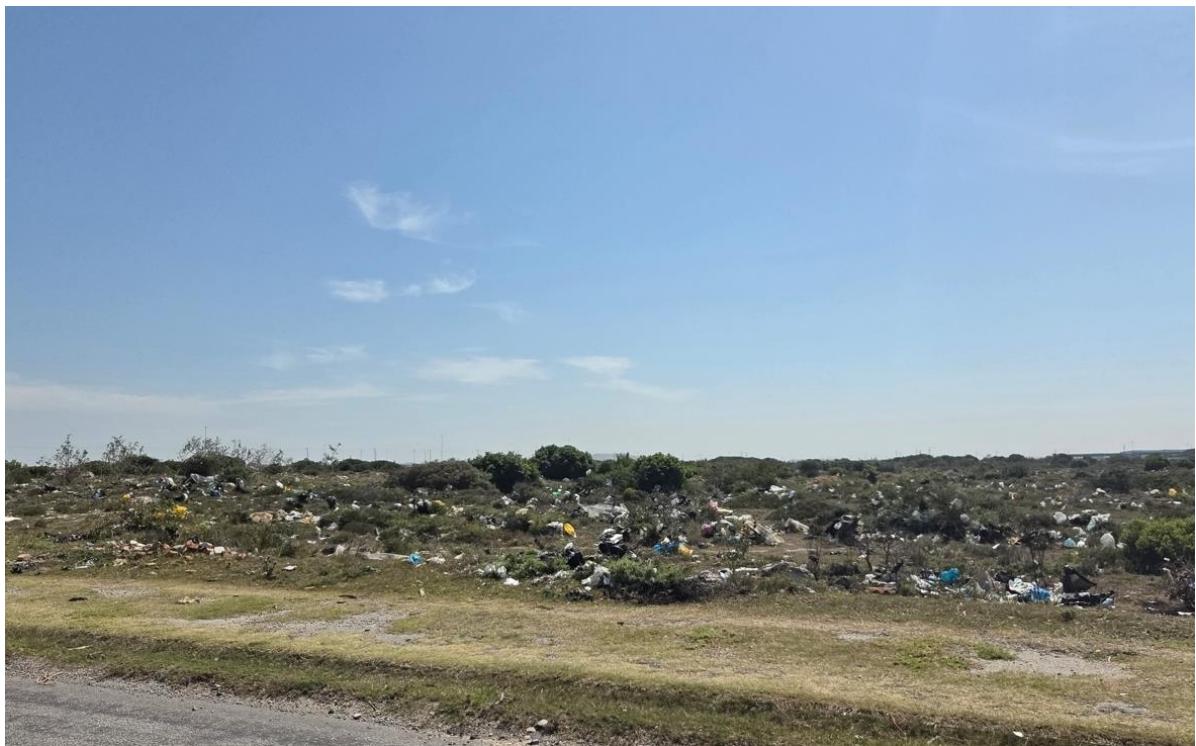
**Photo 6:** Taken from Tynira Road view towards the north, site in distance, extensive litter visible.

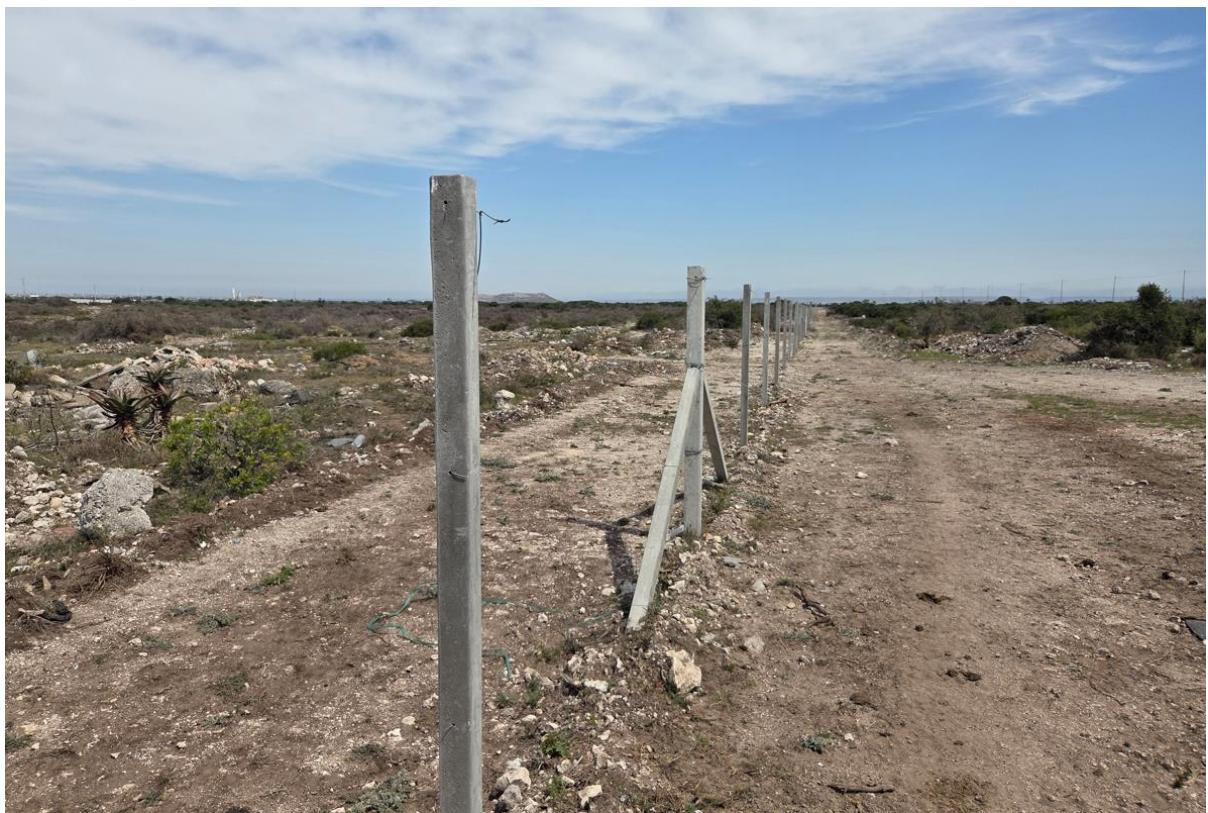
**Photo 7:** Northwestern border of the site, razor wire fence was stolen.

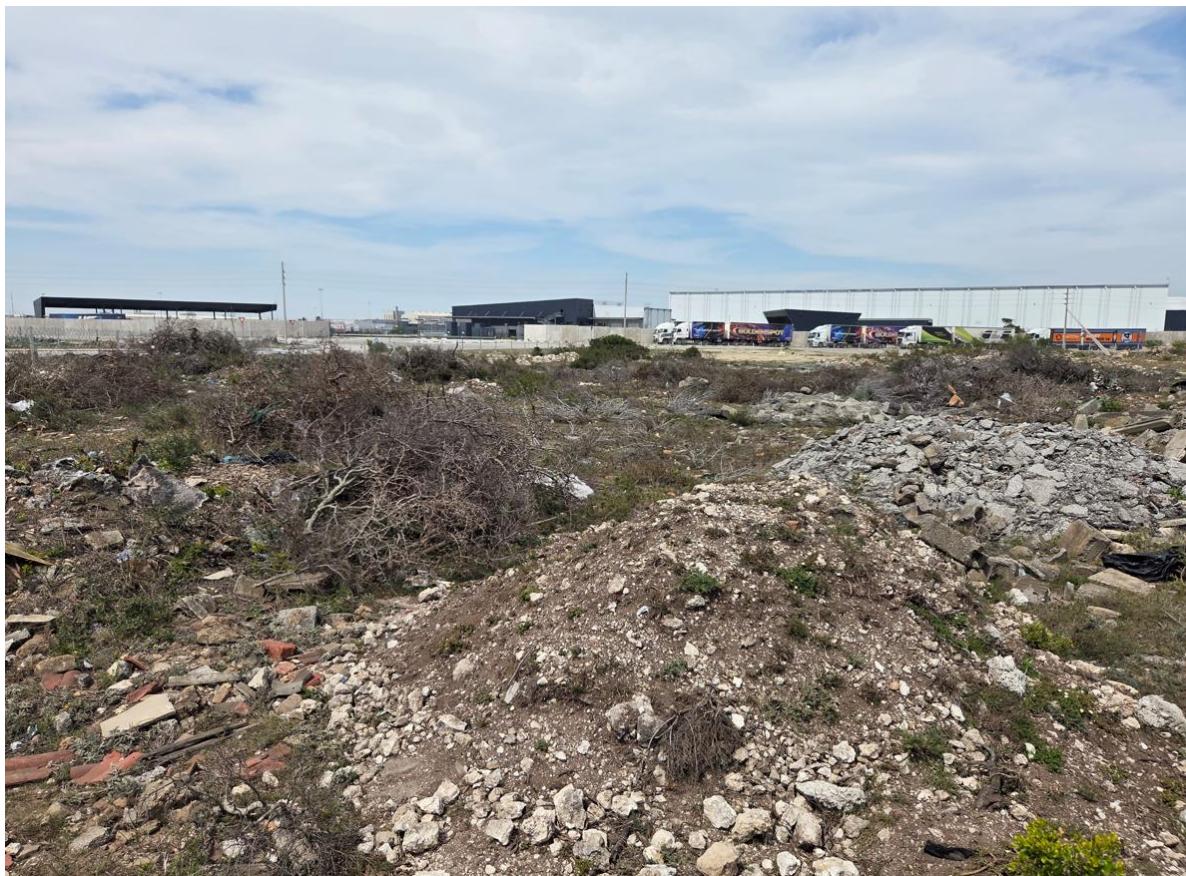
**Photo 8: View towards the east, prior to the applicant ownership the site was used as an illegal dumpsite.**

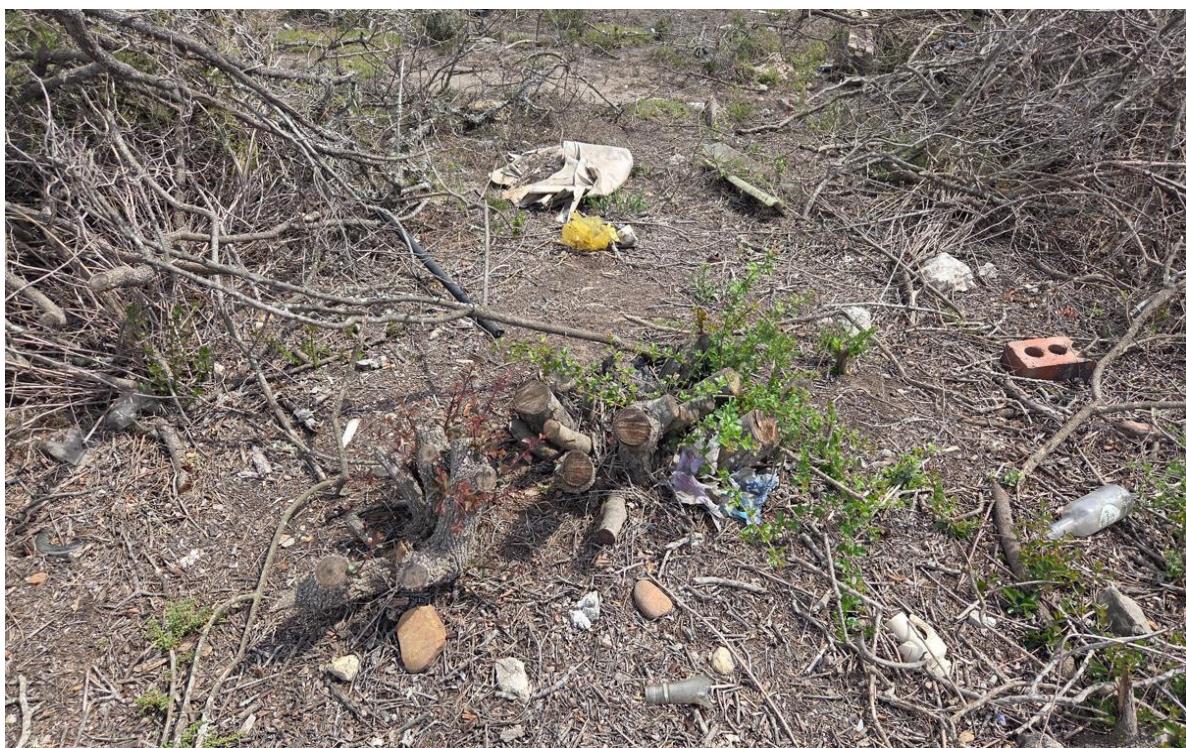
**Photo 9: None notwithstanding dumping, most vegetation on site is hacked, left to dry and then collected for firewood.**

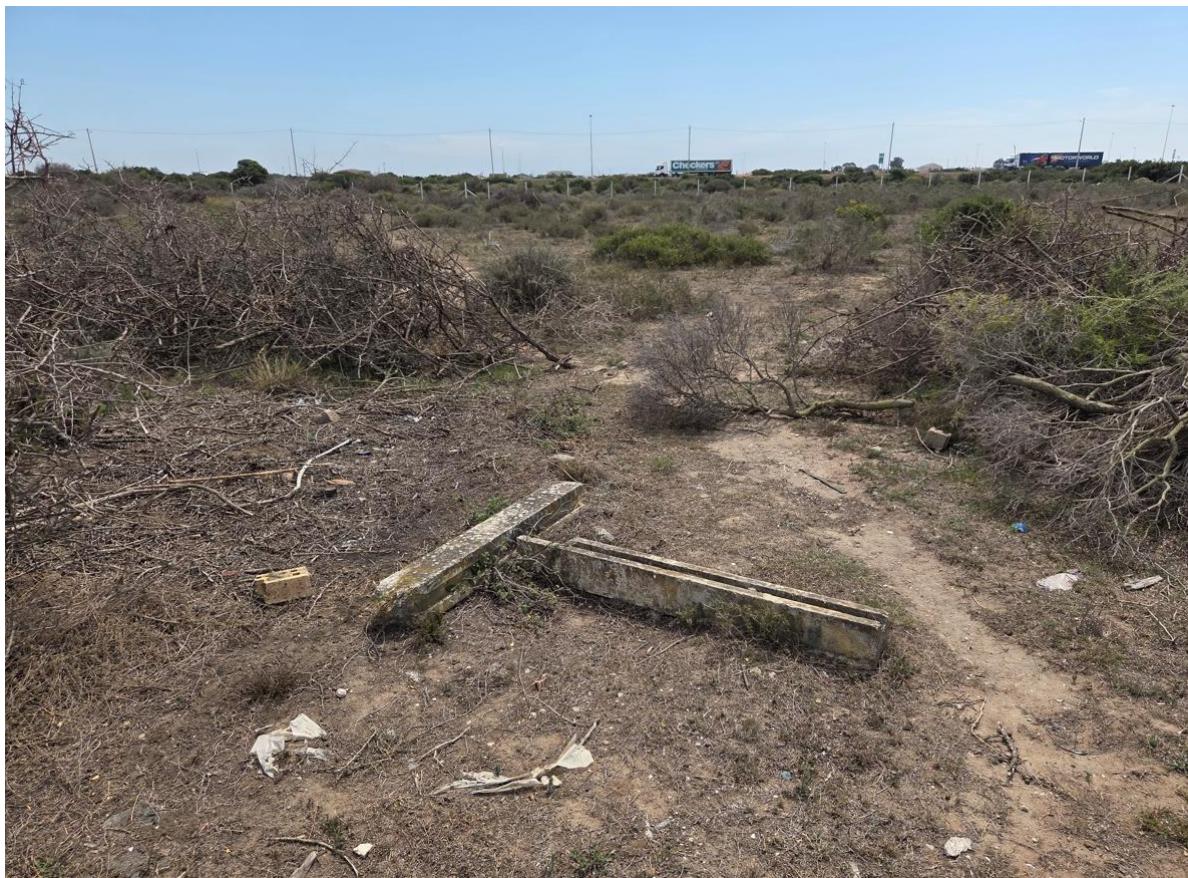
**Photo 10:** View towards the north-west, evidence of old building material dumped on site, various informal footpaths and large heaps of cut to dry vegetation dominating the landscape.

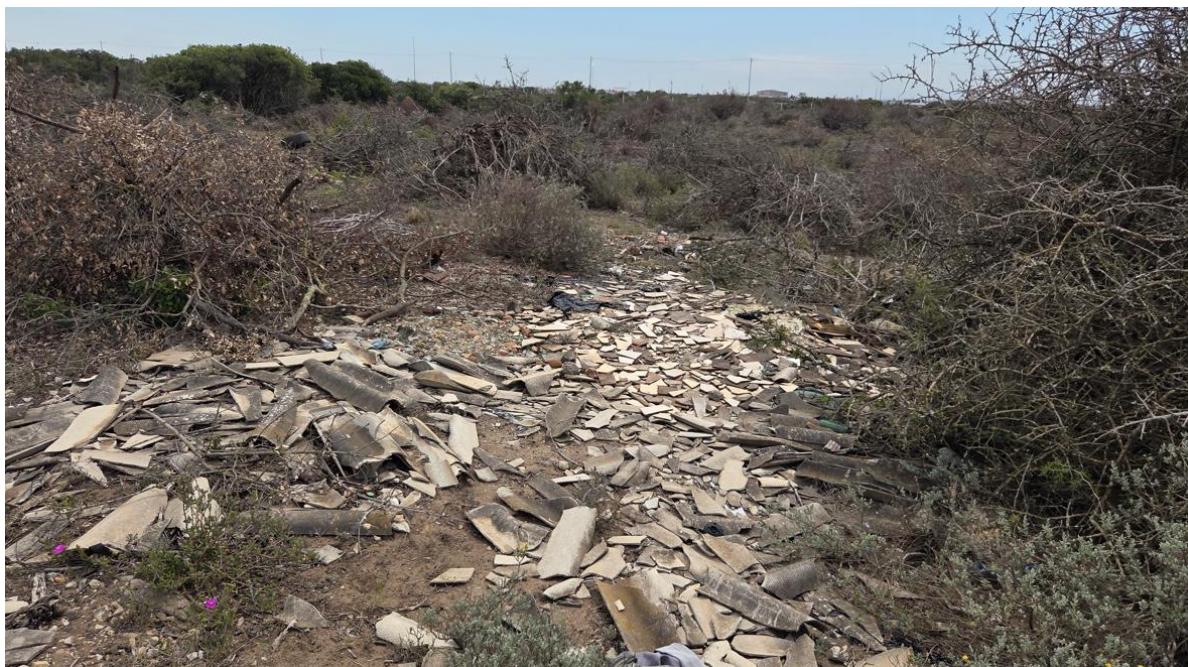
**Photo 11:** Illegal asbestos dumping, subjected to the required safe removal procedures when development takes place.

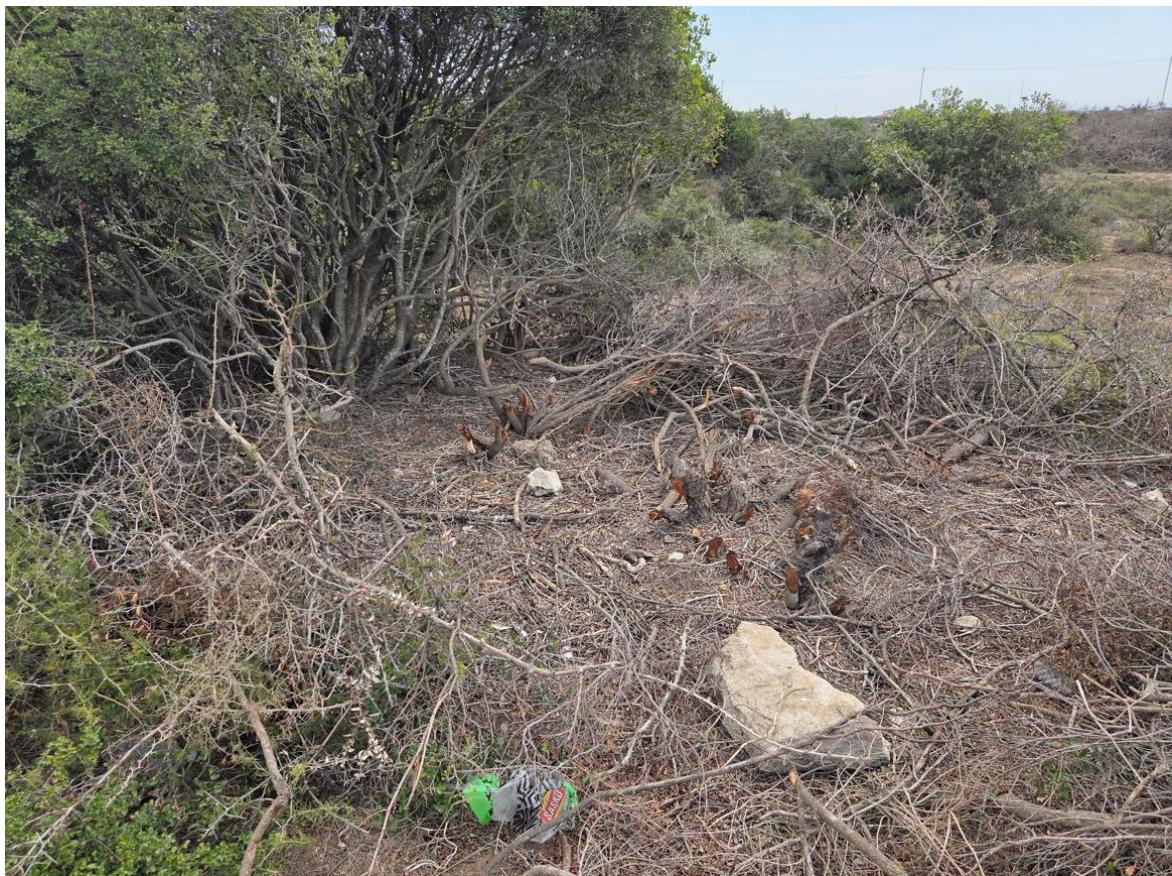
**Photo 12: Most southern edge of current bush clearing for firewood purposes.**

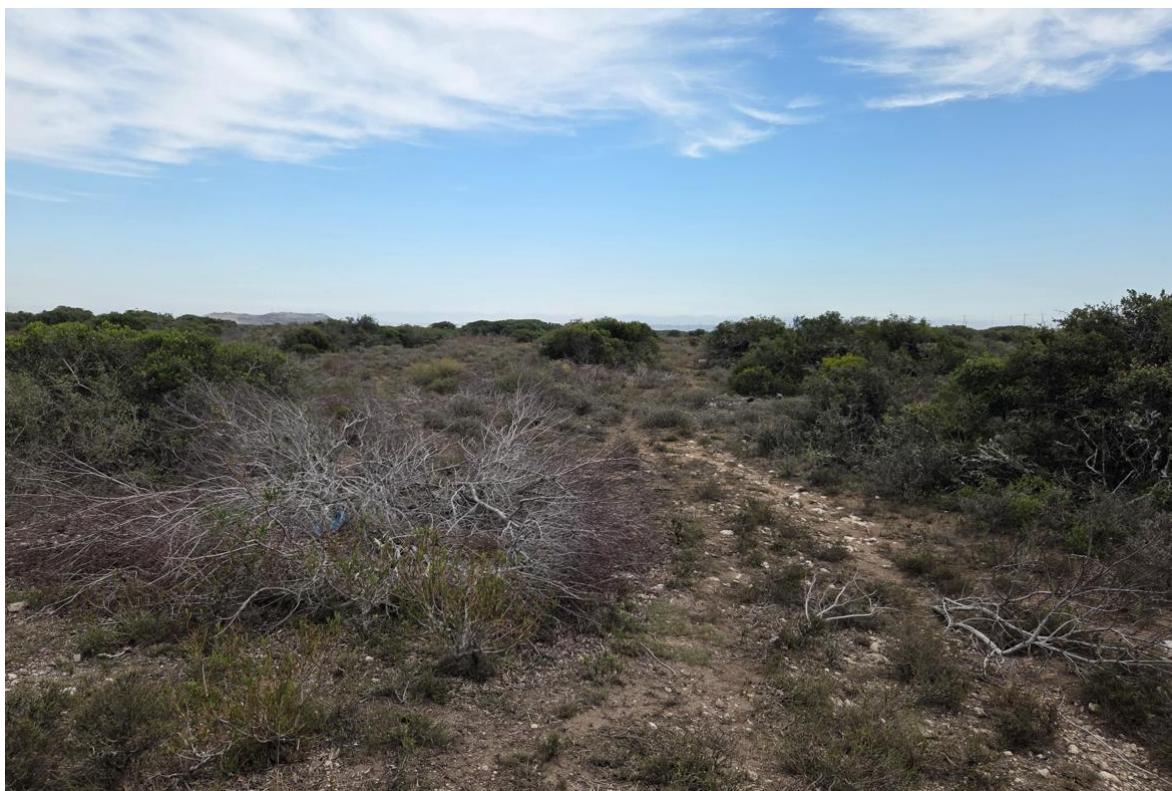
**Photo 13: Area least affected by illegal dumping and bush clearing.**

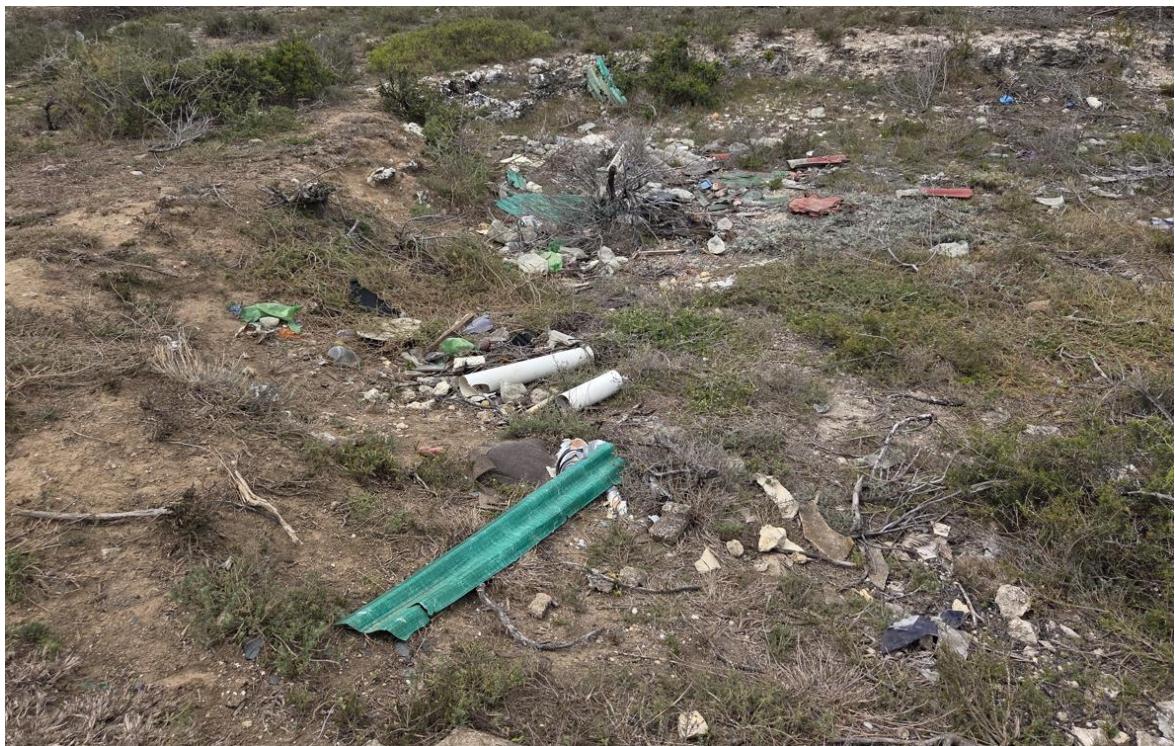
**Photo 14: Previous excavation works on site.**

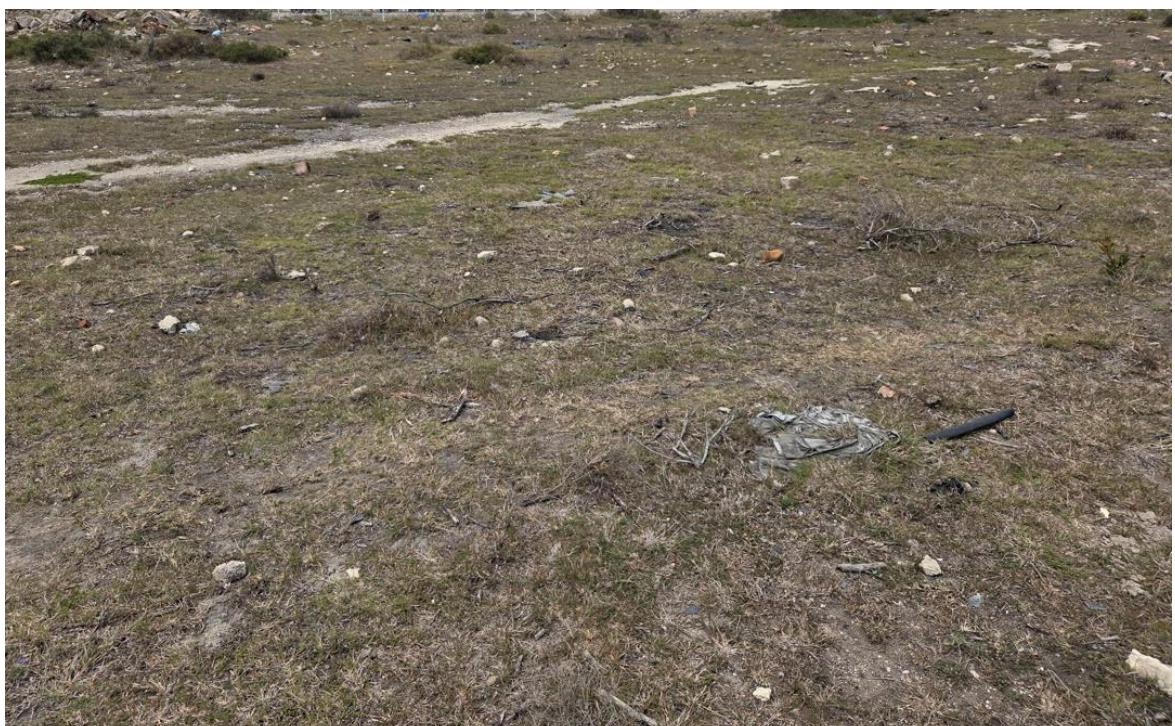
**Photo 15: Cleared open and trampled areas**

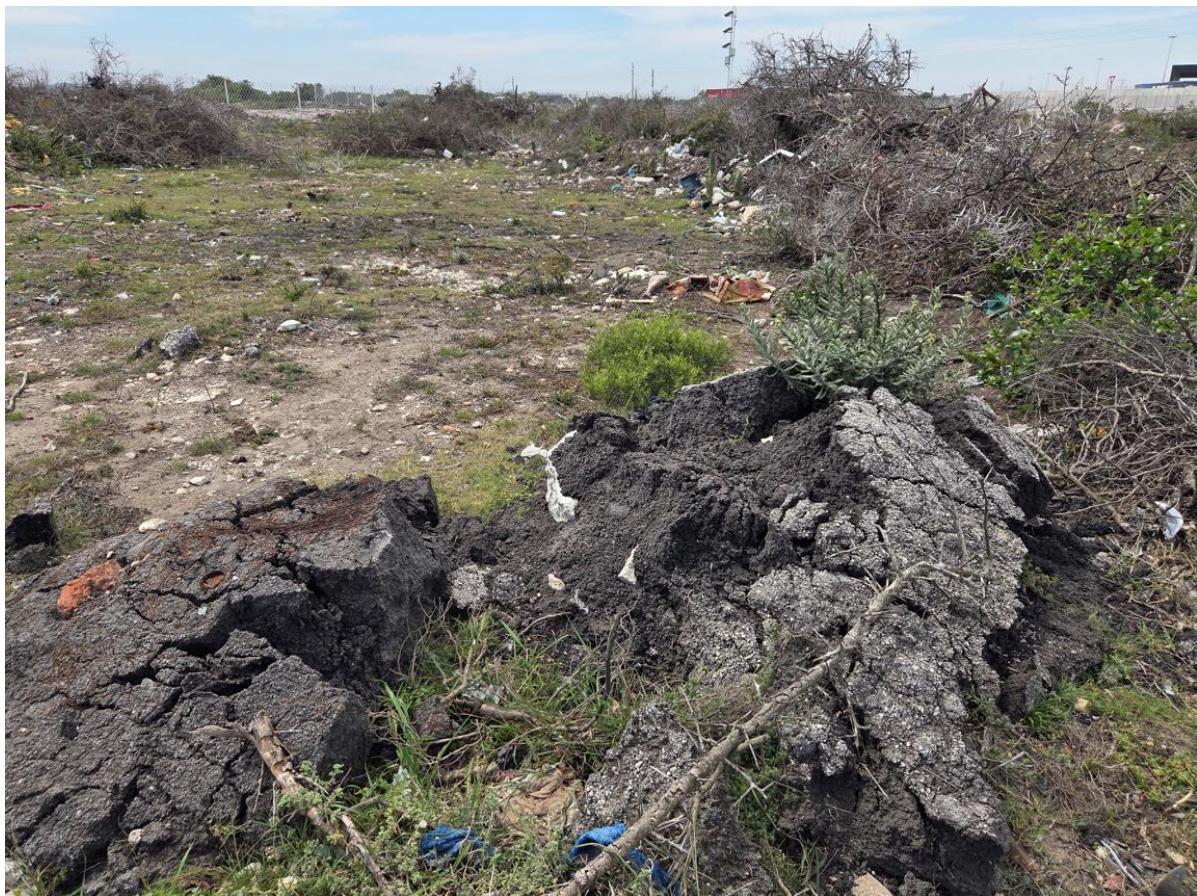
**Photo 16: Dumped asphalt.**

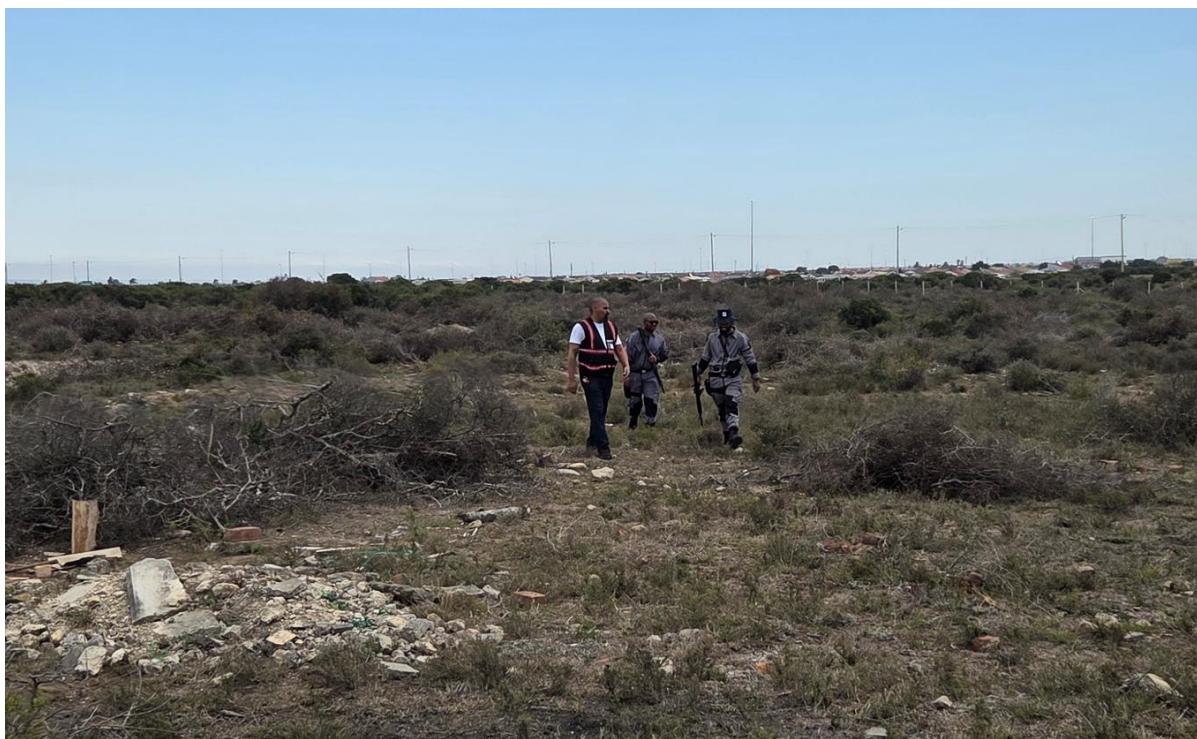
**Photo 17: Criminal activity is rife in the area, armed security required for any site visits**
