## GROUNDWATER IMPACT ASSESSMENT FOR THE PROPOSED CAPE WINELANDS AIRPORT, FISANTEKRAAL, WESTERN CAPE

# Groundwater Impact Assessment for the Proposed Cape Winelands Airport, Fisantekraal, Western Cape

Prepared by  
**GEOSS**  
01 July 2025

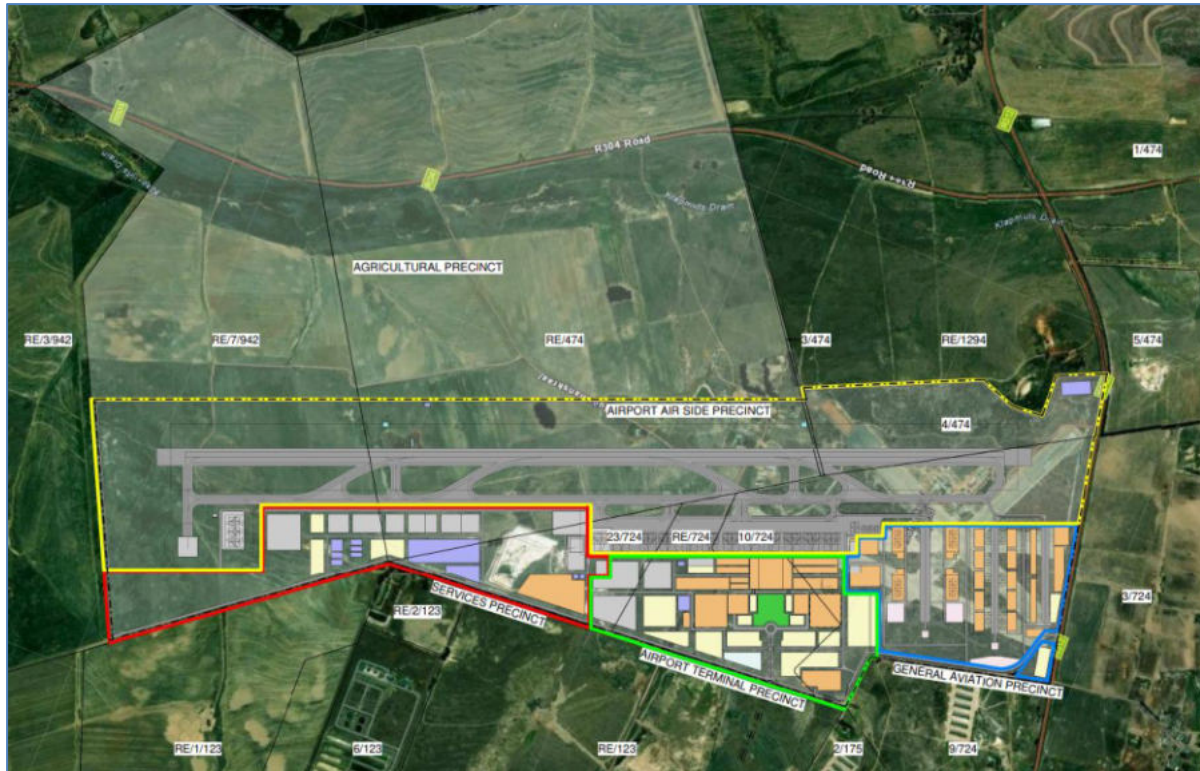
Figure 7: Previous Preferred Development Option (Phase 2) for the CWA (CWA Ltd, August 2024).

The 'previous preferred alternative' development option will host the same precincts mentioned in Alternative 2 with the main difference being that the secondary runway (14-32) will no longer be included in the development. The Phase 1 and Phase 2 plans for the previous preferred development alternative have been provided in **Figure 6** and **Figure 7**, respectively.

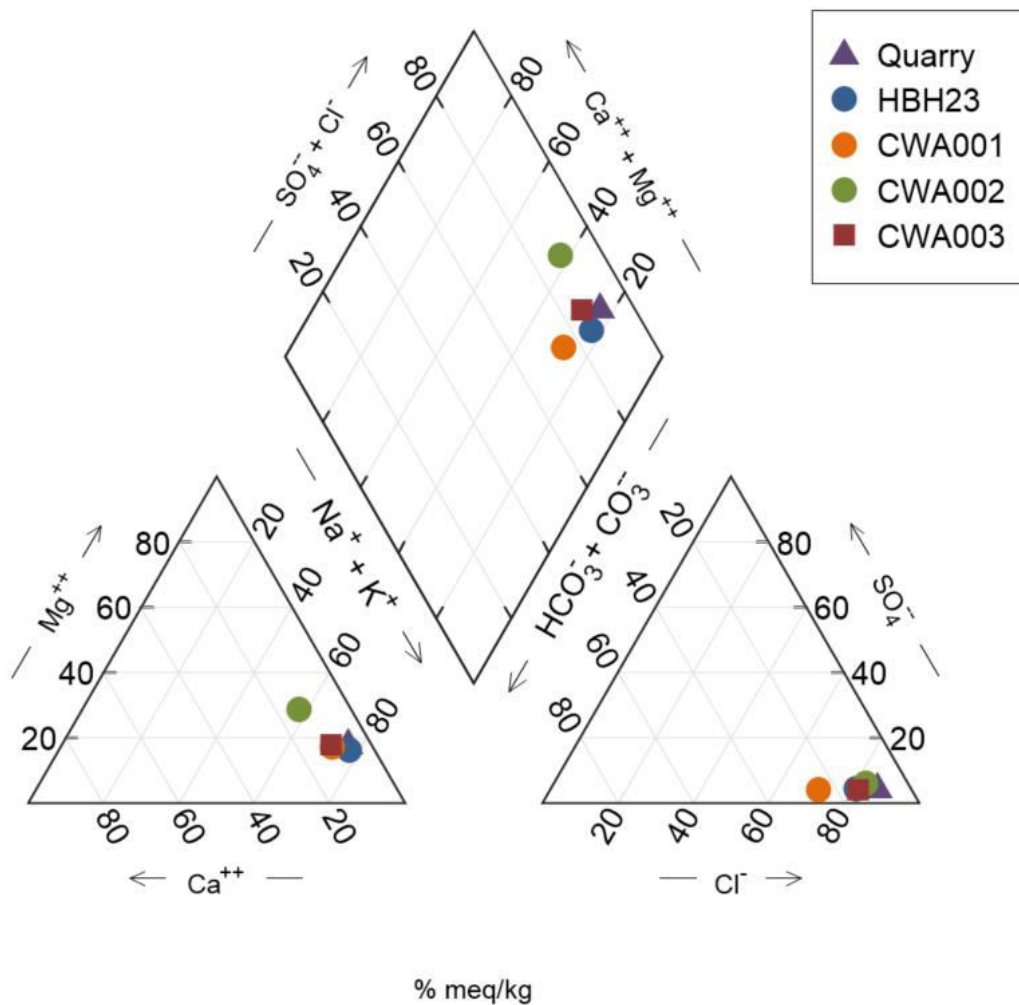
Figure 13: Piper diagram for the collected samples.

A number of chemical diagrams have been plotted for the quarry water sample and the groundwater samples and these are useful for chemical characterisation of the water and illustrate the differences in the water types. The chemistry of the samples has been plotted on a trilinear diagram known as a Piper Diagram. This diagram indicates the distribution of cations and anions in separate triangles and then a combination of the chemistry in the central diamond. From **Figure 13** (central diamond), it is evident that both the quarry and the borehole samples are of a similar sodium-chloride hydrofacies type, indicating that the water has likely originated/evolved in a similar geological environment

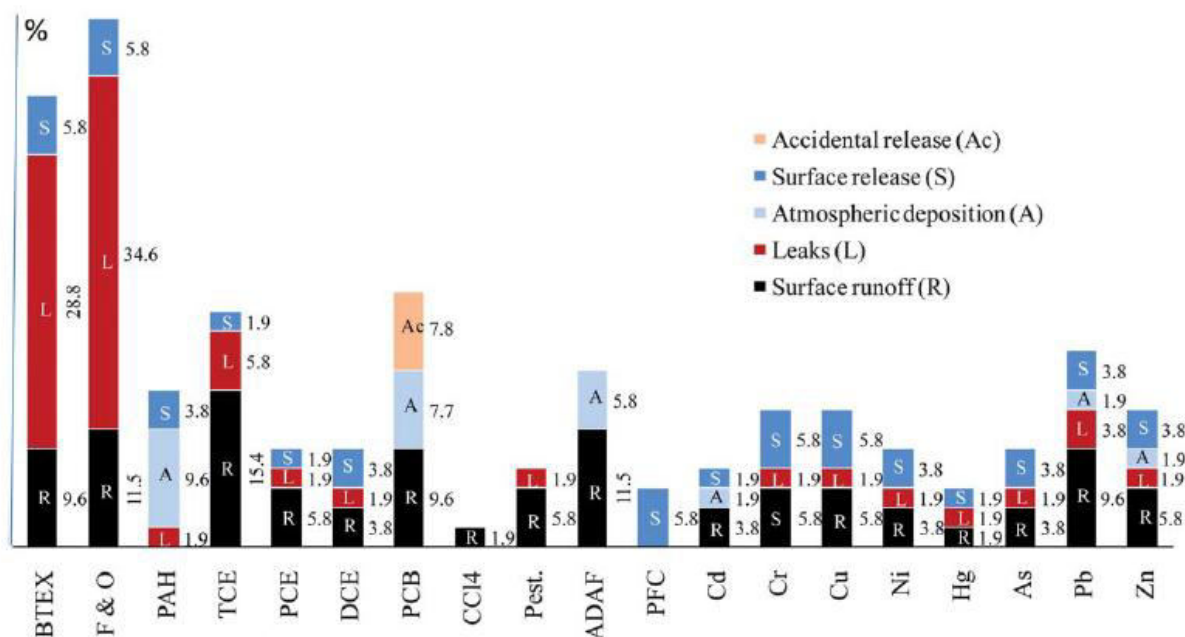
Figure 15: Reported frequency of contaminants for several origins (Nunes et al., 2011). F & O: fuels and Oils; ADAF: anti-icing and de-icing fluids; PFC: perfluorochemicals.

Origins, operations and locations for contamination at civil airport sites around the globe as per Nunes et al. (2011), along with other potential contaminant sources have been summarised in **Table 11**. Where the origin refers to the process of transporting the contaminant to the groundwater, the location indicates the physical place where the contaminants are generated/released; and the operation indicates the activity during which the contaminant is released into the environment. Nunes et al. (2011) compiled information from reports on airports where contamination had taken place. 19 contaminants were assessed and divided into several origins (**Figure 15**). The origins included accidental release (Ac), surface release (S), atmospheric deposition (A), leaks (L), and surface runoff (R). It is clear that surface runoff appears to be the most widespread origin (reported for 17 of the contaminants), followed by surface releases (reported for 15 of the contaminants), and leaks (reported for 14 of the contaminants) (**Figure 15**).

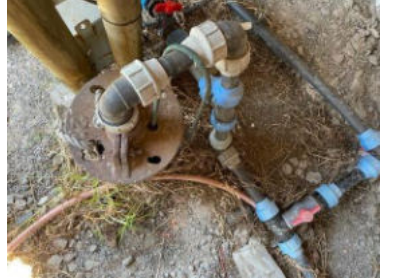
HBH2	103	17.04	0.54	EC: 114.9 mS/m	Used in the nursery.

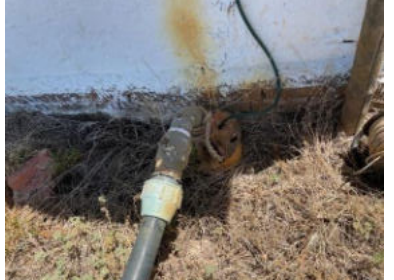
HBH3	83.2	40.87	2.2	EC: 145 mS/m TDS: 710 mg/L pH: 6.2	Used for livestock.

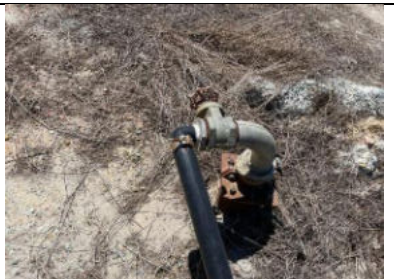
HBH4	-	19	-	EC: 132 mS/m TDS: 650 mg/L pH: 6.7	Livestock watering, BH in use.

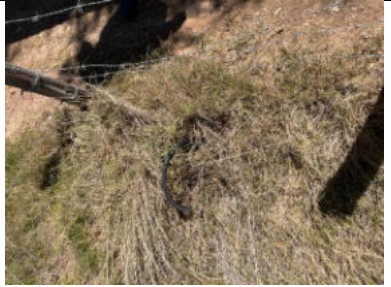
ID	Depth (m)	Water Level (mbgl)	Yield (L/s)	Field Chemistry	Comment	Photo
HBH5	-	-	5	EC: 152 mS/m TDS: 750 mg/L pH: 6.7	Domestic use and garden irrigation. Borehole overgrown.

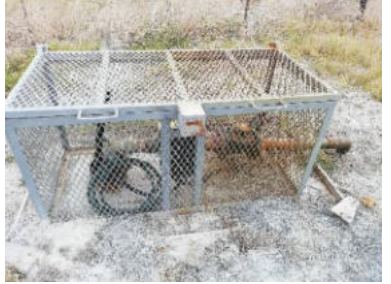
HBH6	102	17.8	8.3	EC: 201.7 mS/m TDS: 1210 mg/L pH: 7.1	County Fair production borehole.  2024 comment on behalf of CF indicates that the borehole is now dry and no longer in use.

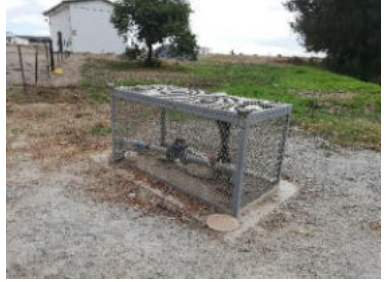
HBH7	90	11.27	5	EC: 284.7 mS/m TDS: 1708 mg/L pH: 7.9	County Fair production borehole

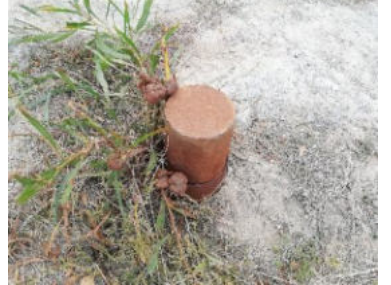
HBH8	-	-	-		County Fair borehole. BH welded shut. Not in use.  2024 comment on behalf of CF indicates that the borehole is now dry.

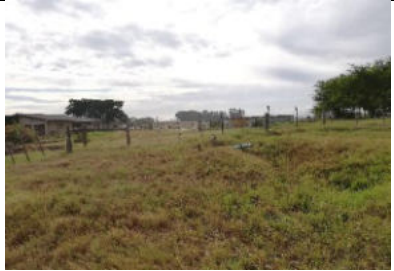
ID	Depth (m)	Water Level (mbgl)	Yield (L/s)	Field Chemistry	Comment	Photo
HBH9	-	-	-		Borehole used for household supply.

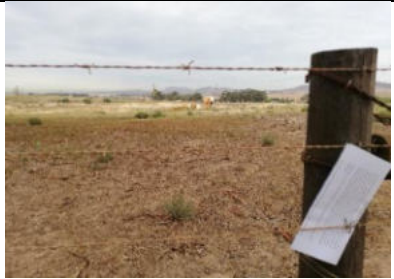
HBH10	-	-	-		Tanks concentrated with red staining, likely groundwater use.

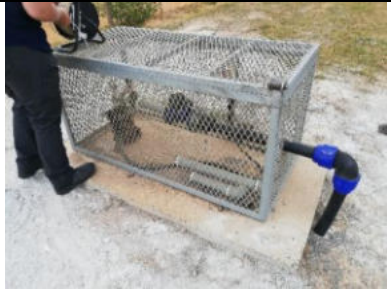
ID	Depth (m)	Water Level (mbgl)	Yield (L/s)	Field Chemistry	Comment	Photo
HBH13	200	15	3	EC: 138.7 mS/m TDS: 832 mg/L pH: 7.5	County Fair production borehole.

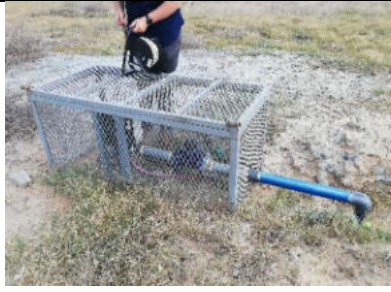
HBH14	156	5.5	5.3	EC: 19.7 mS/m TDS: 118 mg/L pH: 8.7	County Fair production borehole.

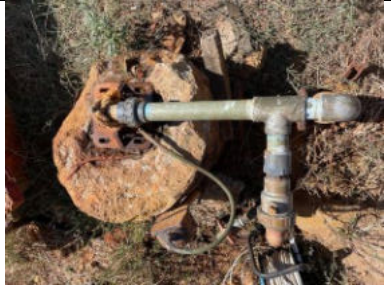
HBH15	-	-	-		Used for garden irrigation, iron staining on walls.	No photo taken
HBH16	30	42.2	0.2	EC: 167 mS/m TDS: 830 mg/L pH: 6.4	Livestock and domestic use.

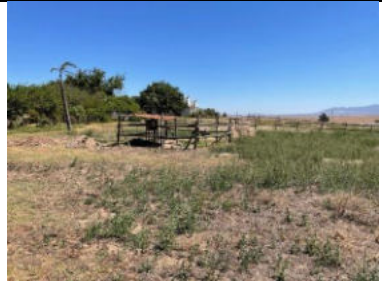
ID	Depth (m)	Water Level (mbgl)	Yield (L/s)	Field Chemistry	Comment	Photo
HBH17	60	-	-	EC: 115 mS/m TDS: 570 mg/L pH: 6.3	Lots of iron. Livestock and domestic use.

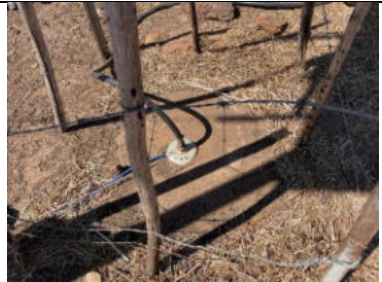
HBH18	25	-	-	EC: 311 mS/m TDS: 1580 mg/L pH: 6.2	Used for livestock.

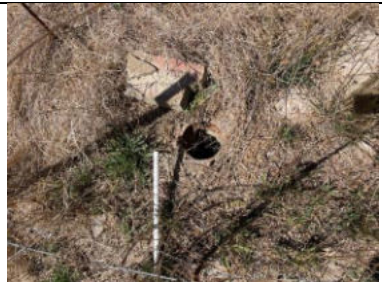
HBH19	15	1.9	-		Not in use.

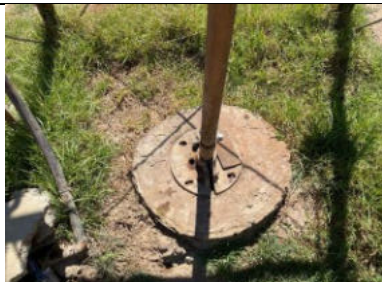
HBH20	-	5.4	-	EC: 632 mS/m TDS: 1820 mg/L pH: 7.0	Used for livestock.

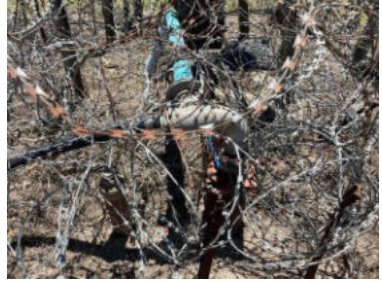
HBH22	-	-	-	EC: 76 mS/m TDS: 370 mg/L pH: 7.2	Low iron, good quality water. Previous owner has used this water as drinking water in their house. Later renamed to CWA_BH001 (/CWA_EastBH).

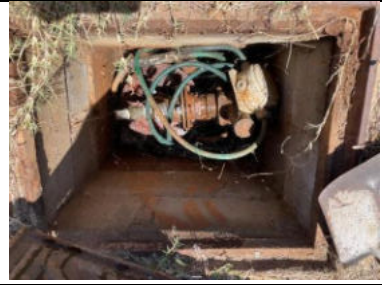
HBH23	-	-	-	EC: 97 mS/m TDS: 480 mg/L pH: 6.7	Airport borehole. Yellow colour in water.

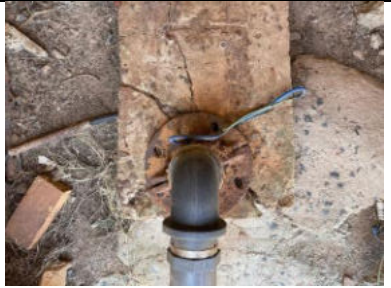
ID	Depth (m)	Water Level (mbgl)	Yield (L/s)	Field Chemistry	Comment	Photo
HBH25	-	-	-	EC: 225 mS/m TDS: 1120 mg/L pH: 6.5	Not in use.

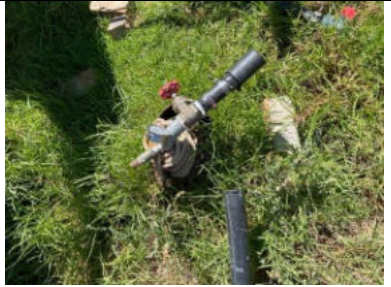
HBH27	-	-	-		Not in use.
