BULK ENGINEERING SERVICES REPORT (VERSION L)

Cape Winelands Airport

Engineering Services Report

Reference: A89083-CWA-ENGINEERING SERVICES REPORT

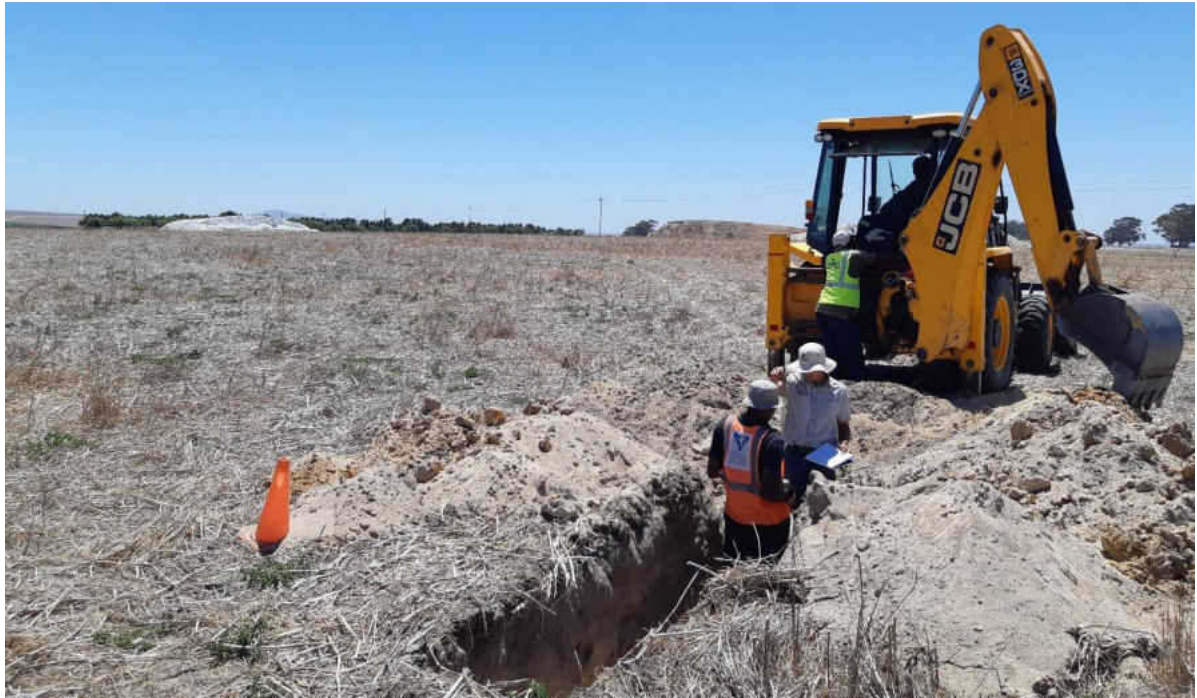
Figure 44: TP21 – GEOSS team conducting DCP test beneath nodular ferricrete horizon. White clay-silt Corrobrick material pictured in the background.

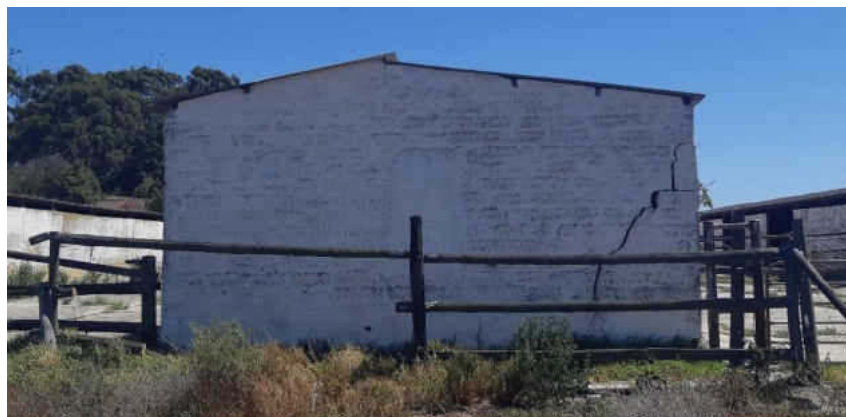
Figure 56: Corner down type crack possibly related to potentially expansive nature of subsoils; stable structure located between TP18 and TP15.

The structures on site were briefly examined for any typical tell-tale signs of geotechnical risks/problem soils, e.g. settlement/differential heave. The structures on the site are located predominantly in the south-eastern extent of the property, none of these showed clear evidence of typical foundation-related cracks. It is important to note that none of these structures appear to be heavily loaded. In the north-western extent of the site; however, the structures located on the Remainder of Erf 724 did show signs of foundation related cracks (**Appendix C**).

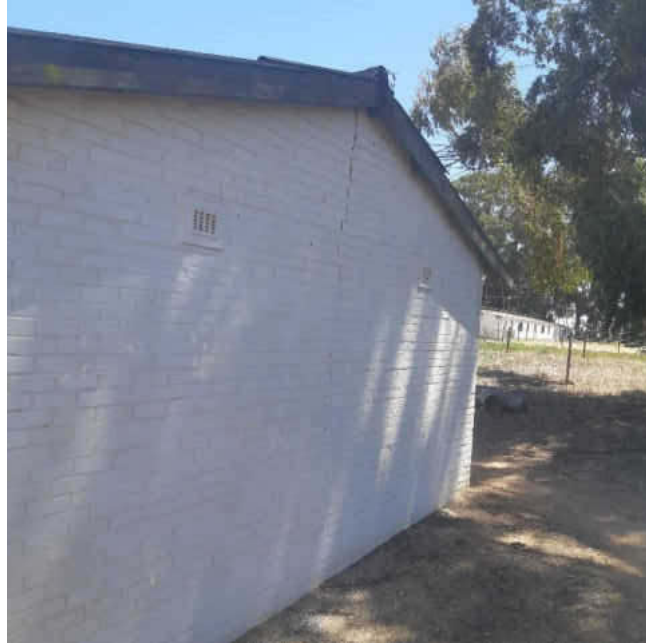
Figure 57: Vertical crack possibly related to potentially expansive nature of subsoils; storage structure located between TP18 and TP15.

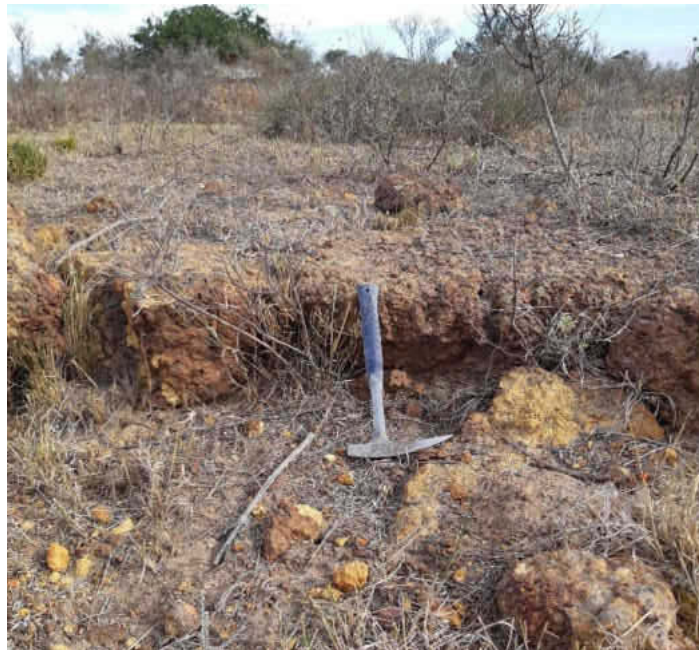
Figure 58: Ferricrete outcrop exposed in northern portion of the site near TP36.
