Ackermans DC

Erf 3865, formerly Portion 9 erf 441, Hagley, Cape Town

Stormwater Management Plan

Revision A
October 2022

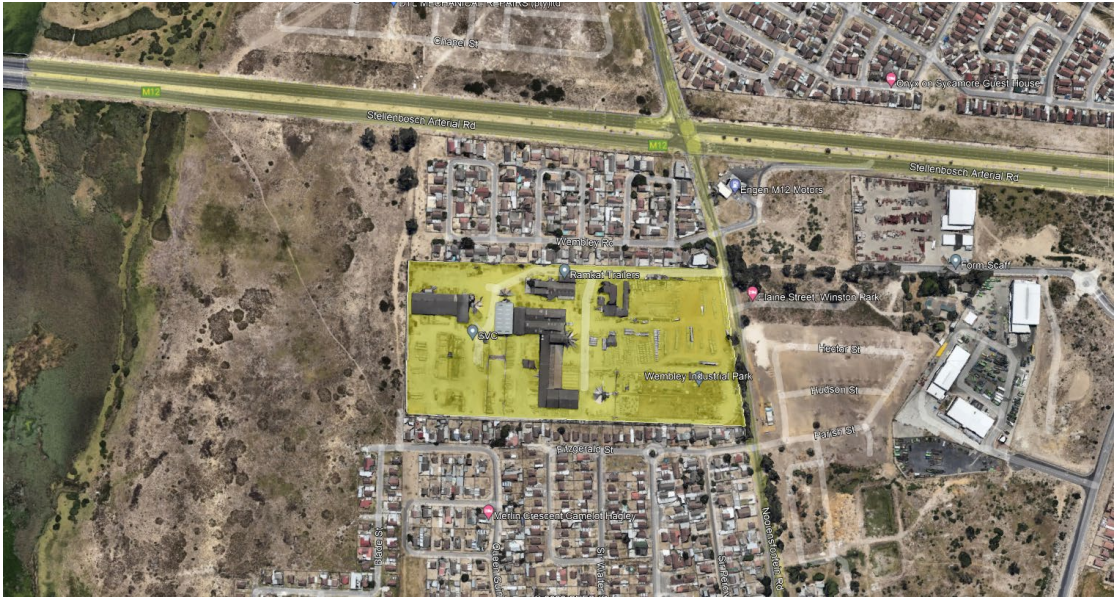
Figure 1 - Locality Plan (Google Earth)

The existing and proposed development is situated on Erf 3865, Hagley, Cape Town. The property is located between Blackheath (East) and Kuils River (West) with the M12 to the North.

The total size of the proposed development is approximately 6.8 ha. Refer to figure 1 for the locality plan.

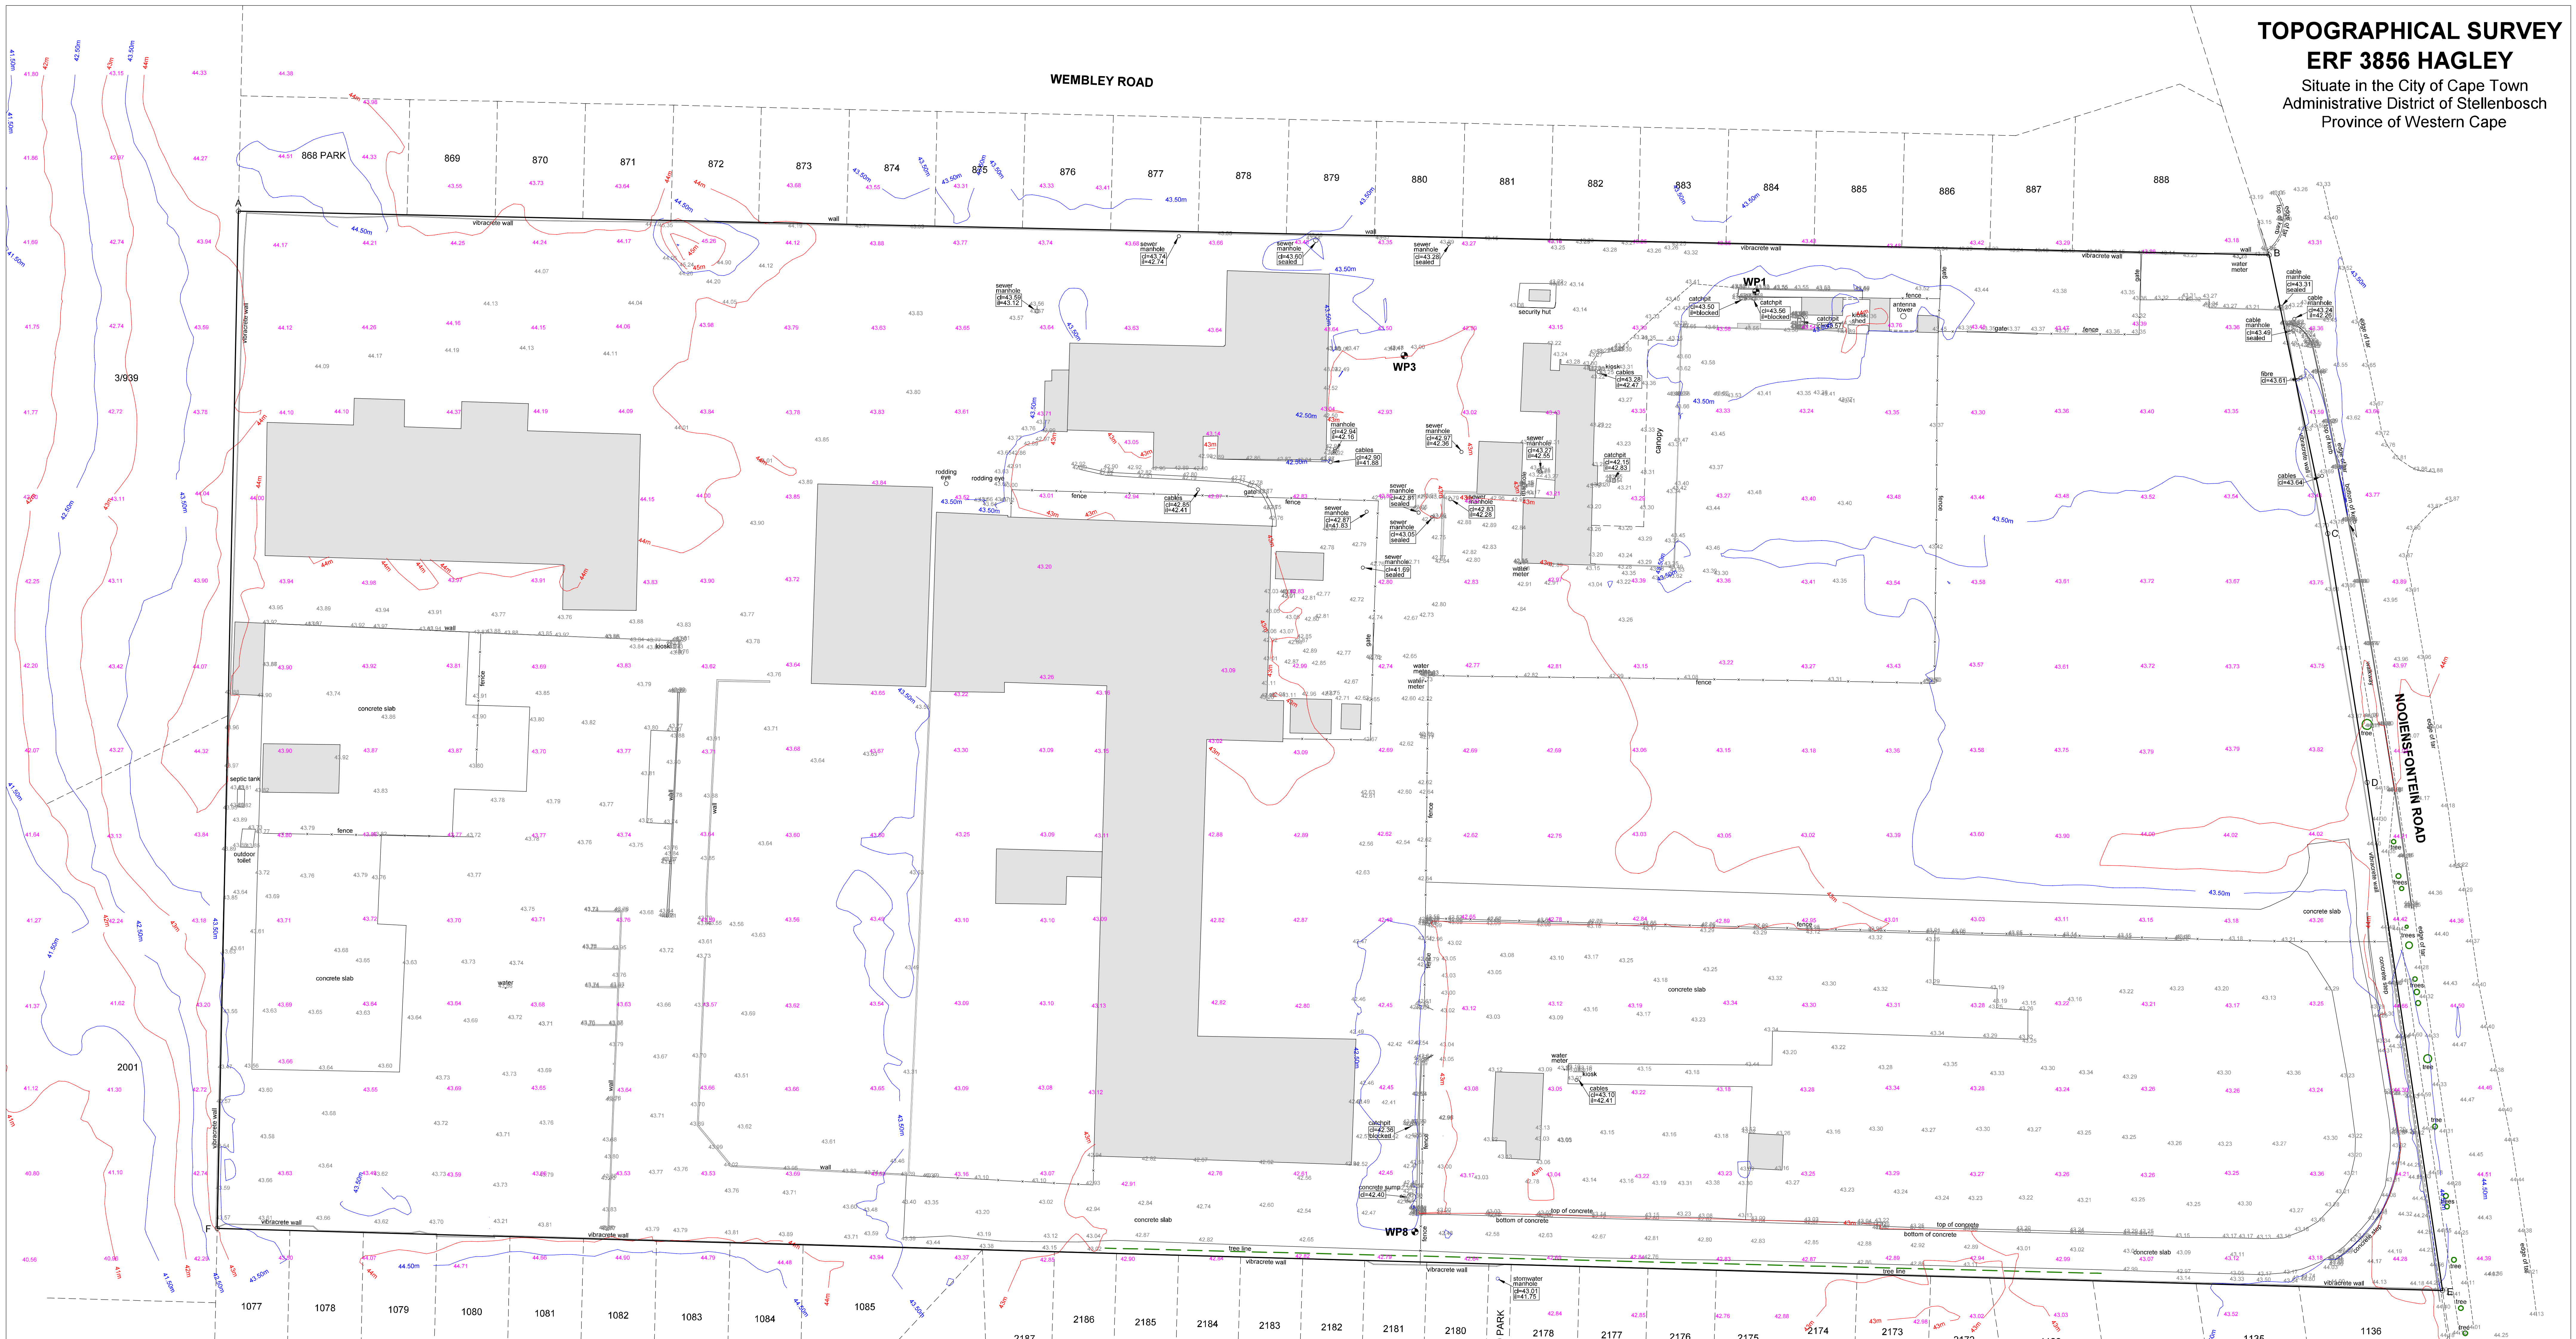
TOPOGRAPHICAL SURVEY
ERF 3856 HAGLEY
 Situate in the City of Cape Town
 Administrative District of Stellenbosch
 Province of Western Cape

- 43.52 denotes laser data
- 44.13 denotes survey data
- Buildings have been taken from aerial imagery

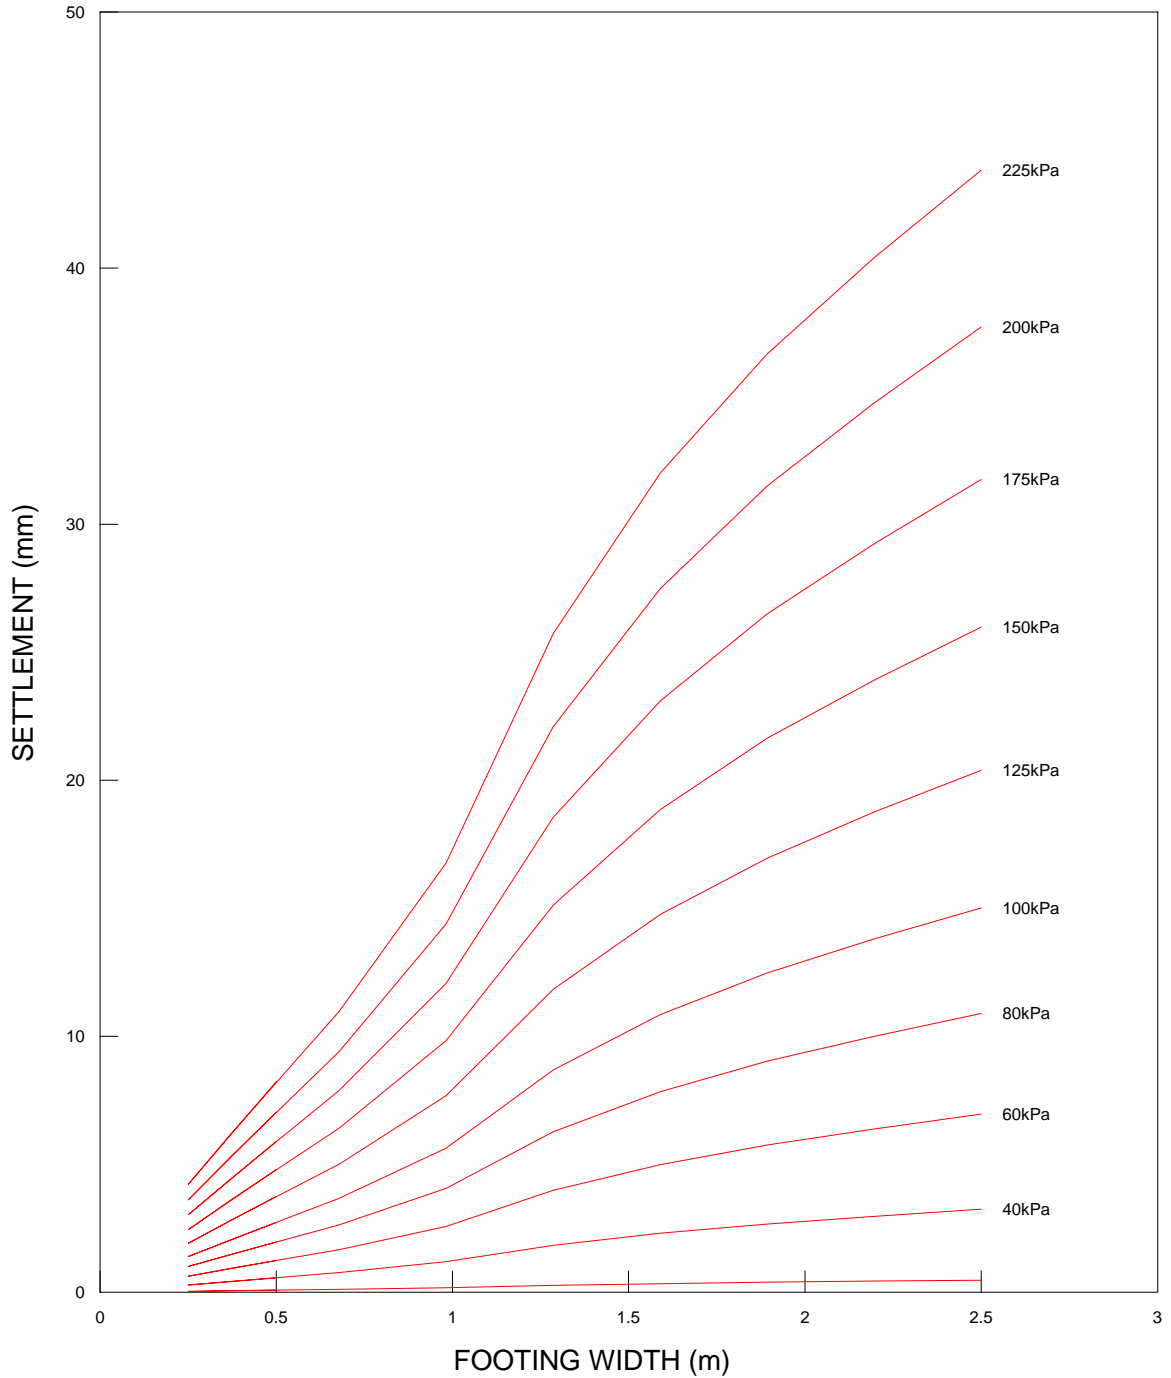
ANALYSIS USES TEST NO. :	DPSH10		
GROUND ELEVATION (m)	N/A	SOIL DEPTH TO BEDROCK (m)	20
FOOTING SHAPE	SQUARE	DEPTH TO FOUNDING LEVEL(m)	0.8

SETTLEMENT ANALYSIS USING SCHMERTMANN (1978) METHOD
