Aquatic risk assessment report for the proposed abstraction of groundwater at the Ackerman's Distribution Centre on Erf 3865, Hagley

September 2024

Freshwater Consulting

Prepared by:
Stuart Barrow
Prepared for:
PHS Consulting

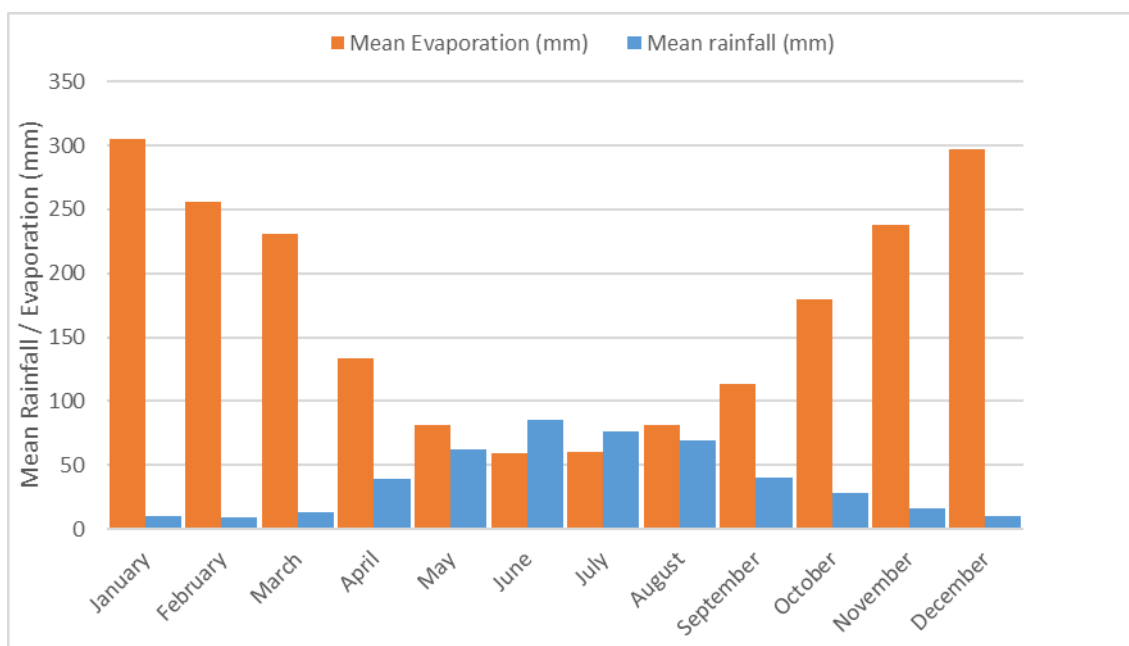
Figure 5. Mean annual rainfall and evaporation for Hagley area (Schulze, R. E. 2009)

The area has a winter rainfall regime (Figure 5). Summers extend from December till February and are dry and hot. During this time the mean evaporation exceeds the mean rainfall. Winters are colder and wetter. From June to August the evaporation is exceeded by the mean rainfall. This results in saturated soil

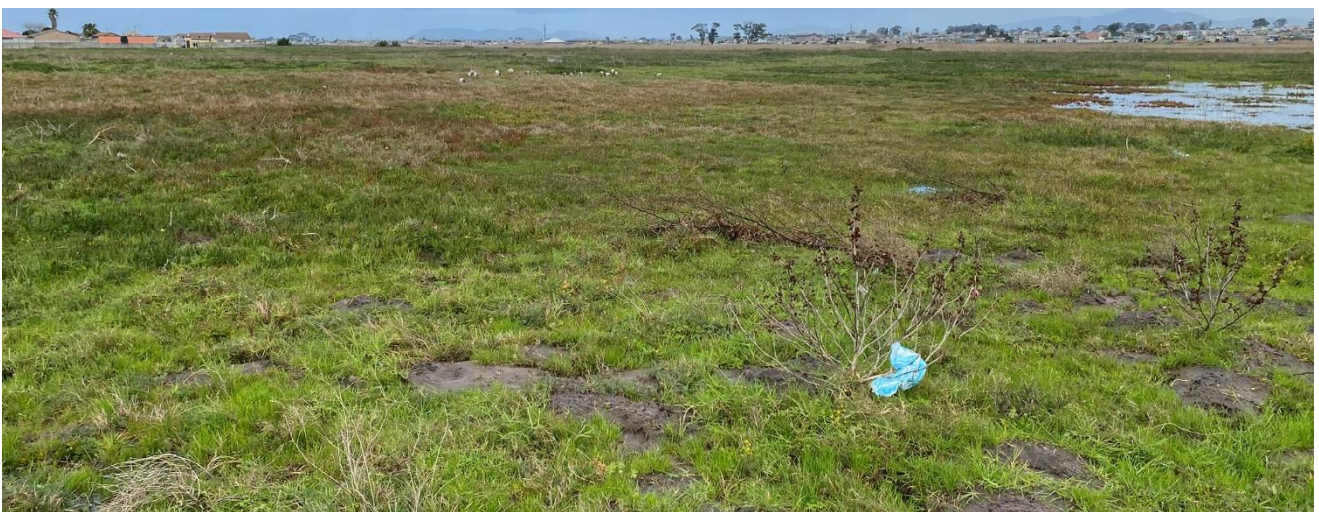
Figure 6. A view across the temporary and seasonally wet areas of the Kuils River corridor.

The natural vegetation which historically occurred in the area would have been Cape Flats Sand Fynbos. This vegetation type is dense and moderately tall, with a dominance of ericoid shrubs (Mucina and Rutherford, 2004). During the site visit in July 2024, there was evidence that the site had recently been cleared of woody vegetation (piles of chips and stumps). It is most likely that the cleared species was *Acacia saligna* (Port Jackson). Shrubs are largely absent from the vegetation community of the corridor (Figure 6), probably because of exclusion by *A. saligna*, as well as the seasonal wetness regime. Low groundcover species are dominant. The permanently saturated zones of the Kuils River corridor are densely vegetated with *Cyperus textilis*, *Phragmites australis* and *Typha capensis*. The wider corridor is dominated by vygies, *Carpobrotus acinaciformis*. This plant forms dense mats, often circular in shape, that can be seen from aerial or satellite imagery. Within seasonally and temporarily saturated zones of the corridor, grasses such as *Cynodon dactylon* (kweek) and *Stenotaphrum secundatum* (buffalo grass) are abundant. Rushes and sedges such as *Juncus capensis*, *Cyperus congestus* and *Ficinia nodosa* were also observed within the seasonal habitats.

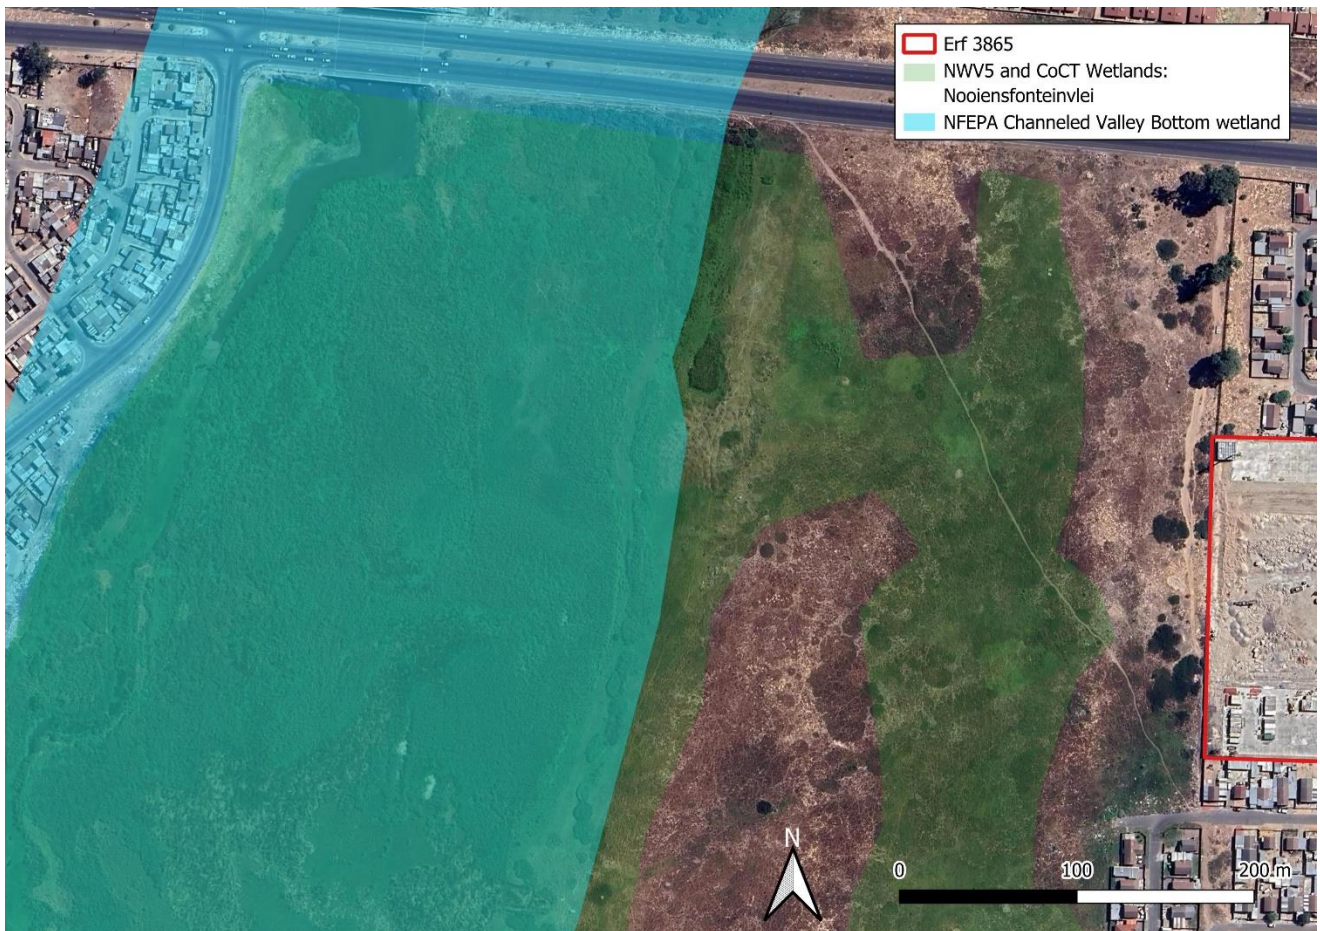
Figure 7. The NFEPA , NWM5 and City of Cape Town’s wetland mapping across the Kuils River corridor adjacent to the site.

Various sets of conservation planning mapping initiatives were consulted: the Biodiversity Network for the City of Cape Town (City of Cape Town, 2017a), the City of Cape Town's wetland mapping (City of Cape Town, 2017b), the National Freshwater Ecosystems Priority Areas mapping (Nel *et al*, 2011) and the National Biodiversity Assessments: National Wetland Map Version 5 (NWM5) (Van Deventer *et al*. 2018). The City's Biodiversity Network has mapped this section of the Kuils River corridor as containing no natural habitat. Furthermore, no Critical Biodiversity Areas or Ecological Support Areas are mapped along this reach of the river (Figure 7 **Error! Reference source not found.**). The NFEPA wetland map delineates the lower floodplain of the Kuils River, i.e. the permanently to seasonally wet zones discussed above, as channelled valley bottom wetlands. The NWM5 and the City of Cape Town's wetland mapping has captured both the permanently wet to seasonally wet areas and the seasonally to temporarily wet areas as floodplain wetland. The City of Cape Town wetland mapping identifies the wetland as the Nooiensfonteinvelei wetland (City of Cape Town, 2017b).

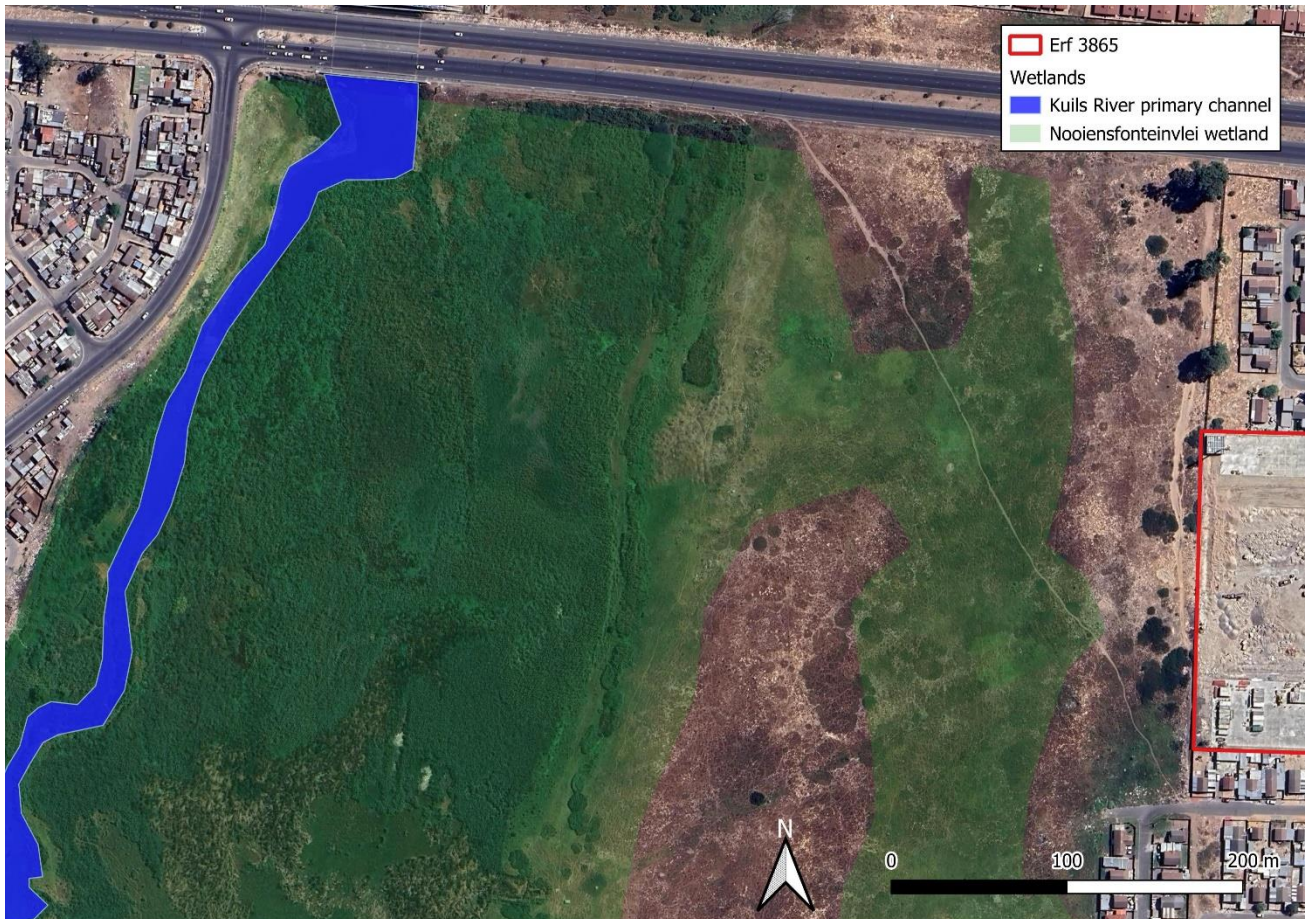
Figure 10. The extent of wetlands which occur across the Kuils River corridor adjacent to the study site

The aquatic features occurring adjacent to Erf 3865, across the Kuils River corridor are the Kuils River, the Nooiensfonteinvlei floodplain wetlands fed by the Kuils River as well as by lateral inputs as they drain towards the Kuils River. The extent of these features are shown in Figure 10 and assessed in this section of the report.

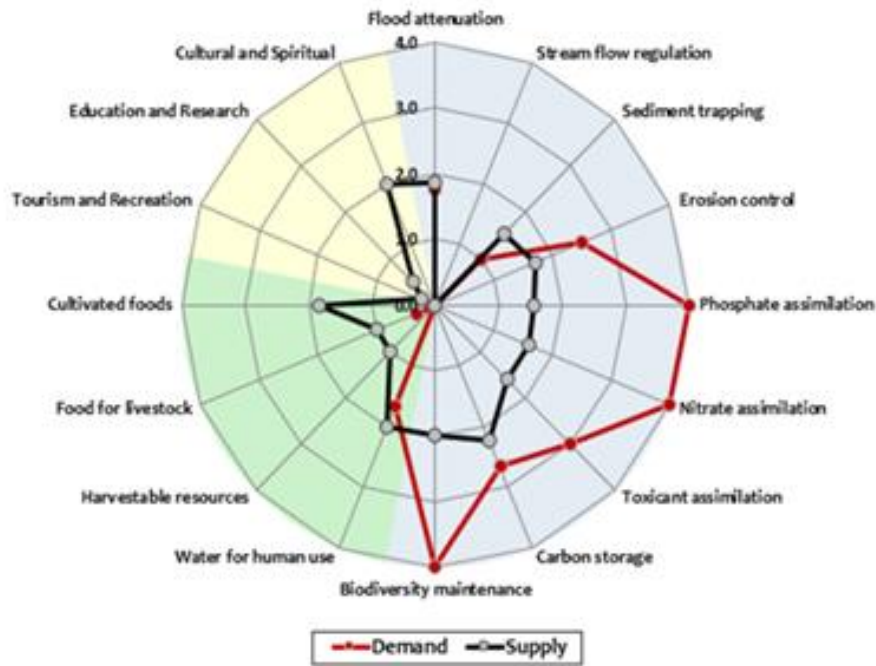
Figure 11. A radar diagram, showing the extent to which various ecosystem services are supplied by- and demanded of the Nooiensfonteinvlei, adjacent to erf 3865

The assessment of the ecosystem services supplied by the Nooiensfonteinvlei was conducted according to the guidelines as described by Kotze *et al* (2020) for WET-Ecoservices assessment. The assessment examines and rates the services shown in Figure 11 **Error! Reference source not found.** The assessment looks at a wide range of relevant characteristics of the wetland being assessed and its catchment to determine 1) the extent to which the wetland is able to supply a specific service and 2) the extent to which this service could be considered valuable in the context of the wetland’s location (demand for the service). The most important ecosystem services are those that are both demanded of and supplied by the wetlands. The maintenance of biodiversity, storage of carbon, assimilation of toxicants, nitrates and phosphates are important ecosystem services supplied by the wetland. The wetland also attenuates floods and assist with erosion control.

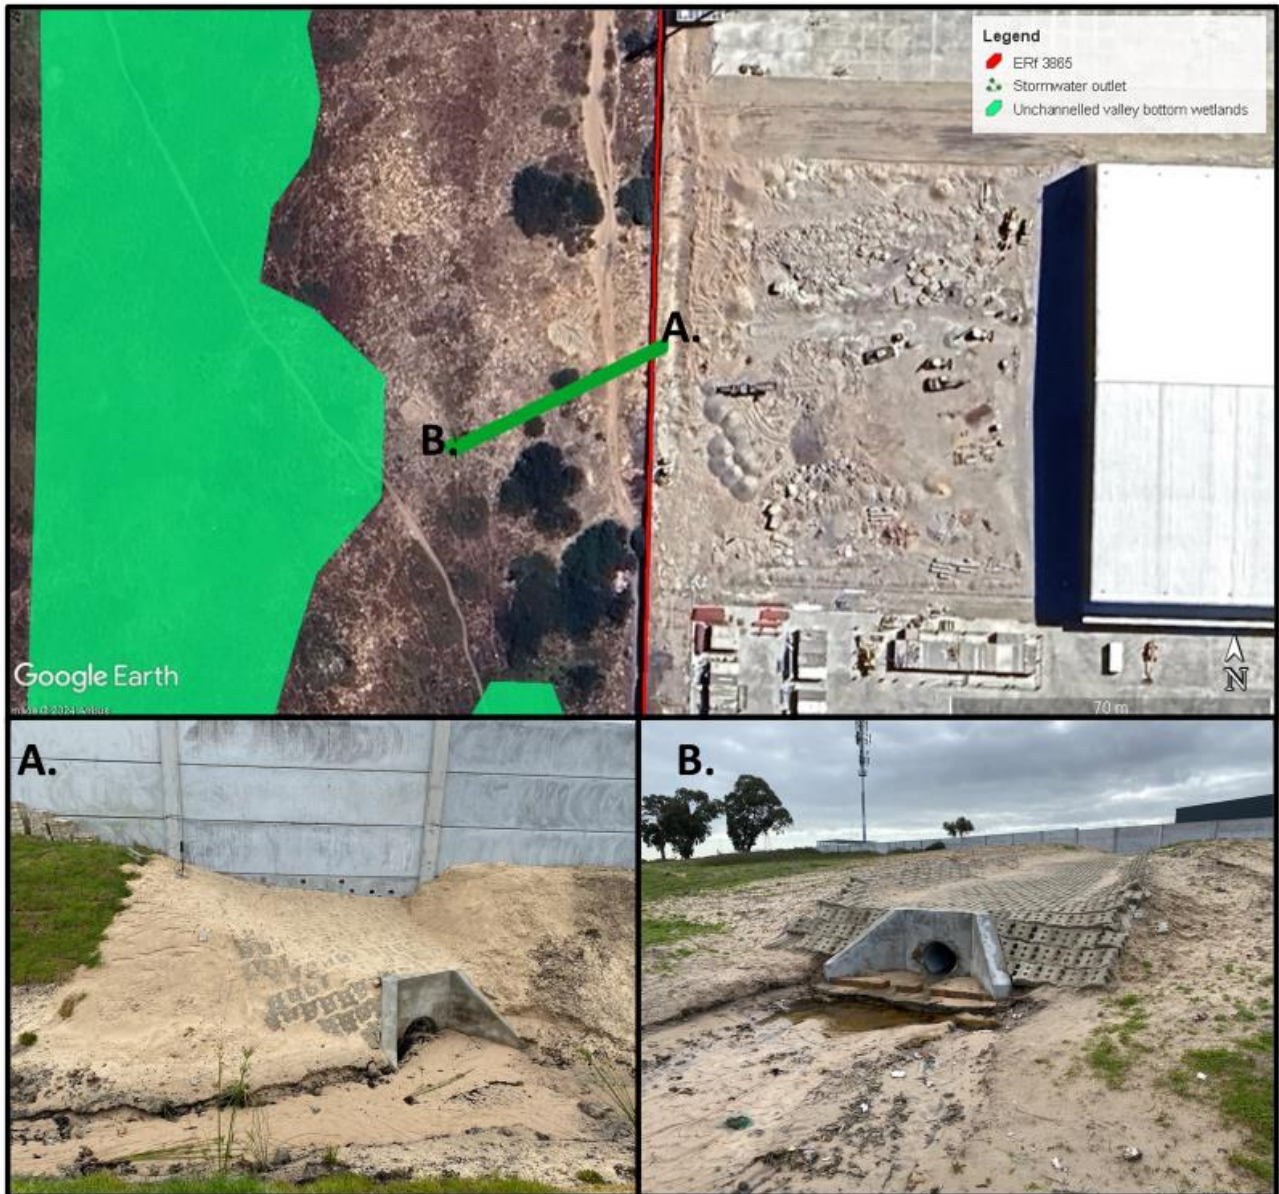
Figure 14. A Google Earth satellite image of the western boundary of the site showing the location of the stormwater outlet from the attenuation pond, A) the inlet to the stormwater outlet pipe within the attenuation pond and B) the outlet from of the stormwater outlet into the Kuils River corridor, showing erosion downstream of the outlet.

This outlet is clearly already having an impact upon the wetlands into which it feeds (Figure 14Figure 15). Whilst the construction has already been completed, the operational aspects will trigger a Section 21 (c) and (i) water use. As such these are also discussed in Section 10.

The concentrated outlet flow has already caused erosion and sedimentation downstream of the outlet. This could facilitate the formation of a channel or several channels within the wetland. This would mean that flows would be more effectively drained to lower portions of the wetland or to the primary channel of the Kuils River, and the areas closer to the outlet would potentially be drier. This risk has a high probability if not mitigated.

It is also recommended that improved energy dissipation be installed at the outlet into the Kuils River corridor. A riprap or loose rock basin would immediately spread flow across a wider area. The downstream end of the basin should be planted with a relatively tall indigenous sedge, such as *Cyperus textilis*. The vegetation would function as a final energy dissipater and assist in preventing erosion downstream of the outlet. An example of this is shown in Figure 16. (Note: a plunge pool style outlet is not being recommended.)

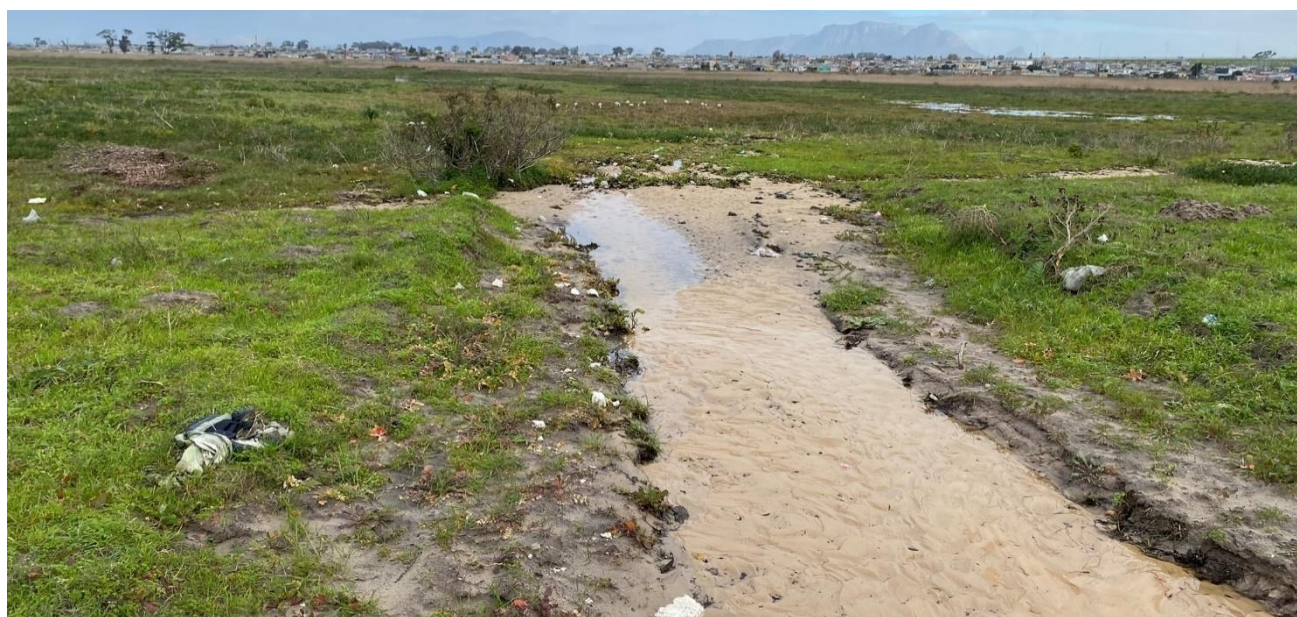
Figure 15. Sediment deposition occurring within the Kuils River corridor at the stormwater outlet.

Due to the lack of channels and the gentle gradient across the Nooiensfonteinvlei, the flows exiting the outlet immediately lose their energy. As a result, deposition of any transported sediment, or other material, occurs. During the site visit, deposited sediment was observed downstream of the outlet (Figure 15). The high rainfall events that led to the sediment being transported through the attenuation pond occurred during and immediately after the construction phase. There were still high sediment inputs on the site from incomplete construction areas and from the attenuation pond itself, which had not yet been adequately vegetated. During the long-term operation of the site, it is likely that this risk will reduce and channelised flow or erosion will become more likely.

It is recommended that the attenuation pond be densely vegetated with appropriate indigenous species, such as *Cyperus textilis*, *Juncus capensis*, *Cyperus congestus* and *Ficinia nodosa* which occur in the adjacent wetlands. This vegetation should cross the banks and bed of the attenuation pond. The vegetation will increase surface roughness of the pond area, reducing flow speed through the pond to the outlet. By slowing the flow, the plants will assist in capturing sediment being transported from the site. The roots of the plants will also assist in binding the soils of the attenuation pond itself, so that it is not washed out into the wetland areas.
