Specialist assessment letter for the Bellville site visit conducted on 2<sup>nd</sup> Nov 2022 prepared by J. Ndou and J. Dawson

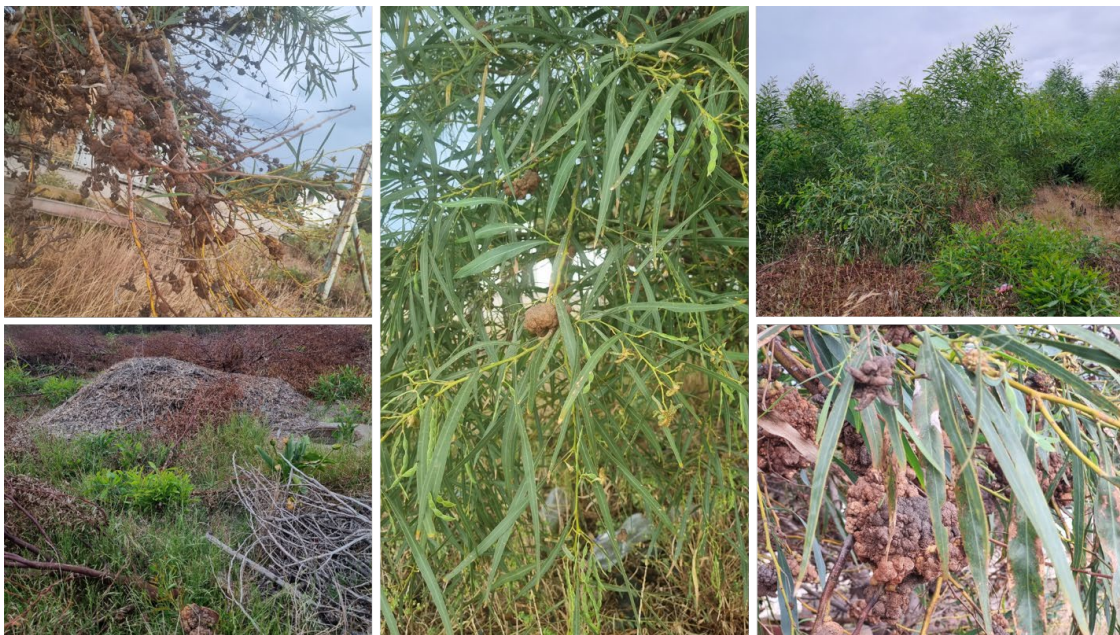
Figure 2. Invasive wattle species photographed on site many of which were infected by a gall-forming rust fungus (*Uromycladium tepperianum*).

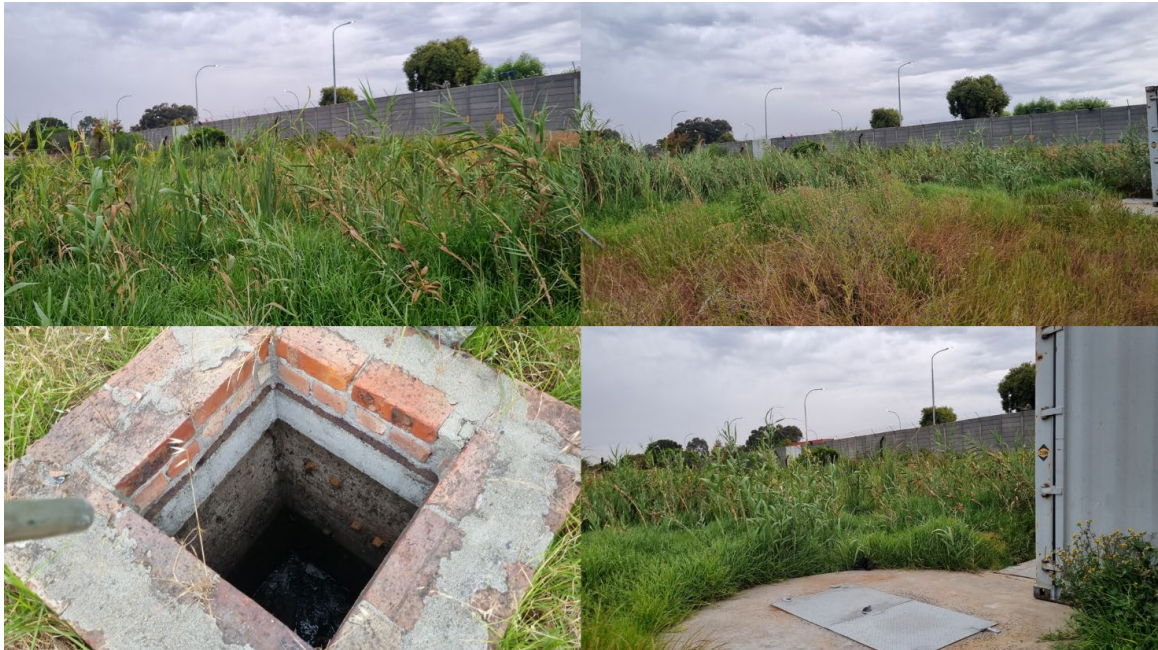
The reeds (*Phragmites australis*) and slender knotweeds (*Persicaria decipiens*) noted on the property likely grew overtime due to the presence of an underground stormwater system which may have not been maintained to avoid leaks or cracks (Figure 3). Therefore, an artificial wetland has become established. This is supported by the presence of small, isolated patches of greener grasses found elsewhere on site suggesting a point source introduction of water (Figure 4) and by the fact that the area is not marked as a wetland on the South African Inventory of Inland Aquatic Ecosystems (SAIIAE) National Wetland Map 5.2 (Figure 5). No other characteristic wetland vegetation species, such as sedges or cattail reeds (*Typha capensis*). Similarly, no frogs, dragonflies and characteristic wetland species were present.

Figure 3. Images of *Phragmites* beds (top) that has formed surrounding the stormwater drainage system (bottom).

In conclusion, artificial wetlands are sometimes spontaneously created by a change in the landscape, for example next to roads due to increased run-off and in this case, possible leak from a stormwater drainage system. It is our opinion that despite the presence of Phragmites reeds, the absence of other characteristic wetland species suggests that this is a poorly functioning, artificial wetland, of low diversity, which has formed as a result of a water leak. It is still important to note that the South African government does take into consideration and does protect artificial wetlands. Therefore, it is important that the competent authority, the city of Cape Town Local Municipality, has the final say/decision about this artificial wetland's status and level of importance.

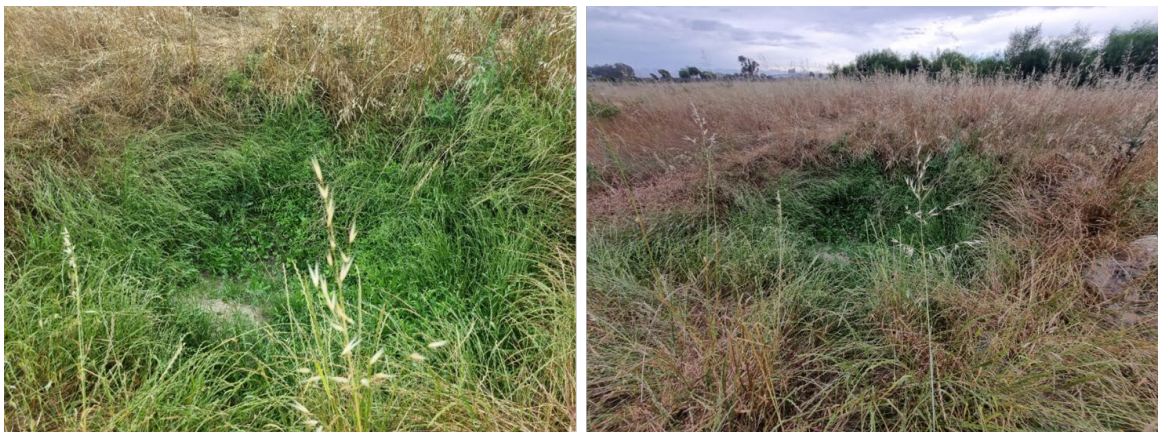
Figure 4. Example of localised point source greening of grasses seen on site, likely due to a leaking pipe.

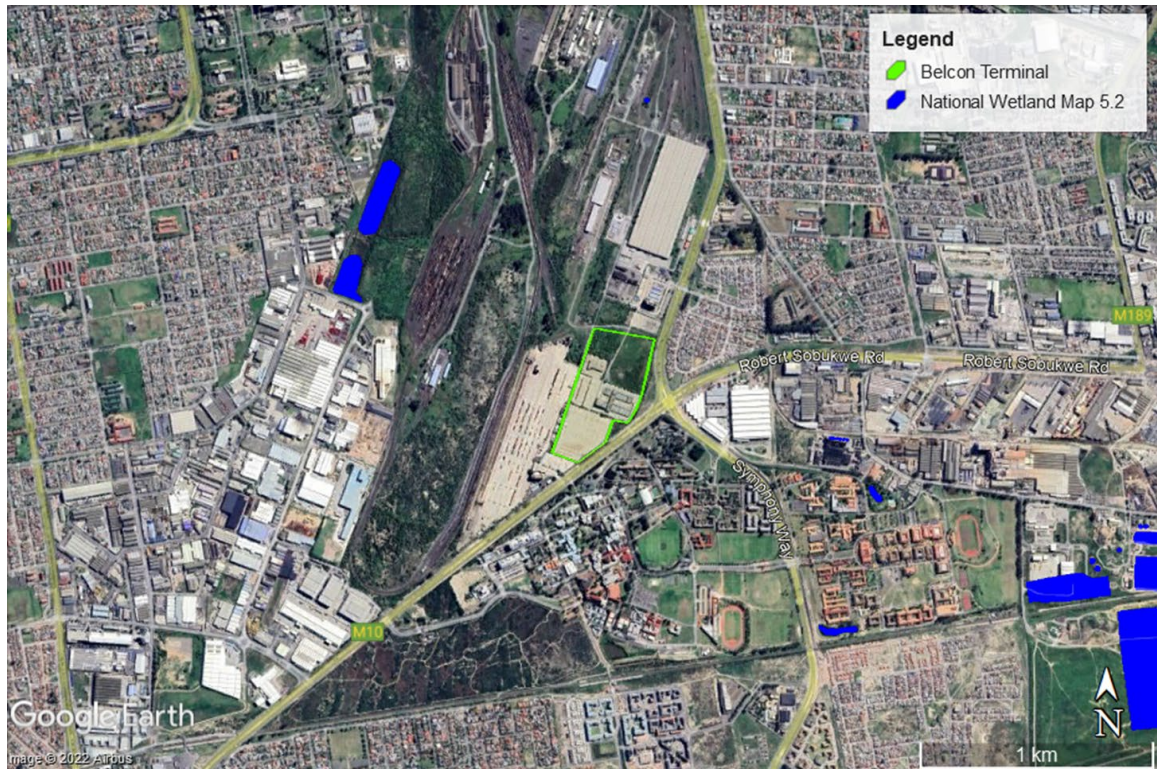
**Figure 5.** The location of the Belcon terminal site in relation to wetlands recognised wetlands mapped on the SAIIE National wetland map.

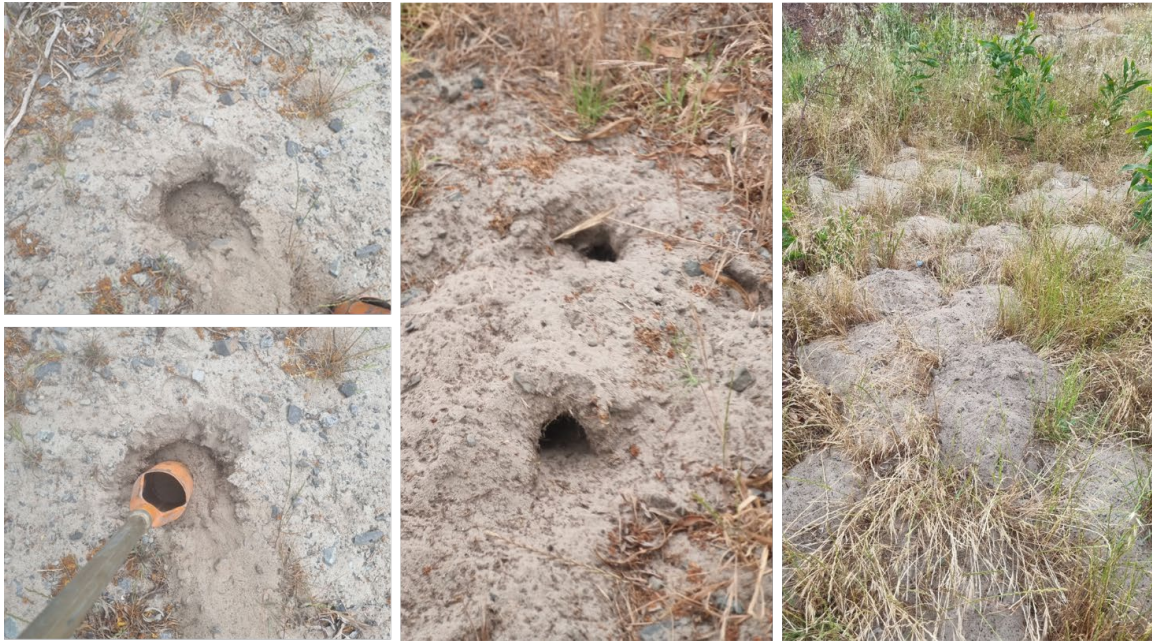
Hydric soils develop when chemical changes take place in the soil due to the low-oxygen conditions associated with prolonged water saturation. Following sampling with an auger it was seen that the soil was very sandy and dry (Figure 6). Unfortunately, due to the onset of heavy rain, the specialist could not fully complete the auger sampling, however not hydric soil was found in those samples completed. Additionally, the presence of numerous animal burrows seen on site, likely moles and/or snakes, is an indication that the soil is not as wet as a typical wetland, or these animal burrows would be flooded. (Figure 6).

Figure 6. Sediment samples taken using an Auger (right) and images of the sediment mounds formed by burrowing animals such as moles and/or snakes (left).
