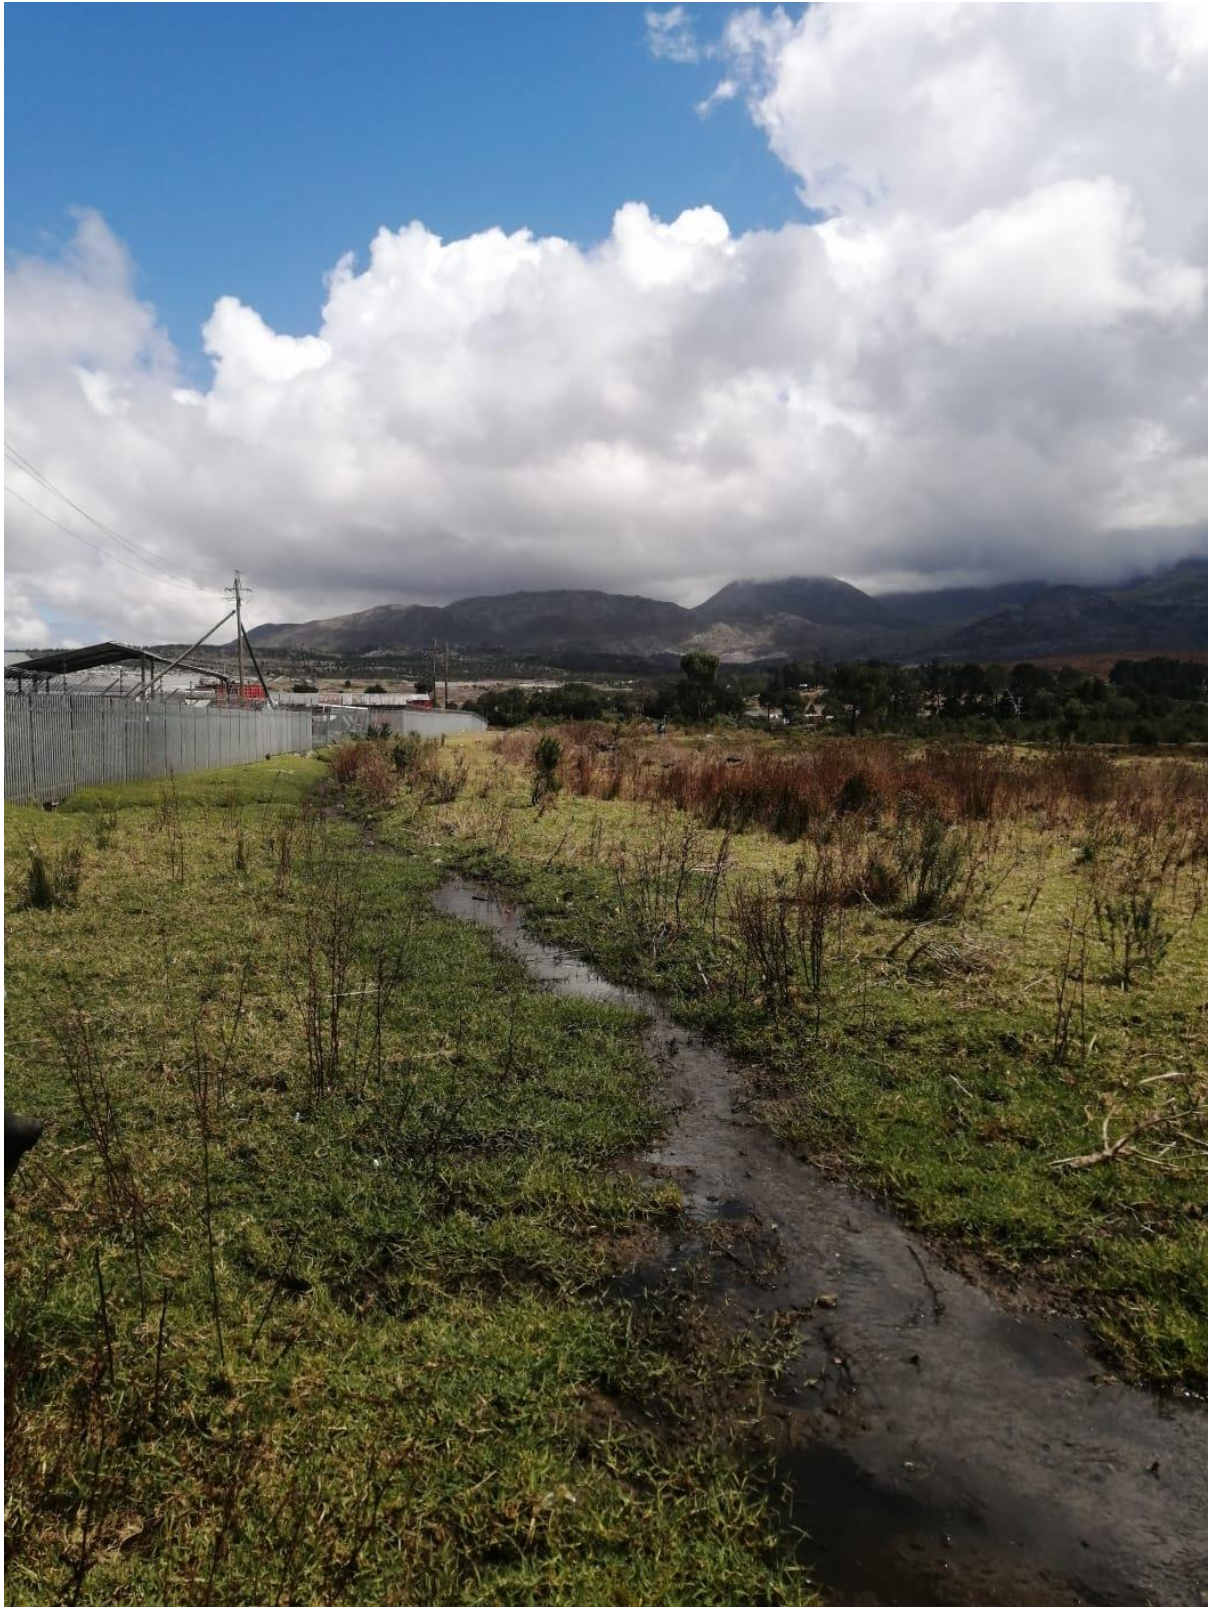
*Photo 1: Wetland area proposed for rehabilitation. This photo was taken facing northwest. This wetland is impacted by canalisation, compaction, rubbish dumping the spread of alien invasive vegetation and polluted water inflow. The EFRC Poultry Abattoir can be seen in the middle left of the photo.*

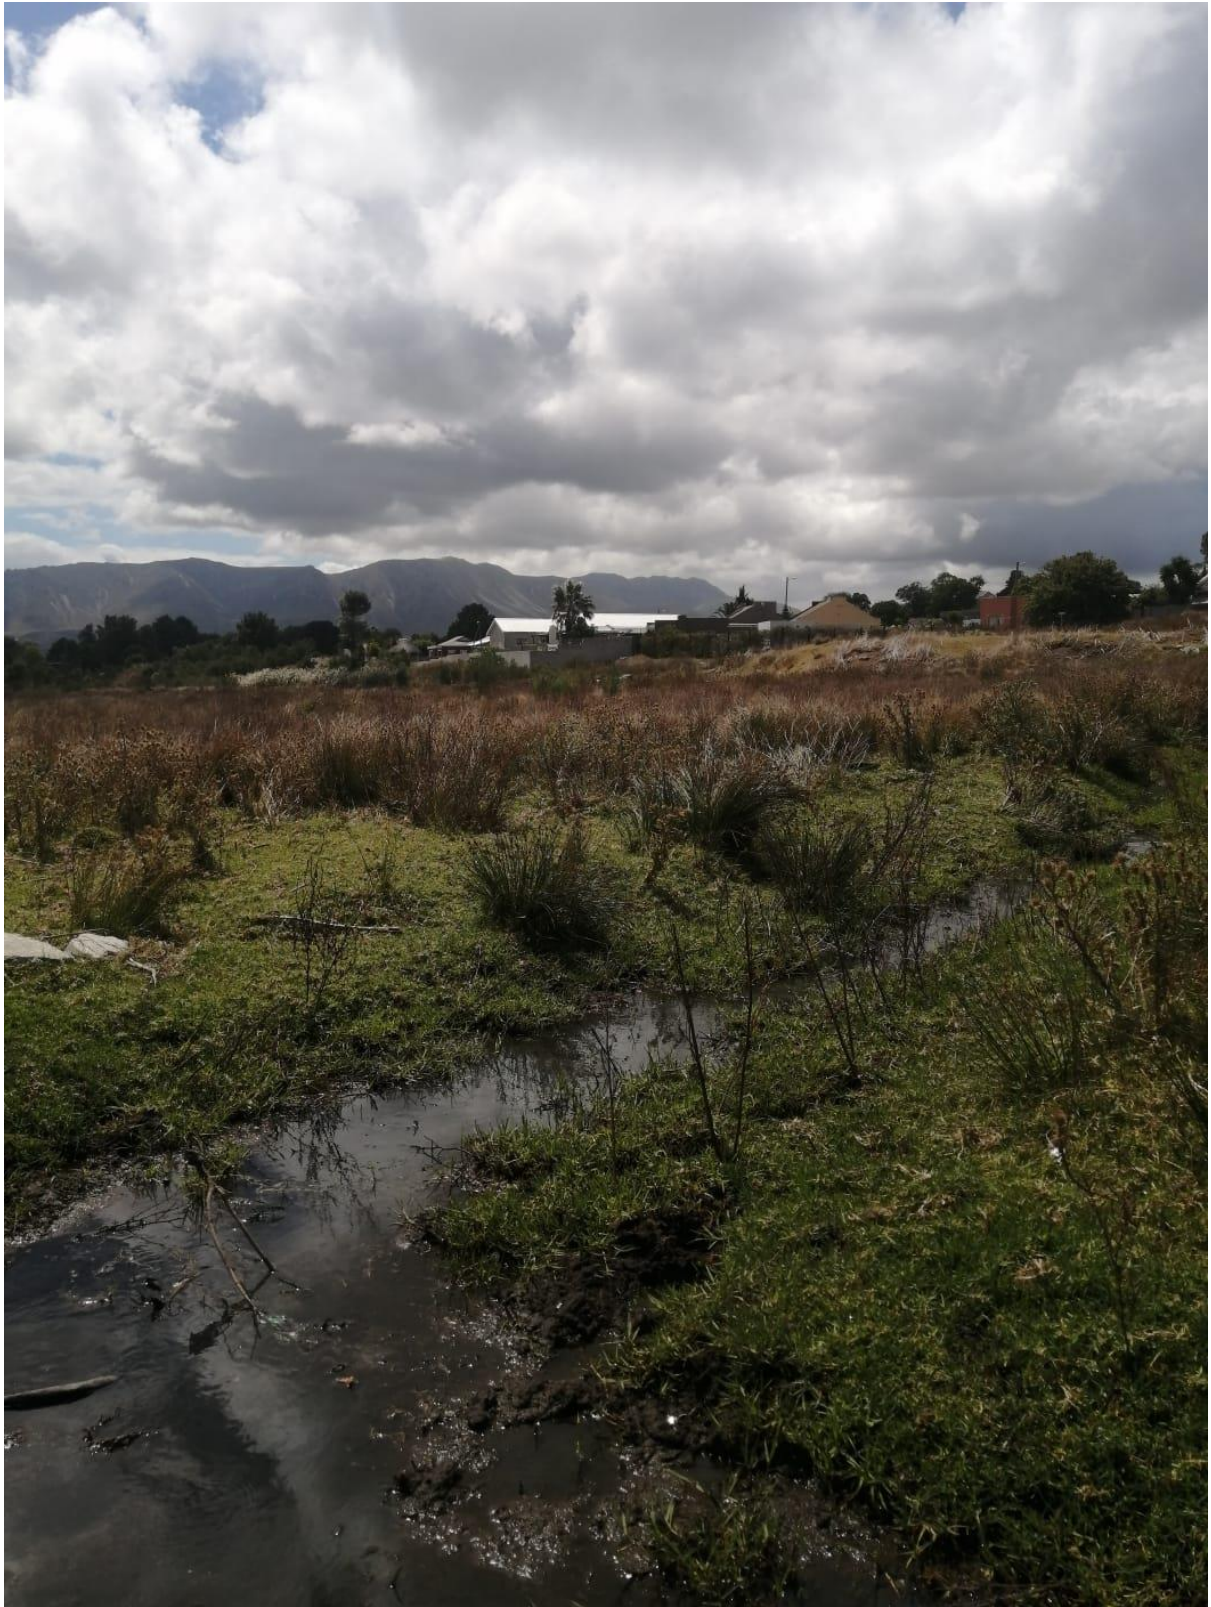
*Photo 2: Wetland area proposed for rehabilitation. This photo was taken facing east. This wetland is impacted by canalisation, compaction, rubbish dumping, the spread of alien invasive vegetation and polluted water inflow. A residential area can be seen in the background.*

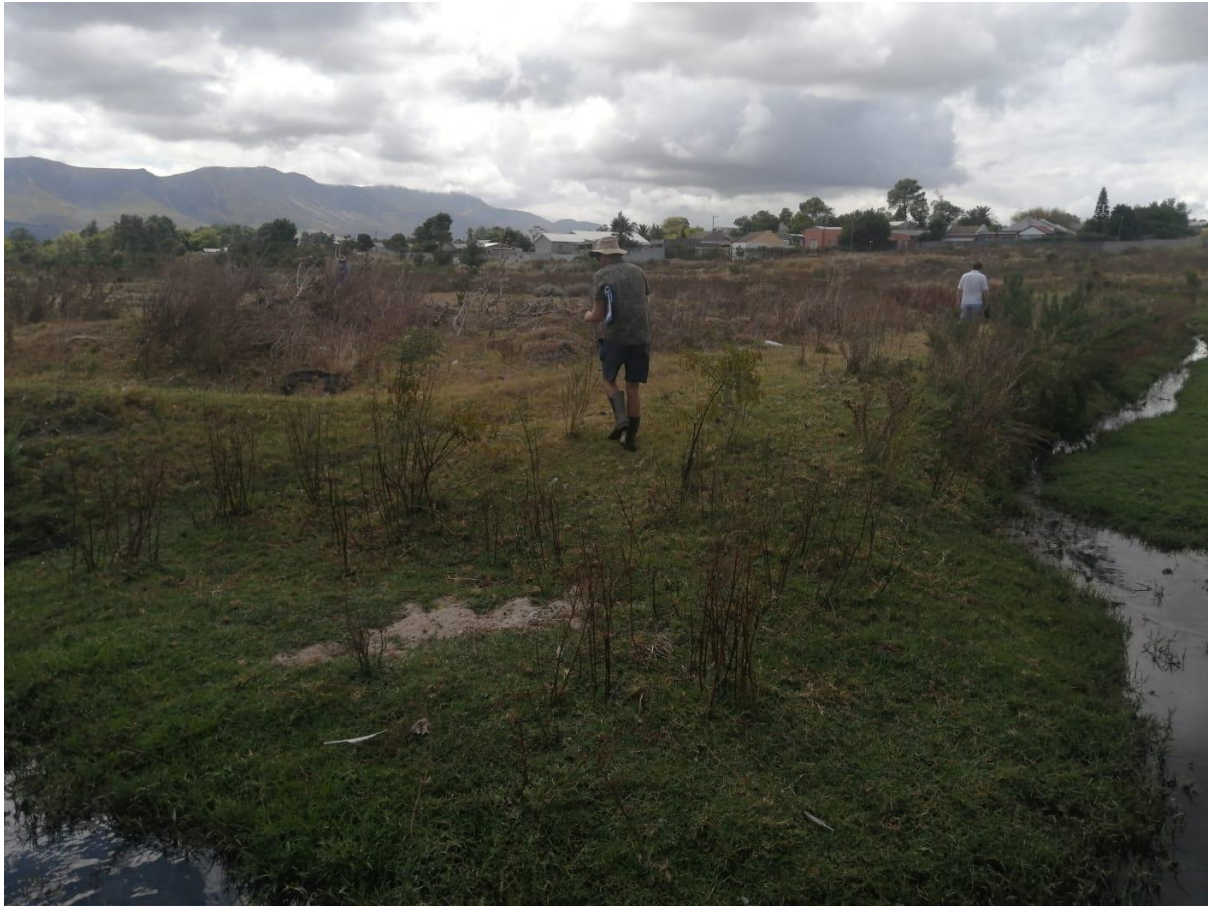
*Photo 3: Wetland area proposed for rehabilitation. This photo was taken facing east. This wetland is impacted by canalisation, compaction, rubbish dumping, the spread of alien invasive vegetation and polluted water inflow. A residential area can be seen in the background.*

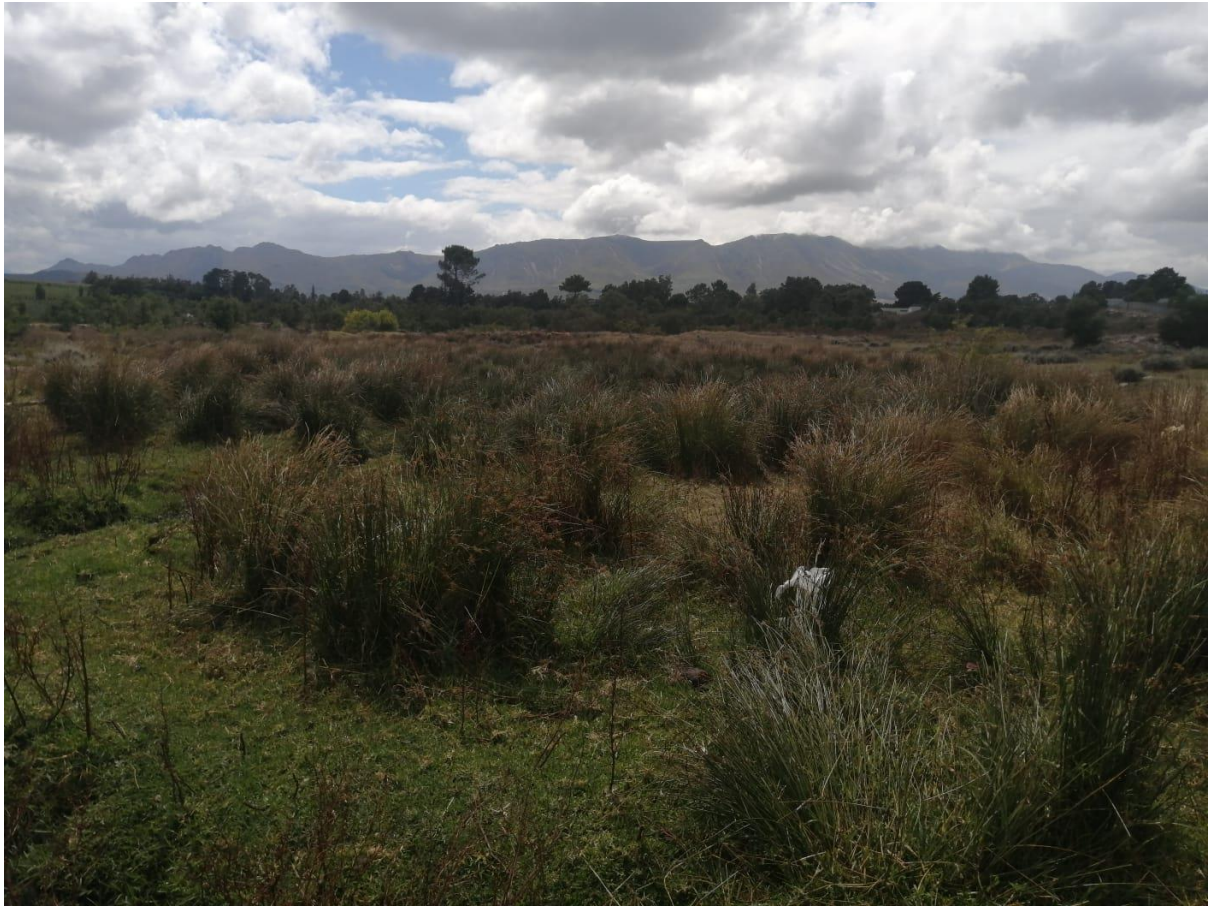
*Photo 4: Wetland area proposed for rehabilitation. This photo was taken facing northeast. Despite the disturbances, present within the wetland area, patches of indigenous vegetation such as *Juncus* spp., *Typha* spp., *Paspalum distichum*, and *Psoralea* spp. are present, with some plants still in a healthy state.*
