AQUATIC BIODIVERSITY COMPLIANCE STATEMENT AND RISK ASSESSMENT

DEVELOPMENT OF AN ADDITIONAL POULTRY REARING FACILITY ON THE
REMAINDER OF FARM GROOTVLEI NO. 225, CALEDON

April 2025

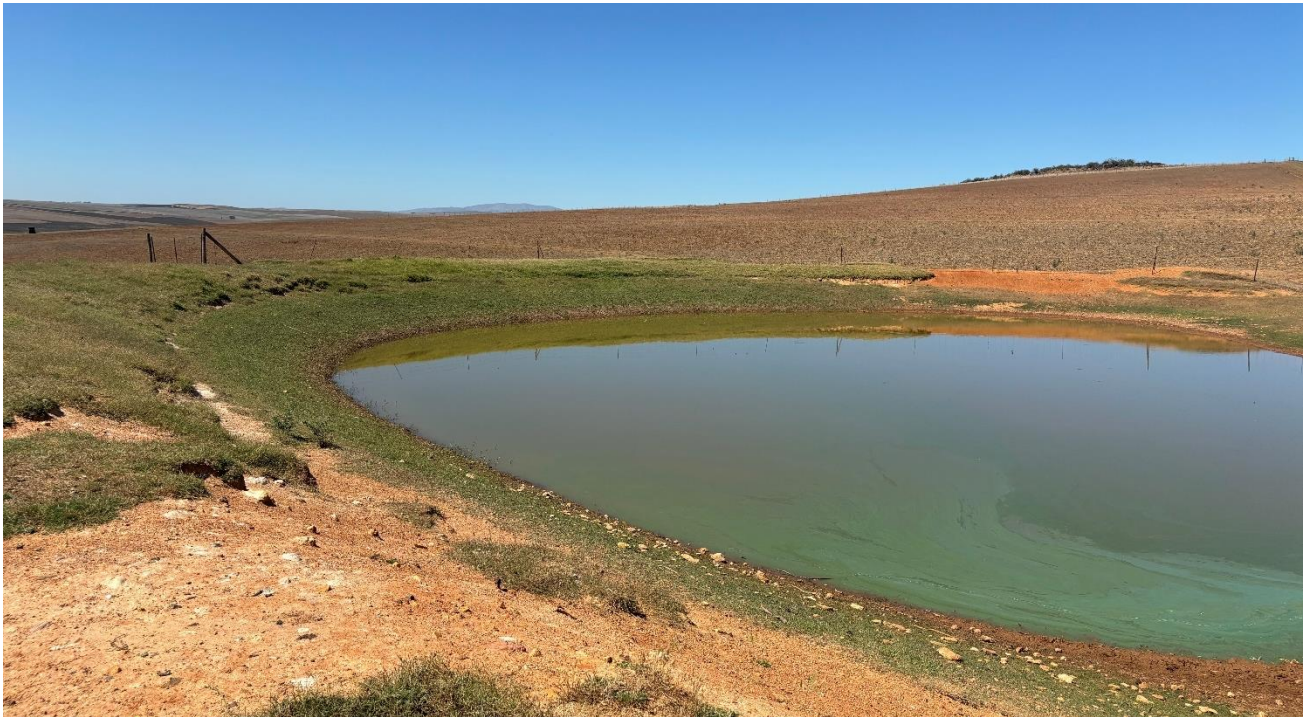
Figure 10: Dam located to the southeast of the proposed development site.

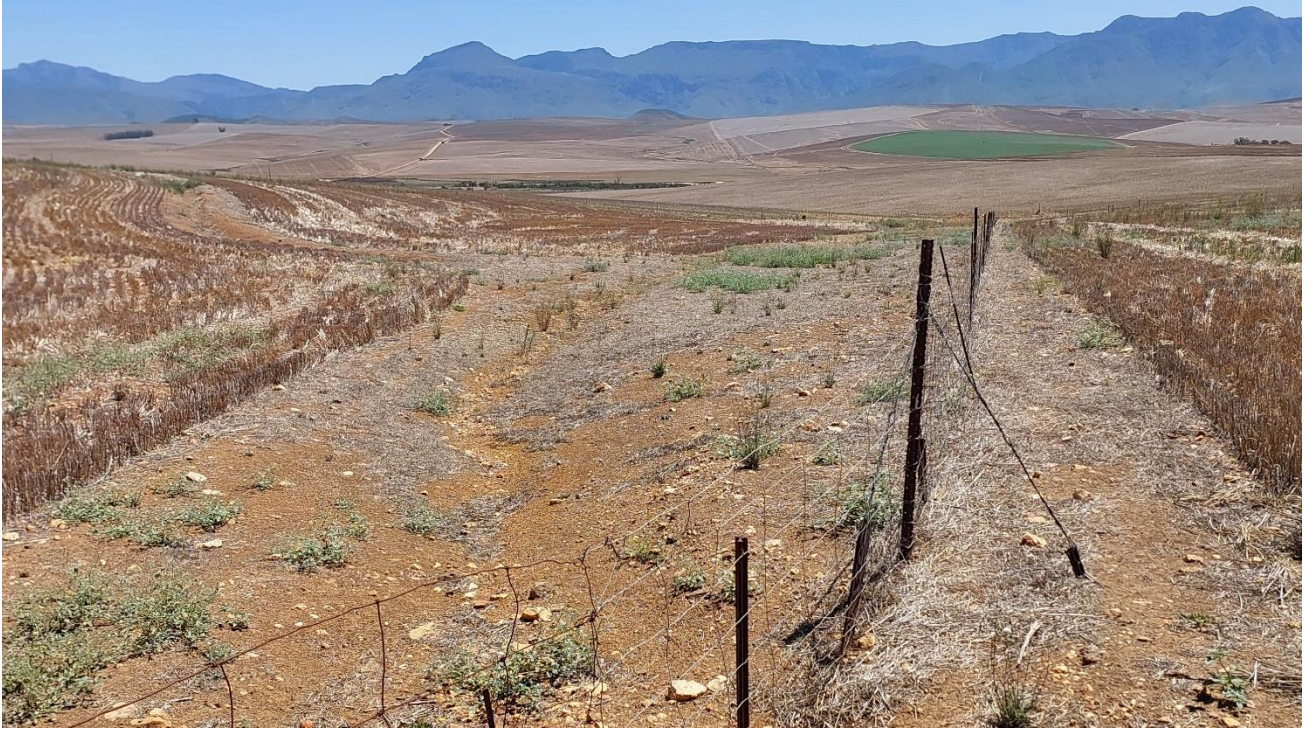
A non-perennial drainage line identified during the desktop assessment to the northwest of the proposed development site was confirmed during the site visit (Figure 9 & Figure 11). This feature is located more than 300 meters from the proposed development footprint and is topographically separated from it by a small hill. No signs of wetland conditions were observed along the drainage line. As it lies outside the 100 m riparian regulated area in terms of the National Water Act (NWA), this feature is not considered further in the current assessment.

Figure 11: Non perennial drainage line located approximately 330m northeast of the proposed development site.

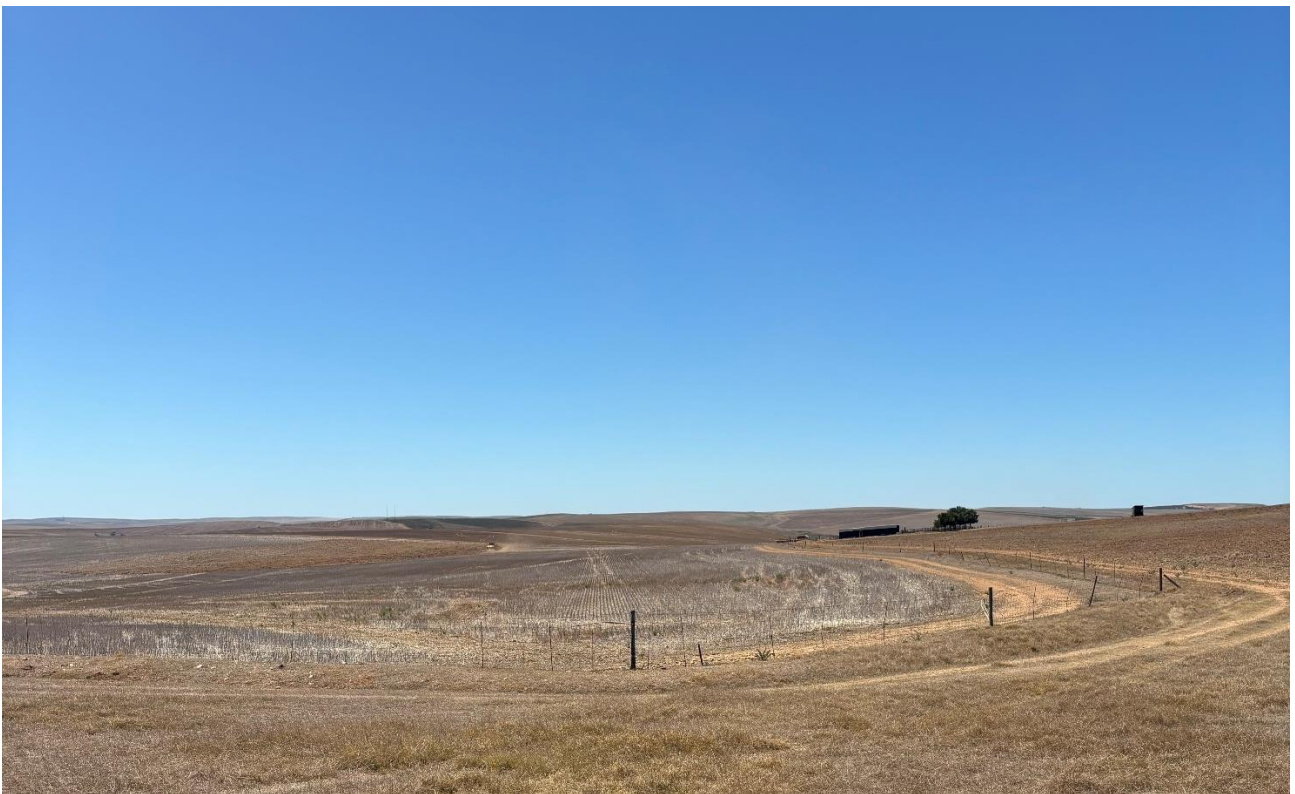
A degraded valley bottom wetland system was identified approximately 80 m southeast and downslope of the proposed development site (Figure 9 & Figure 12). This feature is situated within a gently sloped valley bottom that trends in a northeasterly direction (Figure 13). The wetland lies entirely within an actively cultivated field that appears to be used for grain production. At the time of the site visit, the field was in between cultivation cycles, comprising dried grain stalks and opportunistic weed species. No natural or wetland vegetation remains (Figure 14).

Figure 12: CVB Wetland located approximately 100m southwest of the proposed development site.

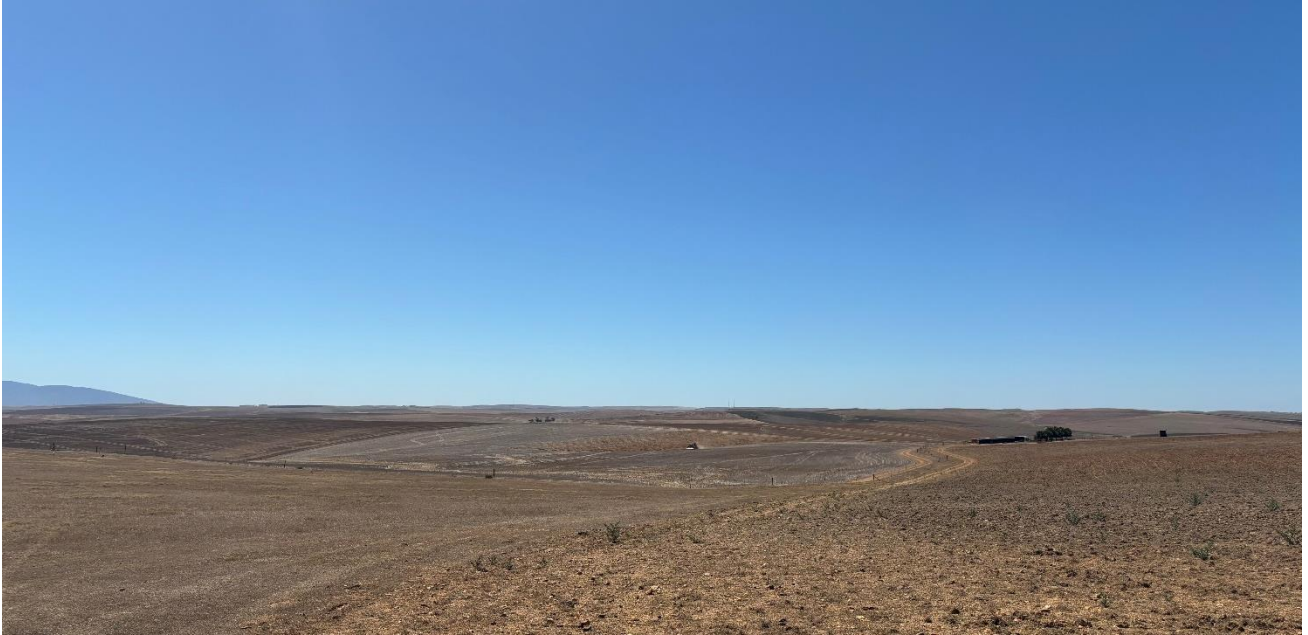
Figure 13: The delineated CVB Wetland is located within a gently sloped valley and trends northeast.

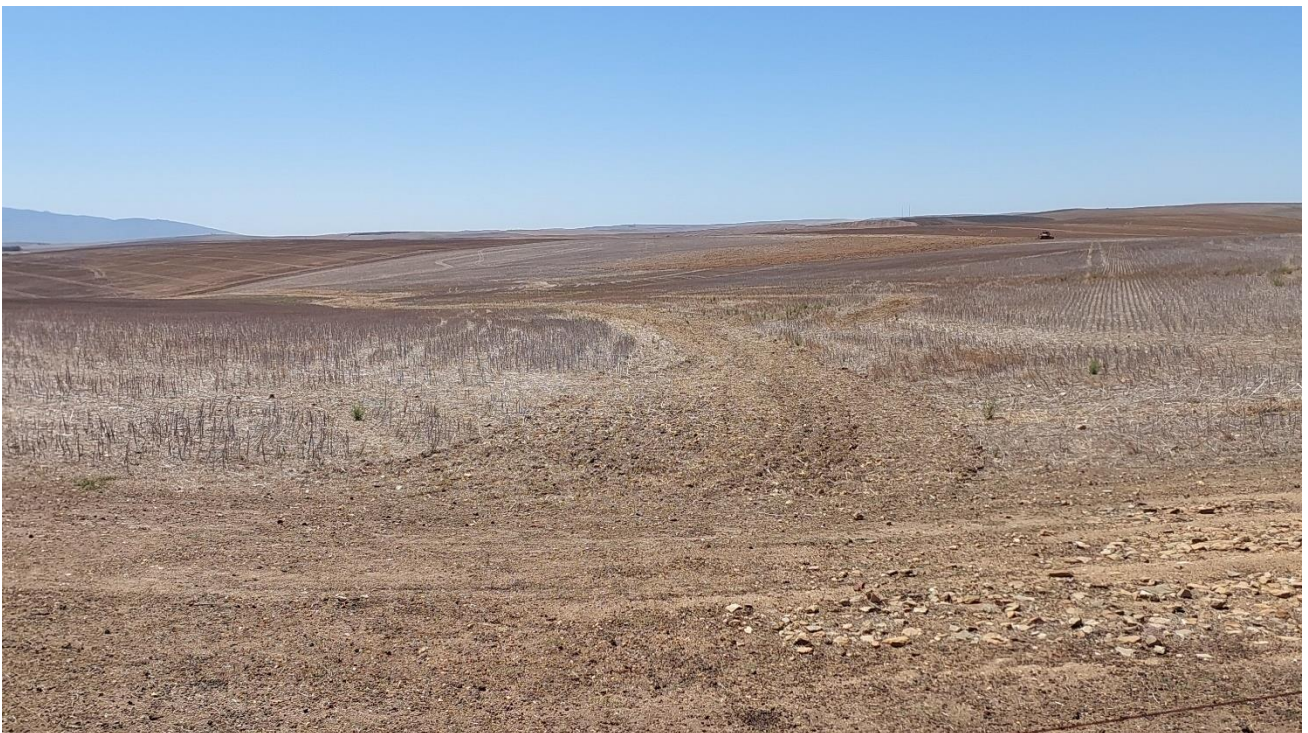
The soils in the wetland area have been severely compacted by repeated ploughing and agricultural activity, making soil sampling difficult. When samples were successfully obtained, they were dry, loosely structured, and immediately fell from the auger—providing limited diagnostic value. No active channel was observed, likely due to the loss of geomorphic features through regular cultivation (Figure 14). However, aerial imagery indicates that a channel is intermittently present, suggesting that under more natural conditions, the system would likely function as a channelled valley bottom (CVB) wetland (Figure 15).

Figure 14: The CVB wetland is located within an actively cultivated agricultural field. No natural or wetland vegetation remains. At the time of the site visit, the field was in between cultivation cycles, comprising dried grain stalks and opportunistic weed species.

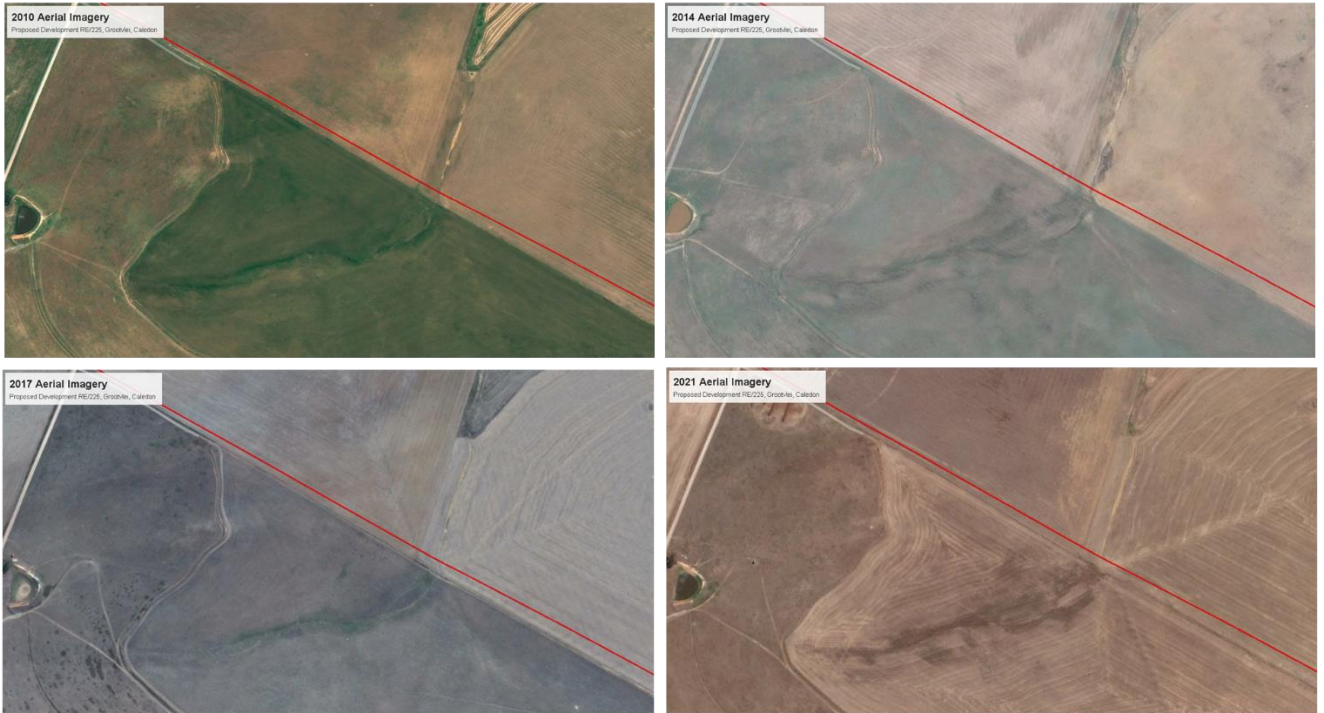
Although no visible wetland indicators were present during the site visit, both historical (Figure 16) and more recent aerial imagery (Figure 15 & Figure 17) reveal hydrological signatures indicative of a diffuse aquatic feature. The local topography, along with desktop evidence of diffuse hydrological signatures and channelled flow support the classification of the feature as a degraded CVB wetland.

Figure 15: Aerial imagery from 2010, 2014, 2017, and 2021 illustrates evidence of surface flow through the system and suggests the likely presence of a channel during at least some periods.

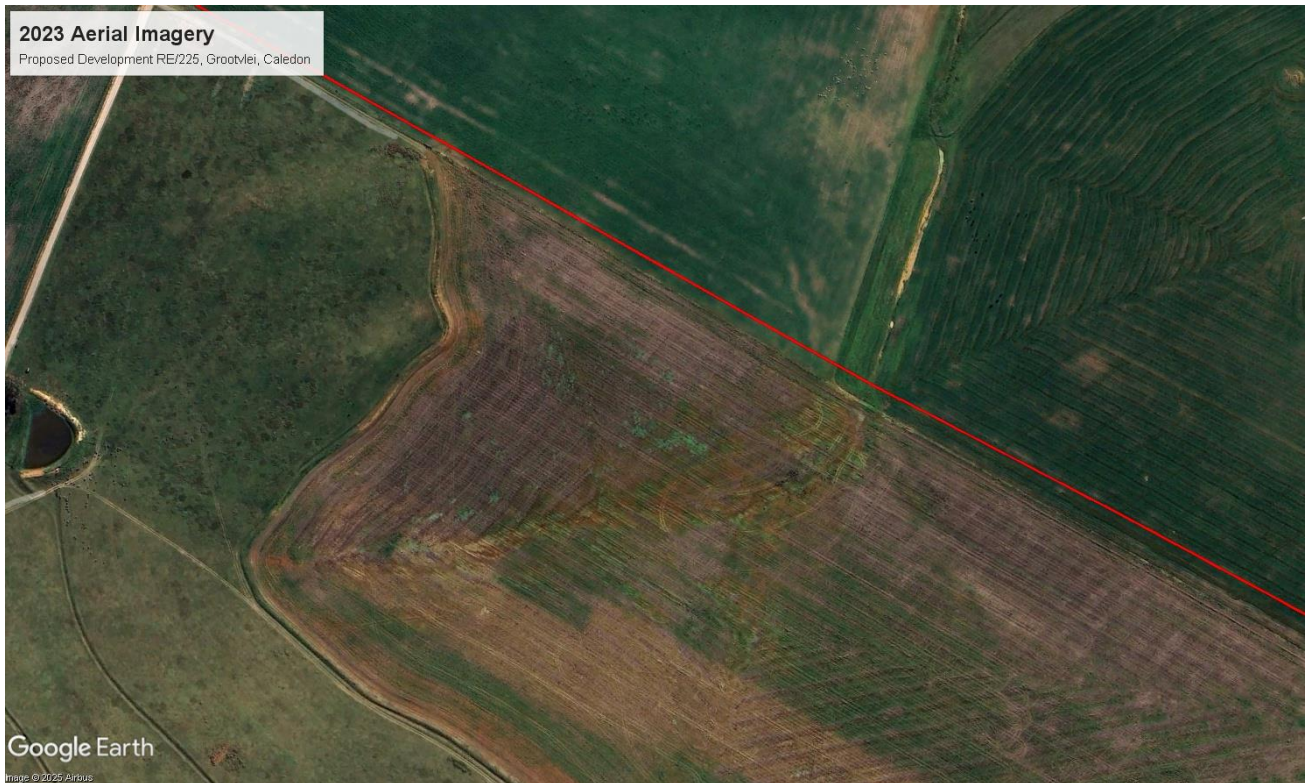
Just north of the site boundary, the valley bottom wetland system transitions into a defined channel, which flows northward as a tributary of the Kwartel River (Figure 9 & Figure 17). The portion of the downstream channel immediately northeast of the property boundary has been artificially modified and does not appear to exhibit wetland characteristics. While it remains uncertain whether the shift to a channelled system is the result of natural topographic constriction or anthropogenic deepening and alteration, the presence of channelised outflow is supported by both the local topography and patterns observed in historical and recent aerial imagery (Figure 15 - Figure 17).

Figure 17: 2023 Aerial imagery showing hydrological markers indicative of flow movement through the area.
