Freshwater Assessment for the New Development on Portion 22 of Farm 82, Caledon.

FEBRUARY 2025

FRESHWATER ASSESSMENT FOR THE PROPOSED NEW DEVELOPMENT ON PORTION 22 OF FARM 82, CALEDON

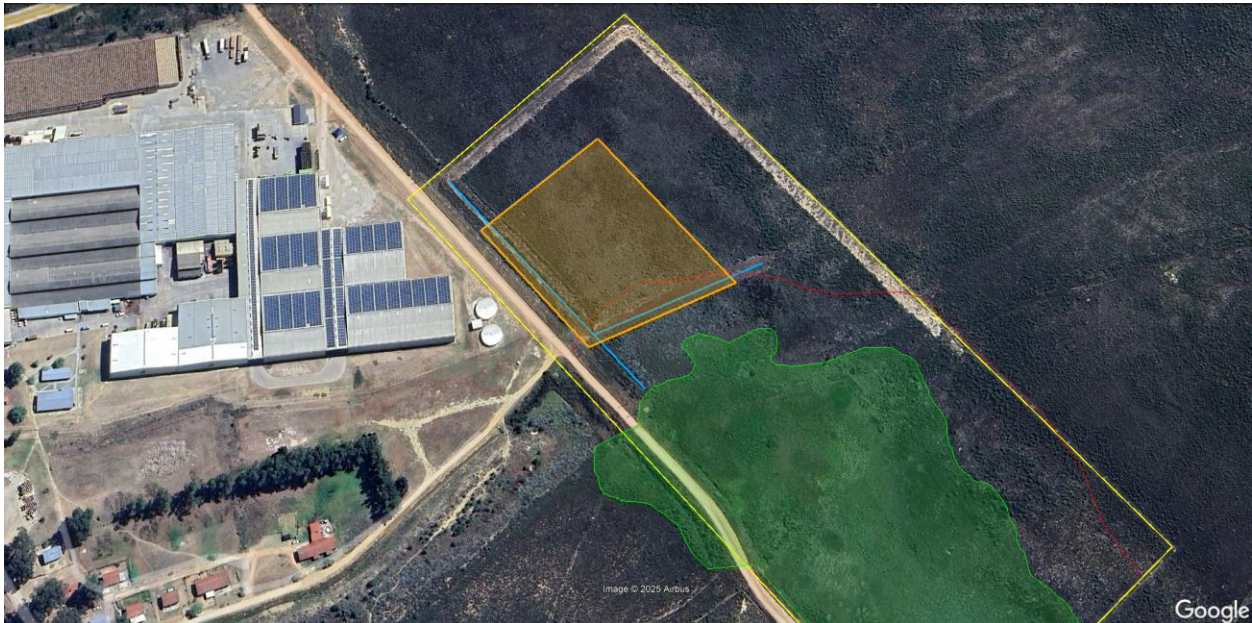
An initial freshwater report was conducted for the client in June 2022 as part of the Environmental Impact Assessment (EIA) process. However, the client has since proceeded with clearing approximately 1 hectare of indigenous vegetation to establish a $\pm 2,400\text{m}^2$ platform for truck parking and fruit bin storage. The existing entrance road between this site and Idea Fruit was utilized, along with an additional entrance further east. Furthermore, two large drainage channels have been excavated over previously semi-rehabilitated drainage channels along the eastern and southern edges of the cleared area, currently actively draining the wetland. Since updated satellite imagery is not yet available, the approximate extent of the newly cleared area is illustrated in Figure 3, based on observations from the field assessment.

Figure 3: Approximate cleared area (orange polygon) and drainage channels (blue lines) in relation to the wetland area (green polygon) and previously proposed buffer line (red line).

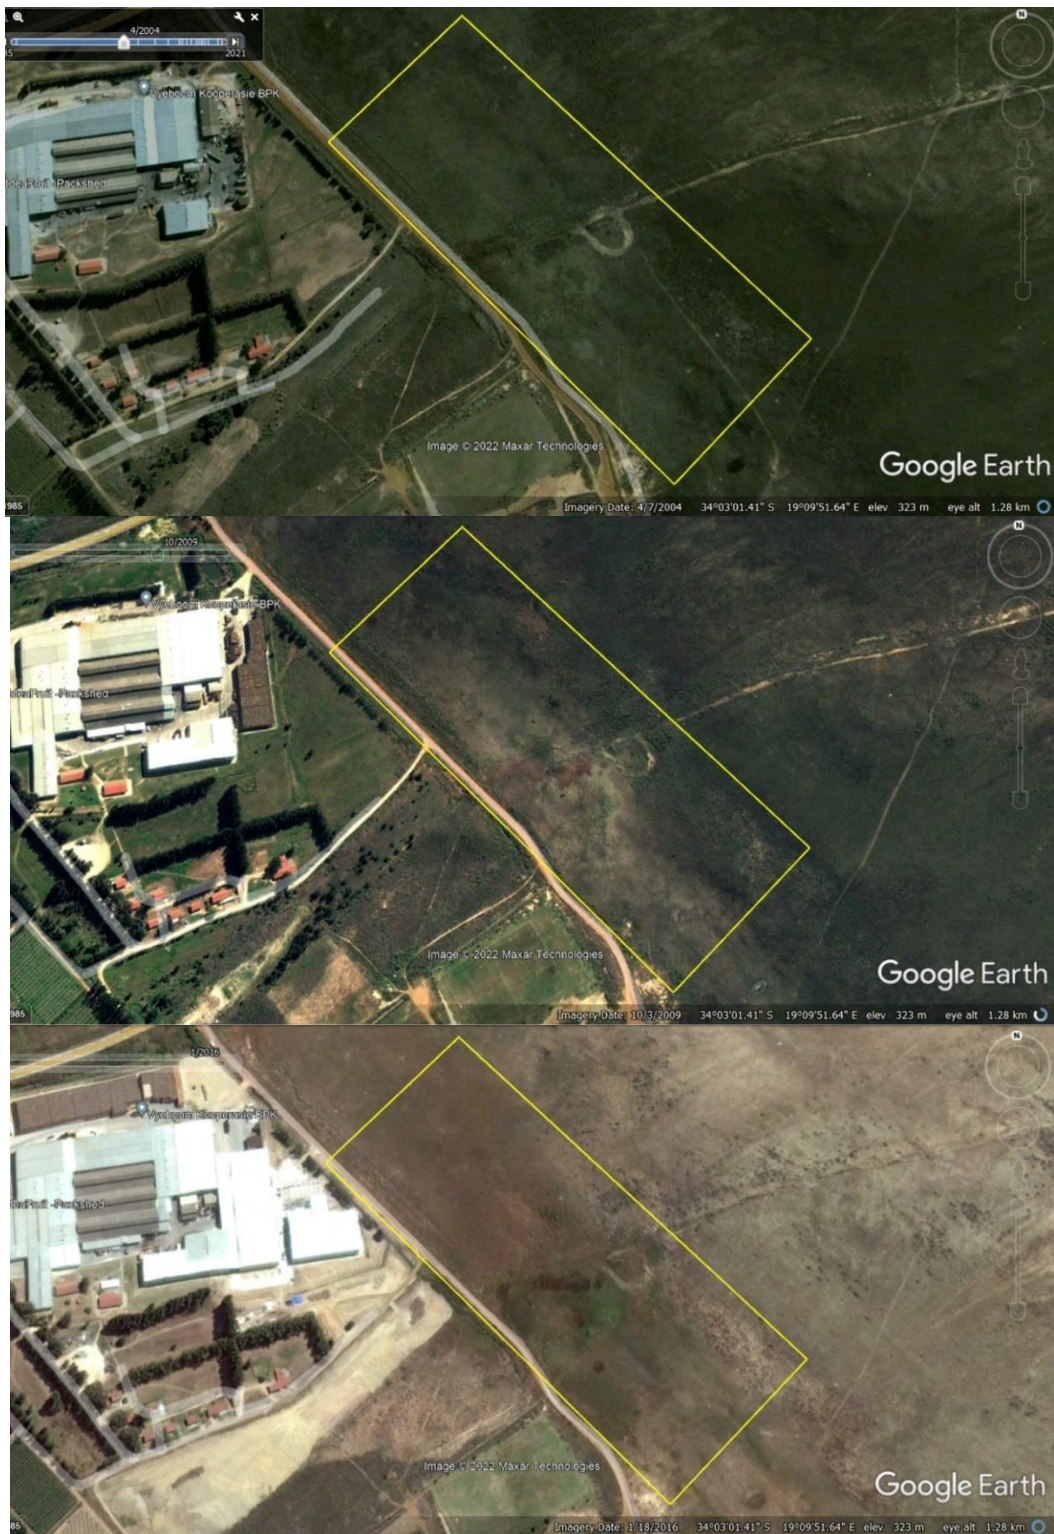
When looking at these images, the land use on the property has for many years remained the same (mostly natural), with only small modifications made to the natural vegetation that occurs on the site. A large valley bottom wetland can be seen on all these images located from the middle of the property towards the southeast of the site, being connected with wet areas falling outside the property boundary as well. A large drainage channel, most probably in an attempt to drain the wetland area, was excavated in early 2017. This channel was rehabilitated between 2017 and the initial field visit in 2022. Rehabilitation of this channel was however never fully completed.

Figure 4: Google Earth imagery from 2004 (top) and 2009(middle) and 2016 (below) for the area affected by the proposed new development (Google Earth, 2022)

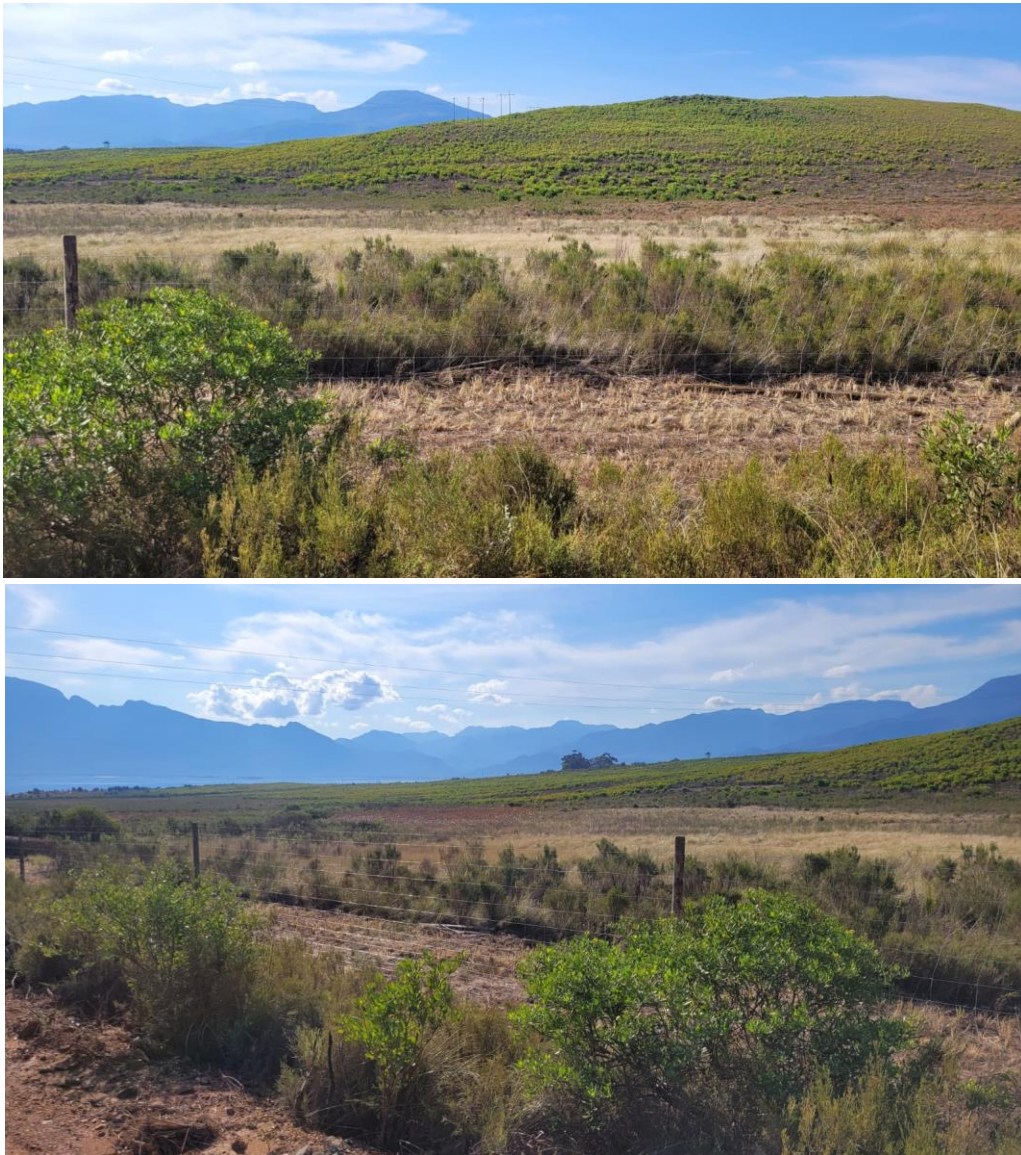
This vegetation type occupies most of the property. Although it was found to be largely in a natural state during the first field visit in 2022, approximately 20% of the property has been cleared, as noted above. Indigenous vegetation surrounding the wet areas on-site consists largely of bulrush (*Typha capensis*), *Agapanthus* species, arum lilies (*Zantedeschia aethiopica*), steekbos (*Cliffortia ruscifolia*), and various sedges, including knoppiesbiesie (*Ficinia indica*) and *Cyperus thunbergii*. Rushes such as spiny rush (*Juncus acutus*), restios including besemgoed (*Restio paniculatus*) and *Elegia nuda*, as well as African feather grass (*Pennisetum macrourum*), koffiepit (*Wachendorfia paniculata*), and suurkanol (*Watsonia* species) are also present.

Figure 8: Vegetation around the upstream (top) and downstream (bottom) section of the wetland area during the 2022 visit.

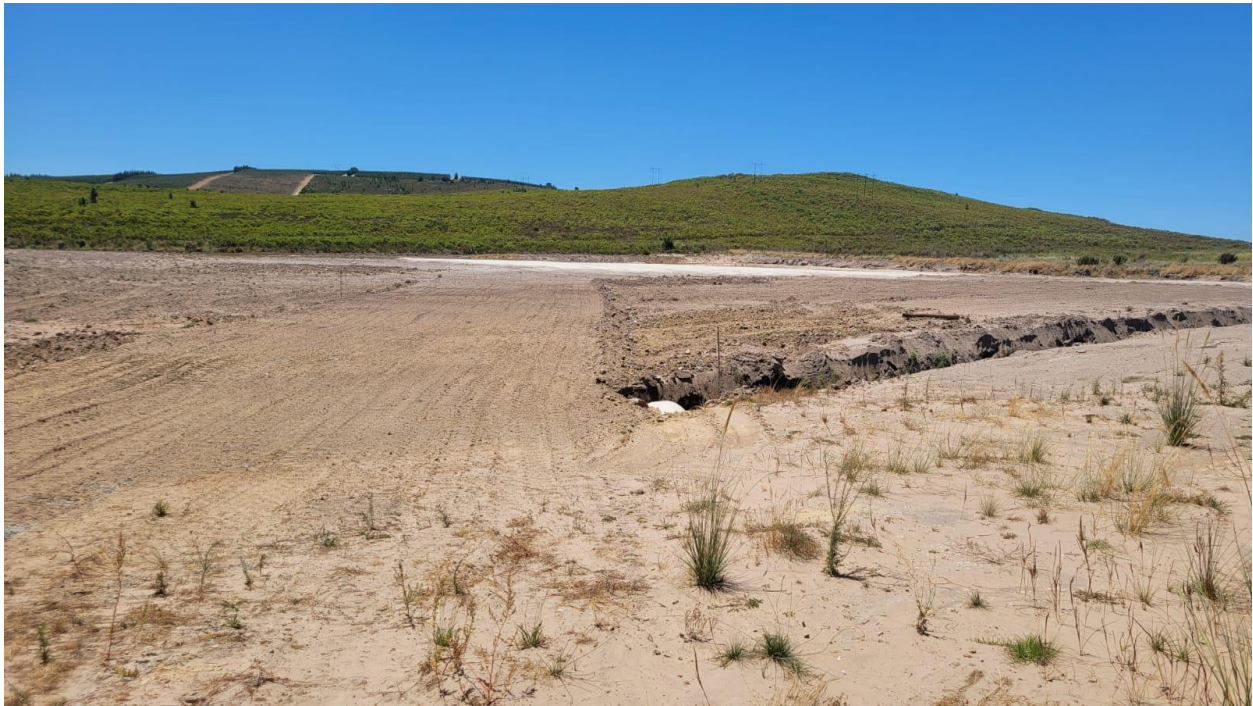
Figure 9: The cleared area west of the wetland area during the 2025 visit.

- The whole buffer zone should be completely rehabilitated and revegetated in order to prohibit any future loss of the pristine wetland area.
- Rehabilitation should take place in accordance with a formal rehabilitation plan, and be monitored regularly (as stipulated in this plan), to ensure proper re-establishment of vegetation and habitat.

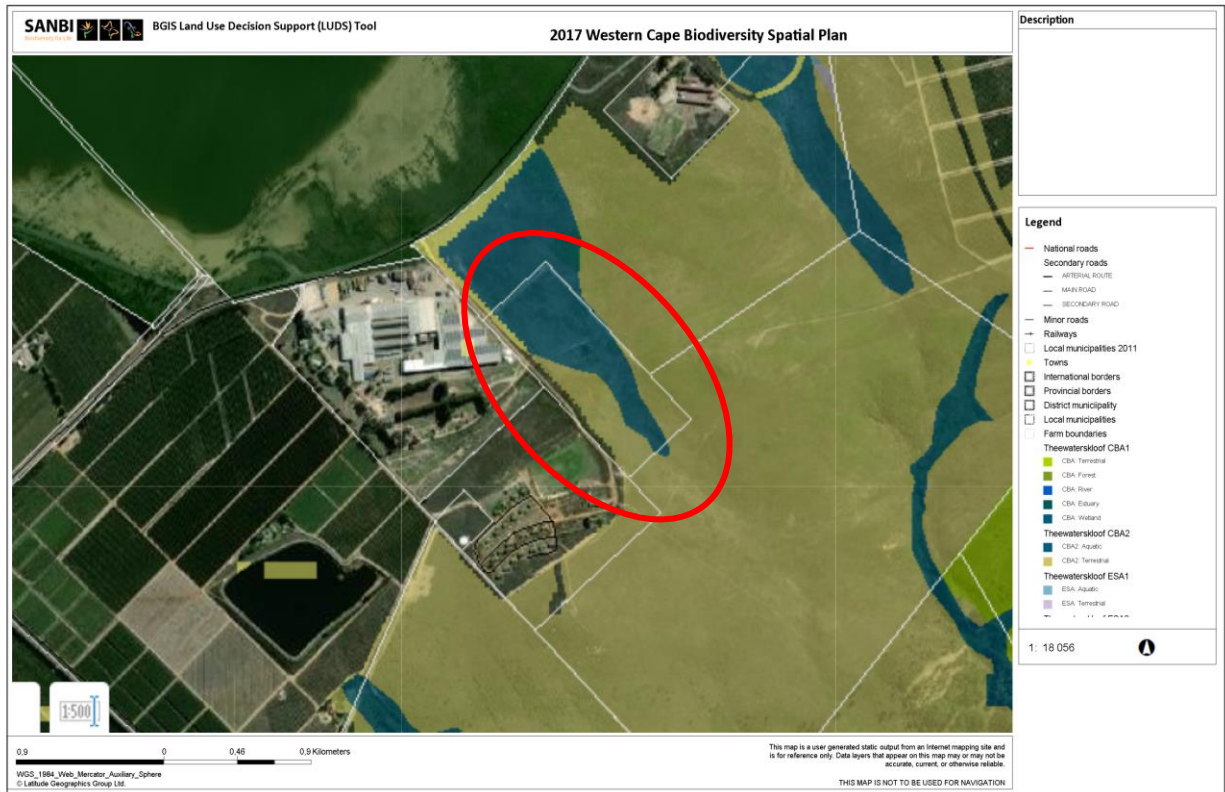
From the 2017 Western Cape Biodiversity Spatial Plan (Figure 10) it is clear that a large wetland area indicated on site, is marked as an aquatic critical biodiversity area (CBA₁) with the rest of the property marked as Critical Biodiversity Area 2: Degraded (terrestrial). Although the position of the wetland area is inaccurate, the CBA classification for the wetland itself would be considered valid. **These areas are considered to be important on a national scale and required to meet biodiversity targets for ecosystems, species and ecological processes and should be maintained in a natural or near-natural state, with no further loss of natural habitat. Degraded areas should be rehabilitated and only low-impact, biodiversity-sensitive land uses are appropriate.** The broader terrestrial CBA₂ associated with the remainder of the vegetation, usually includes areas in a degraded or secondary condition that are required to meet biodiversity targets, for species, ecosystems or ecological processes and infrastructure. Such areas are to be maintained in a natural or near-natural state, with no further loss of habitat. Degraded areas should be rehabilitated and only low-impact, biodiversity-sensitive land-uses are appropriate.

Figure 10: The 2017 Western Cape Biodiversity Spatial Plan for the area (SANBI GIS, 2022).

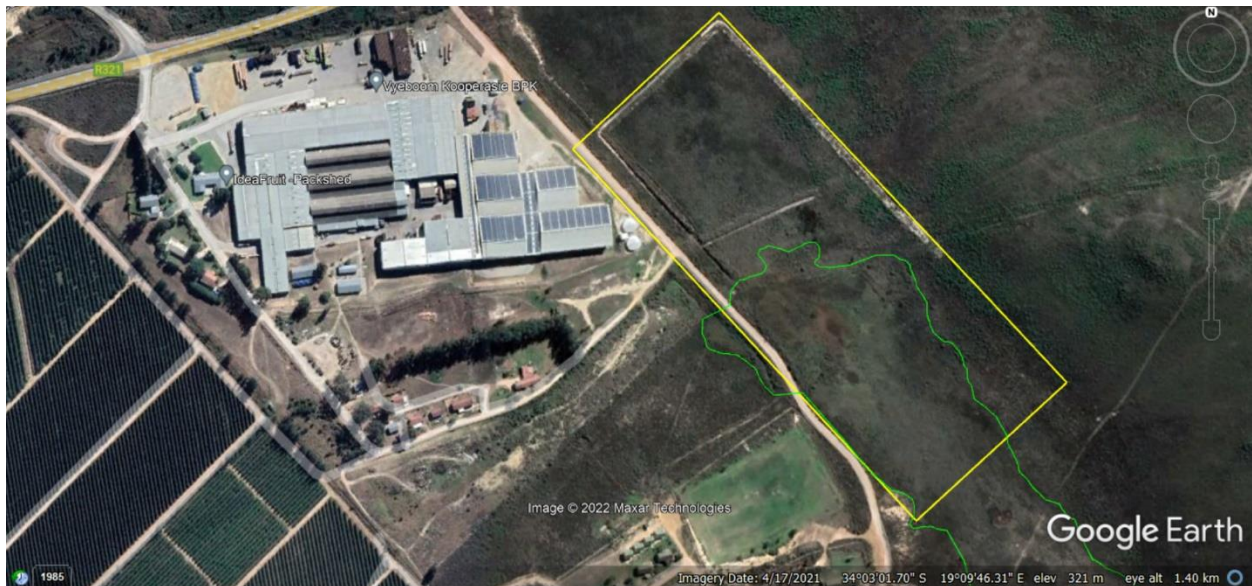
Freshwater features affected by the new development include a large valley-bottom wetland located on the property. To obtain a representative evaluation of the present ecological state of the affected wetland, a formal Habitat Integrity (Present Ecological State), Ecological Importance and Sensitivity (EIS) (EcoStatus Level III), as well as a Wetland Ecoservices assessment was conducted for the wetland area and compared to the findings of the 2022 study.

Figure 12: A satellite image indicating the affected freshwater features, marking the large wetland area (light green polygon) within the property boundary (yellow polygon).

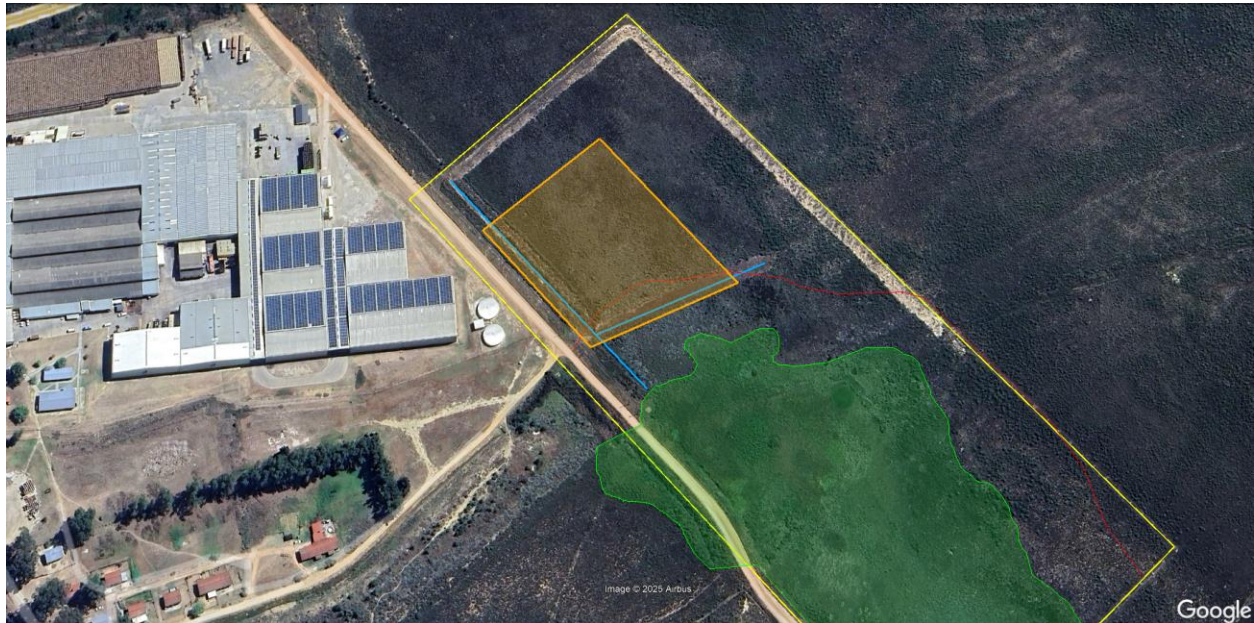
According to the Buffer Zone Tool for the Determination of Aquatic Impact Buffers developed by the Department of Water and Sanitation (2014), a 50m buffer zone is recommended for wet areas. **Considering the critically endangered status of both the wetland type and the associated vegetation, along with the fact that this wetland remains in a largely natural state, making it an excellent reference site, a 50m buffer zone was proposed in the initial freshwater assessment.**

Figure 13: A satellite image showing the wetland area (green polygon) with the proposed 50m buffer zone (red line) as well as the approximate position of the development (orange polygon) and drainage channels (blue lines).

- No drainage structures should be allowed within the 50m buffer zone. All existing drainage channels within this zone must be rehabilitated and revegetated. Rehabilitation should involve infilling the excavated areas with similar soils, ensuring no soil compaction occurs in the newly filled channels.
- New drainage channels should be located outside the 50m buffer zone and should preferably be designed as vegetated, shallower, and wider stormwater swales.
- A small, vegetated stormwater retention area should be created at the property's boundary to allow for infiltration and to prevent erosion and sedimentation towards the downstream wetland areas.

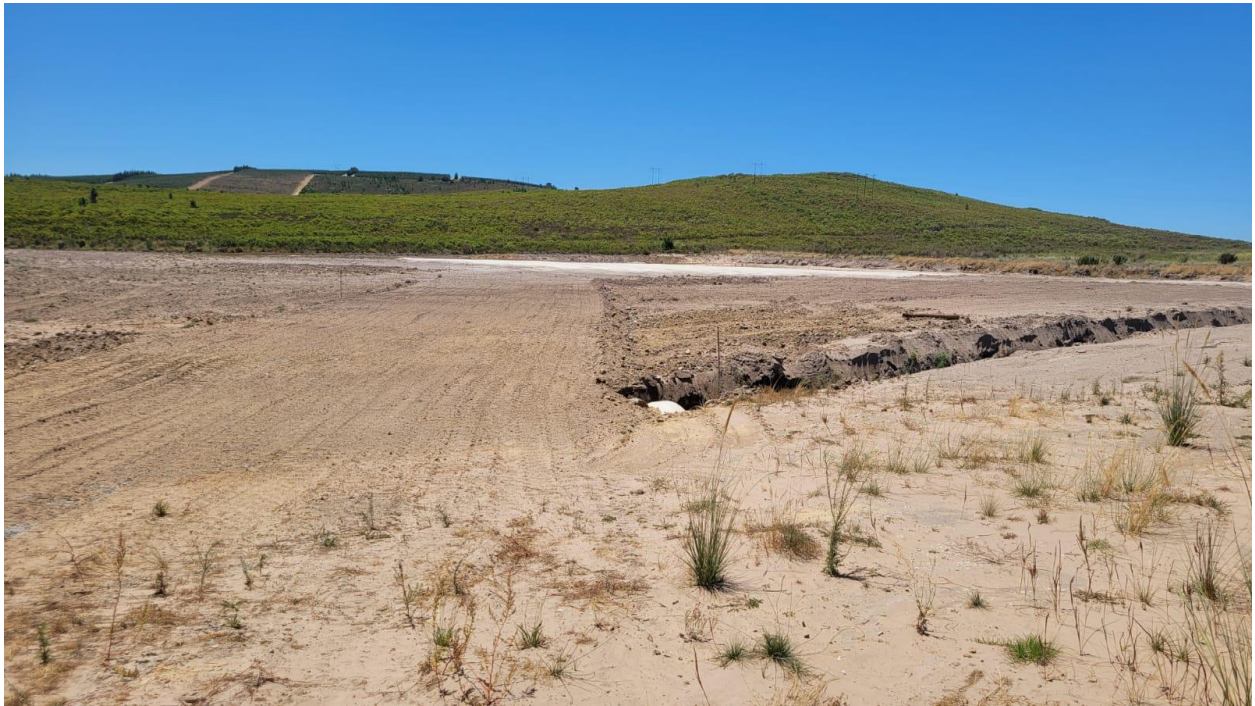
Although the current degradation is not yet severe, the presence of larger drainage channels and the reduction of the buffer zone will likely lead to a more significant decline in the coming years. Additionally,

Figure 14: Footage of the western section of the cleared area with the drainage channel in the forefront.

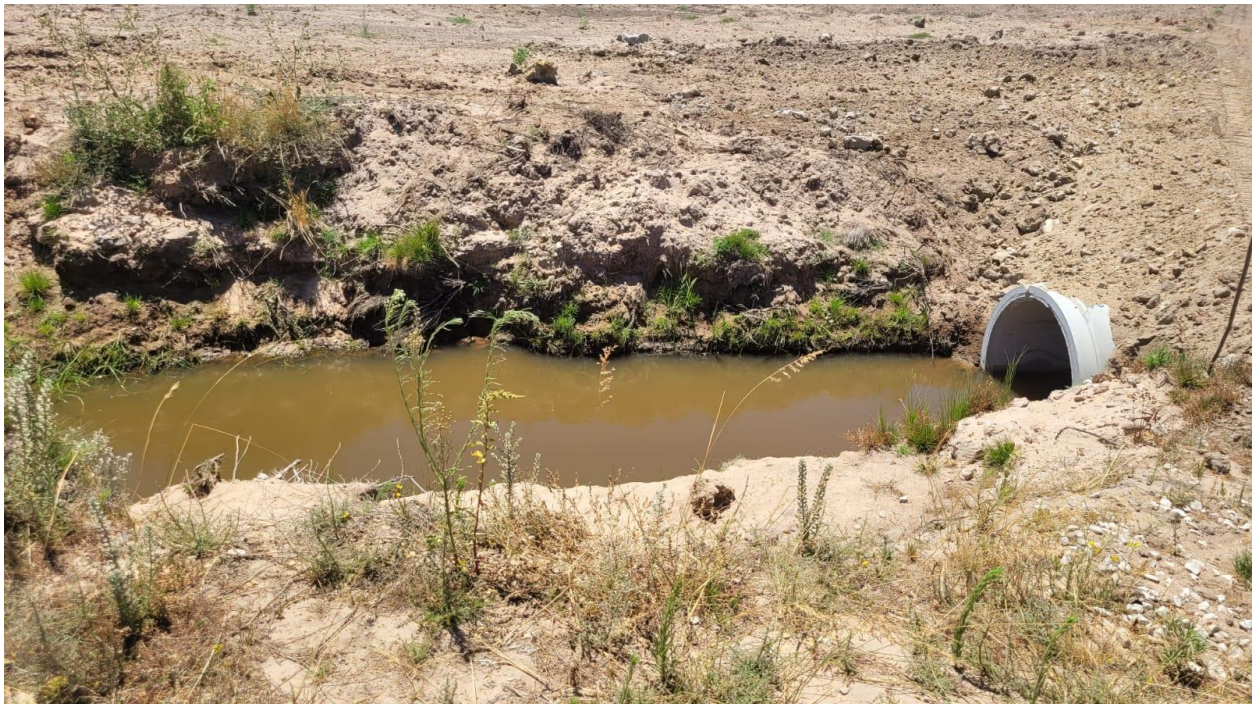
Figure 15: Footage of the drainage channel and current water drainage.

These impacts were largely caused through site access, clearing of vegetation, excavation of soils and the creation of drainage channels around the wetland area. Additionally, the operational phase might also lead to a decline in water quality within the wet areas.

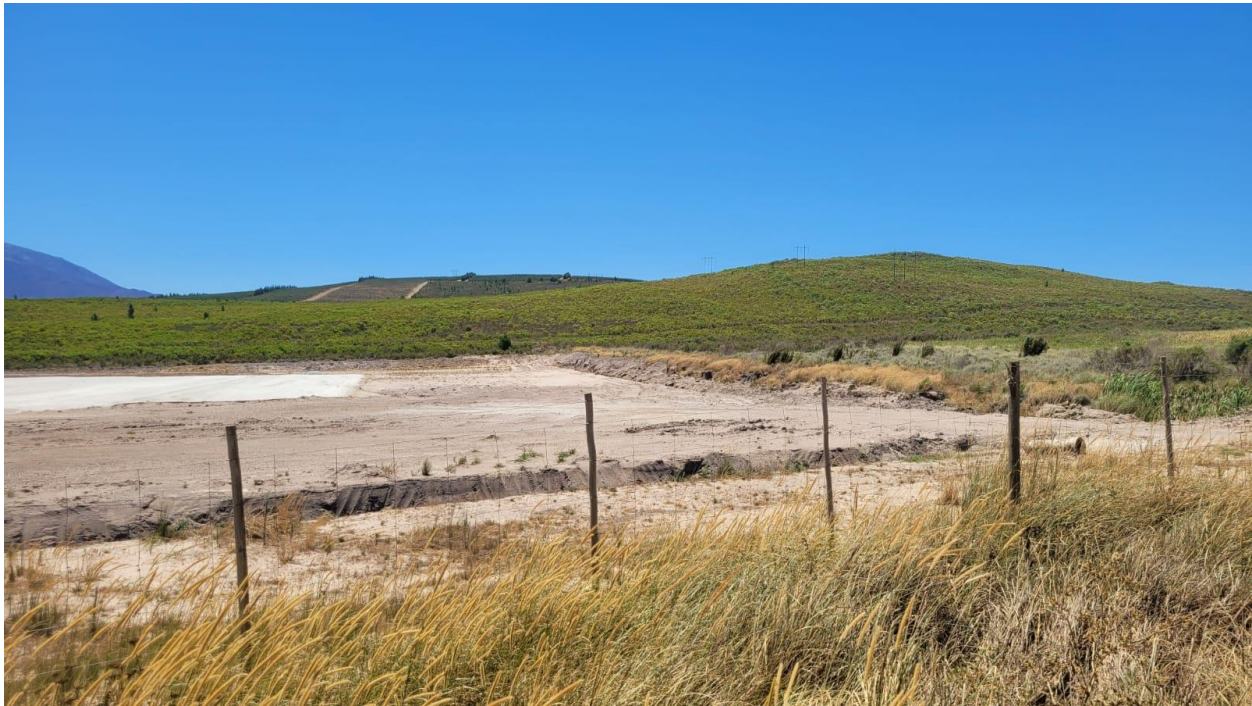
Figure 16: Footage of the eastern section of the cleared area with the drainage channel in the forefront and the wetland area located to the right.
