WATER USE LICENCE APPLICATION SUMMARY REPORT (WU44082)

**ABSTRACTION OF GROUNDWATER AND STREAM CROSSINGS ON FARMS 563, 564, 565
AND FARM KLEINFONTEIN 954, VILLIERSDORP**

**NAME OF APPLICANT:
EFRC AGRI OPERATIONS (PTY) LTD**

**Compiled by
PHS Consulting**

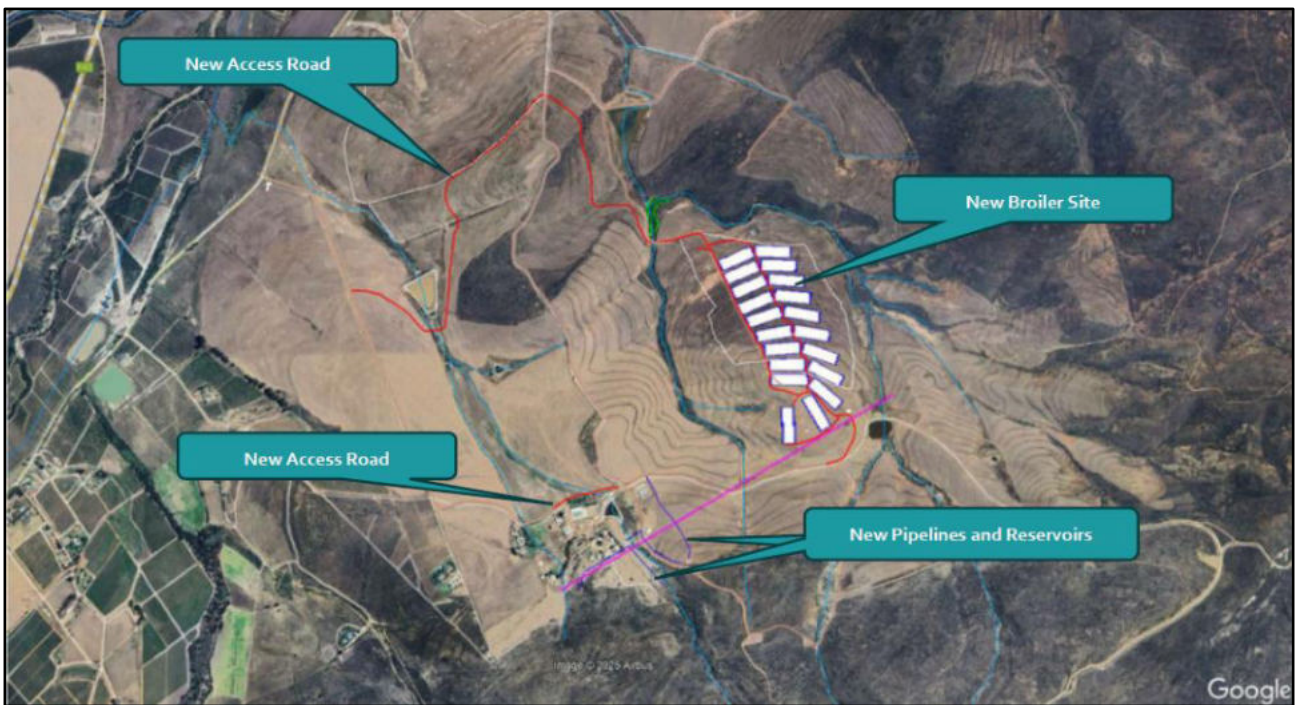
Figure 4: Proposed activities in relation to the affected freshwater features (Everwater Freshwater Consulting Services, August 2025).

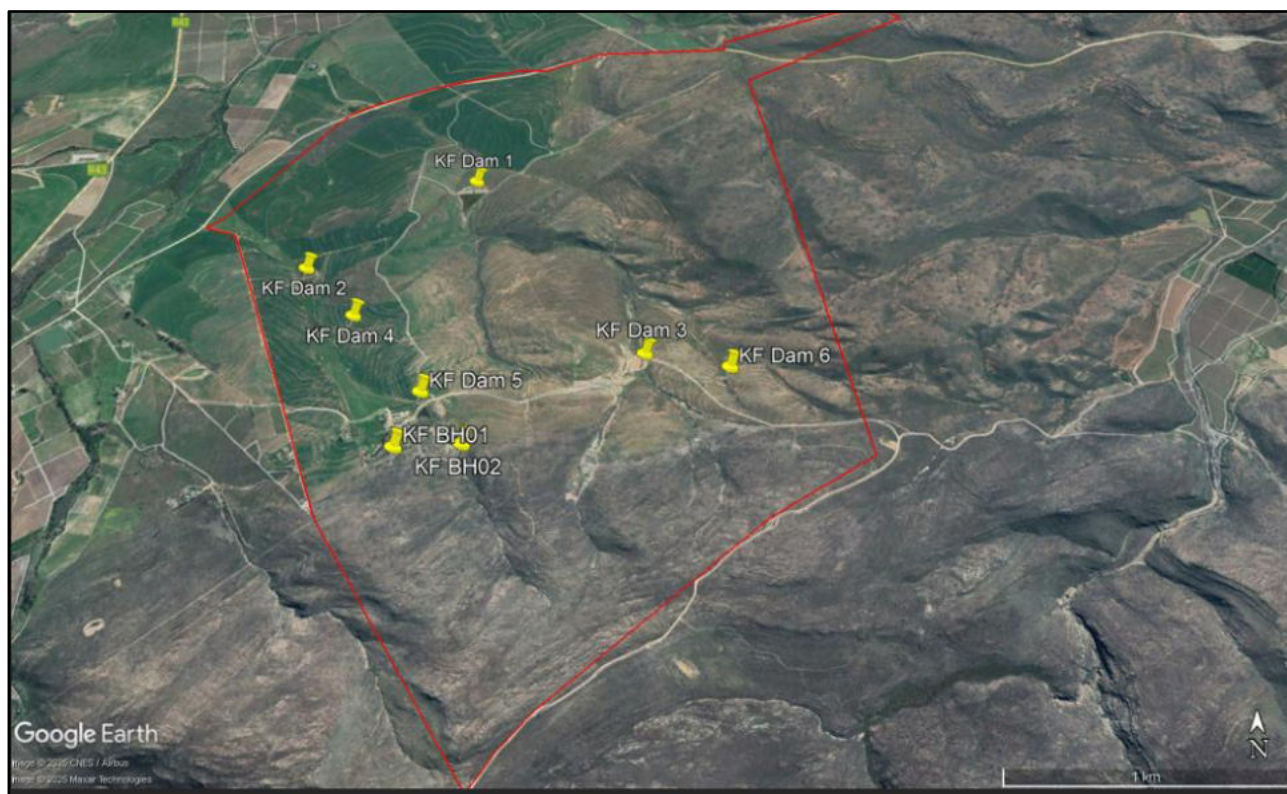
Figure 5: Map showing location of 2 abstraction boreholes and 6 ELU dams

This WULA is for the application of groundwater abstraction from 2 boreholes (KF_BH1 & KF_BH2) as indicated in Figure 5, and for four stream crossings (refer Figure 6).

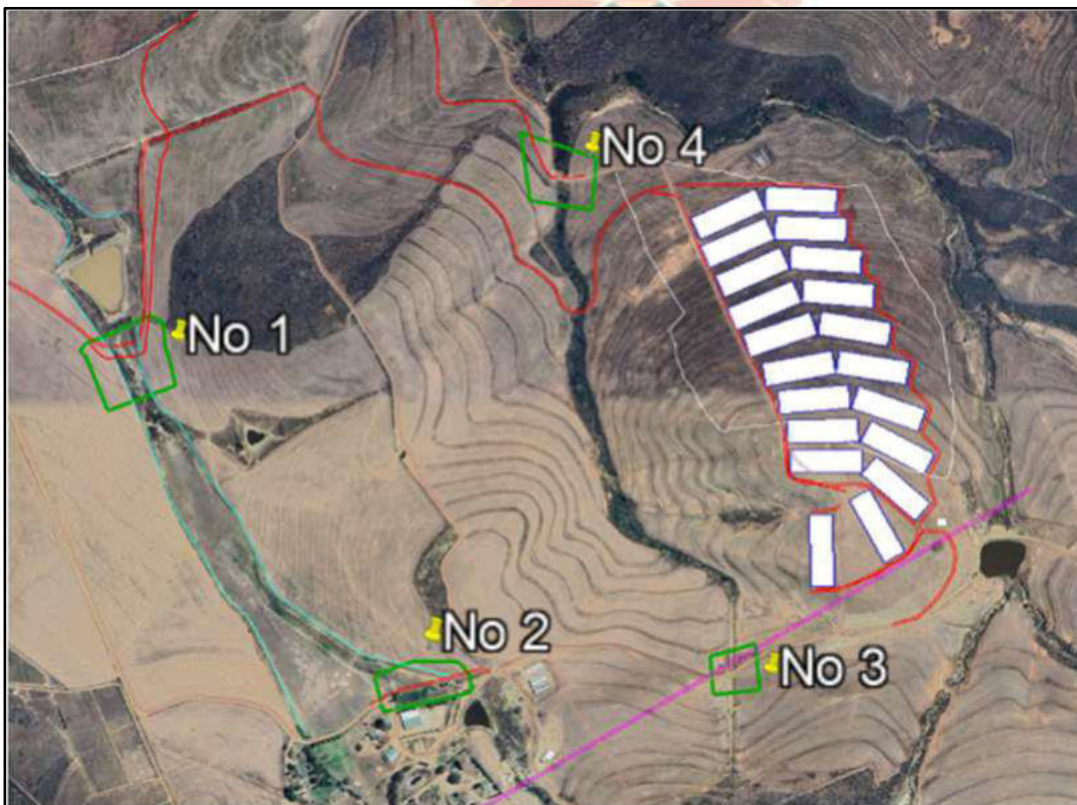
Figure 6: Proposed location of stream crossings (Fore Engineering Design report; July 2025)

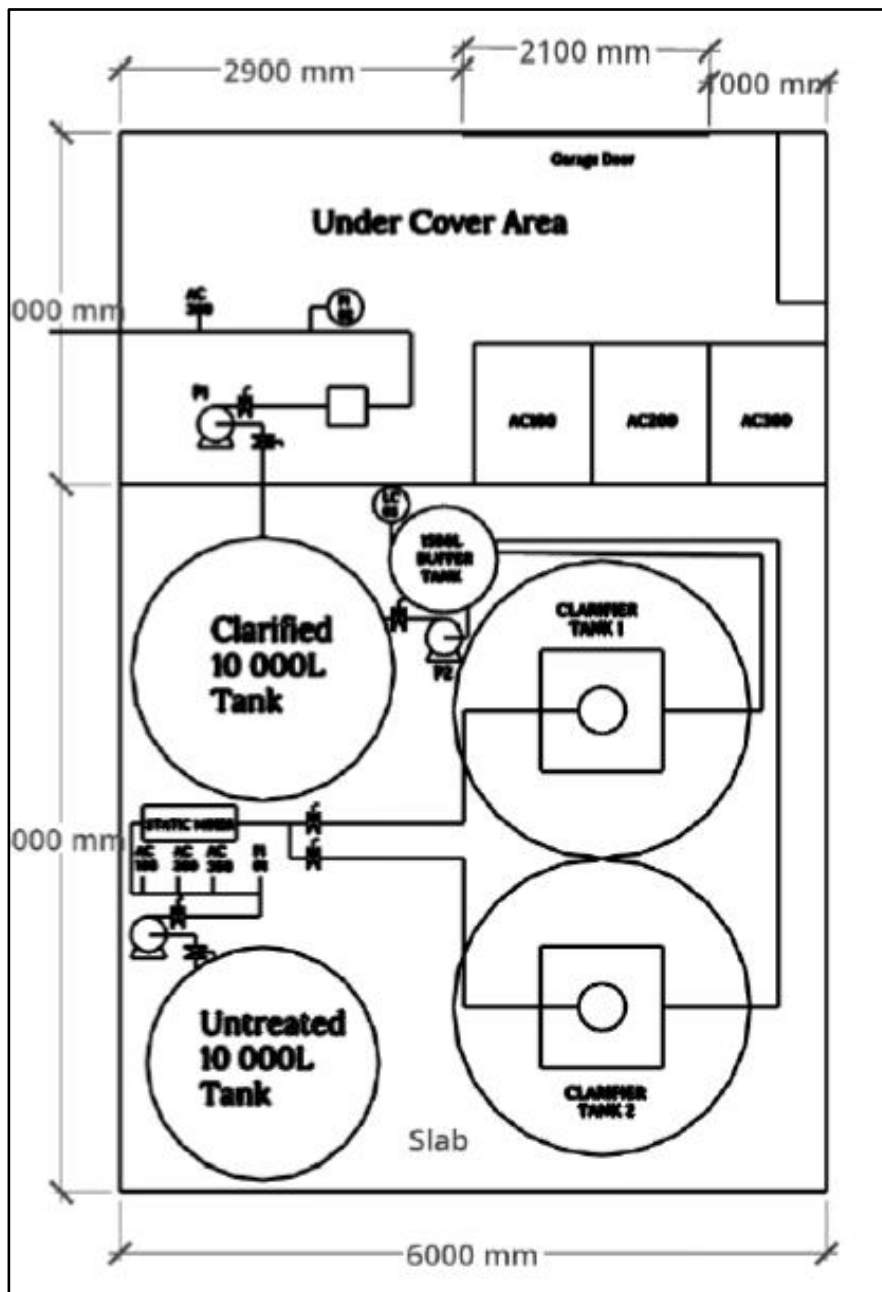
Figure 7: Proposed plant layout (Tuschemy, August 2025)

The proposed water treatment process involves adding a coagulant, chlorine, and rectifying the pH. The iron and manganese can be removed by settling. A specialist company will be responsible for the design and installation of the treatment plant and the monthly monitoring and maintenance associated with the treatment plant. Refer to Figure 7 below which illustrates the proposed treatment plant layout and design to be placed on a concrete slab.

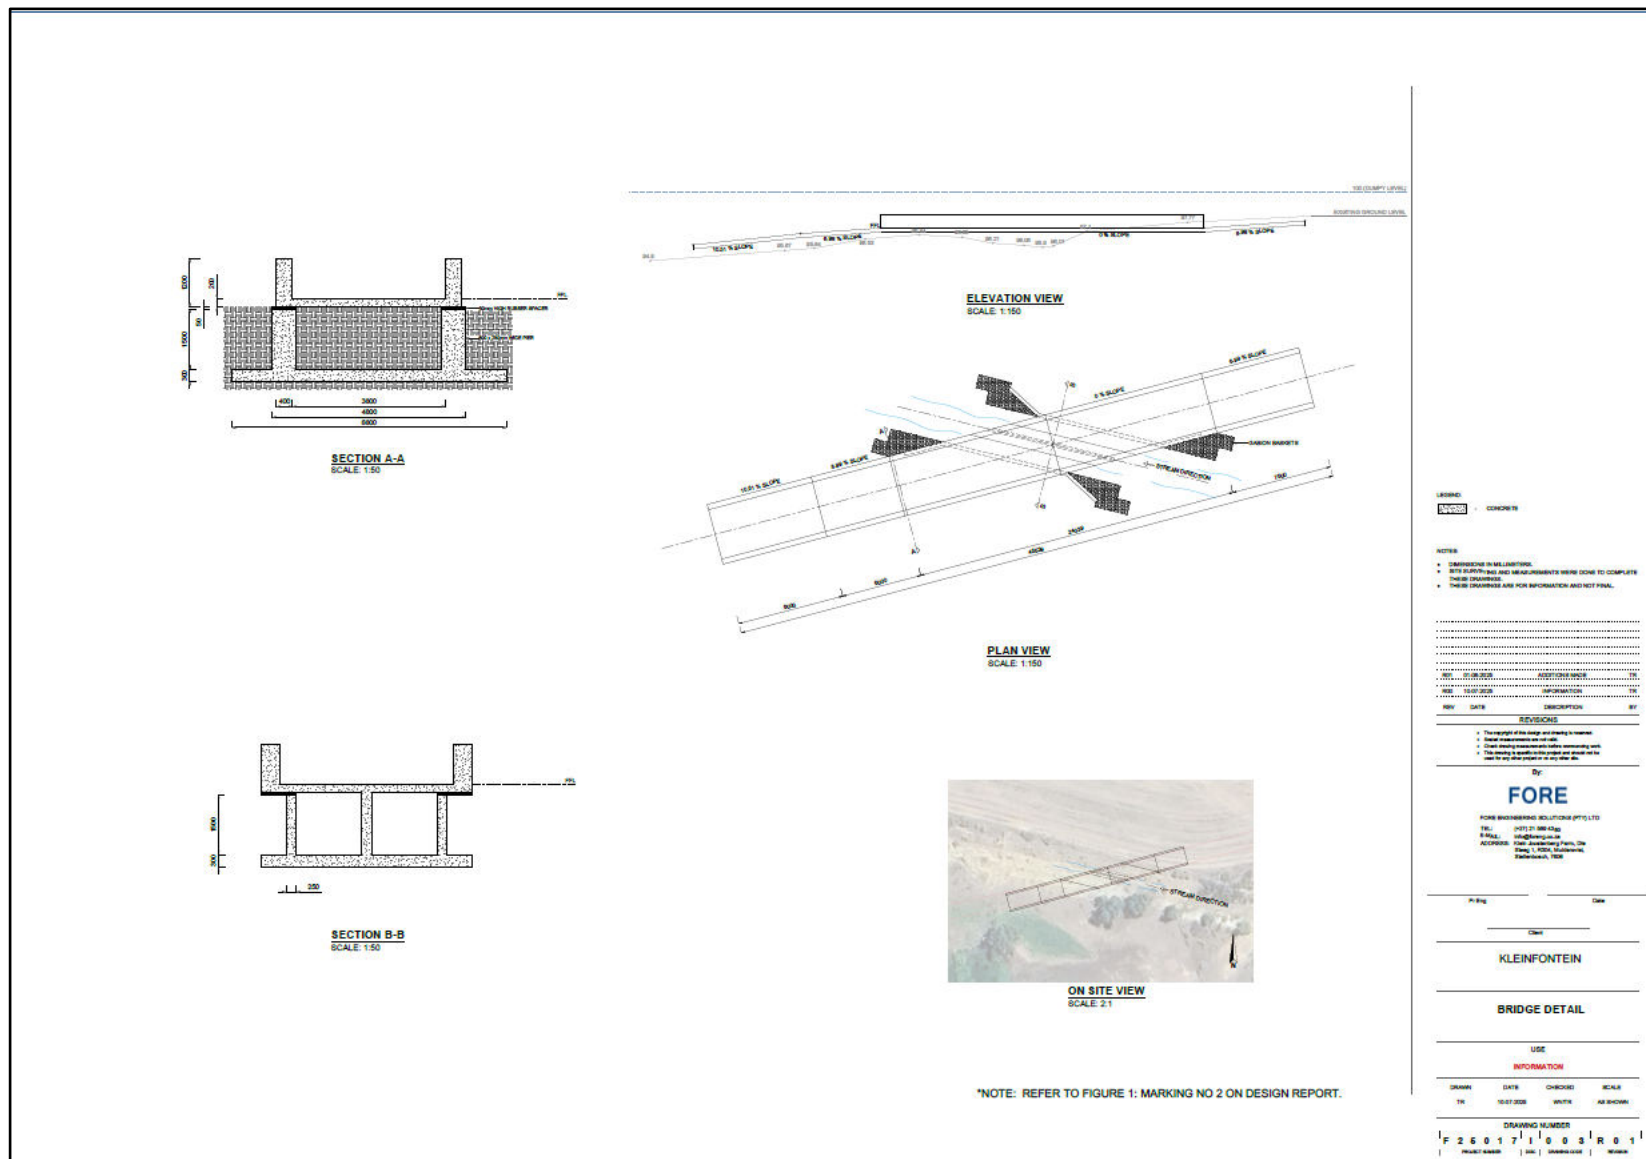
Figure 9: Low waterway stream crossing 2 design detail (Fore Engineering Design report; July 2025)

Suspended bridges are reinforced concrete structures with a driving surface (final top level) raised above ground (natural ground level). Bridge support walls (3 in total) are reinforced concrete which is founded on rock. Gabion structures both at the upstream and downstream side of the supporting walls will protect the structure against erosion. Refer Figure 9 for design detail on stream crossing 2.

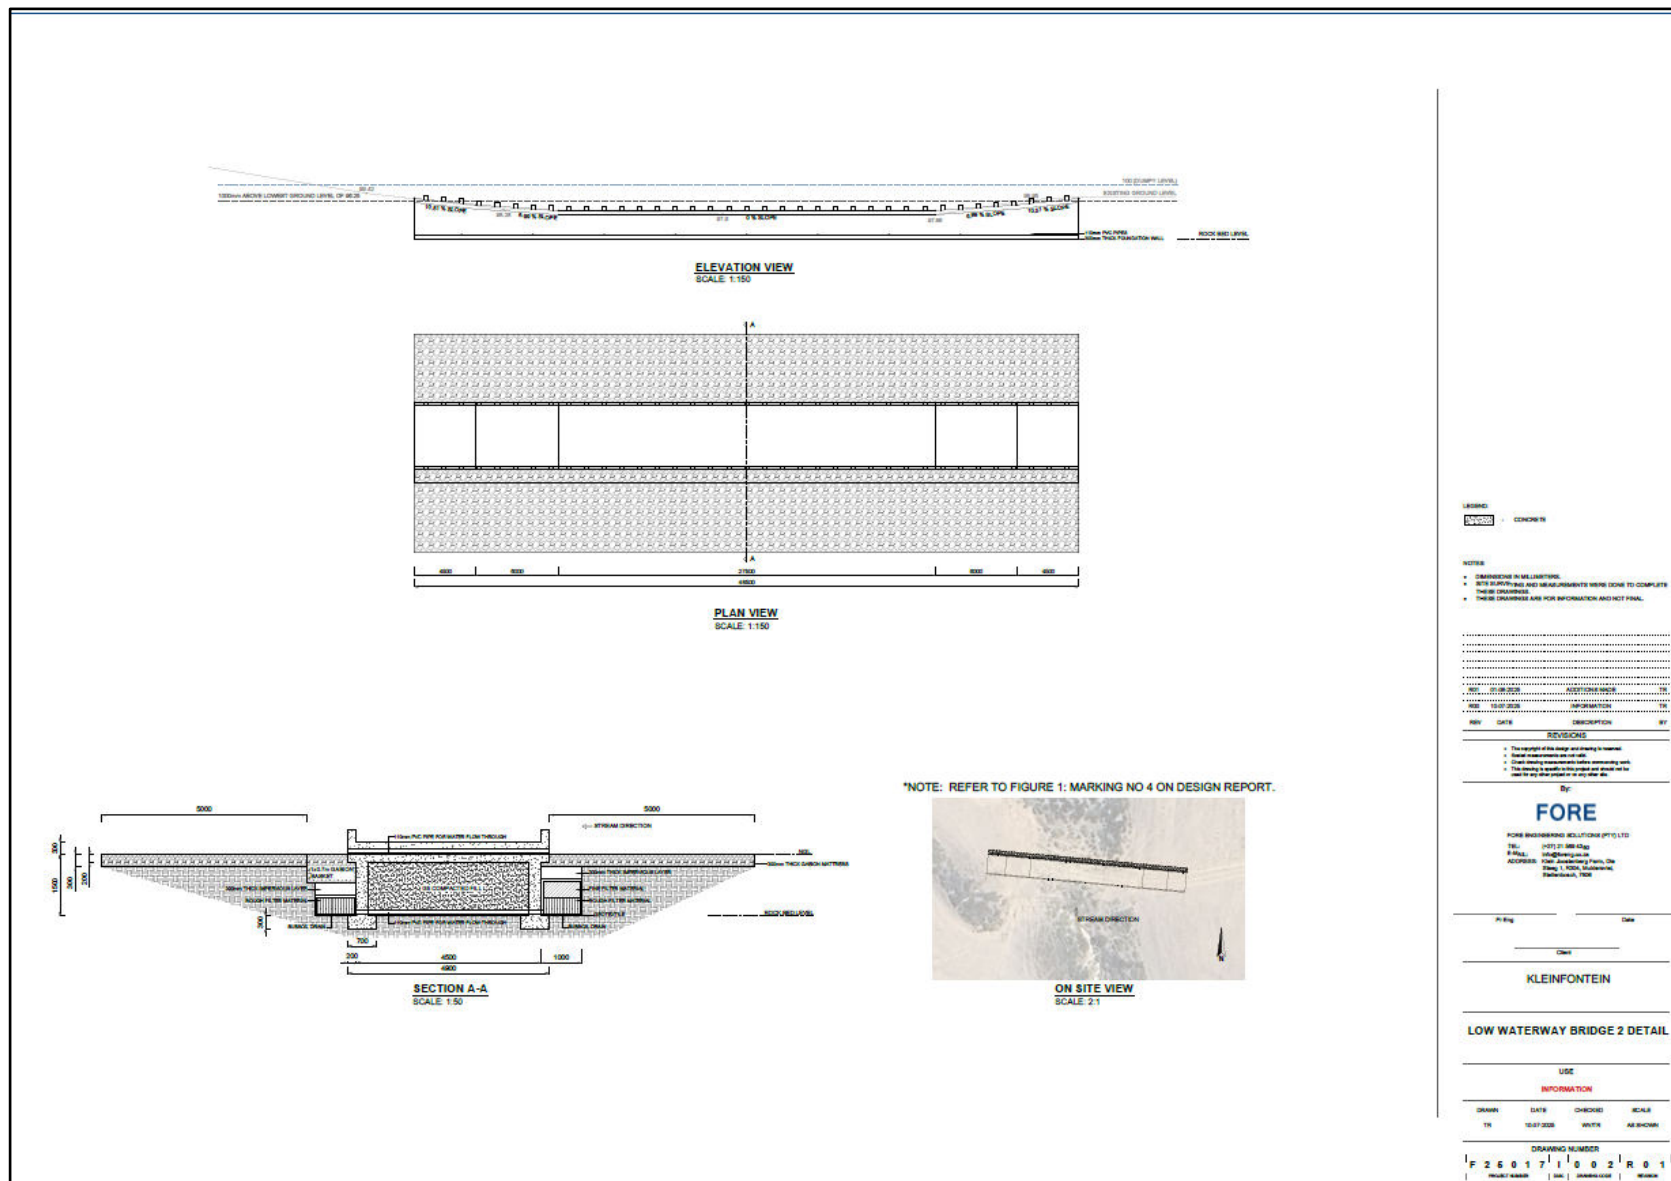
Figure 11: Low waterway stream crossing 4 design detail (Fore Engineering Design report; July 2025)

Low waterway bridges are reinforced concrete structures with a driving surface (final top level) raised above ground (natural ground level) and these structures cross waterways nearly perpendicular to the natural water flow direction of the stream. Pipes will be installed at set intervals across the bridge length to allow water to freely pass through. Bridge foundations are concrete walls. combination of Gabion baskets, blankets and biddim material will be used to prevent erosion directly up and downstream from the bridge. Refer Figures 8, 10 and 11 for detail on the design of stream crossings 1, 3 and 4.

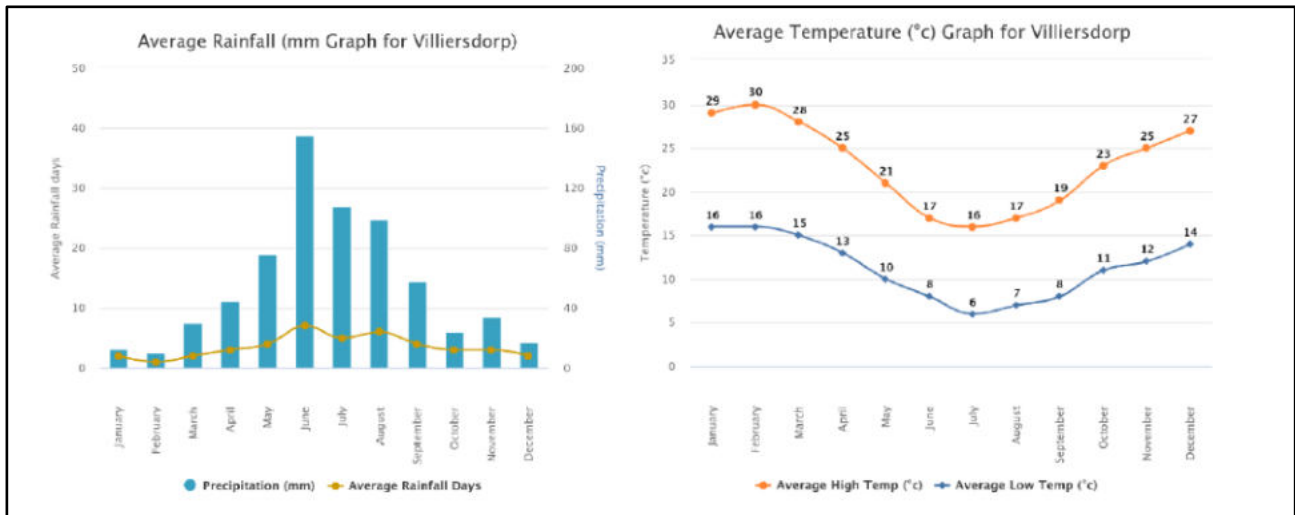
Figure 12: Climate graphs for the Villiersdorp area (Freshwater Ecological report, June 2025)

dry summers and cool, wet winters. The surrounding mountains and Theewaterskloof Dam influence the local microclimate, with slightly cooler and wetter conditions compared to more inland or low-lying parts of the Breede Valley. The project area receives about 519mm of rain annually (CFM, 2025). The chart below shows the average rainfall values for Villiersdorp per month. In the last year, it received the lowest rainfall (9,9mm) in February and the highest (155.5mm) in June. The monthly distribution of average daily maximum temperatures shows that the average midday temperatures for Villiersdorp range from 16°C in July to 30°C in February. The region is the coldest during July, when the mercury drops to 6°C on average during the night.

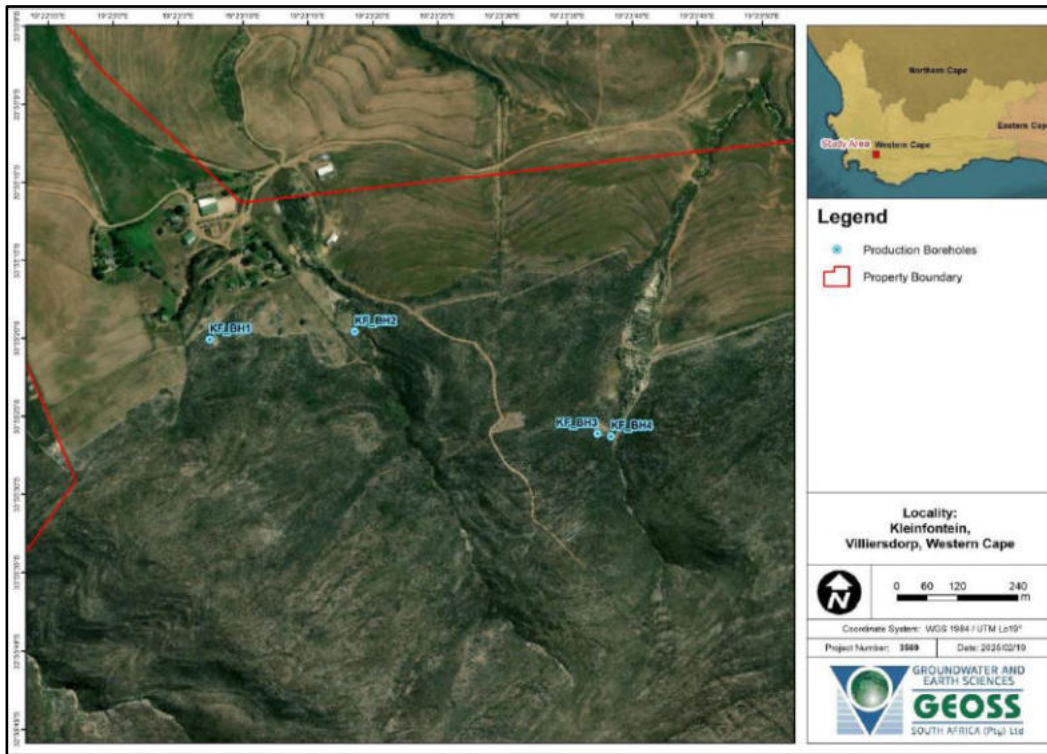
Figure 13: Borehole locality map (GEOSS, March 2025)

KF_BH1 is 96.94m deep, and KF_BH2 is 163m deep. Based on the estimated borehole logs KF_BH1 is drilled into the Gydo Formation of the Bokkeveld Group and KF_BH2 is drilled into the Rietvlei Formation of the Table Mountain Group. It is anticipated that these two boreholes intersect the feldspathic and quartzitic sandstones of the Table Mountain Group (refer Appendix 2 for the Borehole Yield and Quality Testing report).

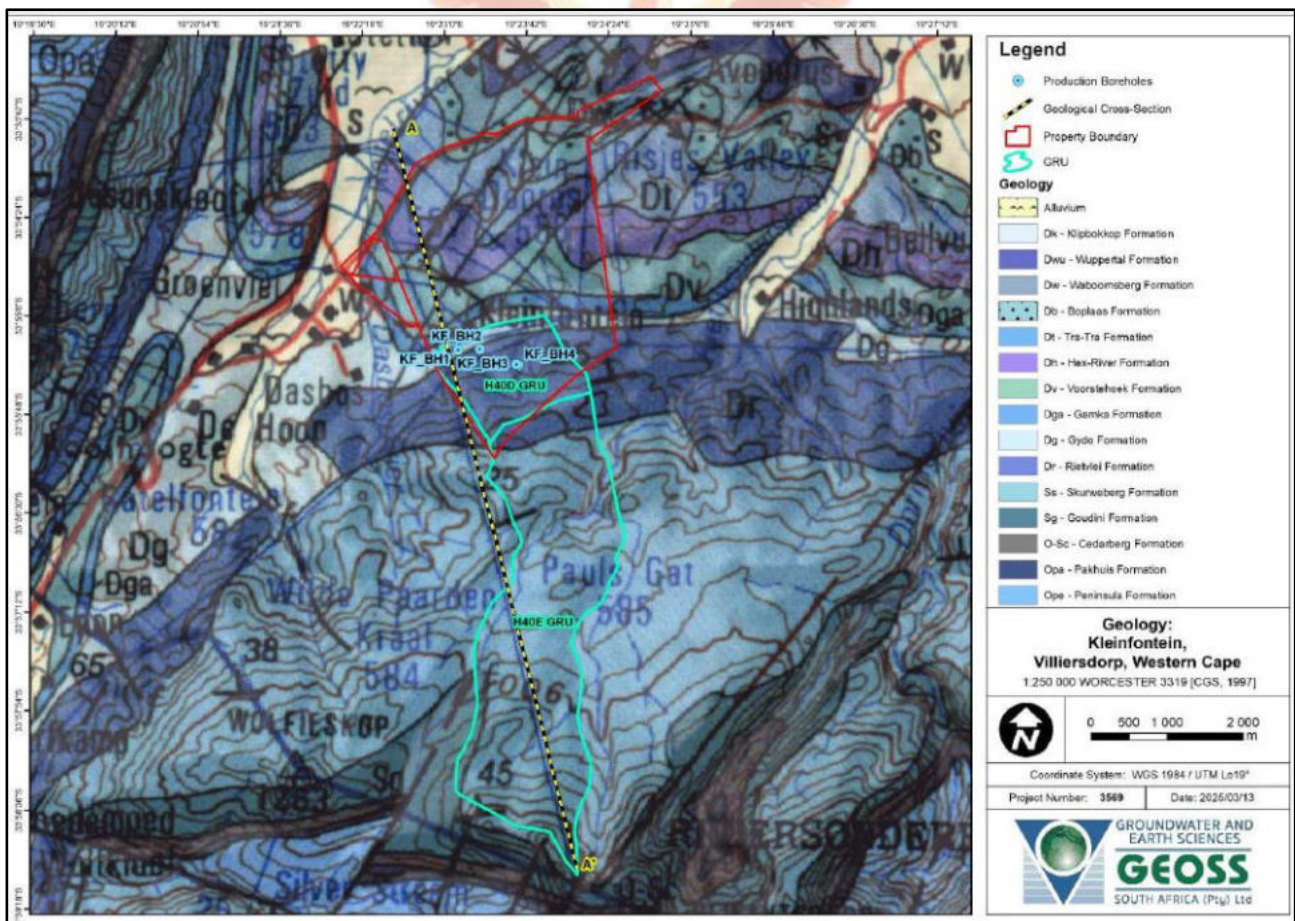
Figure 14: Geological map indicating properties (in red outline) and location of boreholes tested (GEOSS, March 2025). Note: Geological cross section illustrated in Figure 15 below.

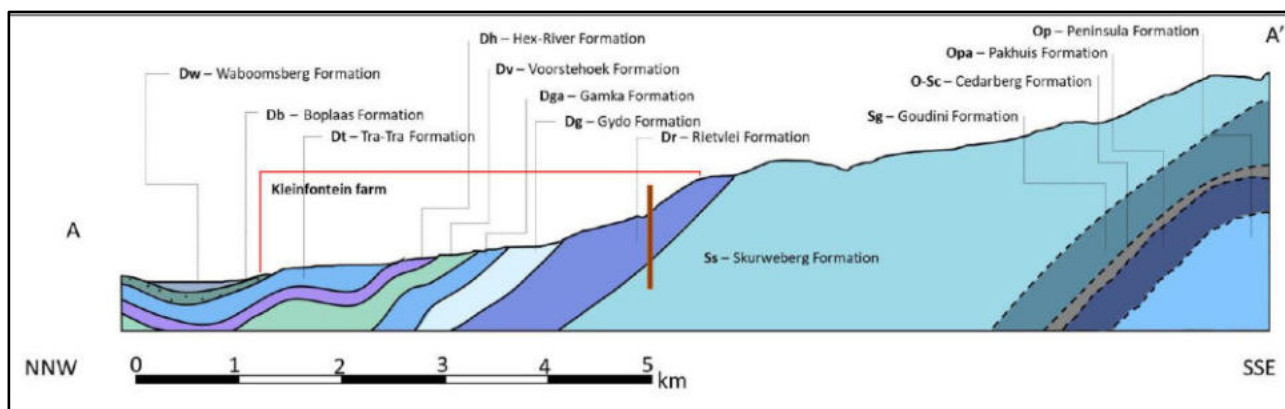
Figure 15: Geological cross section (GEOSS, March 2025)

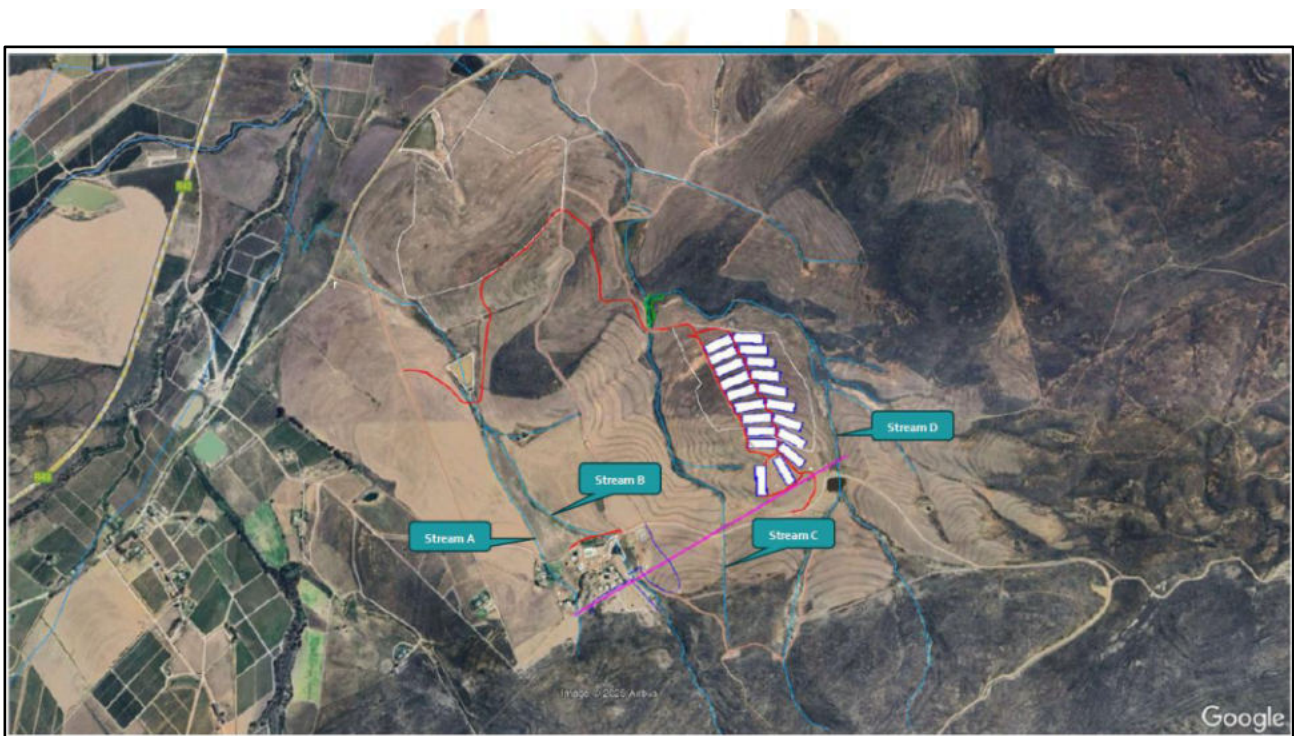
Figure 16: The project site with the proposed new roads (red lines), the broiler area (white polygons) as well as the affected streams (blue lines) with their associated wetland areas (green polygons) (Everlast Freshwater Consulting Services, August 2025).

A large portion of the Streams A and B system likely historically comprised an unchanneled valley bottom wetland. However, this area has been so extensively modified that it has lost all ecological function. Only a small remnant of the wetland remains at the confluence of the two streams. In contrast, Streams C and D have been the least impacted, with large sections still ranging from largely natural to moderately modified in condition.

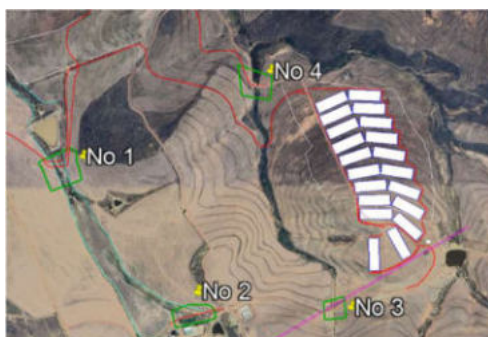
Figure 1: Waterway crossing positions

The farm Kleinfontein is being developed, and vehicular access roads is required to accommodate heavy vehicles travelling to and from a chicken production facility. The road alignment requires 4 waterway crossings as indicated in figure 1. In the figure markings No 1, 3 and 4 indicate low waterway bridges and marking no 2 indicate a suspended bridge structure. Addendum A include detail drawings of the proposed structures.

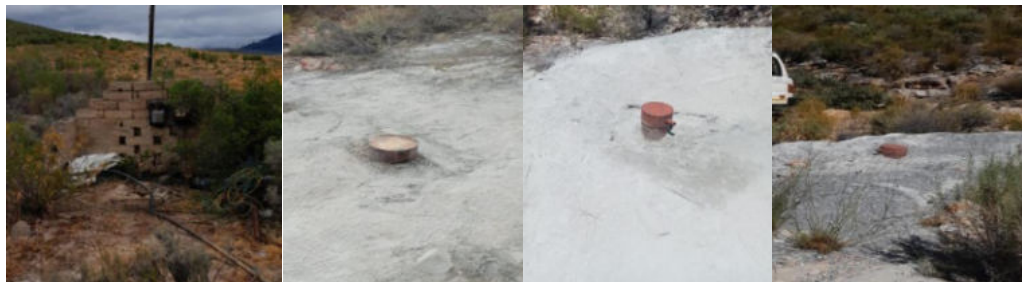
Figure 1: KF_BH1, KF_BH2, KF_BH3 and KF_BH4, respectively (from left to right).

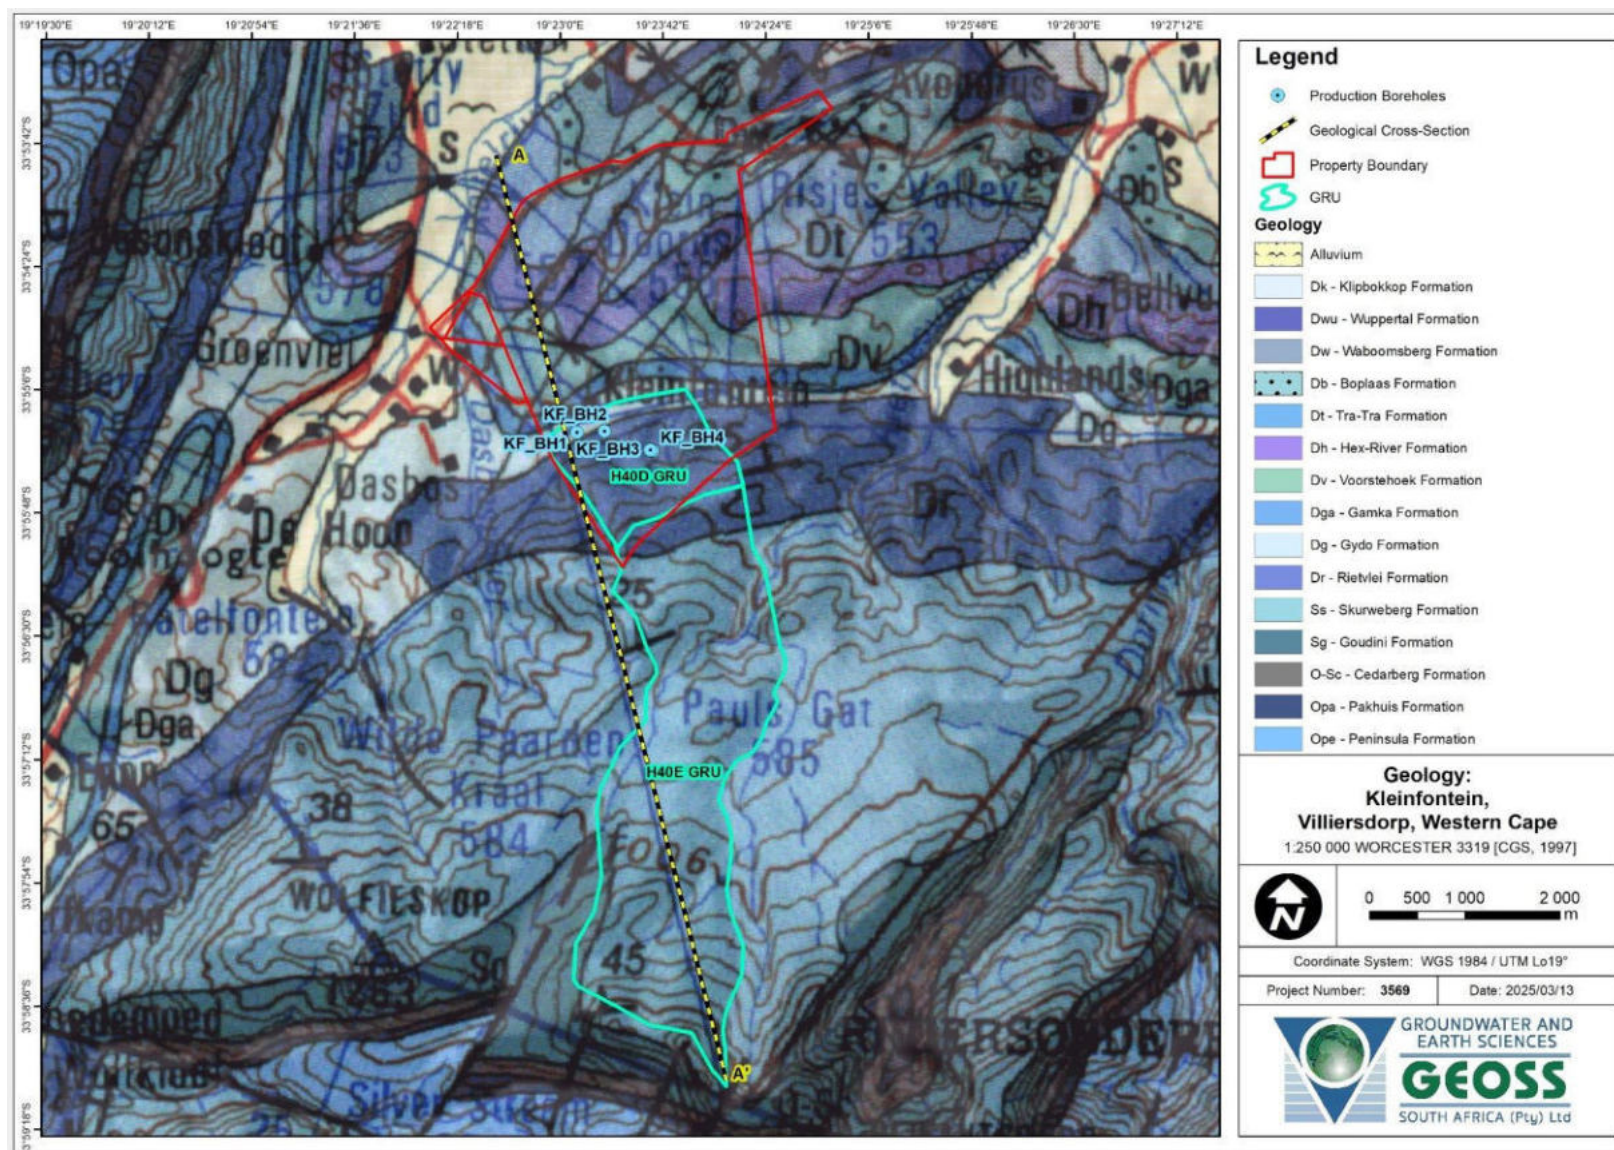
Map 2: Geological Map with Property Boundary and Tested Borehole Positions (1:250 000 Geological Map Series, 3319 Worcester) (CGS, 1997).

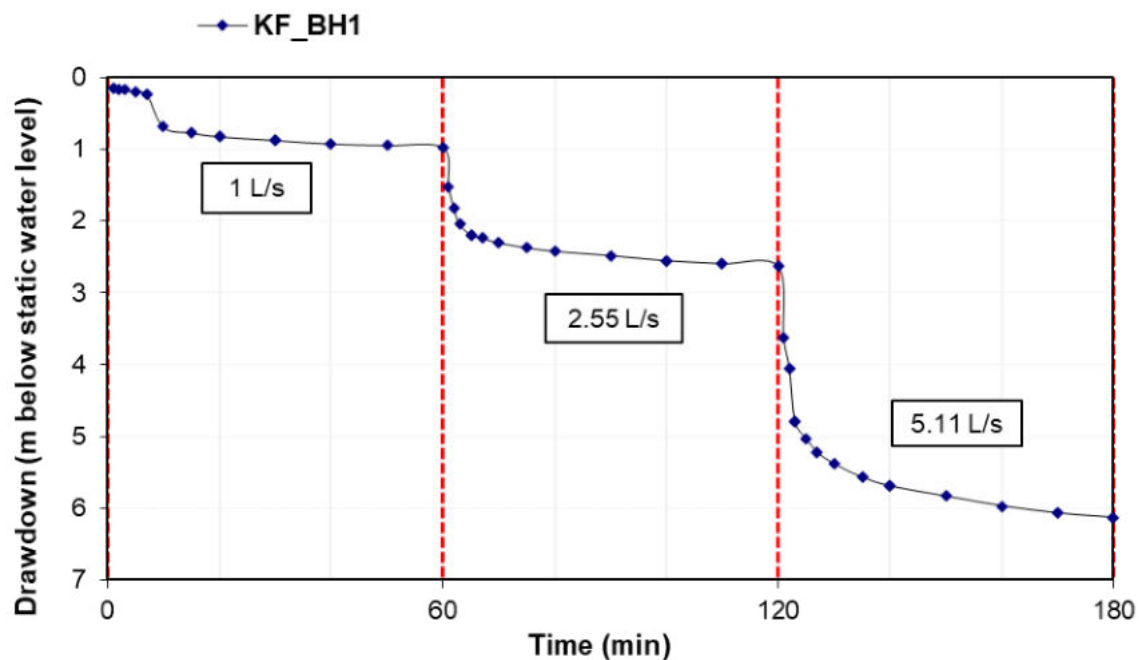
During the Step Test, the water level was drawn down 6.13 meters below the rest water level to 29.10 mbgl during the 3rd step at a rate of 5.11 L/s (18 396 L/hour, pump max due to borehole inner diameter). **Figure 2** shows the time-series drawdown for the Step Test.

Figure 2: Step Test drawdown data for KF_BH1.

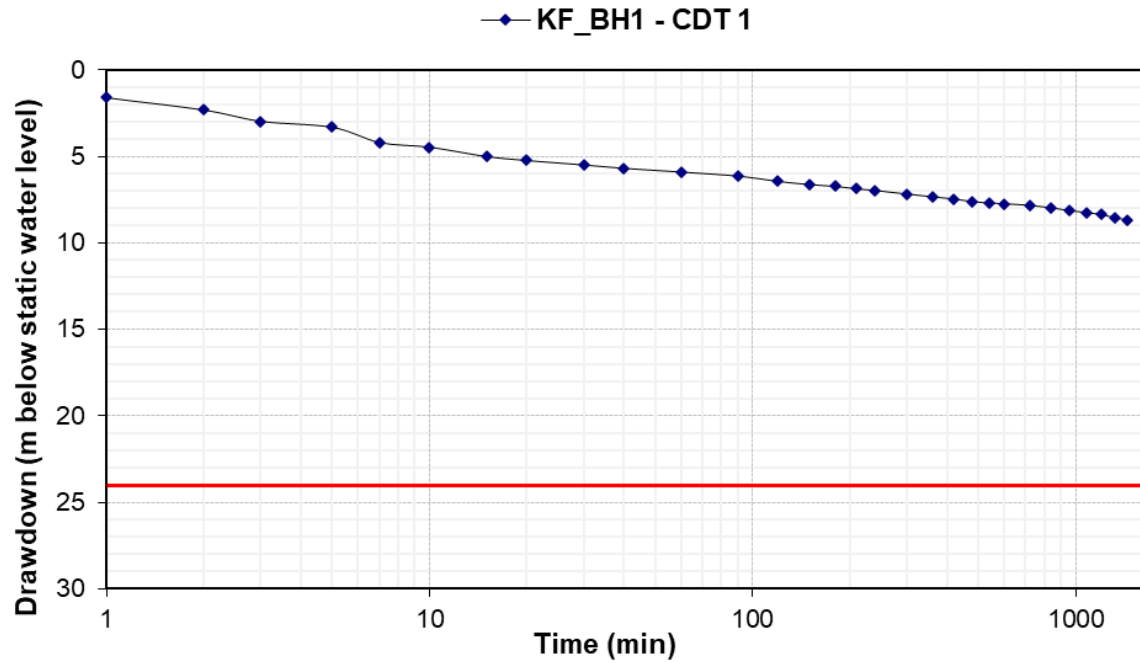
The semi-log plot of the drawdown from the CDT is presented in **Figure 3**. The available drawdown (AD) is indicated with the horizontal red line at 24.1 m.

Figure 3: Semi-Log Plot of drawdown during the CDT of KF_BH1 (5.13 L/s).

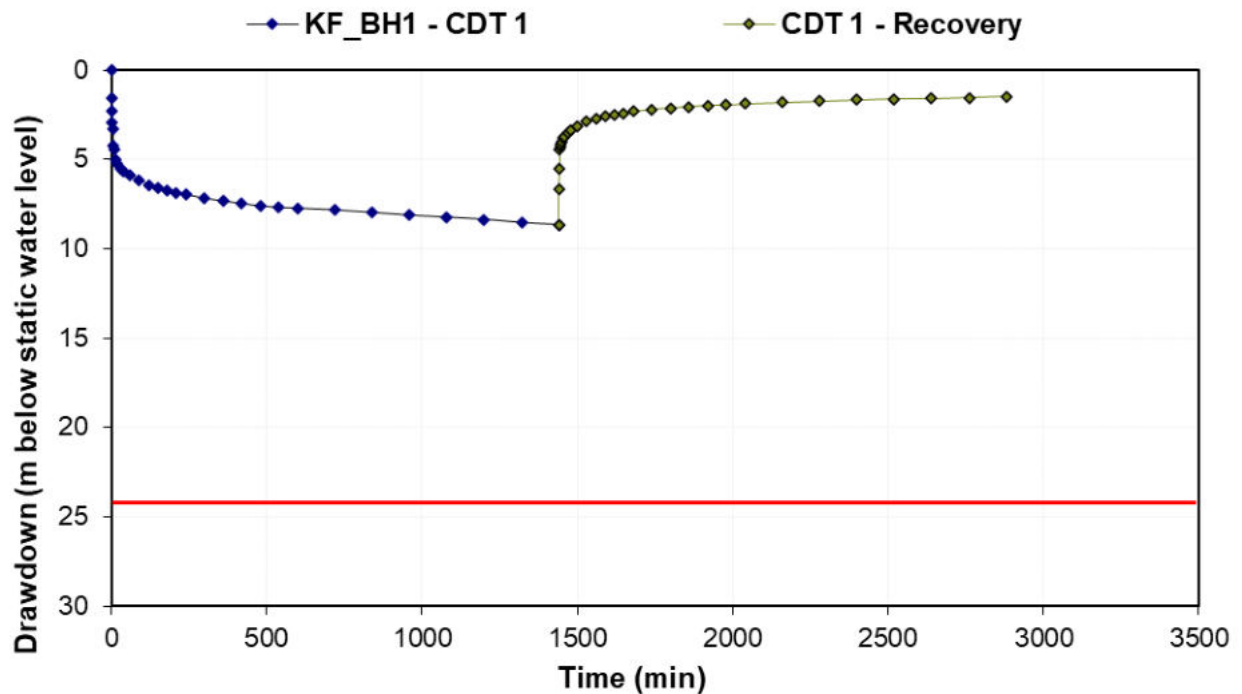
The recovery of the water level was monitored after the CDT and is presented in **Figure 4**. The recovery was moderate to slow, only reaching 82.7% in 24 hours. Monitoring will be essential to determine the long-term recovery of the borehole.

Figure 4: Time-series drawdown and recovery for KF_BH1 (5.13 L/s).

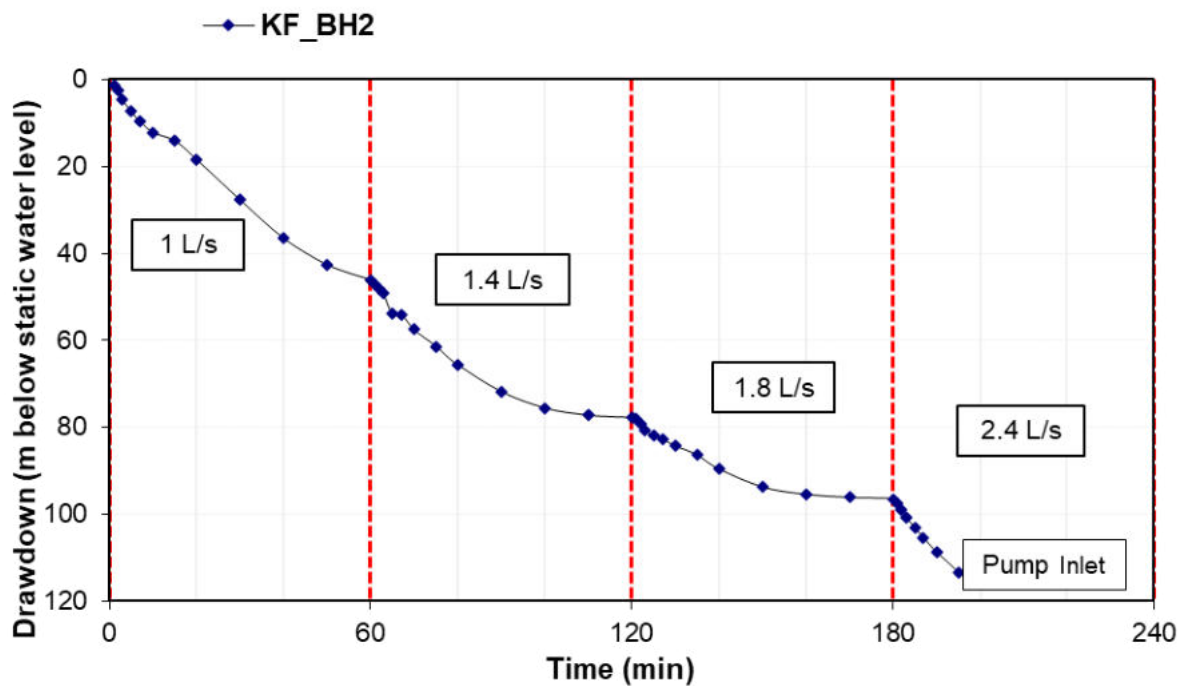
During the Step Test, the water level was drawn down 113.32 meters below the rest water level (pump inlet) during the 4th step at a rate of 2.4 L/s (8 640 L/hour). **Figure 5** shows the time-series drawdown for the Step Test.

Figure 5: Step Test drawdown data for KF_BH2.

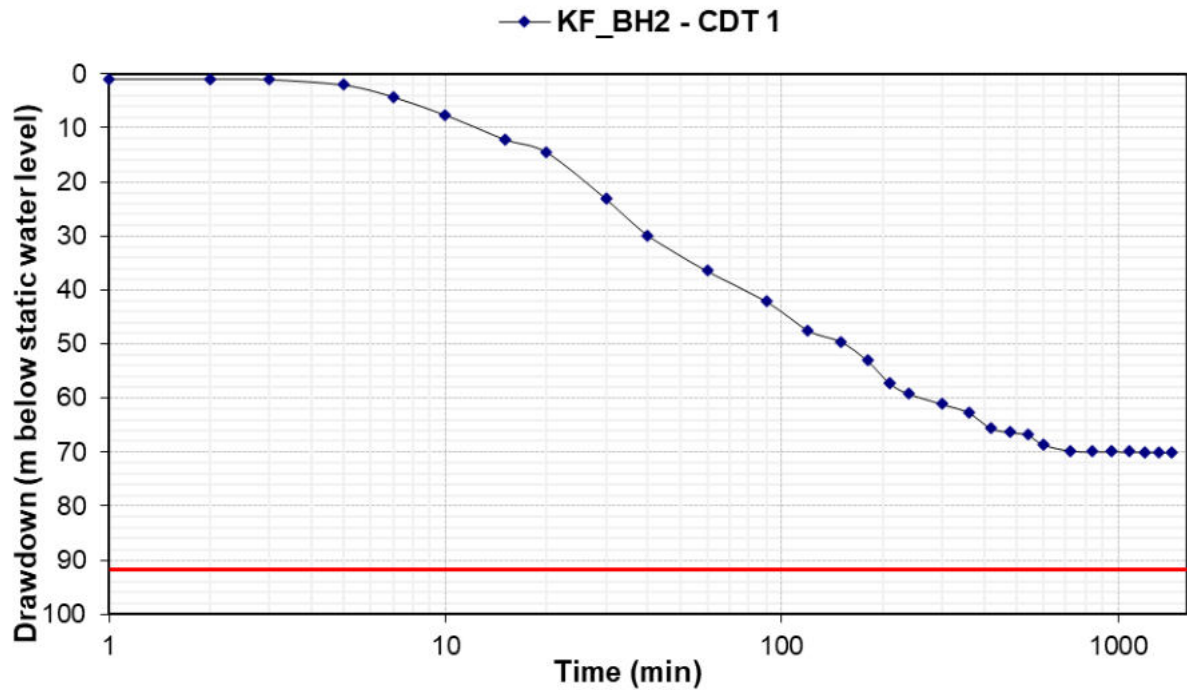
The semi-log plot of the drawdown from the CDT is presented in **Figure 6**. The available drawdown (AD) is indicated with the horizontal red line at 92.10 m

Figure 6: Semi-Log Plot of drawdown during the CDT of KF_BH2 (1.5 L/s).

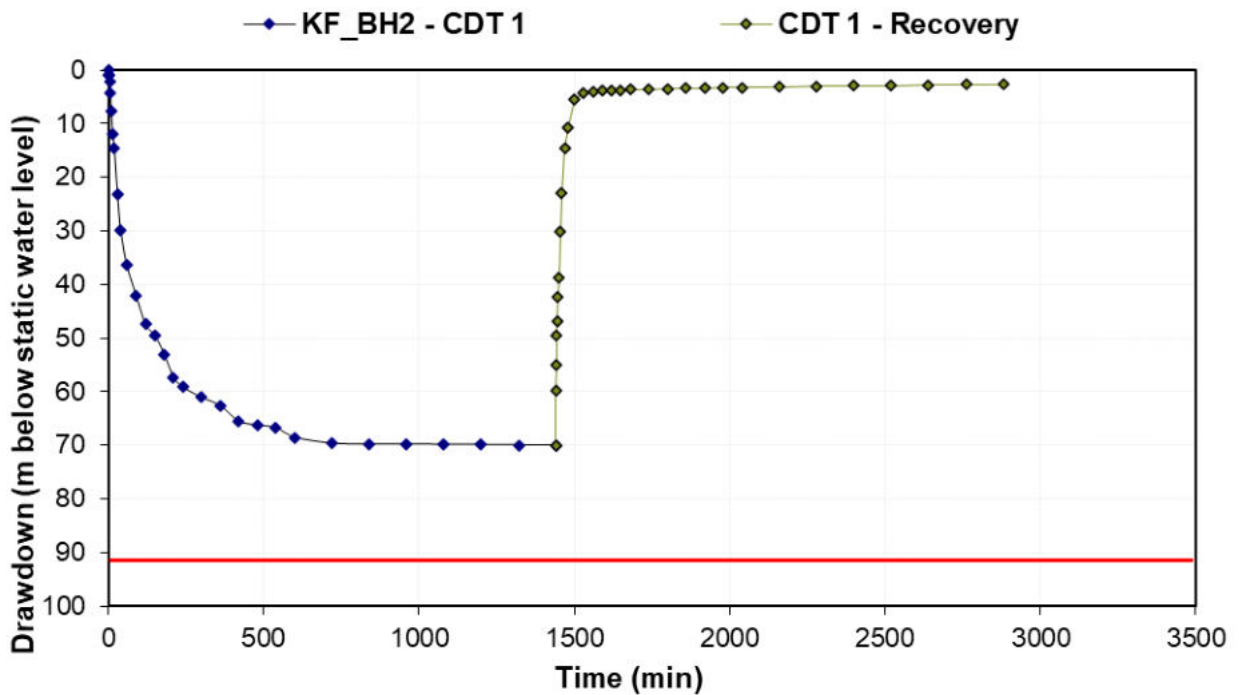
The recovery of the water level was monitored after the CDT and is presented in **Figure 7**. The recovery was good, reaching 96.2% in 24 hours. Monitoring will be essential to determine the long-term recovery of the borehole.

Figure 7: Time-series drawdown and recovery for KF_BH2 (1.5 L/s).

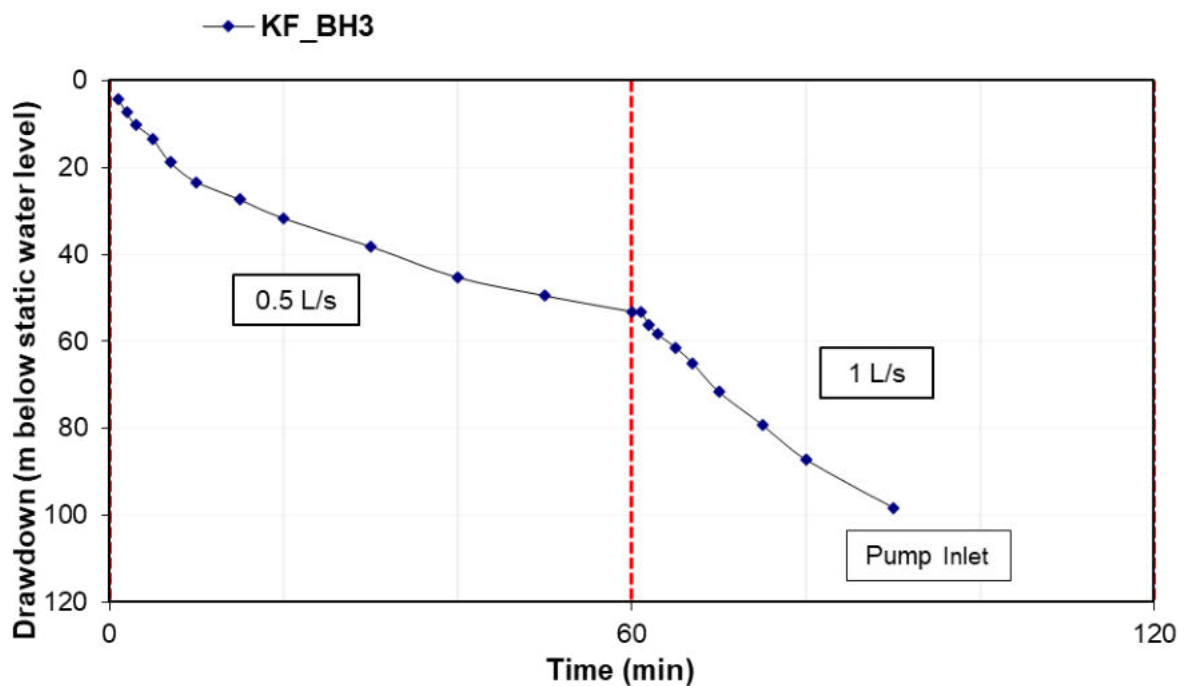
During the Step Test it was determined that the yield of the borehole is considered insufficient. Accordingly continued monitoring and further CDT testing of the borehole was abandoned. The use of this borehole is not recommended due to insufficient yield.

Figure 8: Step Test drawdown data for KF_BH3.

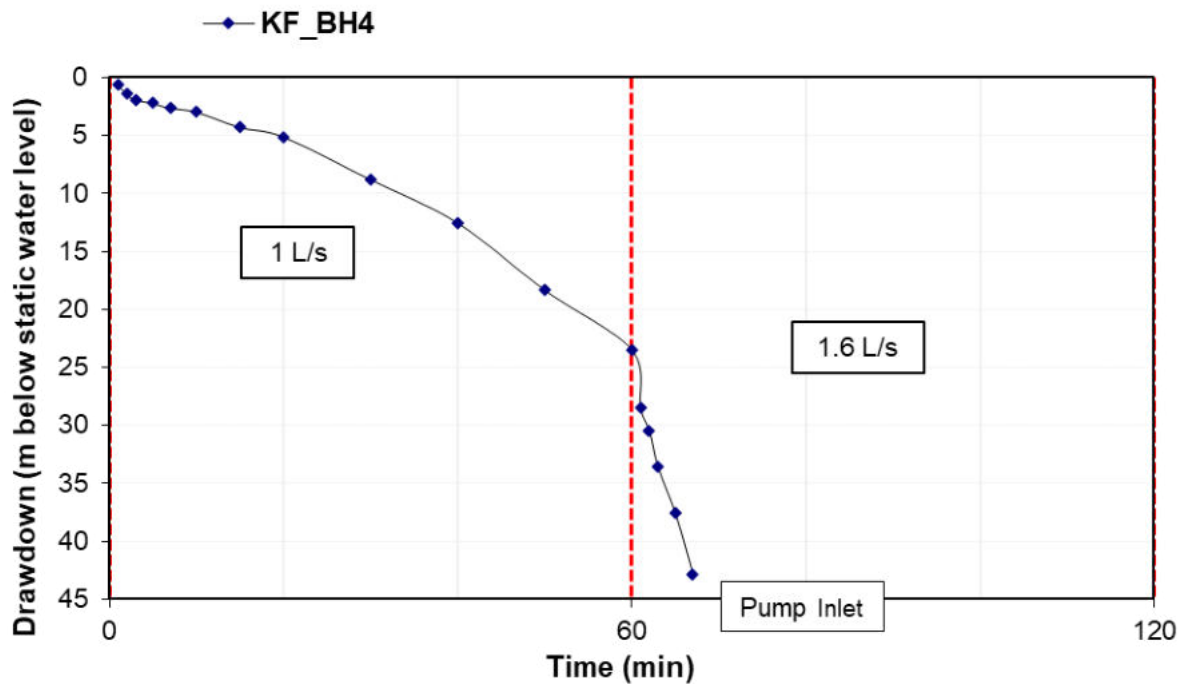
During the Step Test it was determined that the yield of the borehole is considered insufficient. Accordingly continued monitoring and further CDT testing of the borehole was abandoned. This use of this borehole is not recommended due to insufficient yield.

Figure 9: Step Test drawdown data for KF_BH4.
