WATER USE LICENCE APPLICATION SUMMARY REPORT (WU44082)

**ABSTRACTION OF GROUNDWATER AND STREAM CROSSINGS ON FARMS 563, 564, 565
AND FARM KLEINFONTEIN 954, VILLIERSDORP**

**NAME OF APPLICANT:
EFRC AGRI OPERATIONS (PTY) LTD**

**Compiled by
PHS Consulting**

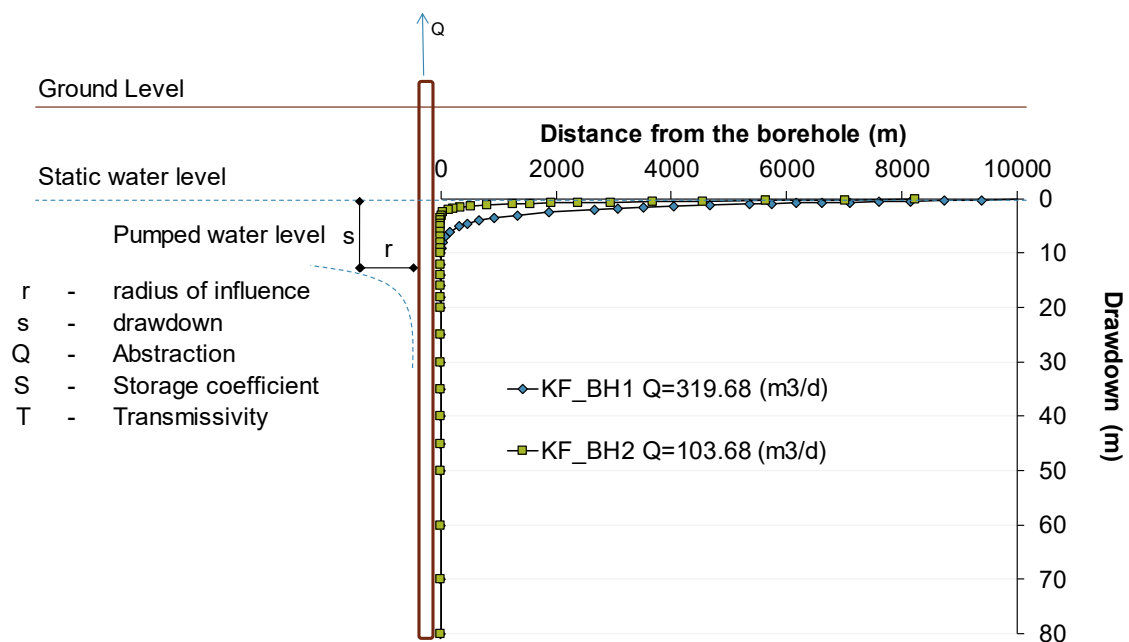
Figure 10: Radii of influence for KF_BH1 and KF_BH2 at the recommended sustainable yields.

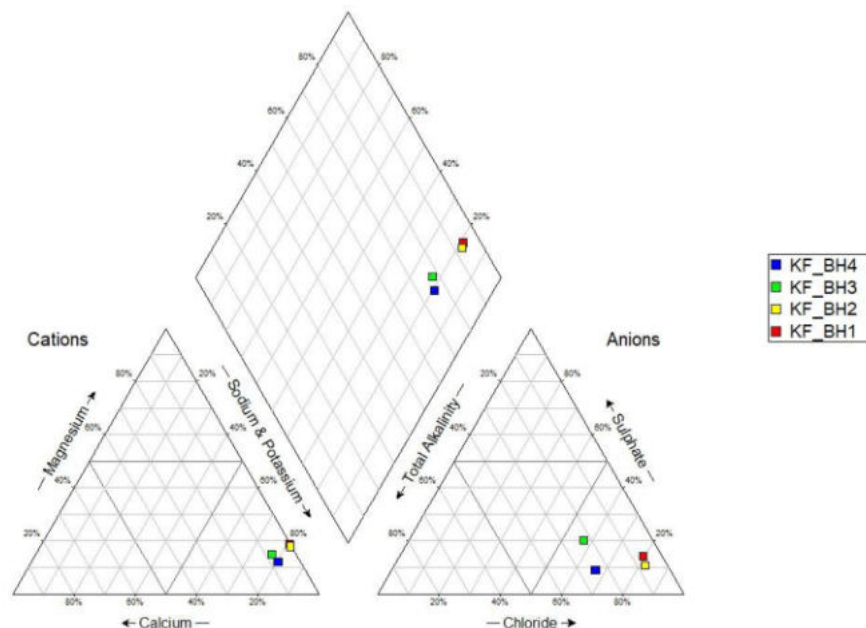
Figure 11: Piper diagram of the groundwater samples.

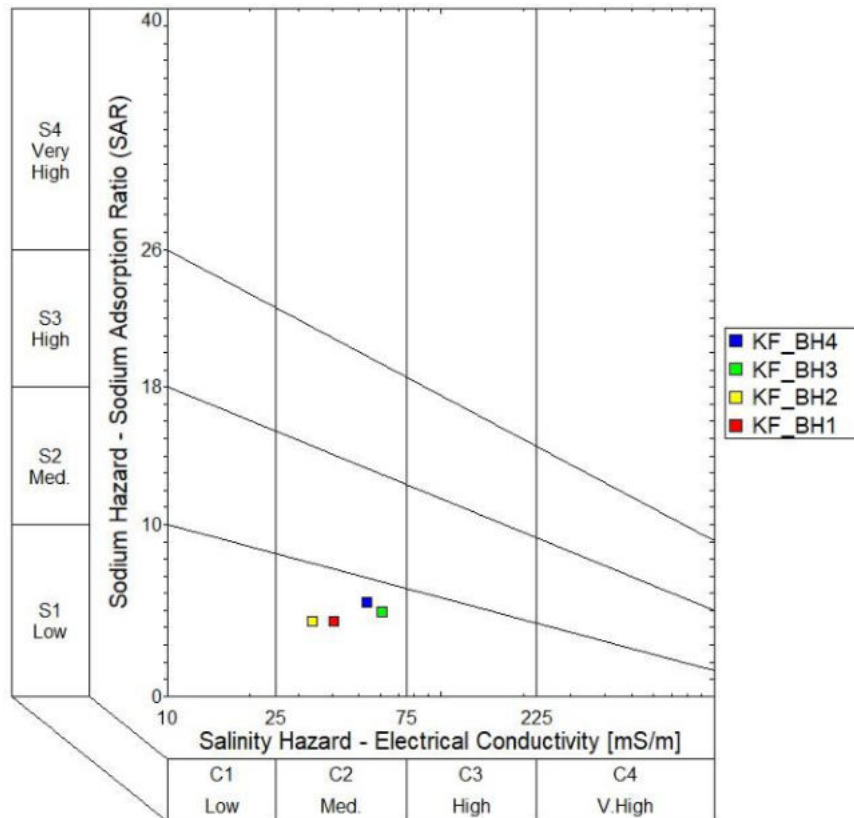
Figure 12: SAR diagram of the groundwater samples.

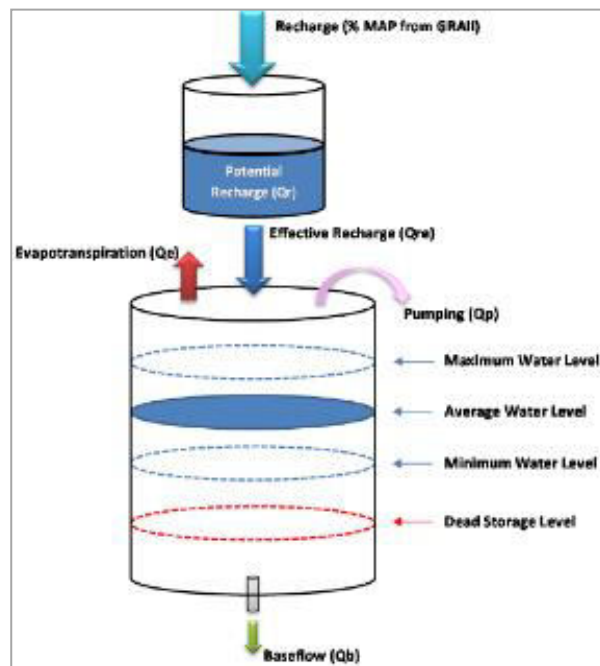
The “Box Model” approach is schematically presented in Figure 13.

Figure 13: Aquifer Firm Yield lumped box model (WRC, 2012).

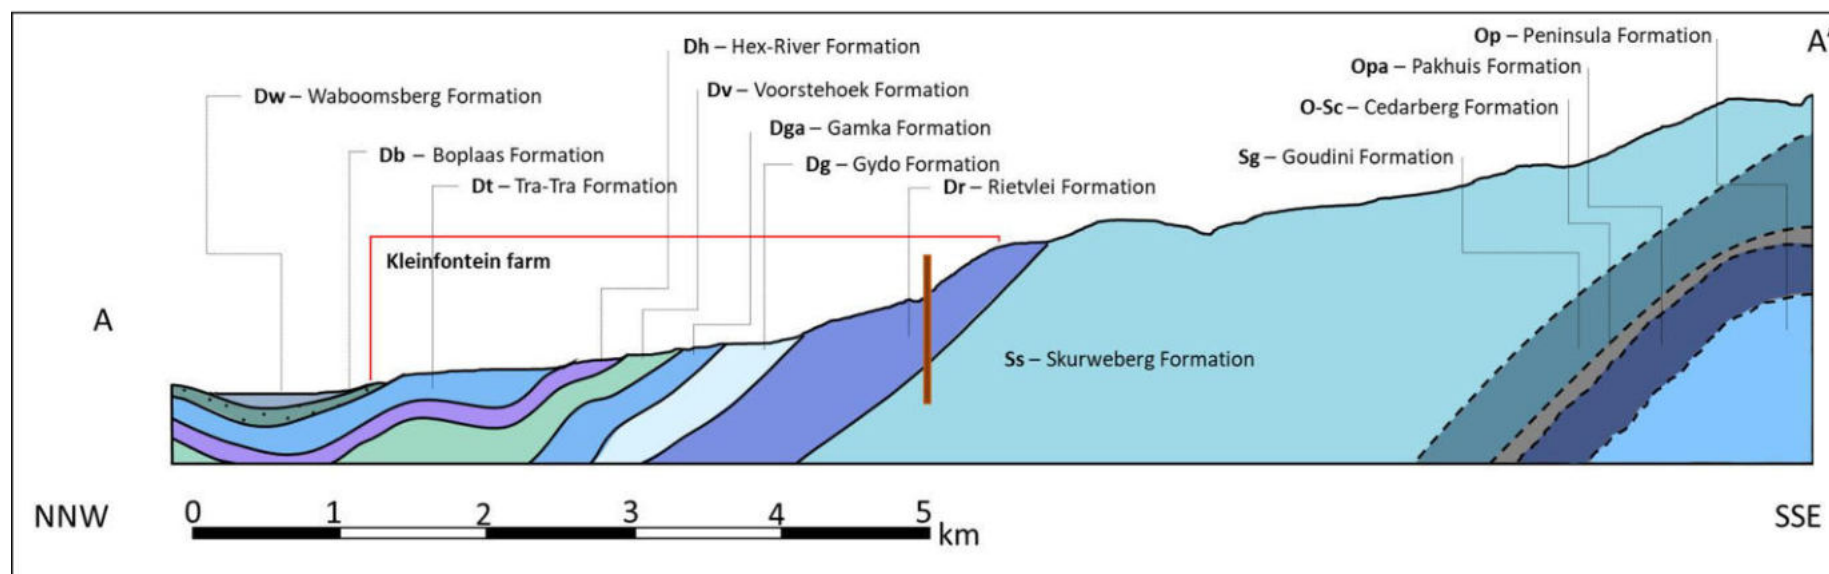
Figure 14: A schematic and conceptual east-west geological cross section.

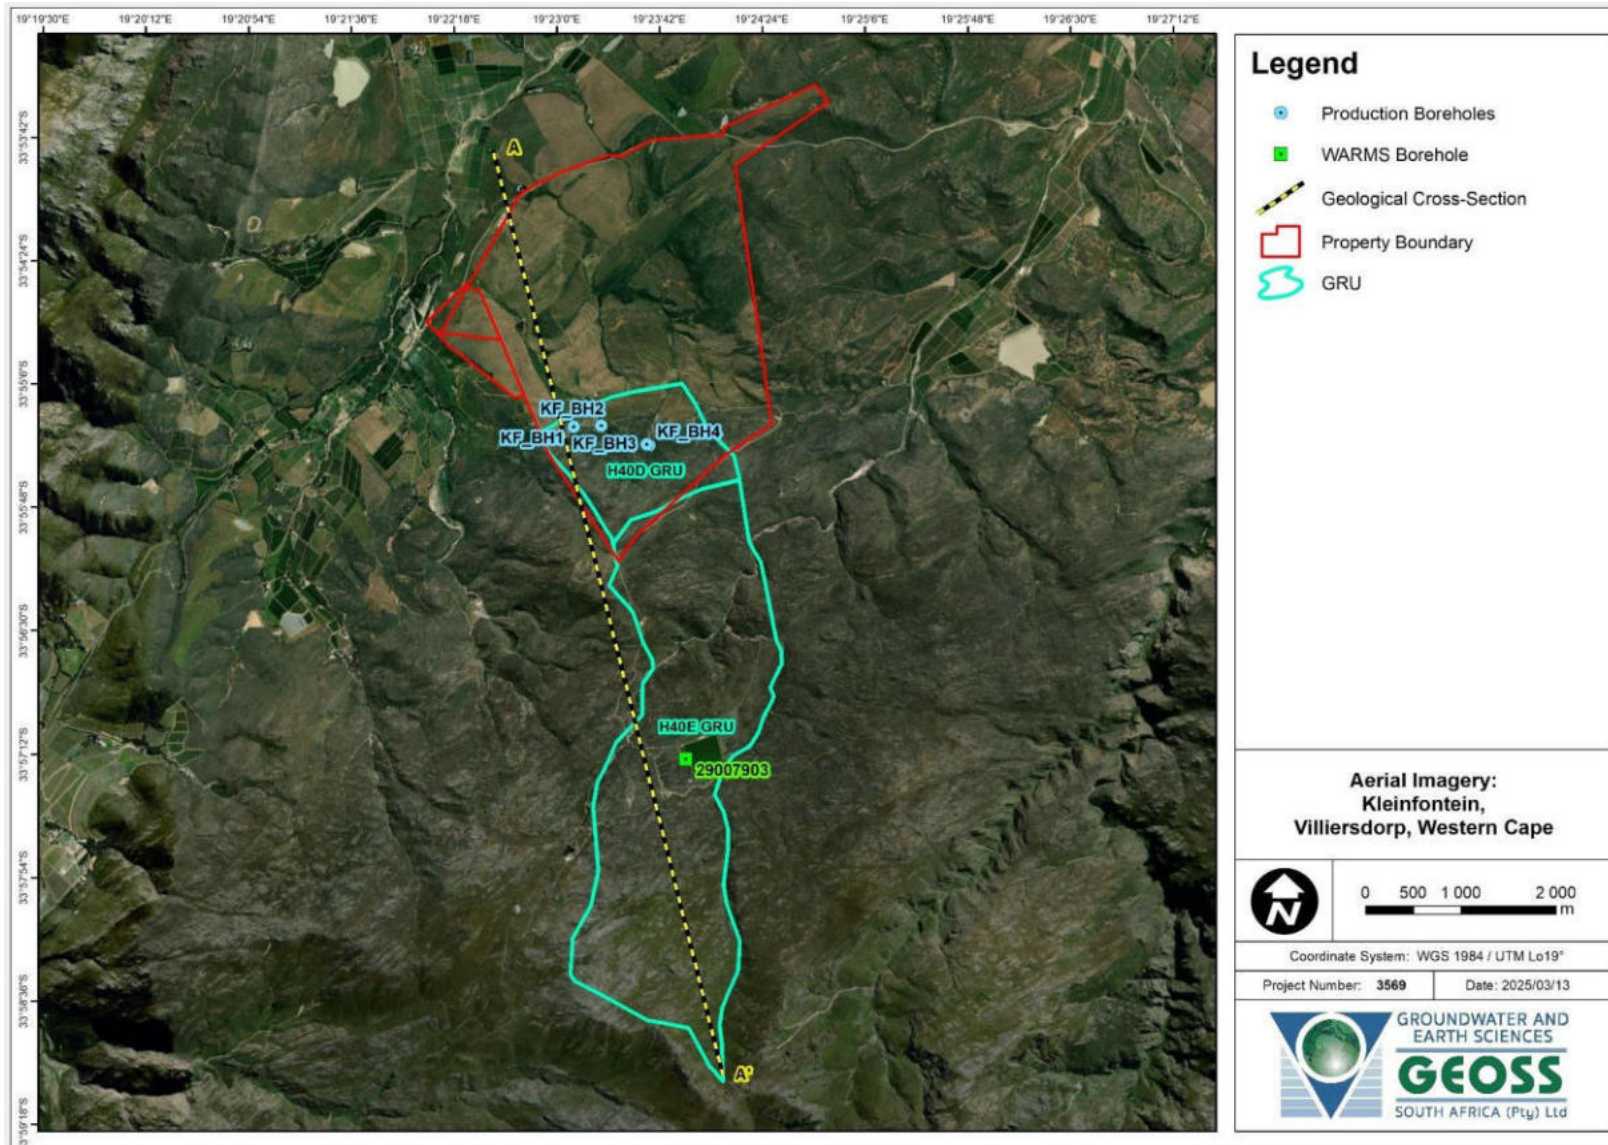
Map 3: GRU, property boundaries and WARMS boreholes superimposed on a satellite image.

For this study area there are geological features that enable the definition of a more localised aquifer (i.e., a groundwater resource unit (GRU)). The Kleinfontein farm is located on the South Eastern limb of a North East – South West trending synform hosted in the Cape Supergroup. All the boreholes are drilled intersecting the fractured rock aquifer of the Table Mountain Group. The southern boundary of the GRU was delineated based on the quaternary catchment boundary and the Skurweberg-Goudini contact. The northern boundary of the GRU was delineated based on the Gydo-Gamka contact with the western and southern boundaries delineated as per the topographical lay of the area. The area is highly faulted, with major faults in both NE-SW and NW-SE orientations, creating groundwater flow paths. The GRU has been delineated and is displayed in Map 3, and Figure 14 depicts a schematic cross-section of the geology and the groundwater flow.

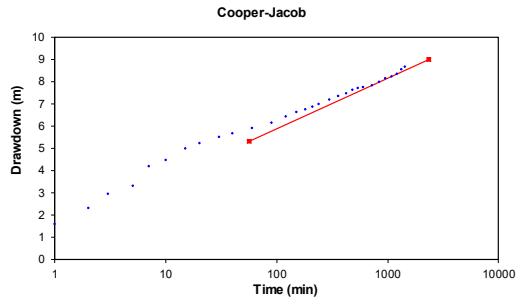
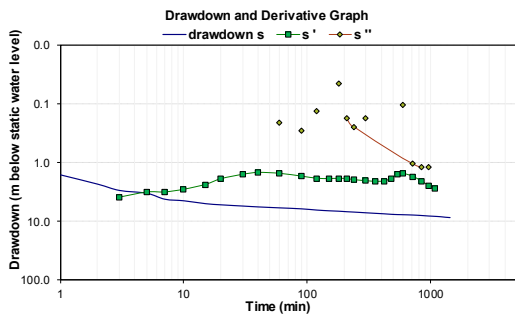
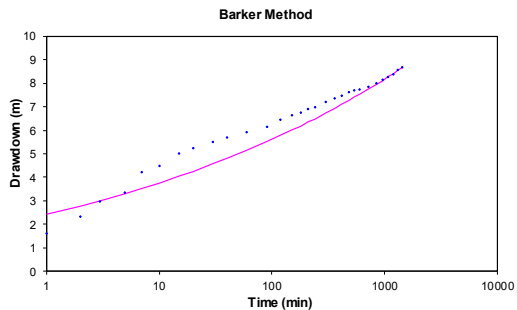
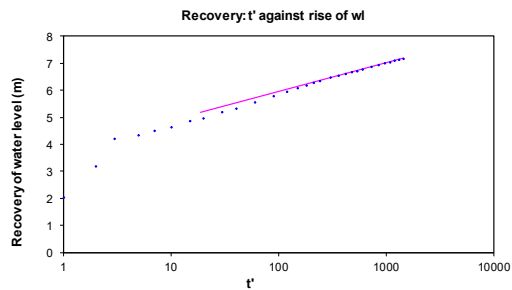
KF_BH1

Cooper-Jacob method

| $T(m^2/d) =$ | 35.5 | $r_p (m) =$ | 0.1 | |

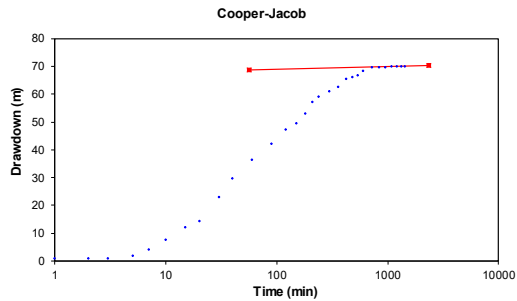
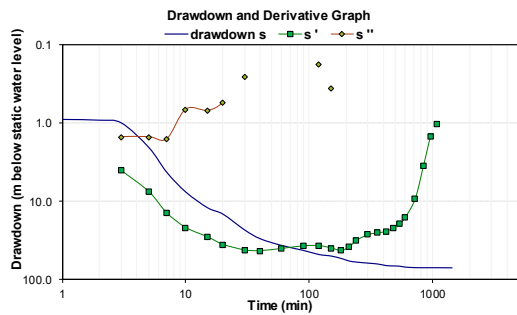
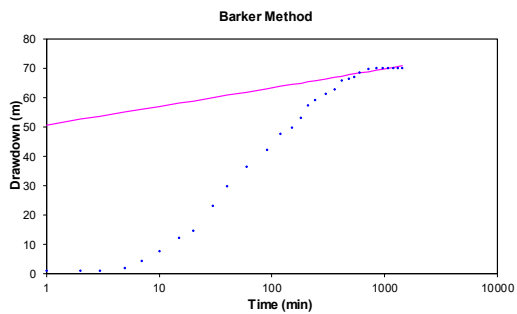
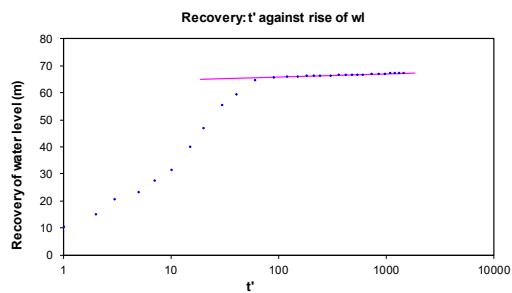
KF_BH2

Cooper-Jacob method

| $T(m^2/d) =$ | 29.6 | $r_w(m) =$ | 0.1 |

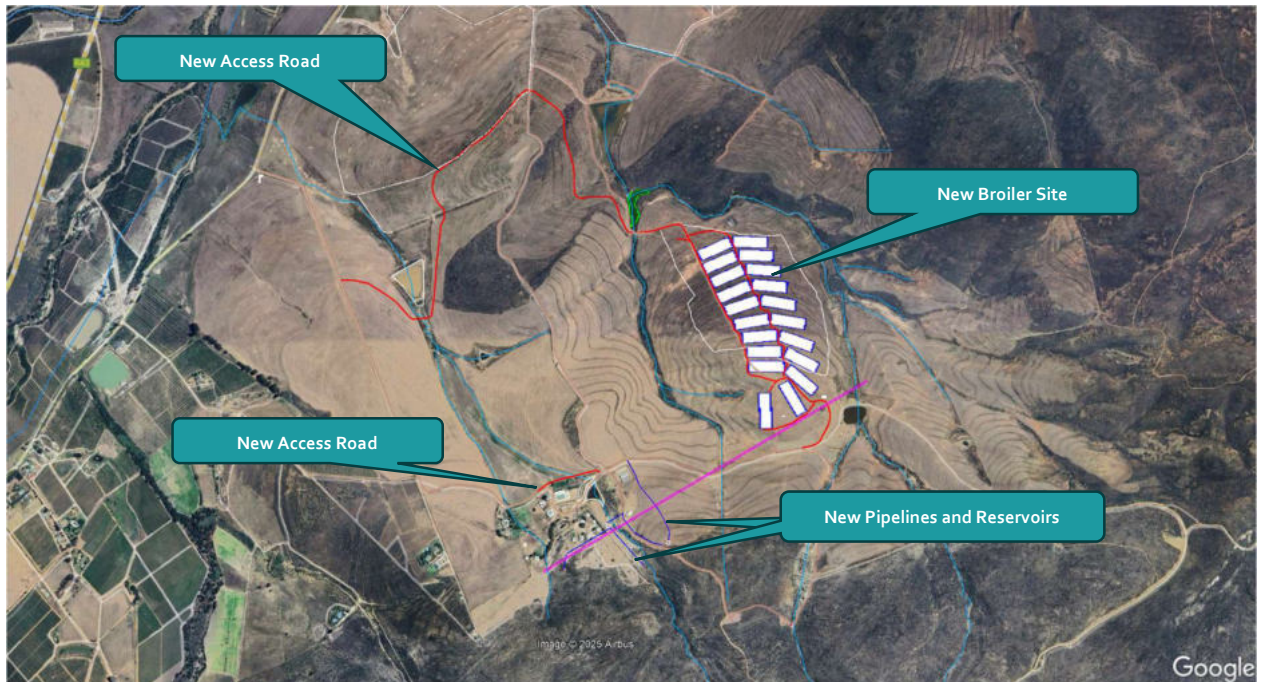
Figure 2: Proposed activities in relation to the affected freshwater features (Google Earth, 2025).

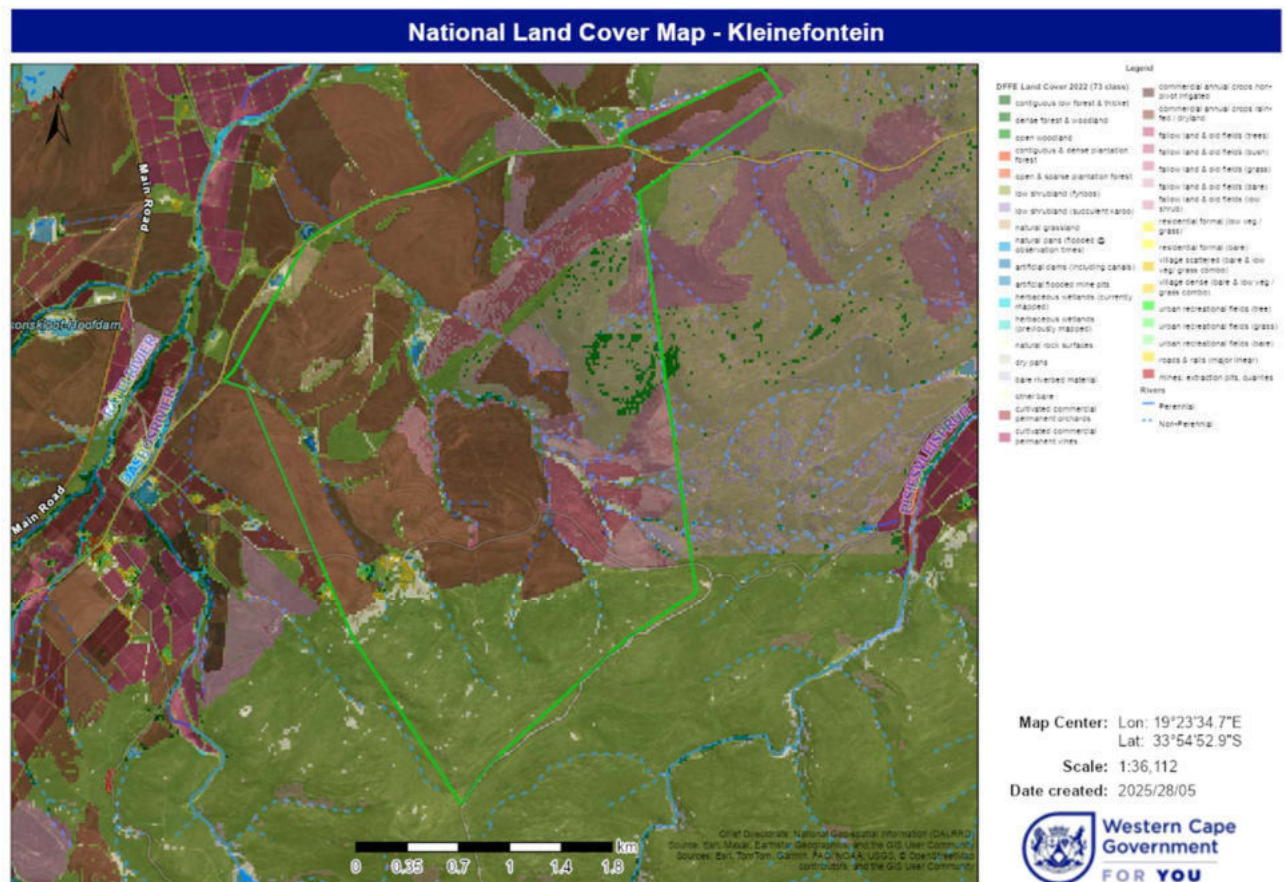
Figure 3: National land cover map (2014) covering the proposed development area (CFM, 2025)

The project site is generally surrounded by a mix of agricultural land, natural areas, and a few small watercourses. According to the National Land Cover Map (Figure 3), the new development will largely fall over areas classified as Cultivated – commercial annual crops rain-fed / dryland (Temporary crops) (dark brown), Cultivated - fallow land & old fields (grass) (Pink) and Shrubland – Low Shrubland Fynbos (light green).

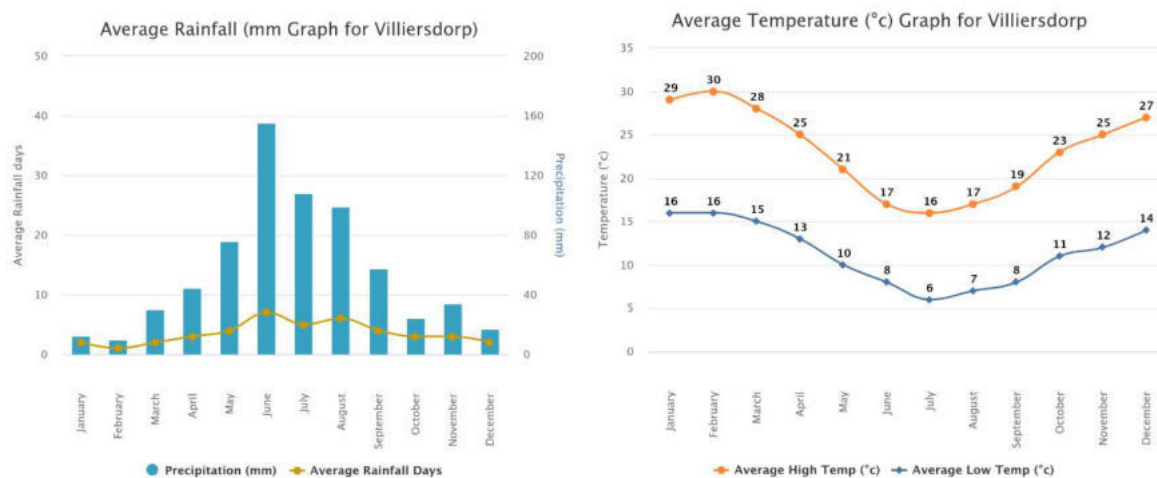
Figure 4: Climate graphs for the Villiersdorp area (World Weather Online, 2025)

Villiersdorp's climate was used as a benchmark for the site and can be classified as a Mediterranean climate, which is generally characterised by warm, dry summers and cool, wet winters. The surrounding mountains and Theewaterskloof Dam influence the local microclimate, with slightly cooler and wetter conditions compared to more inland or low-lying parts of the Breede Valley. The project area receives about 519mm of rain annually (CFM, 2025). The chart below shows the average rainfall values for Villiersdorp per month. In the last year, it received the lowest rainfall (9,9mm) in February and the highest (155.5mm) in June. The monthly distribution of average daily maximum temperatures shows that the average midday temperatures for Villiersdorp range from 16°C in July to 30°C in February. The region is the coldest during July, when the mercury drops to 6°C on average during the night.

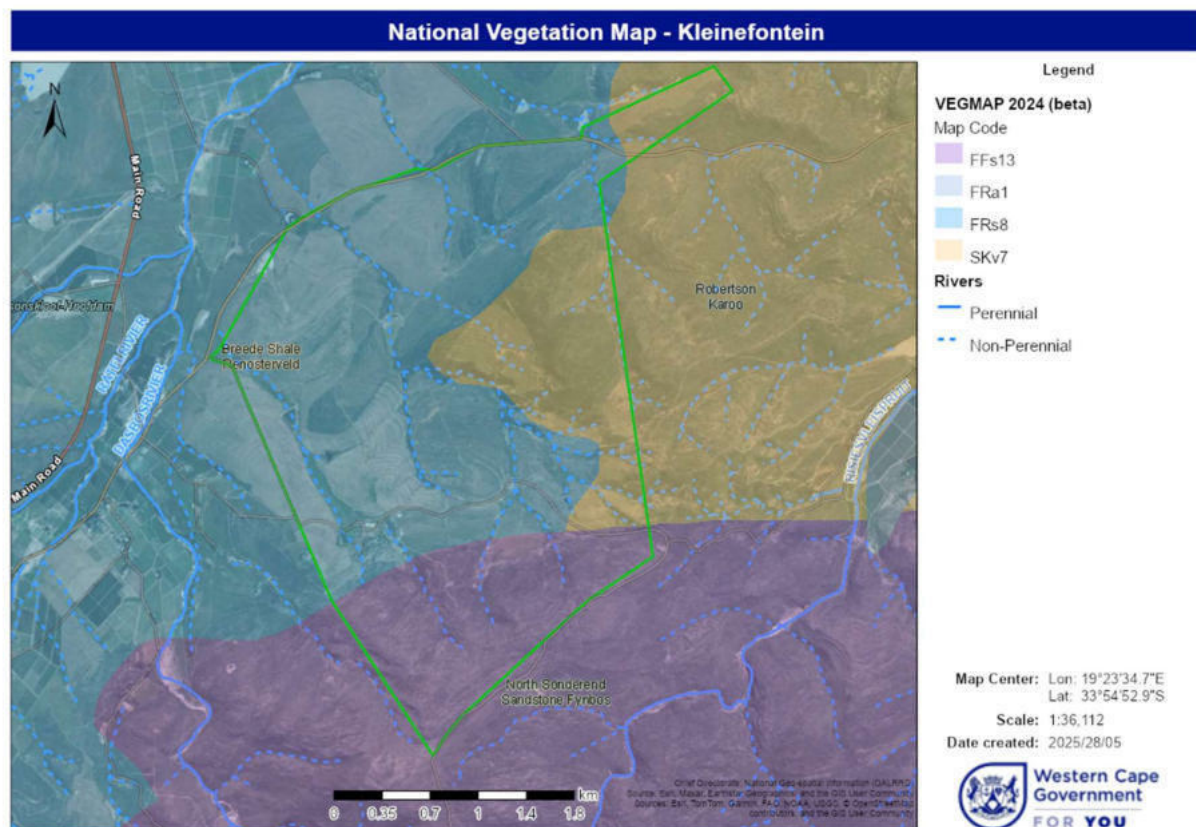
Figure 5: National vegetation map for the project site (green polygon) (CFM, 2025).

Vegetation associated with the project site is largely classified as the Critically Endangered Breede Shale Renosterveld (FRs8), represented by the blue area in Figure 5. Smaller patches of North Sonderend Sandstone Fynbos (purple area) and Robertson Karoo (yellow area) are also present.

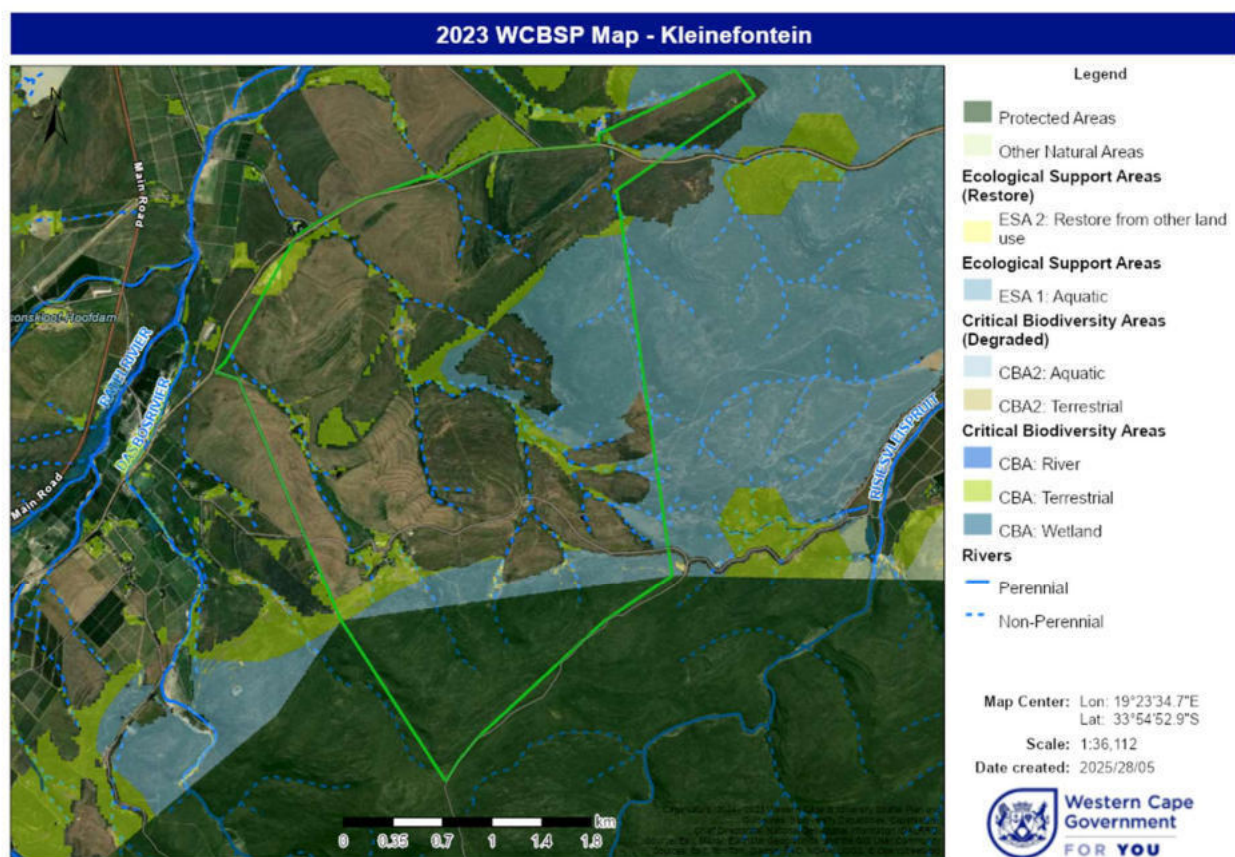
Figure 6: 2025 Western Cape Biodiversity Spatial Plan for the project site (green polygon) (CFM, 2025).

Based on the 2023 WCBSP map (Figure 6), several terrestrial Critical Biodiversity Areas (CBA's) were found along the remaining natural areas on the property. These areas are areas in a natural condition that are required to meet biodiversity targets, for species, ecosystems or ecological processes and infrastructure, and such areas are to be maintained in a natural or near-natural state, with no further loss of natural habitat. Degraded areas should be rehabilitated. Only low-impact, biodiversity-sensitive land uses are appropriate.

Furthermore, aquatic Ecological Support Areas (ESA1: Ground Water Source) were also indicated specifically towards the south and east of the property. These areas play a vital role in helping to sustain the baseflow of surrounding rivers, wetlands, and streams during dry periods.

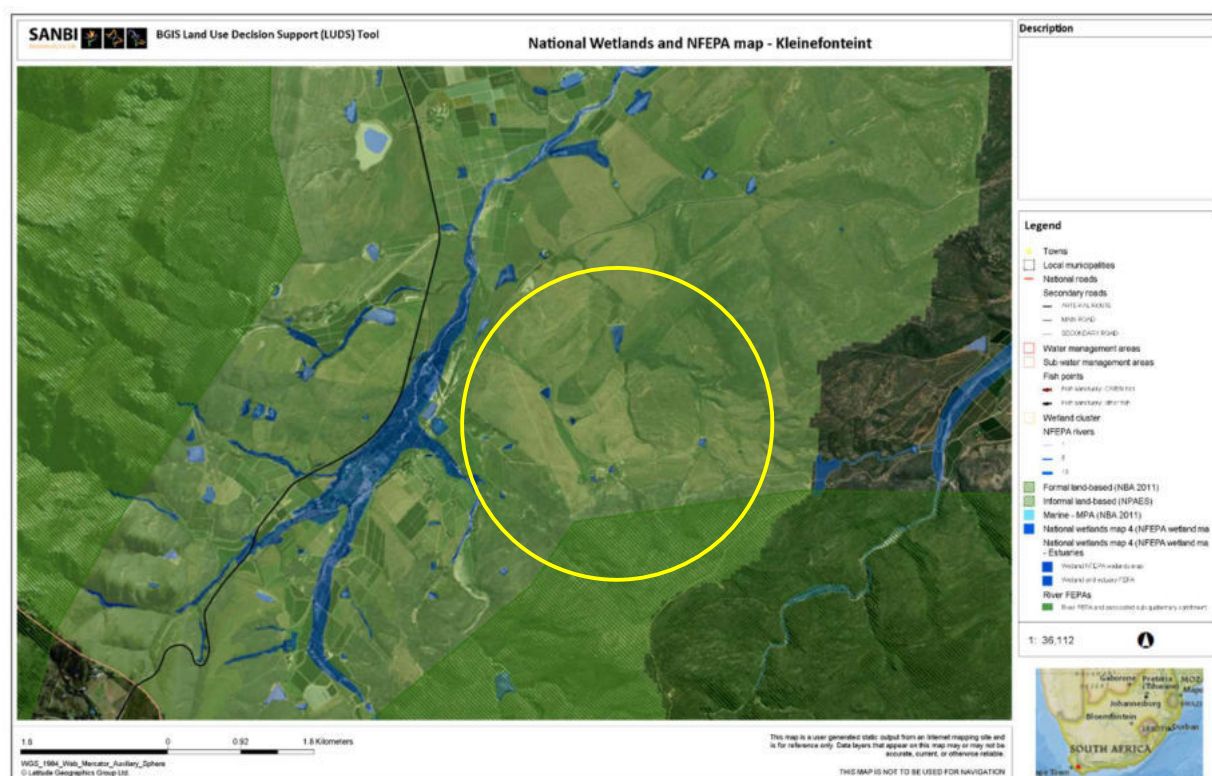
Figure 7: NFEPA map for the larger area surrounding the Project site (yellow circle)(SANBI GIS, 2025).

FishFEPAs, or fish sanctuaries, are sub-quaternary catchments that are critical for the protection of threatened and near-threatened freshwater fish species indigenous to South Africa. These catchments are denoted by either a red or black fish symbol on the map. The sub-quaternary catchment associated with the project area is marked with a black fish, indicating the presence of at least one population of vulnerable or near-threatened fish species, or a population of special concern. The primary objective of FishFEPAs is to prevent further decline in the condition of aquatic ecosystems, particularly those supporting sensitive fish species. As such, no further deterioration in river condition should occur within fish sanctuaries, and no new permits should be issued for the introduction or stocking of invasive alien fish species in these catchments.

In addition to the above, the National Wetlands Map classifies the Ratel River and its larger associated floodplain as East Coast Shale Renosterveld_Floodplain wetland, currently in a C condition (FEPA rank 5). These wetlands are marked as being critically endangered – both from a vegetation and wetland ecosystem perspective.

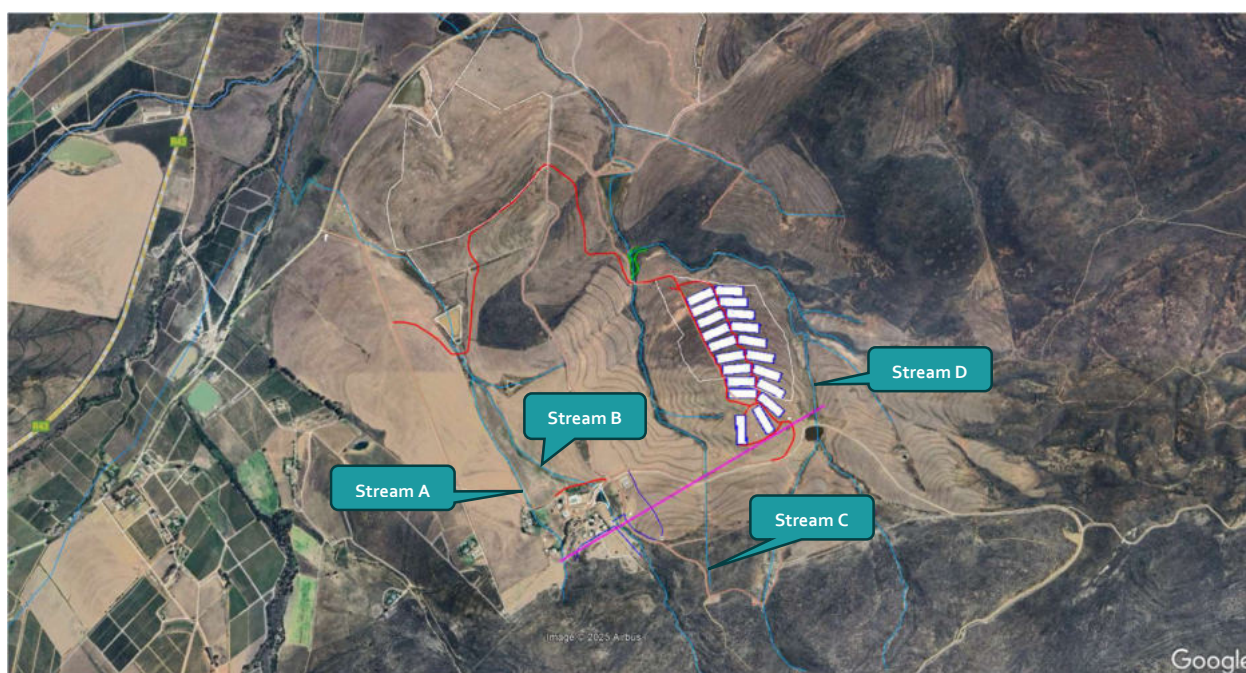
Figure 8: Satellite imagery indicating the project site with the proposed new roads (red lines), the broiler area (white polygons) as well as the affected streams (blue lines) with their associated wetland areas (green polygons).

For the purpose of this report, the freshwater features on site are referred to as Streams A to D (shown in Figure 8). All four streams are primarily seasonal, with permanently wet areas observed along their channels, suggesting a degree of groundwater contribution to baseflow. They originate in the hills to the southeast and flow generally in a north-northwestern direction, where Streams A and B, and Streams C and D converge, respectively, before joining the Ratel River.

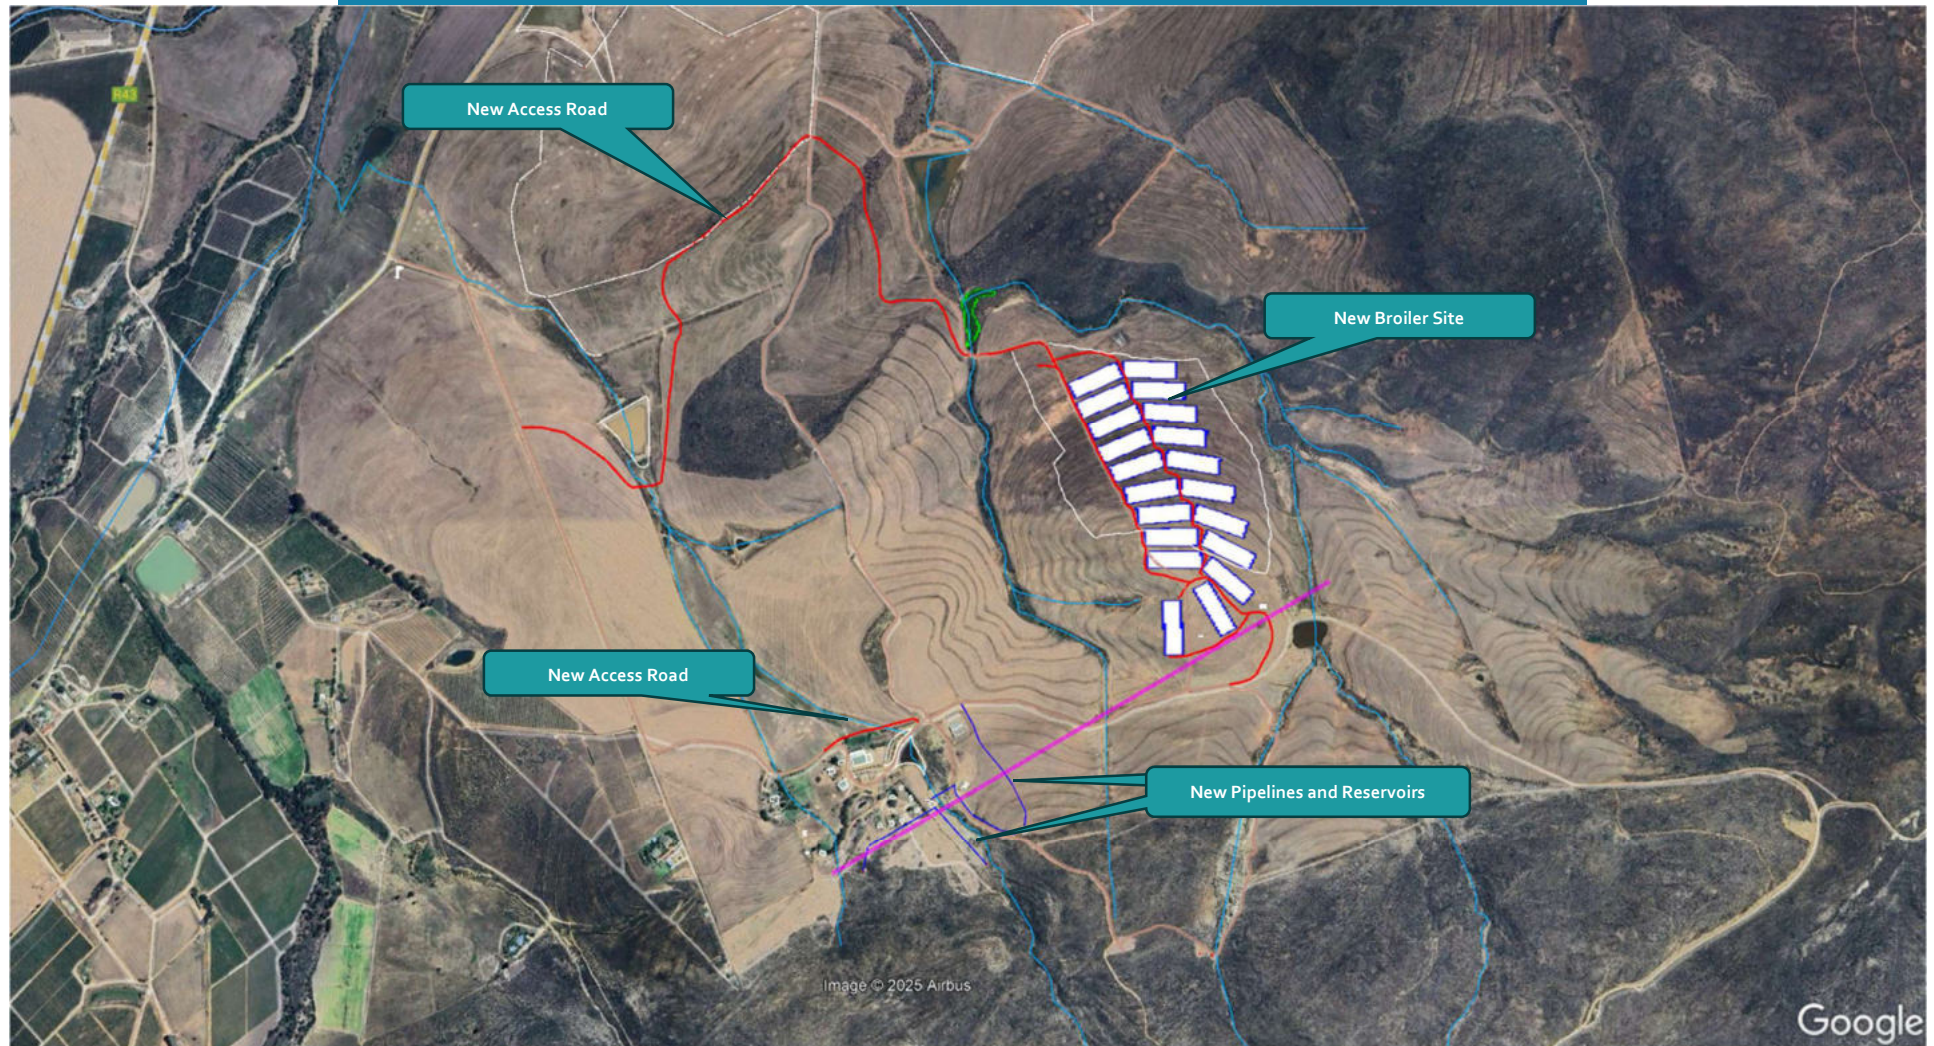
Figure C-2: Proposed activities in relation to the affected freshwater features (Google Earth, 2025).

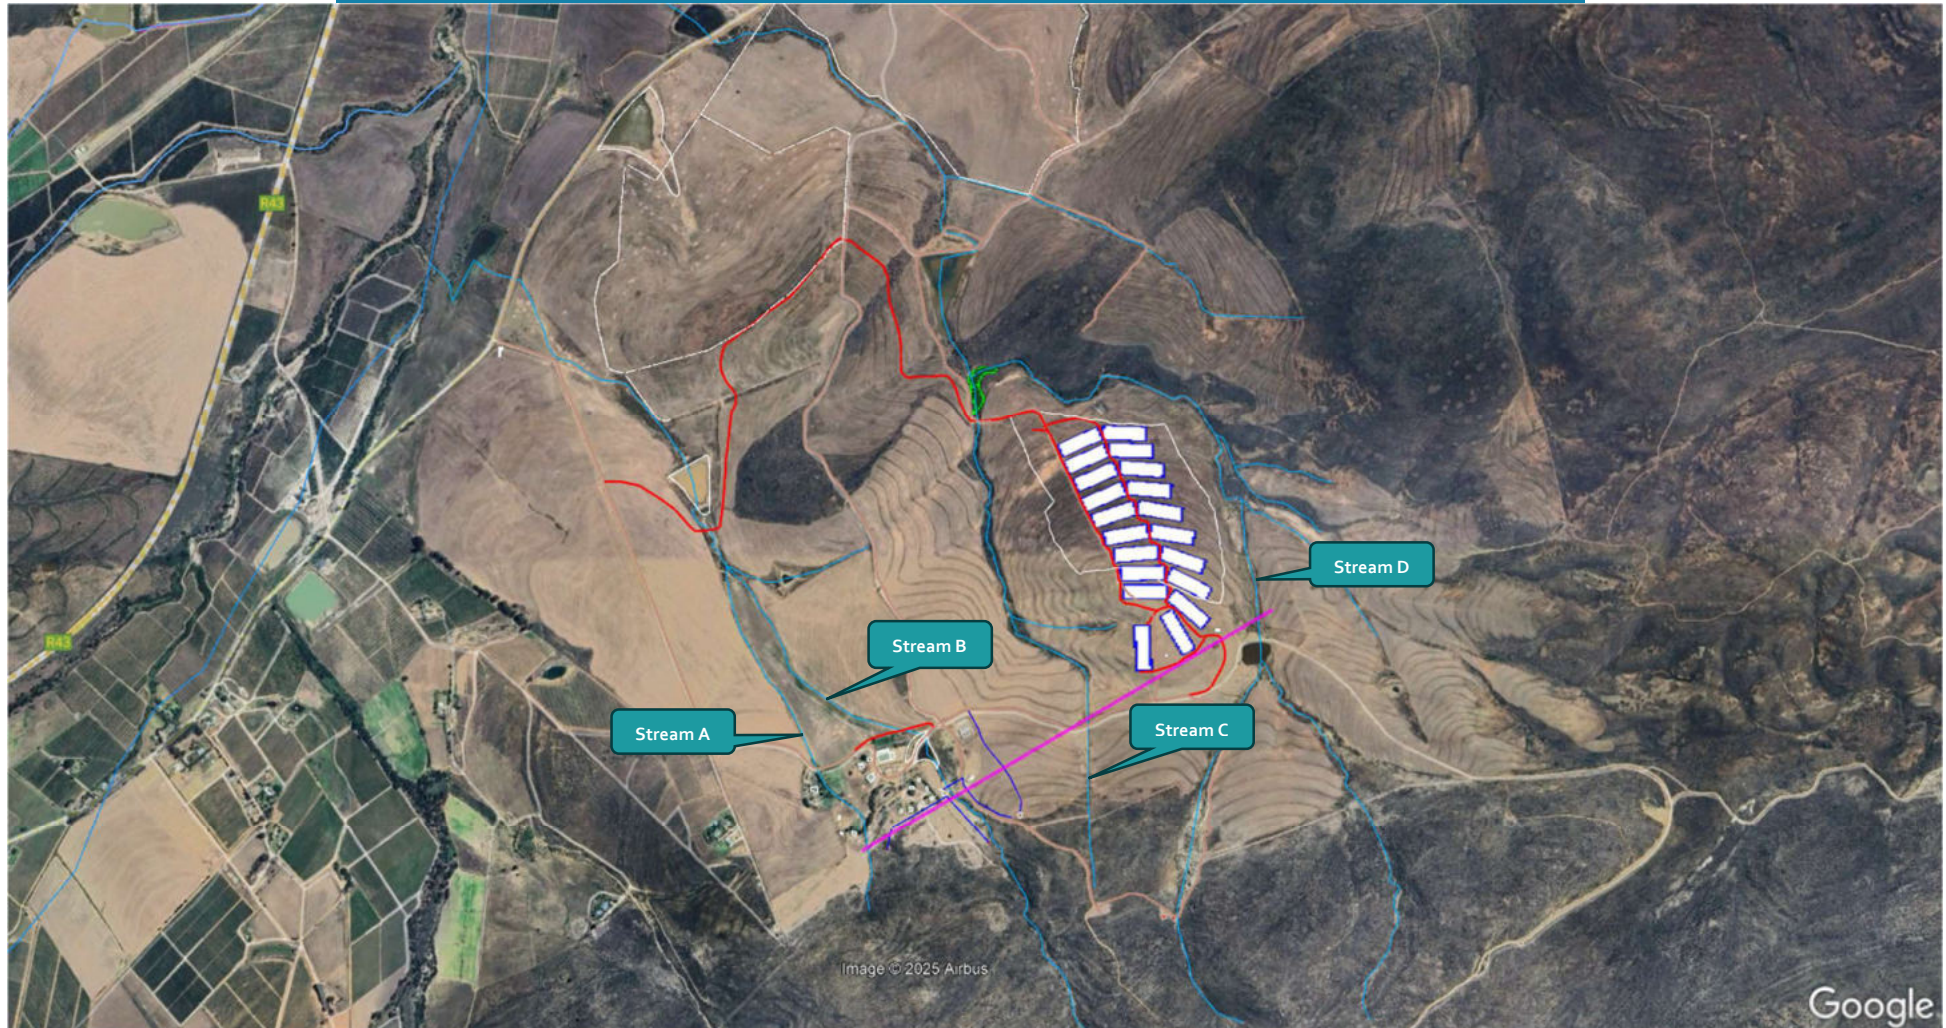
Figure C-7: Satellite imagery indicating the project site with the proposed new roads (red lines), the broiler area (white polygons) as well as the affected streams (blue lines) with their associated wetland areas (green polygons).

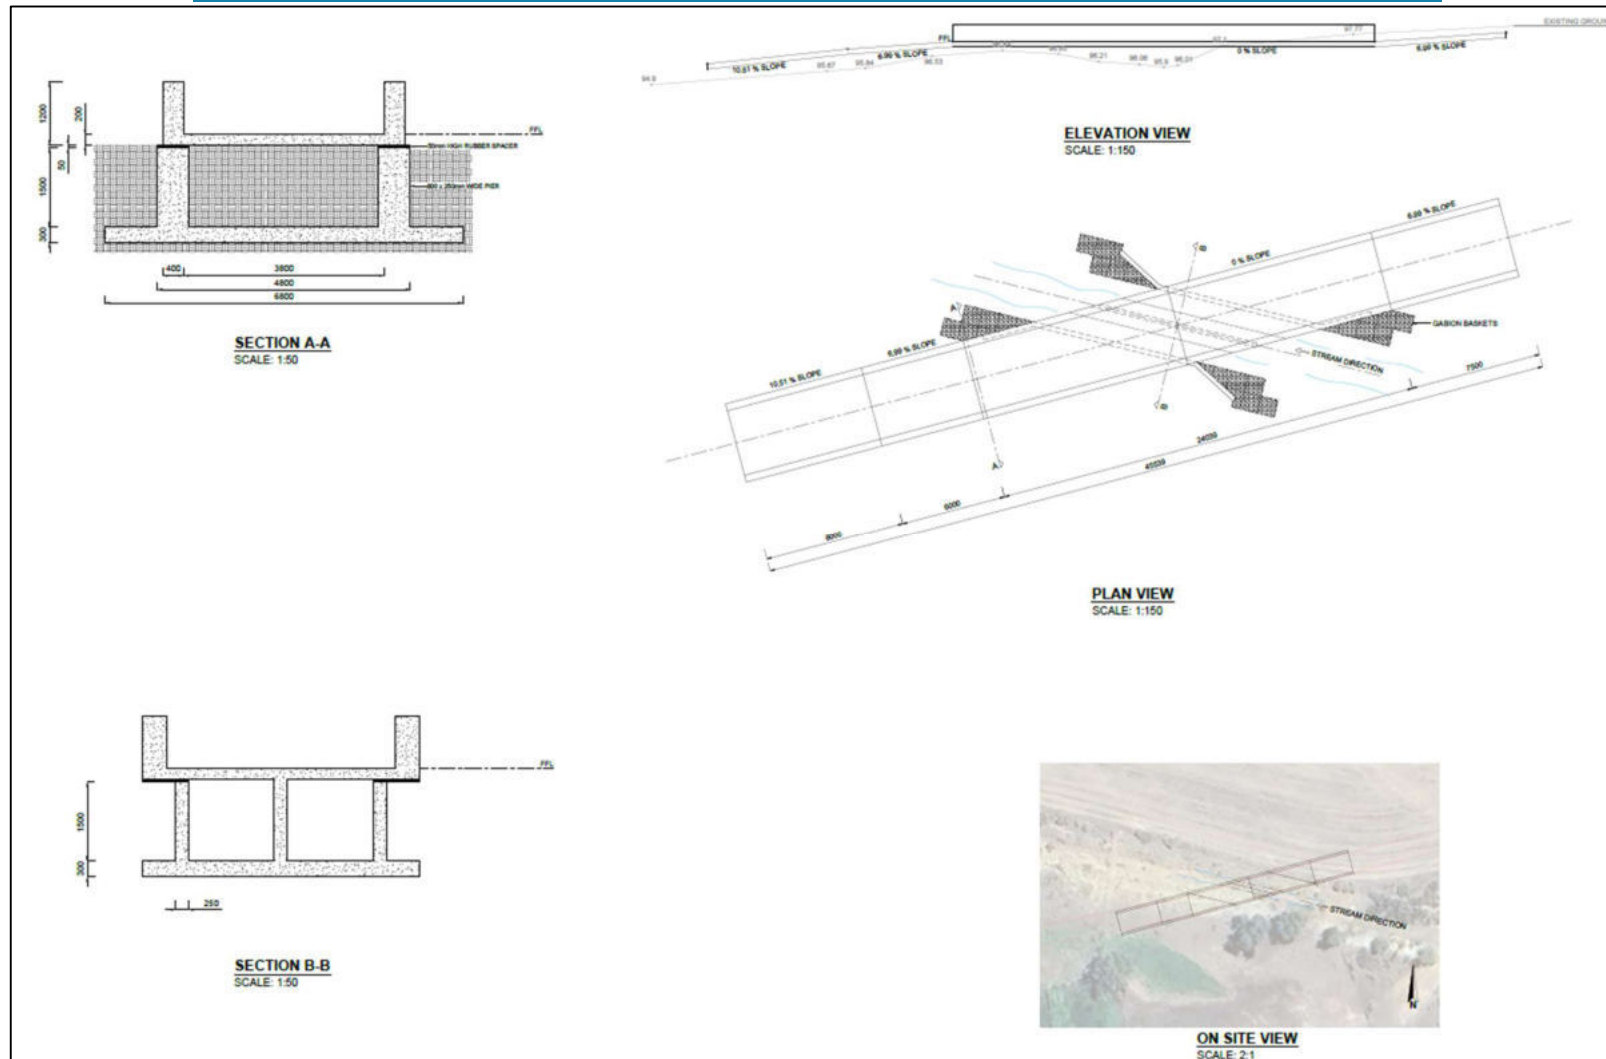
Figure C-8: Engineer drawings for the preferred alternative for the bridge crossing Stream B.

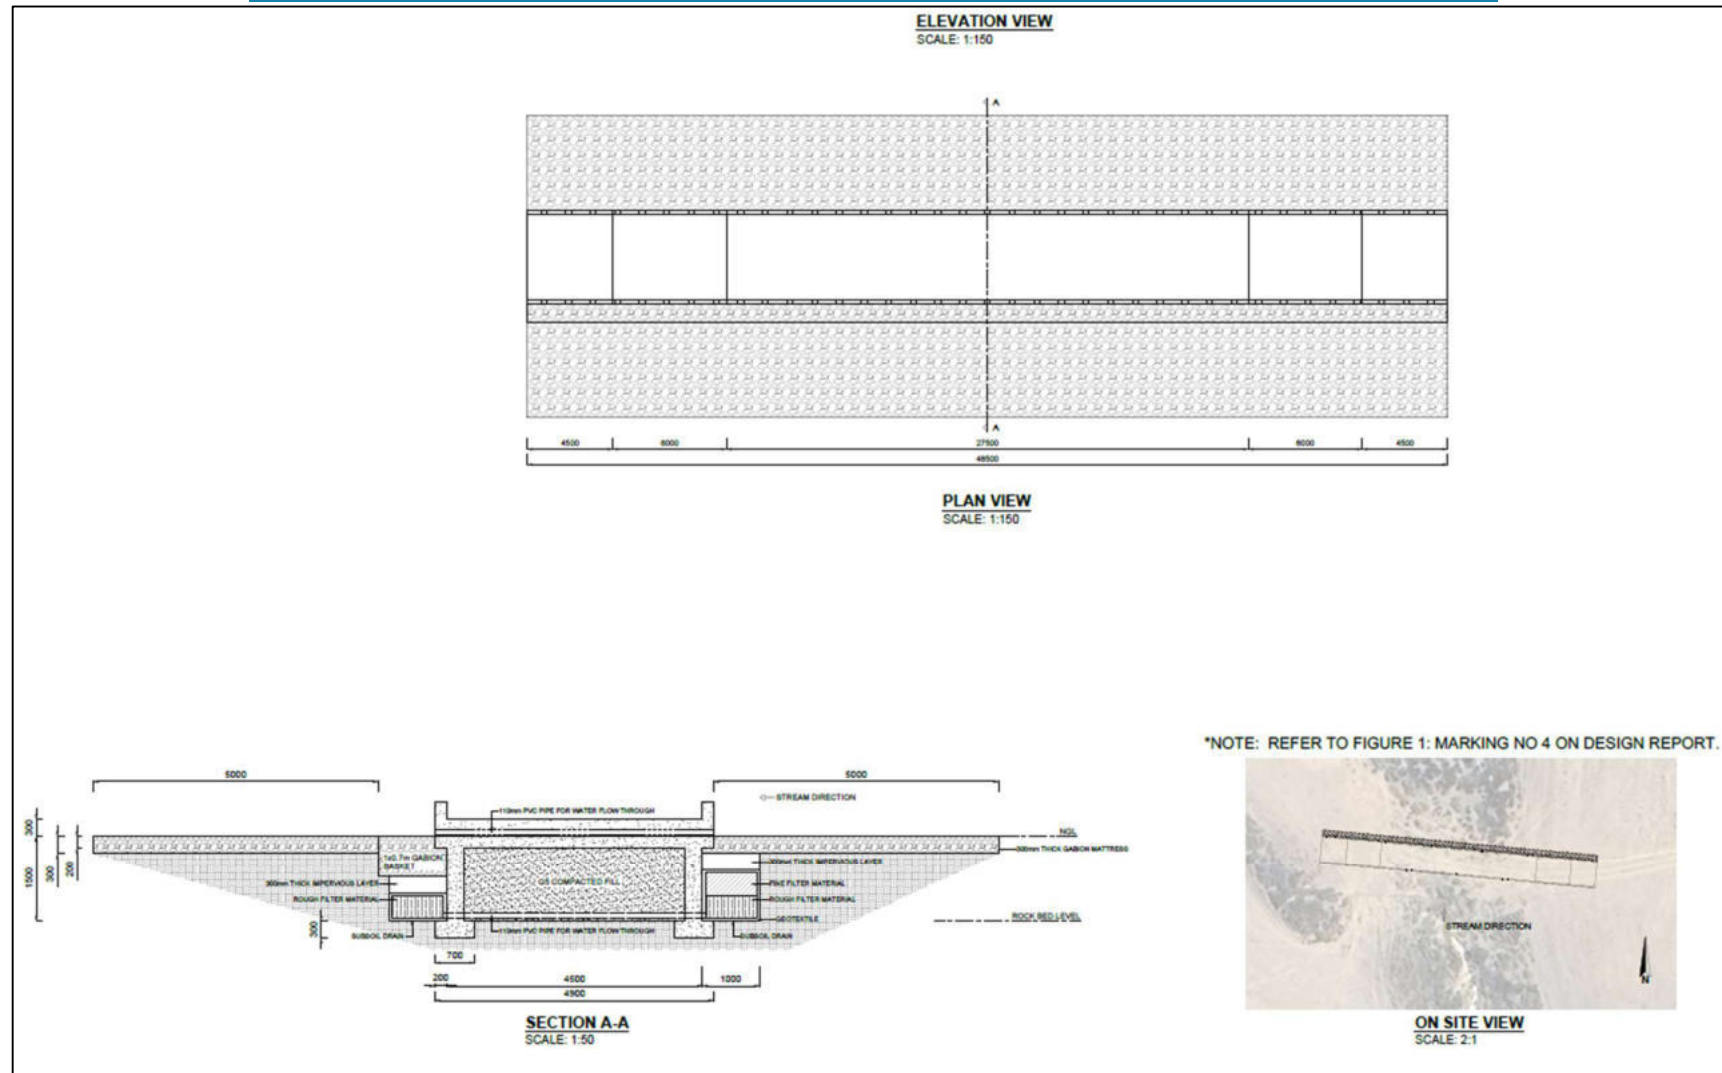
Figure C-10: Engineer drawings for the preferred alternative for the bottom bridge crossing Stream C.
