WATER USE LICENCE APPLICATION SUMMARY REPORT (WU44082)

**ABSTRACTION OF GROUNDWATER AND STREAM CROSSINGS ON FARMS 563, 564, 565
AND FARM KLEINFONTEIN 954, VILLIERSDORP**

**NAME OF APPLICANT:
EFRC AGRI OPERATIONS (PTY) LTD**

**Compiled by
PHS Consulting**

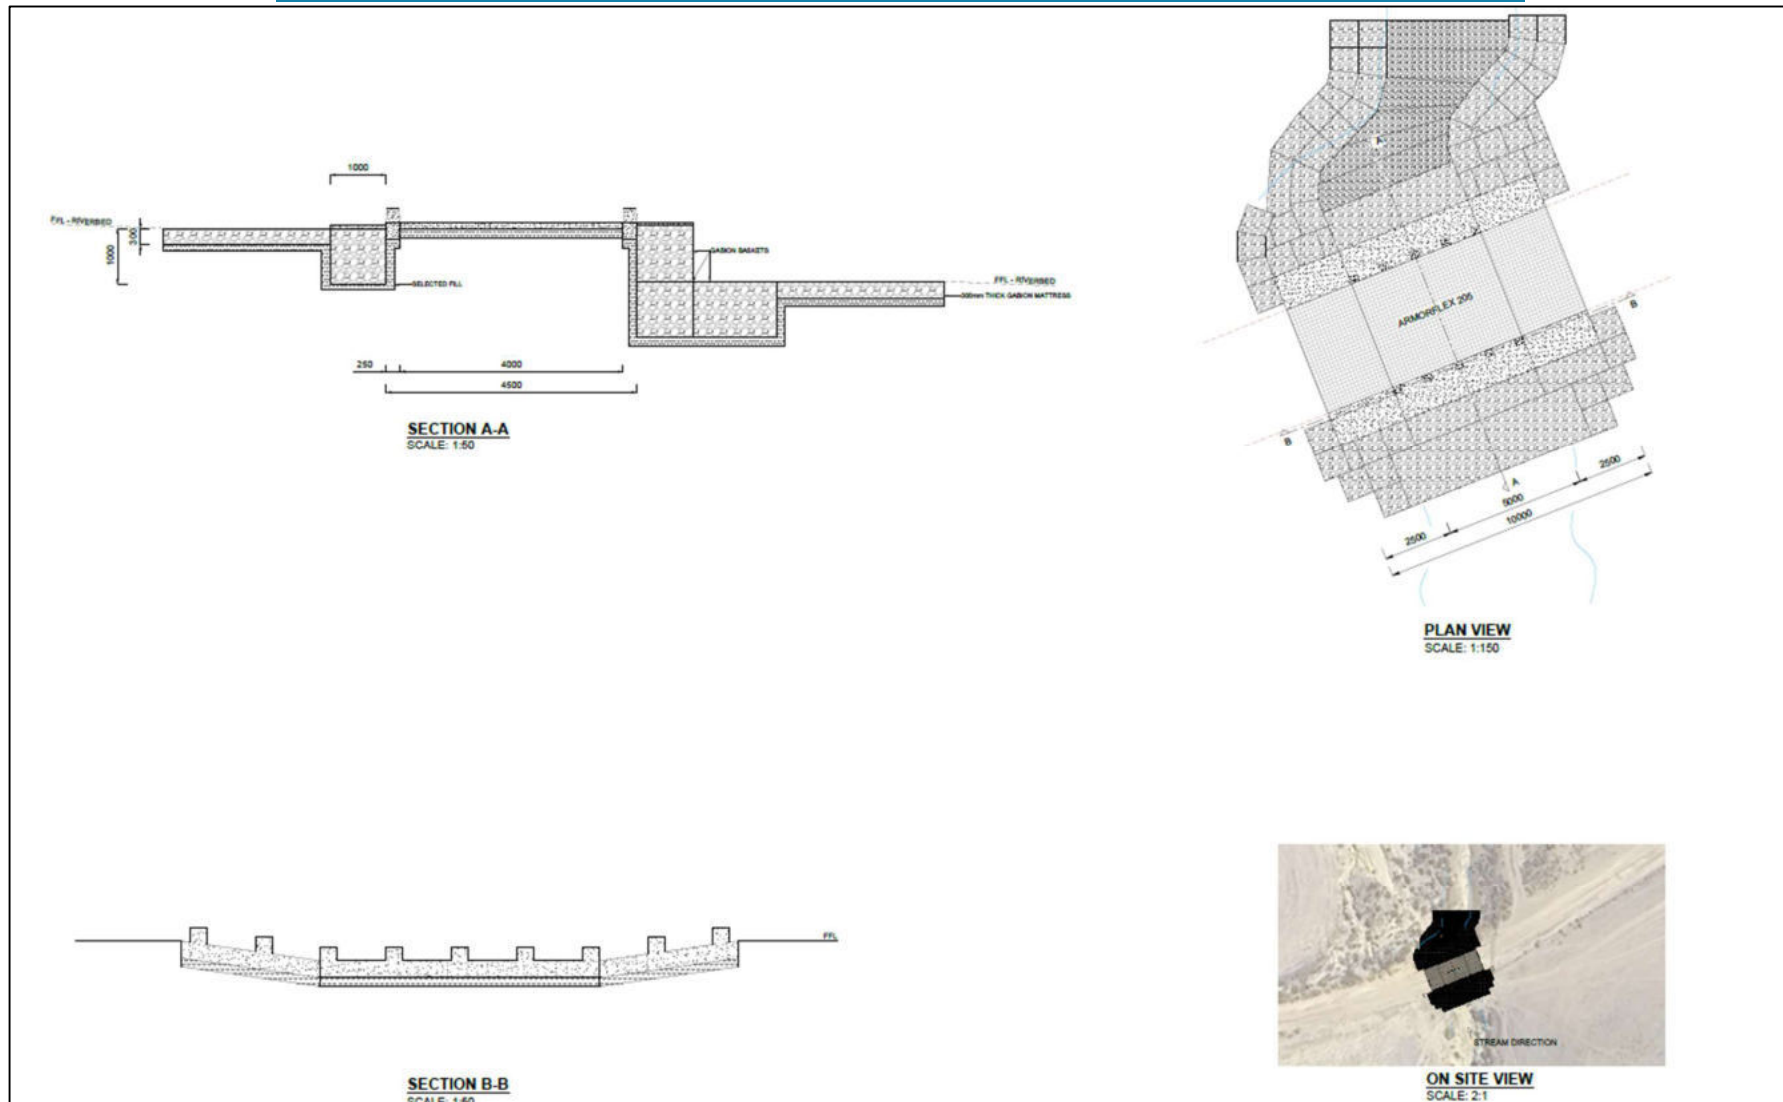
Figure C-11: Engineer drawings for the preferred alternative for the top crossing at Stream C.

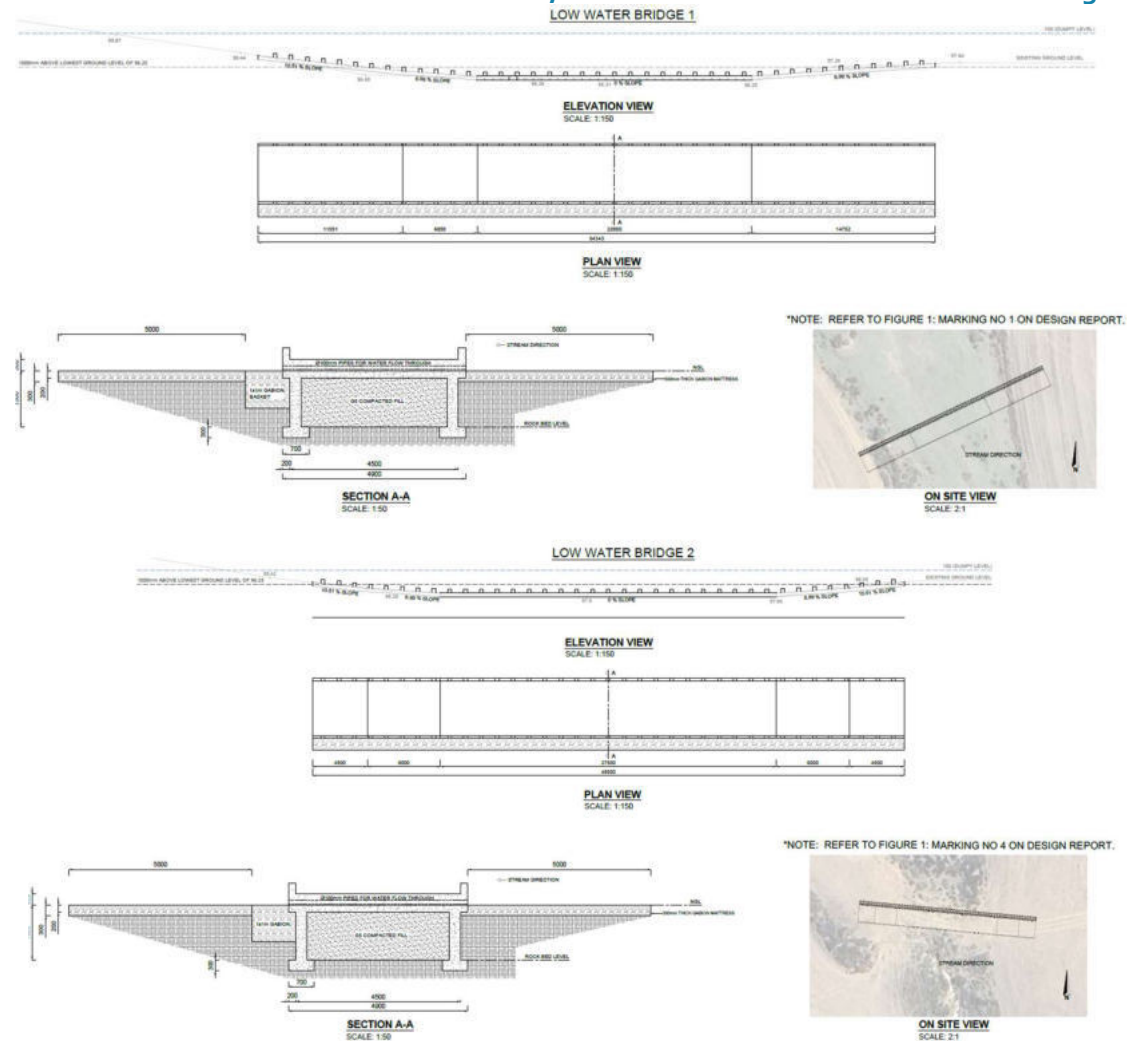
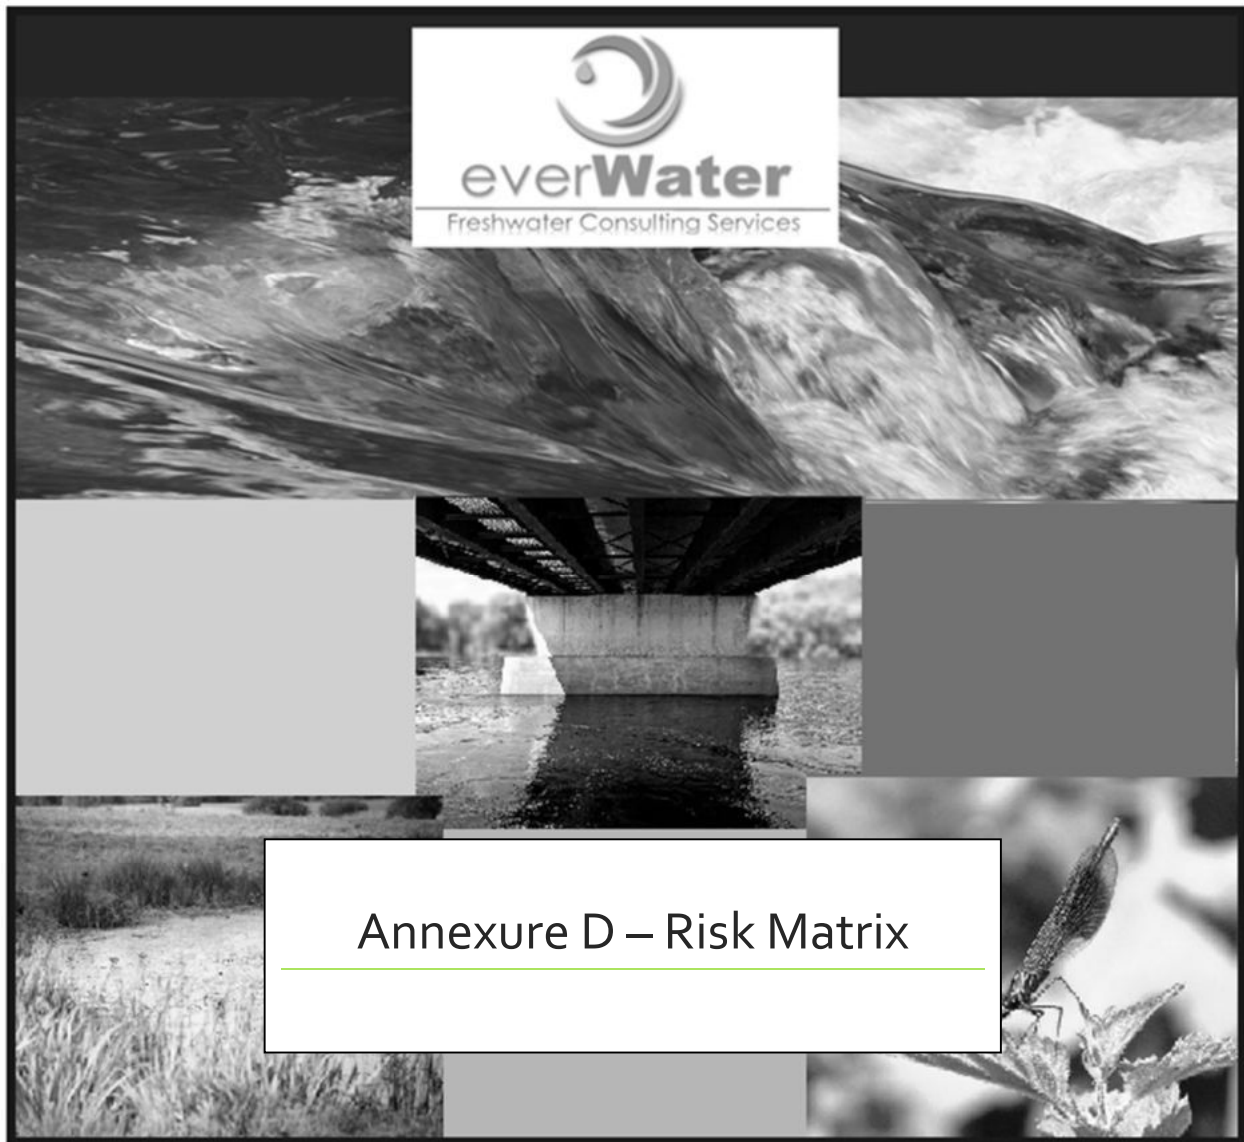
Alternative bridge crossings at the confluence of Streams A & B and the bottom of Stream C, which does not include subsurface drainage:

designs for the bridge

- The initial design for the proposed stream crossings (now the **alternative option**), particularly at the confluence of Streams A and B and at the lower crossing over Stream C, did not accommodate subsurface flow. This would have impeded groundwater movement and likely caused fragmentation and possible desiccation of downstream wetland areas associated with these reaches. In response, the **preferred option** now incorporates subsurface drainage via a no-fines sub-soil drain and an embedded pipe network to maintain hydrological connectivity and lower any flow modification impacts associated with these structures. Engineer plans for both the preferred and alternative options have been added under Annexure C.
