# **AQUATIC IMPACT ASSESSMENT REPORT FOR THE ALLEGED UNAUTHORISED ACTIVITIES AT FARM MELKHOUTRIVIER PORTION 1 OF NO. 492, MALGAS**

*July 2023*

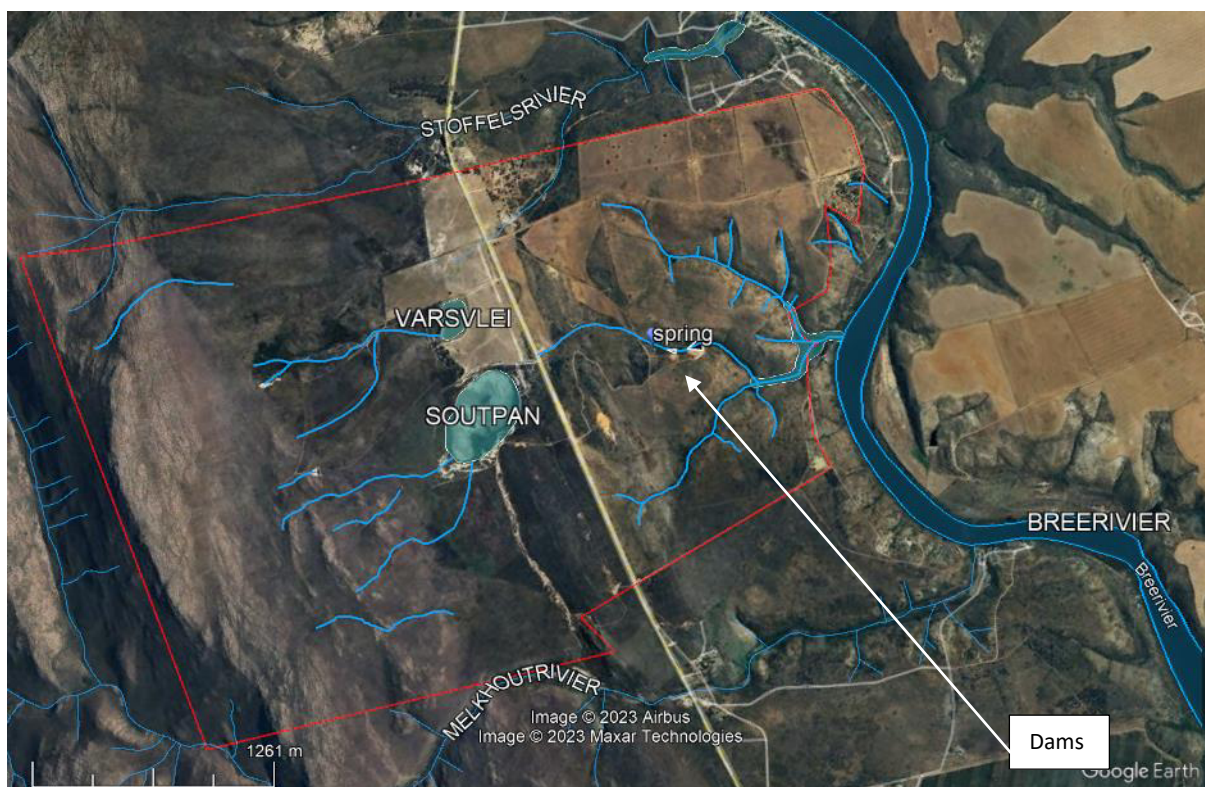
Aquatic features on the property comprise a minor tributary of the lower Breede River and Estuary. The tributary originates in the foothills of the Potberg downslope of the gravel road to Infanta and flows in a northerly direction through the property. The stream is joined by several other streams before it drains into the Breede Estuary. Valley bottom wetland is mapped along the lower watercourse. Isolated depressions (Soutpan and Varsvlei) are mapped upstream of the gravel road to Infanta.

**Figure 7. Orthophotograph taken in 2016 with the river systems associated with the property shown, as well as the location of the dams**

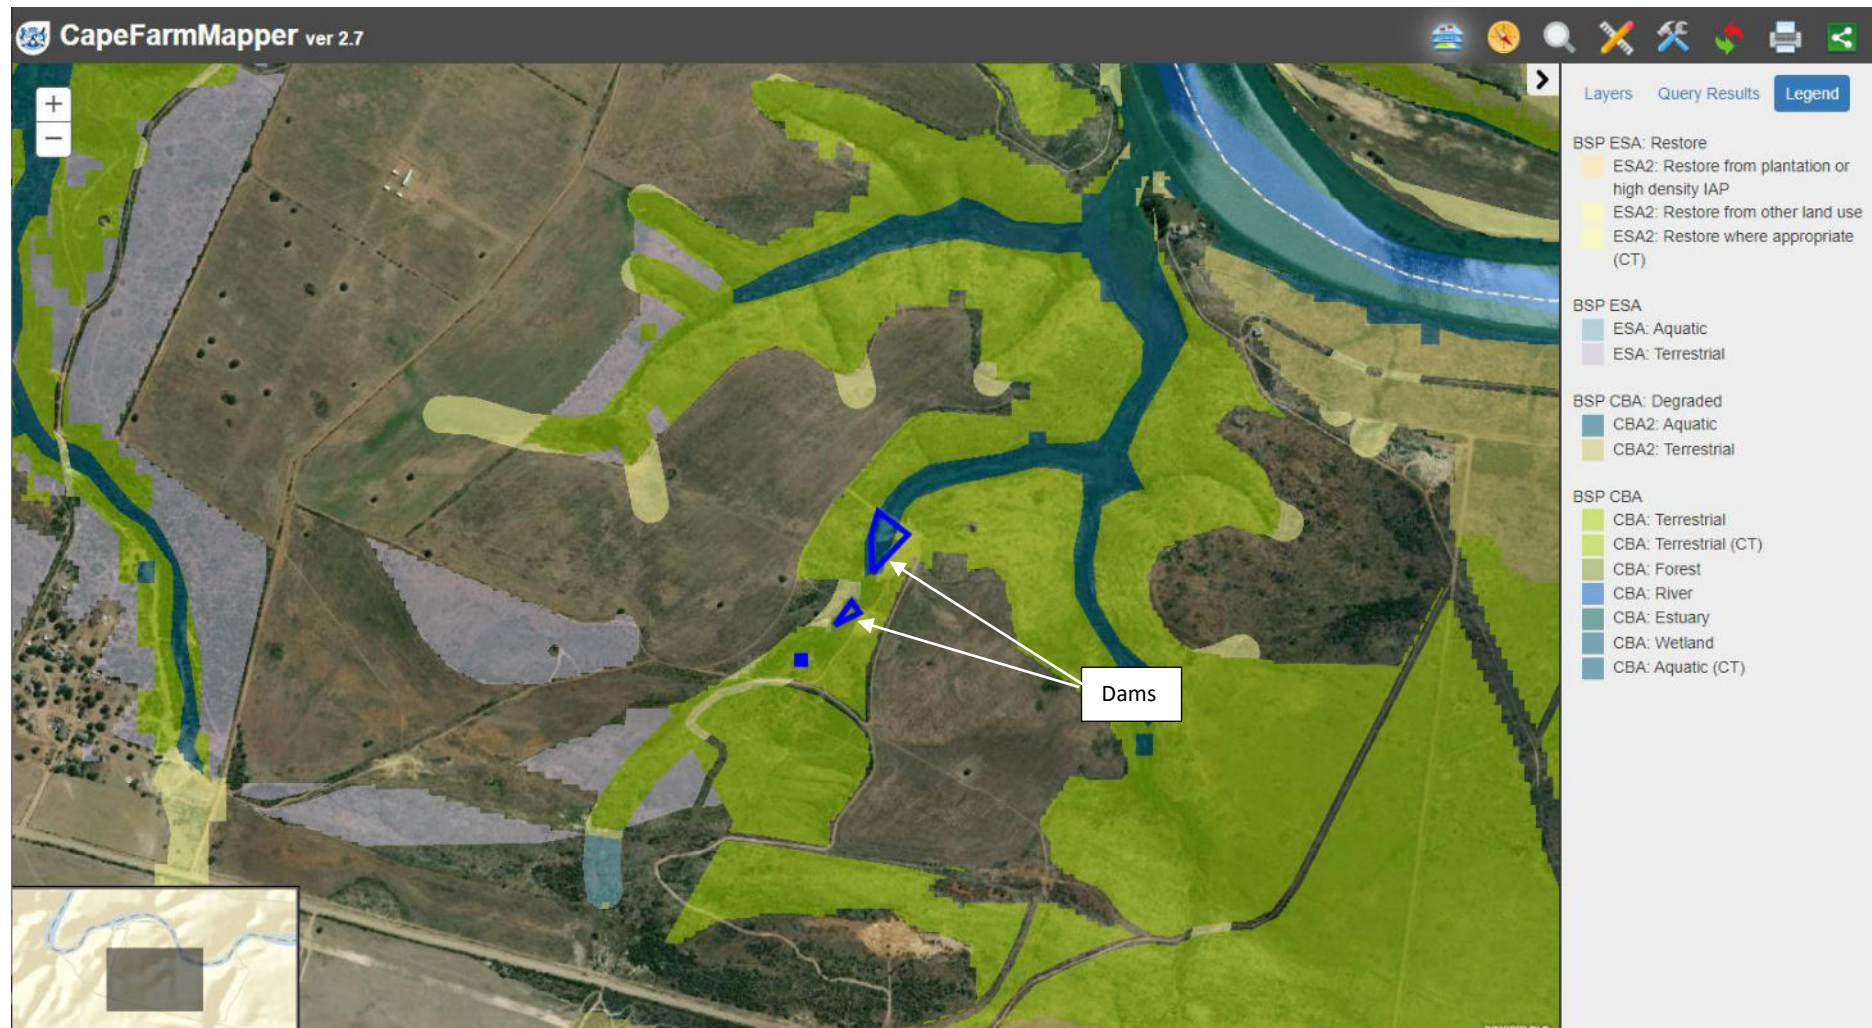
Figure 8. Western Cape Biodiversity Spatial Plan in the vicinity of the site (CapeFarmMapper, 2023)

The study area is within a FEPA River Sub-catchment associated with the lower Breede River (Figure 8). The valley bottom wetlands mentioned above as well as the large depression wetlands (Soutpan and Varsvlei) that are upslope of the gravel road and the site are mapped as natural FEPA Wetlands and a Wetland Cluster in the case of the depression wetlands. These wetlands are also mapped within the National Wetland Map version 5 (Figure 9), which is the third mapping initiative that provides a national map of the extent and ecosystem types of the estuarine and inland wetlands.

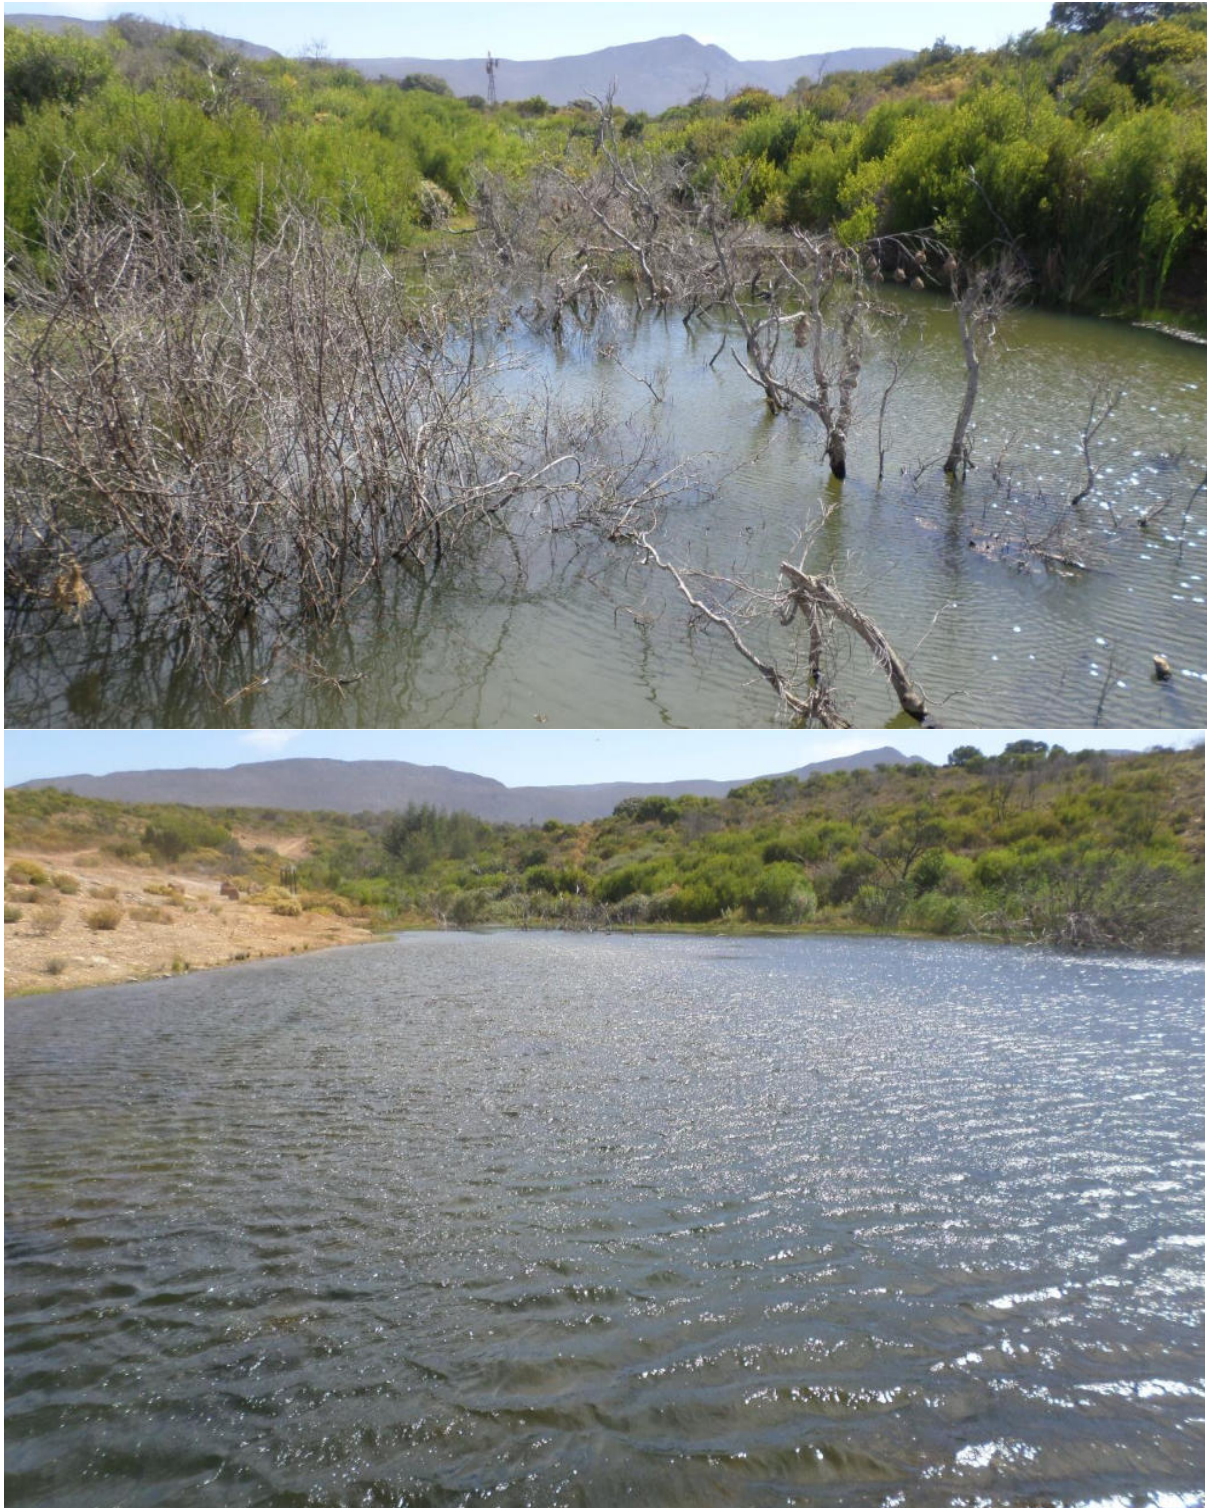
The landowner is currently removing the alien vegetation from the watercourse. Downstream of this, the stream is confined within a valley and is dominated by a valley bottom wetland area that is dominated by *Phragmites australis* reeds with clumps of the mat sedge, *Cyperus textilis*. Vegetation in the dam comprises bulrush (*Typha capensis*), with sedges such as *Cyperus textilis* and *Isolepis prolifera* occurring along the shallow margins.

*Figure 11. View of the upper (top) and lower (bottom) dams within the watercourse*

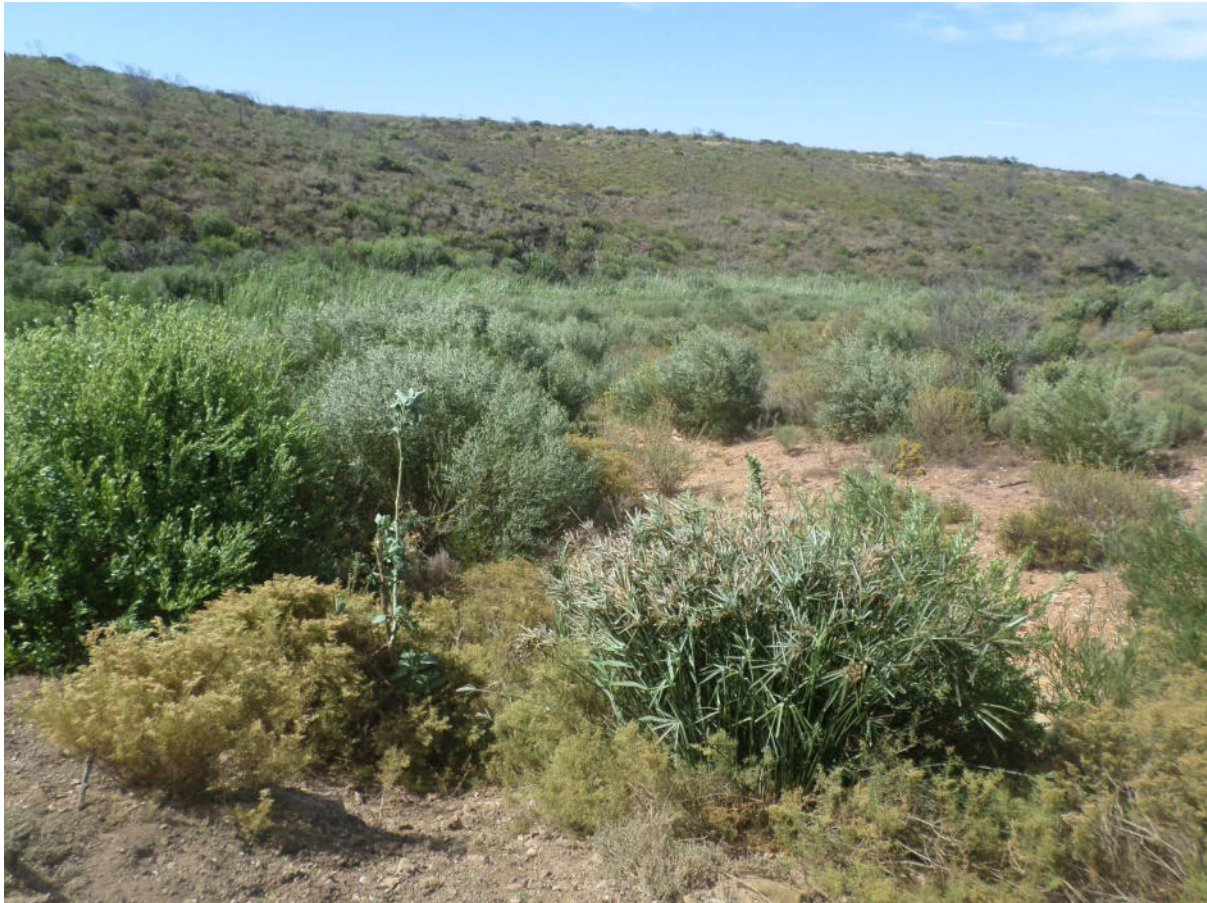
The stream flows through agricultural areas where it has been more significantly impacted by past cultivation activities. Much of the valley bottom wetland and riparian vegetation is however still intact but has been invaded with alien vegetation such as rooikrans (*Acacia cyclops*), Port Jackson willows (*Acacia saligna*) and black wattle (*Acacia mearnsii*).

*Figure 12. View of the watercourse upstream (top), within (middle) and downstream (bottom) of the dams*

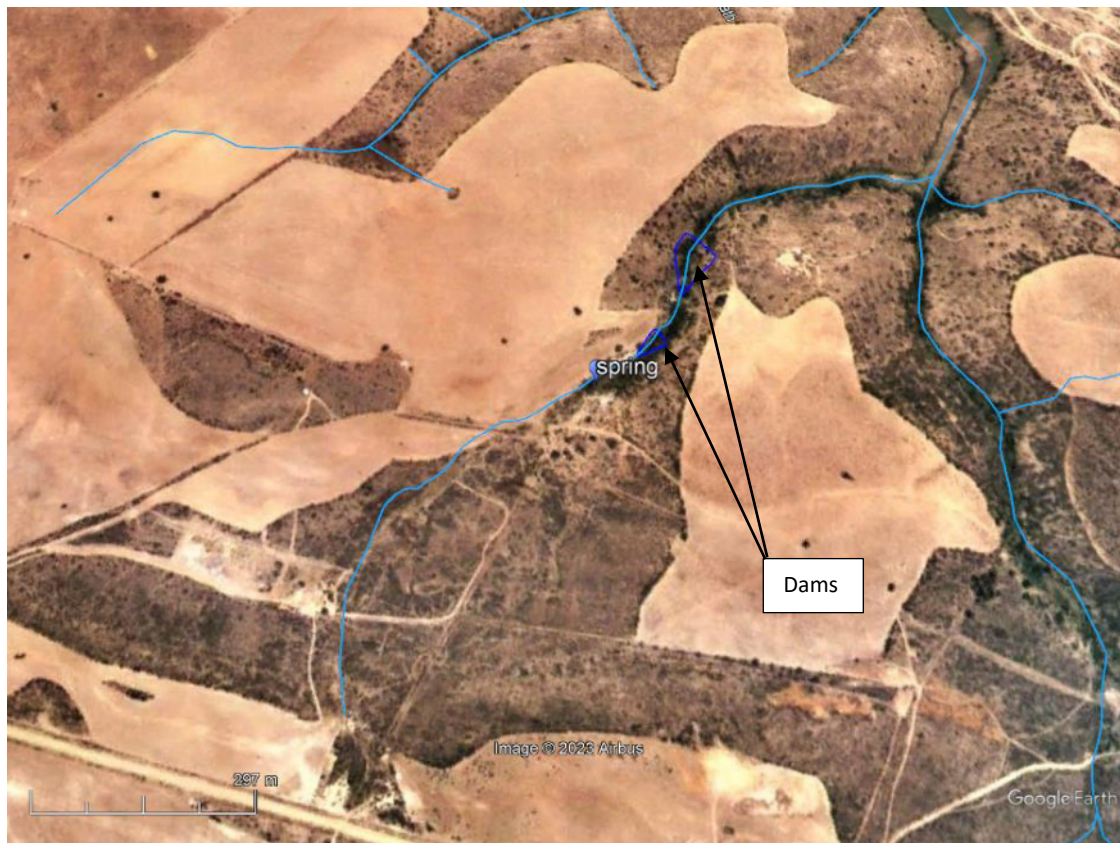
The earliest available imagery of the site, taken in 1942 (Figure 13), shows the site prior to much activity in the area. Instream wetland habitat extended up to the spring, just upstream of the two dams. It does appear as if there was some disturbance/excavation at or near the two dam sites. Figure 14 shows the site in 1967, cultivation of the flat areas adjacent to the watercourses had all been cultivated. Disturbance at or near the two dam sites is visible. The same cultivation areas are visible in the 2005 image (Figure 15). The disturbance at the two dam sites is not as visible but still appears to still be present. There had also been a significant clearing of wetland habitat in the lower river system.

*Figure 15. Aerial image taken in 2005 and overlaid in Google Earth with the location of the dams shown*

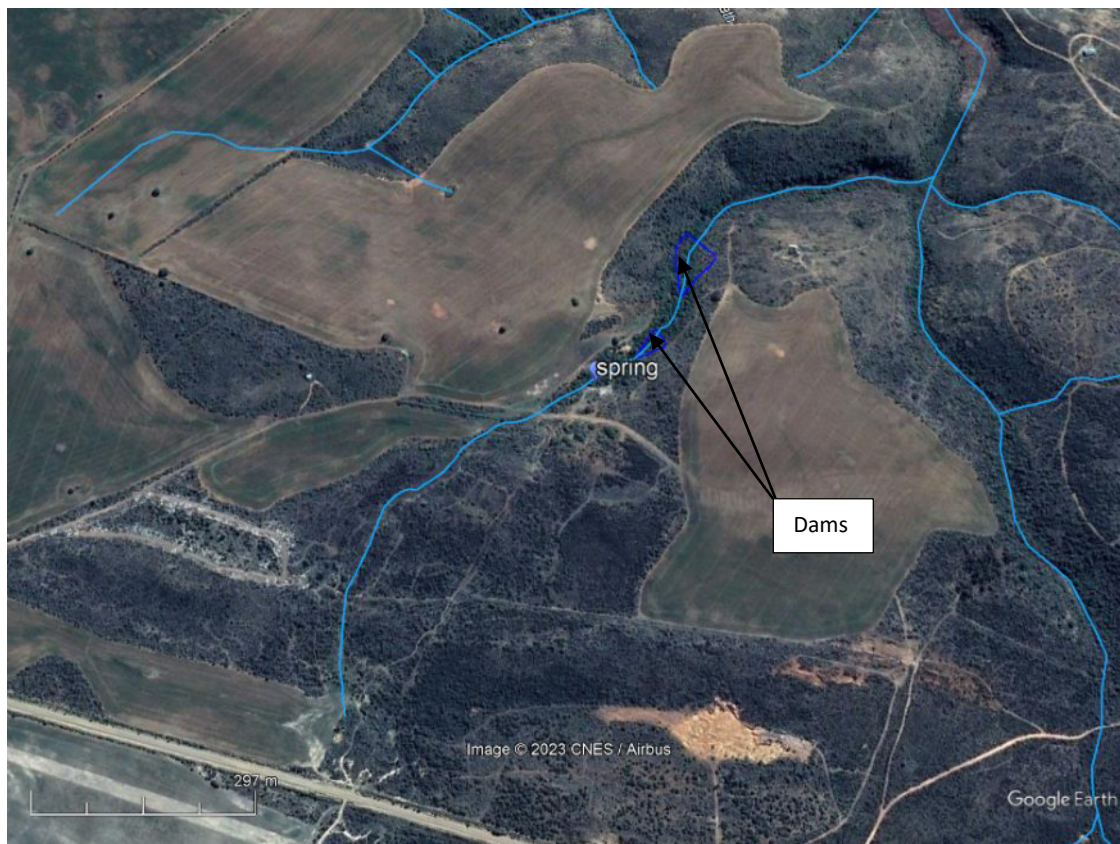
The Google Earth images shown in Figures 16 and 17 show the site before and after the works were undertaken on the two dams. The surrounding cultivation areas have remained the same however new roads have been constructed to the dams, the area around the dams cleared and the dam basins excavated.

*Figure 16. Google Earth image of the site, taken August 2019, with the location of the dams shown*

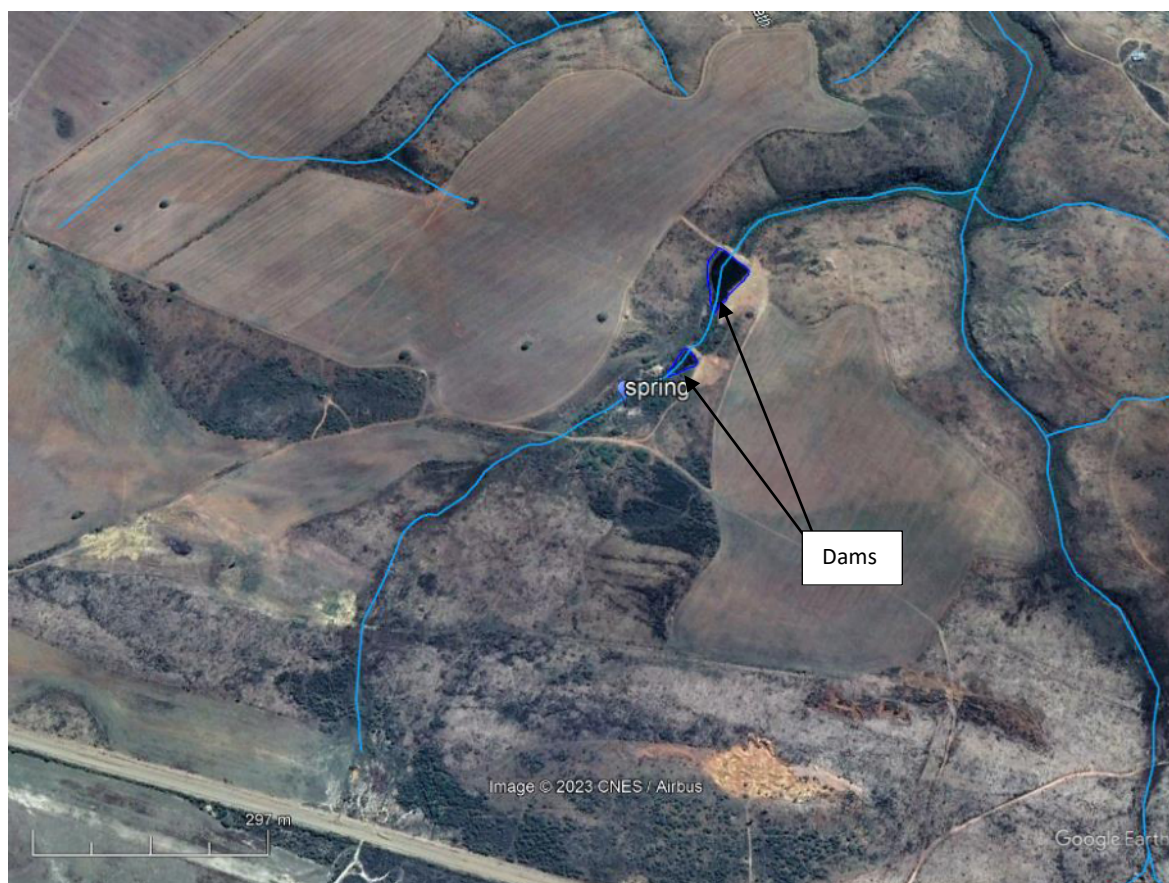
*Figure 17. Google Earth image of the site, taken March 2021, with the location of the dams shown*

The potential impact of the constructed dams on the tributary of the Breede Estuary is considered from an aquatic ecological perspective in this report. Past imagery for the farm indicates that the tributary at the dam sites has long been disturbed. The recent works have taken place within these already disturbed areas and thus have not resulted in any further degradation of the river system.

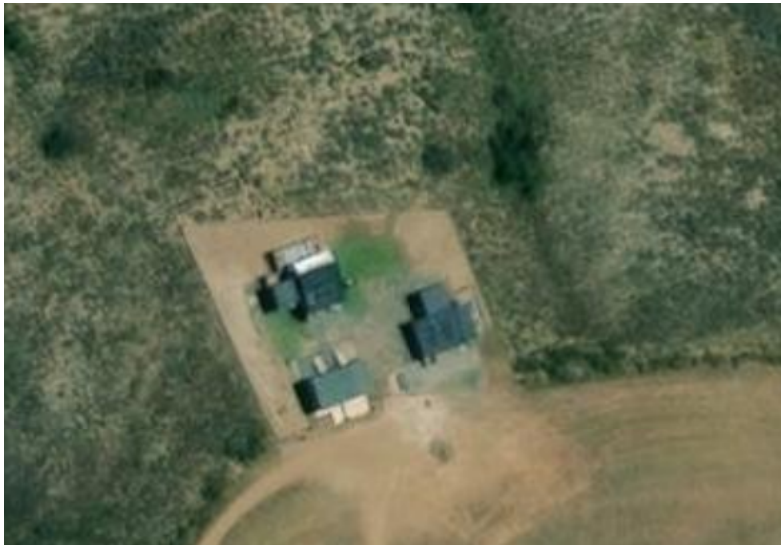
There are two cottages of 150m<sup>2</sup> (deck area included) and a parking / utility building of 160m<sup>2</sup> with a total area cleared around these of 2700m<sup>2</sup>.

The clearance and buildings do not show clearly on Google Earth, but the below image is from CFM and indicates the clearance. The most easterly cottage is approximately 60m<sup>2</sup> within 32m of the drainage line.
