**BOTANICAL AND FAUNAL IMPACT  
ASSESSMENT OF VEGETATION CLEARING  
(PROPOSED AND PAST) AND INSTREAM DAM  
ENLARGEMENT, REM OF PTN 1  
MELKHOUTRIVIER 492, MALGAS,  
SWELLENDAM.**

**Submitted to: PHS Consulting, Hermanus**

**4 Sep 2025**

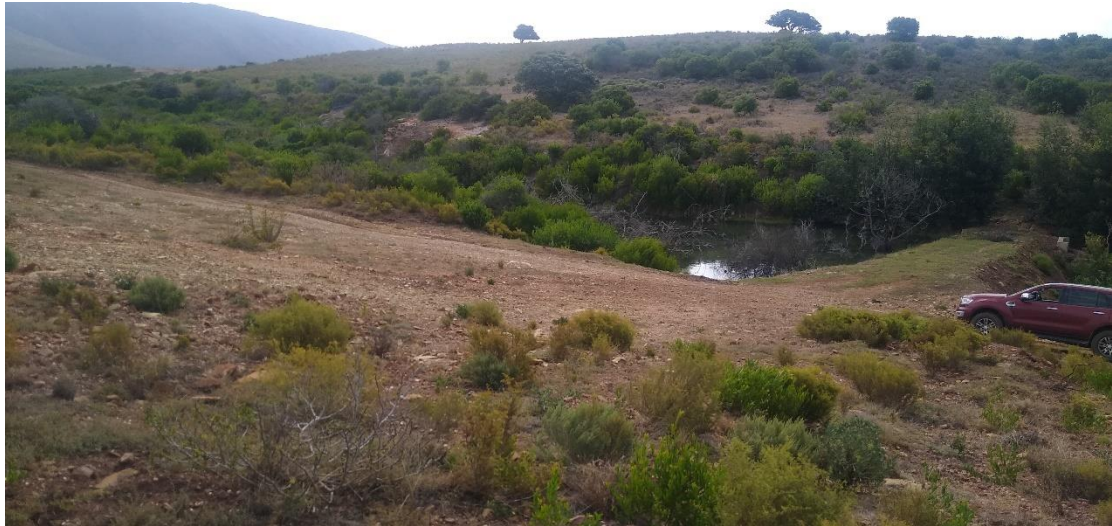
**Plate 1:** View of upper (western) dam (dam 2), dam wall and partly cleared area in foreground, looking northwest.

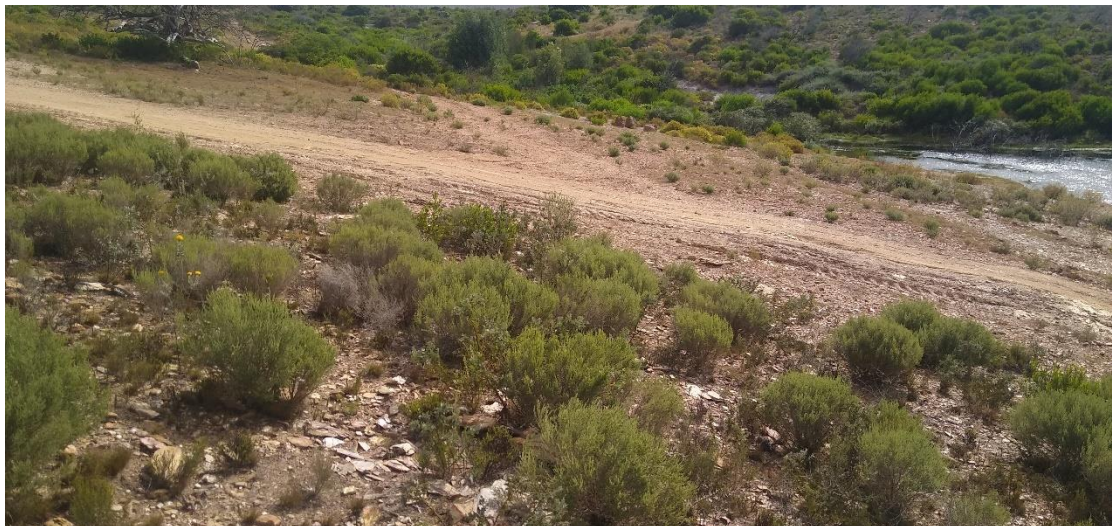
**Plate 2:** View (looking west) of lower dam (dam 1), partly rehabilitated cleared area and untouched Renosterveld in foreground.

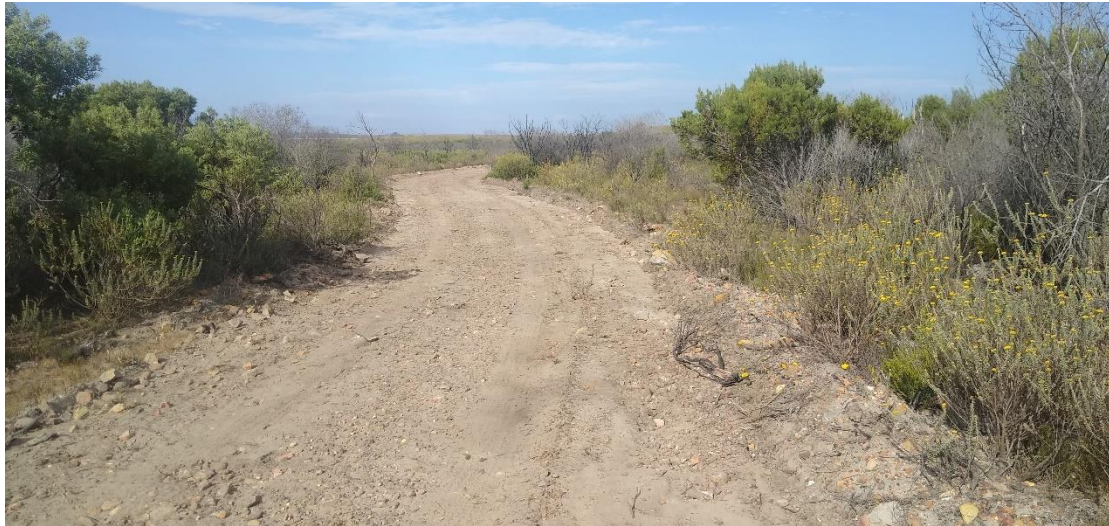
**Plate 3:** View of portion of new access track.

The access road skirts a low sandstone ridge (with Potberg Sandstone Fynbos elements), and traverses an area that has been aggressively invaded by alien shrubs such as rooikrans (*Acacia cyclops*) and Port Jackson (*Acacia saligna*). The road is an average of 4-5m wide, and indigenous vegetation grows right up to the edge of the road, as does a lot of alien vegetation. Many of the same indigenous species as noted in Section 5.2.1 occur in this area, along with *Blepharis capensis*, *Lobostemon daltonii*, *Serruria ludwigii*, *Erica quadrangularis*, *Struthiola argentea*, *Microdon dubius*, *Metalasia brevifolia* and *Cliffortia stricta*.
