**WATER USE LICENCE APPLICATION SUMMARY REPORT (WU44082)**

**ABSTRACTION OF GROUNDWATER, STREAM CROSSINGS AND INSTALLATION OF  
SEPTIC TANKS ON FARMS 563, 564, 565 AND FARM KLEINFONTEIN 954,  
VILLIERSDORP**

**NAME OF APPLICANT:  
EFRC AGRI OPERATIONS (PTY) LTD**

**Compiled by  
PHS Consulting**

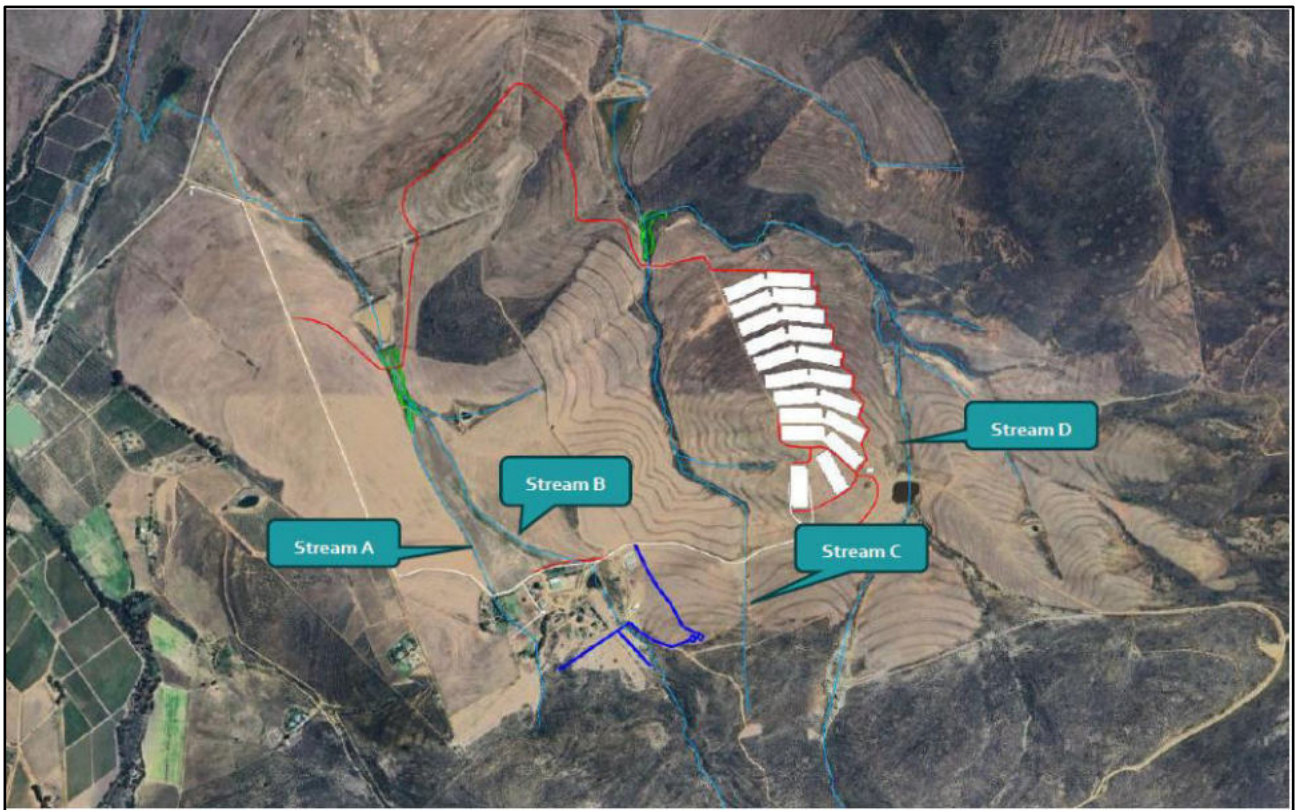
**Figure 4: Proposed activities in relation to the affected freshwater features (Everwater Freshwater Consulting Services, October 2025).**

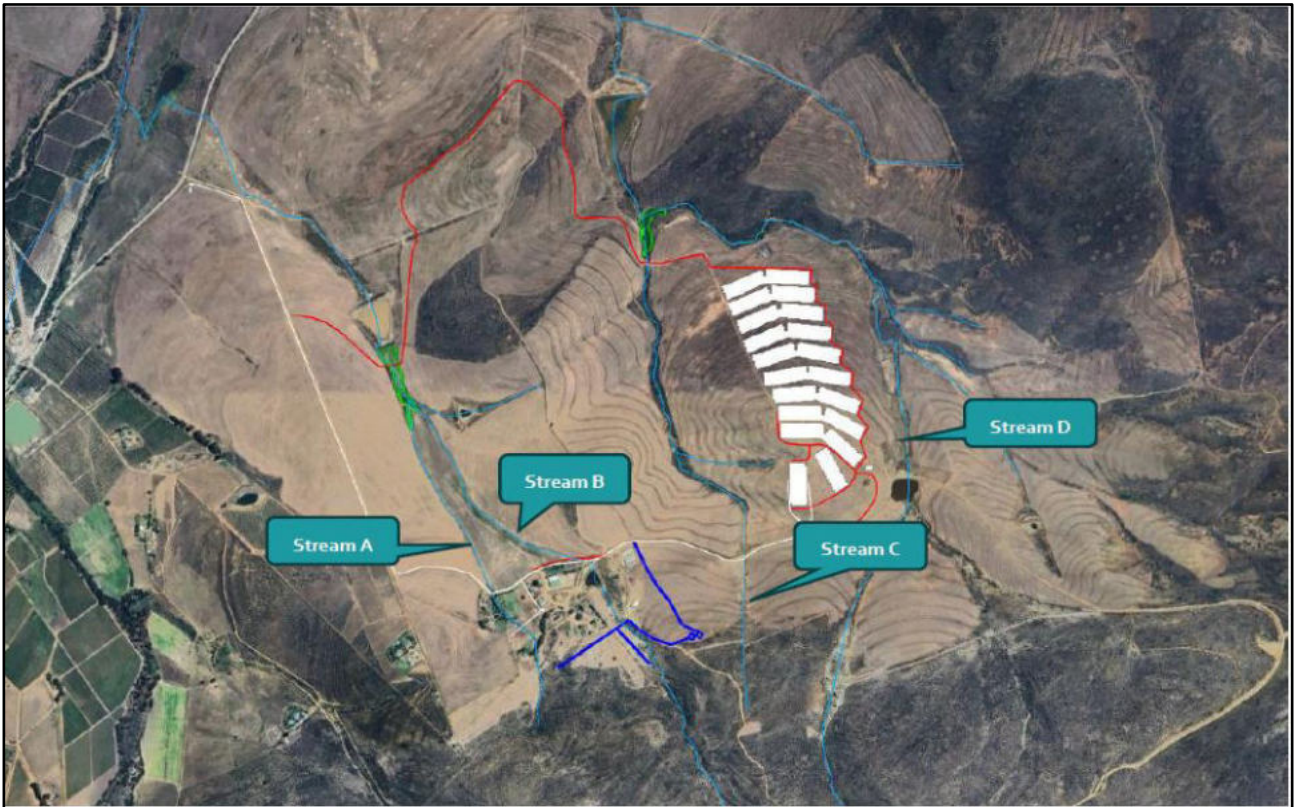
**Figure 16: The project site with the proposed new roads (red lines), the broiler area (white polygons) as well as the affected streams (blue lines) with their associated wetland areas (green polygons) (Everlast Freshwater Consulting Services, October 2025).**

The upper reaches of these streams remain largely in a natural state; however, their condition deteriorates to varying degrees (moderately to seriously modified) upon entering farmed areas. In these sections, several historic impacts have been observed, including vegetation removal, agricultural encroachment into riparian zones, the construction of instream dams, and artificial canalisation, particularly in Streams A and B. Both of these converged stream systems terminate in large farm dams shortly before reaching the Ratel River.

A large portion of the Streams A and B system likely historically comprised an unchanneled valley bottom wetland. However, this area has been so extensively modified that it has lost all ecological function. Only a small remnant of the wetland remains at the confluence of the two streams. In contrast, Streams C and D have been the least impacted, with large sections still ranging from largely natural to moderately modified in condition.

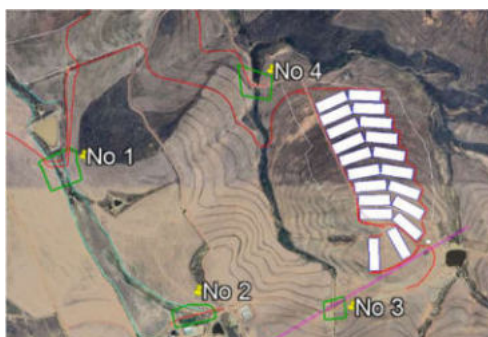
Figure 1: Waterway crossing positions

The farm Kleinfontein is being developed, and vehicular access roads is required to accommodate heavy vehicles travelling to and from a chicken production facility. The road alignment requires 4 waterway crossings as indicated in figure 1. In the figure markings No 1, 3 and 4 indicate low waterway bridges and marking no 2 indicate a suspended bridge structure. Addendum A include detail drawings of the proposed structures.

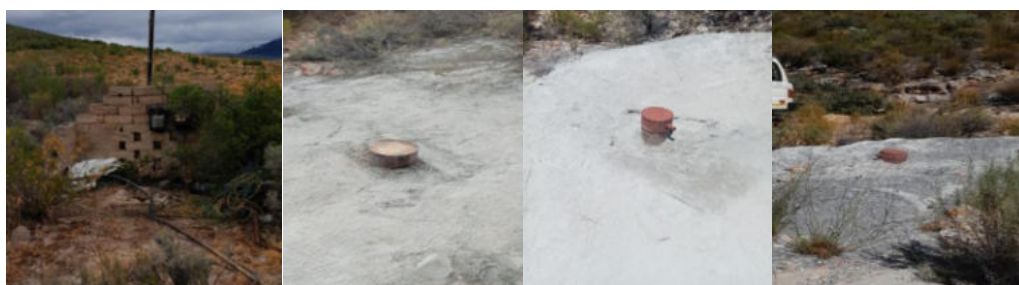
Figure 1: KF\_BH1, KF\_BH2, KF\_BH3 and KF\_BH4, respectively (from left to right).

Borehole	Latitude (DD, WGS84)	Longitude (DD, WGS84)	Depth (m)
KF_BH1	-33.922230°	19.385410°	96.94
KF_BH2	-33.922080°	19.388520°	163.00
KF_BH3	-33.923882°	19.393724°	206.00
KF_BH4	-33.923930°	19.394008°	90.30

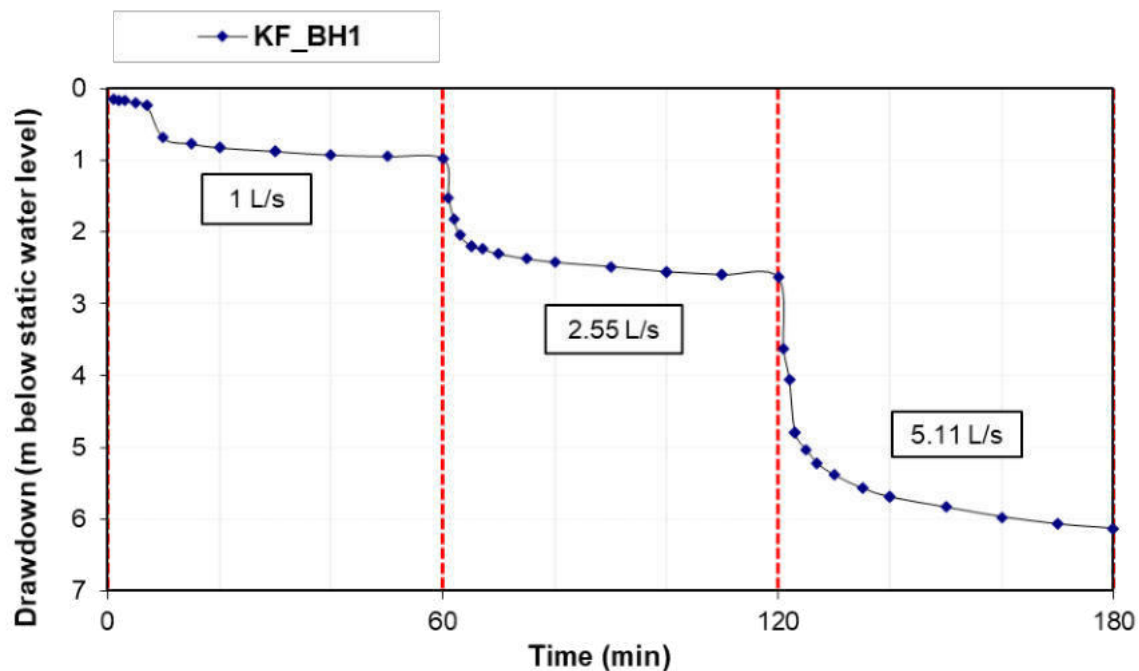
During the Step Test, the water level was drawn down 6.13 meters below the rest water level to 29.10 mbgl during the 3rd step at a rate of 5.11 L/s (18 396 L/hour, pump max due to borehole inner diameter). **Figure 2** shows the time-series drawdown for the Step Test.

Figure 2: Step Test drawdown data for KF\_BH1.

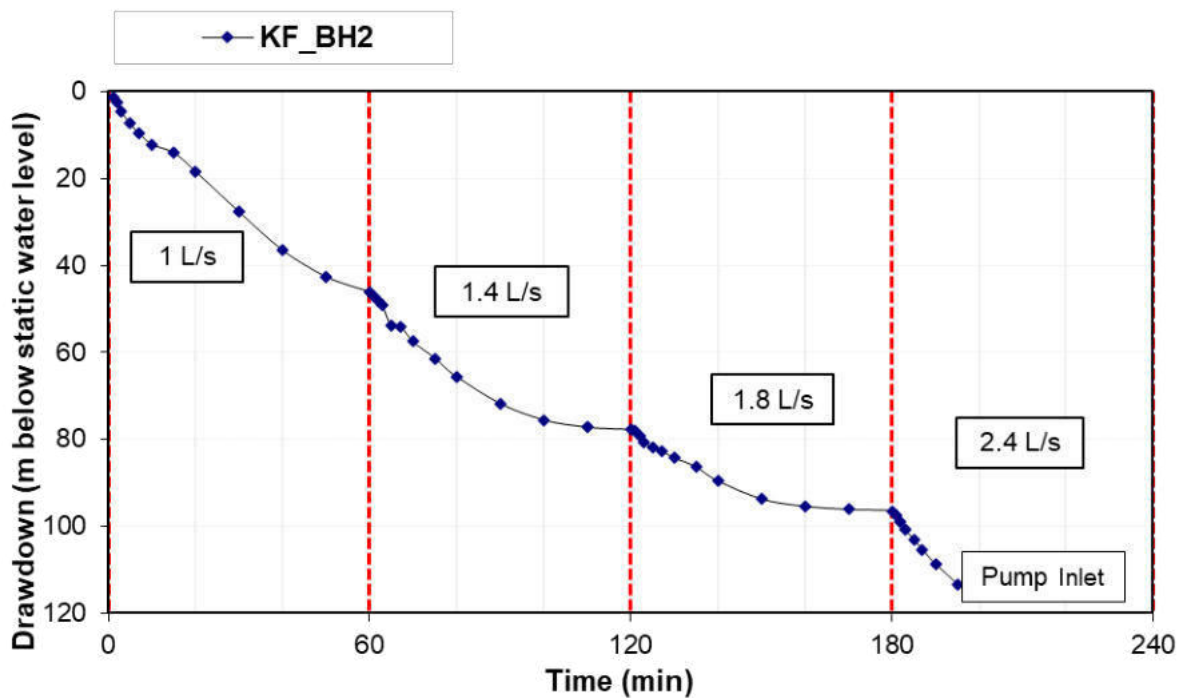
During the Step Test, the water level was drawn down 113.32 meters below the rest water level (pump inlet) during the 4<sup>th</sup> step at a rate of 2.4 L/s (8 640 L/hour). **Figure 5** shows the time-series drawdown for the Step Test.

Figure 5: Step Test drawdown data for KF\_BH2.

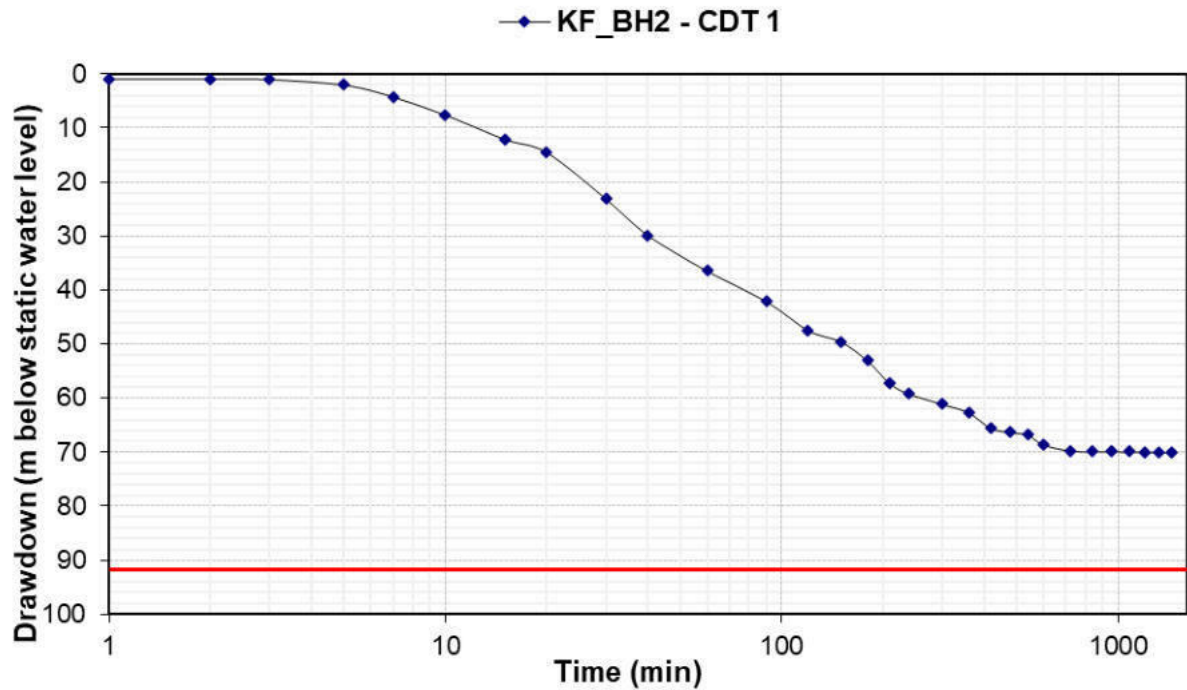
The semi-log plot of the drawdown from the CDT is presented in **Figure 6**. The available drawdown (AD) is indicated with the horizontal red line at 92.10 m

Figure 6: Semi-Log Plot of drawdown during the CDT of KF\_BH2 (1.5 L/s).

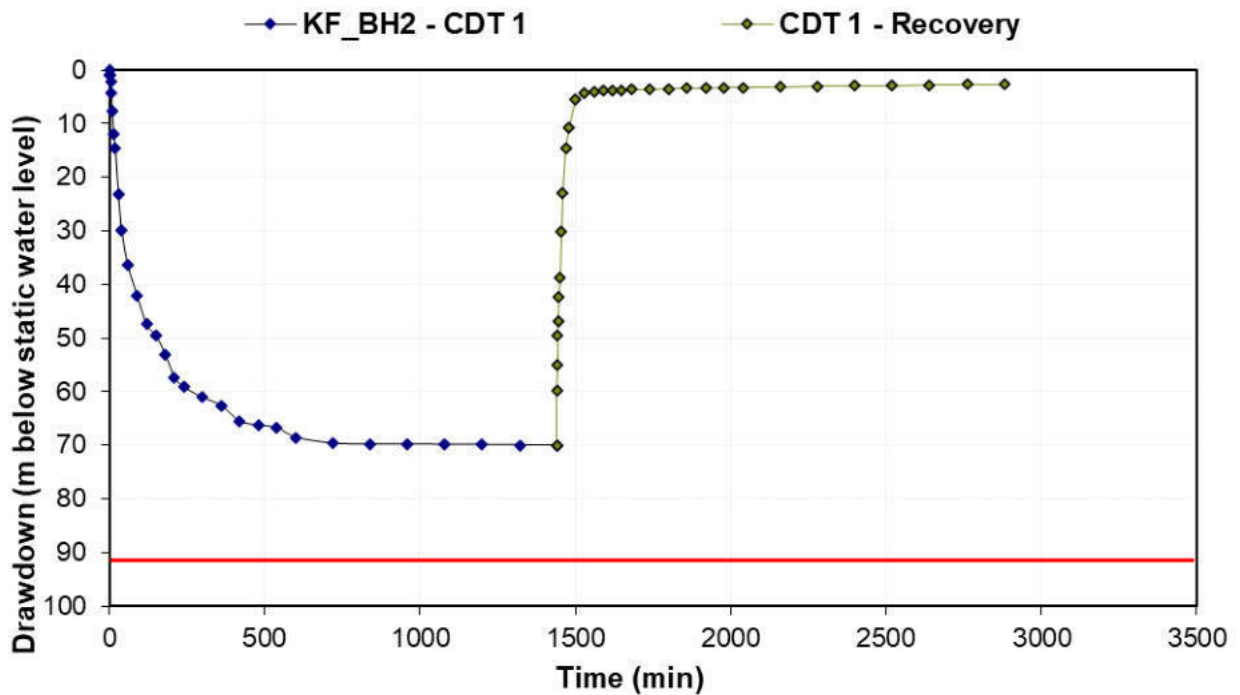
The recovery of the water level was monitored after the CDT and is presented in **Figure 7**. The recovery was good, reaching 96.2% in 24 hours. Monitoring will be essential to determine the long-term recovery of the borehole.

Figure 7: Time-series drawdown and recovery for KF\_BH2 (1.5 L/s).

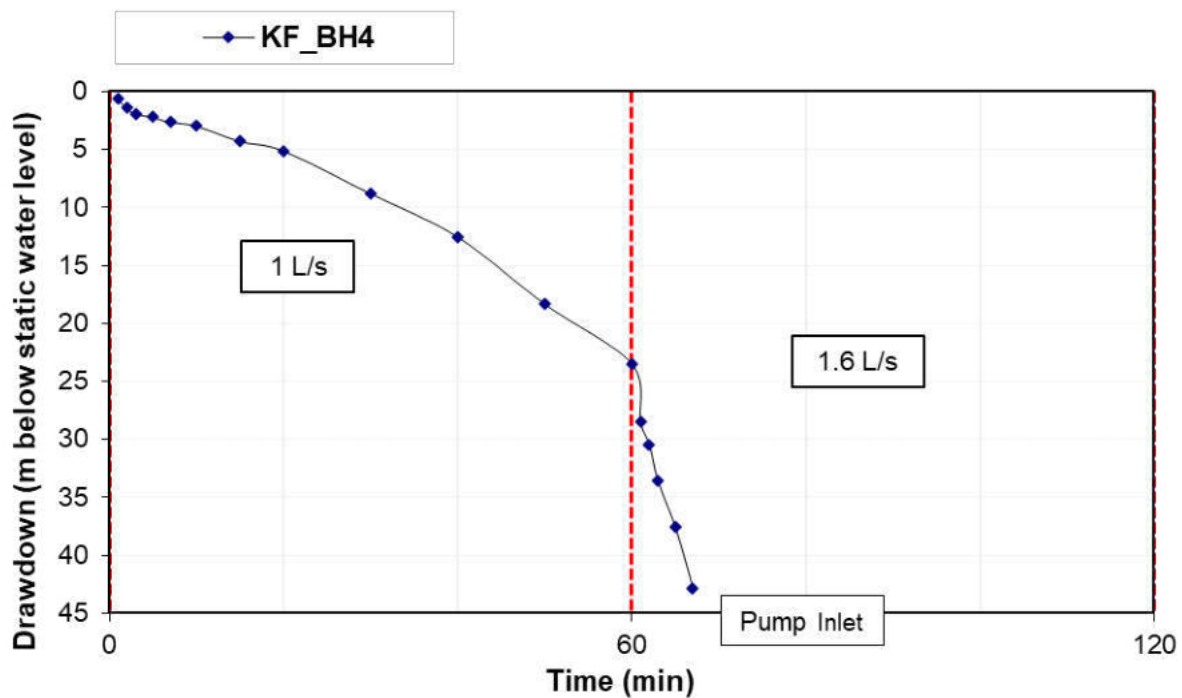
During the Step Test it was determined that the yield of the borehole is considered insufficient. Accordingly continued monitoring and further CDT testing of the borehole was abandoned. This use of this borehole is not recommended due to insufficient yield.

Figure 9: Step Test drawdown data for KF\_BH4.

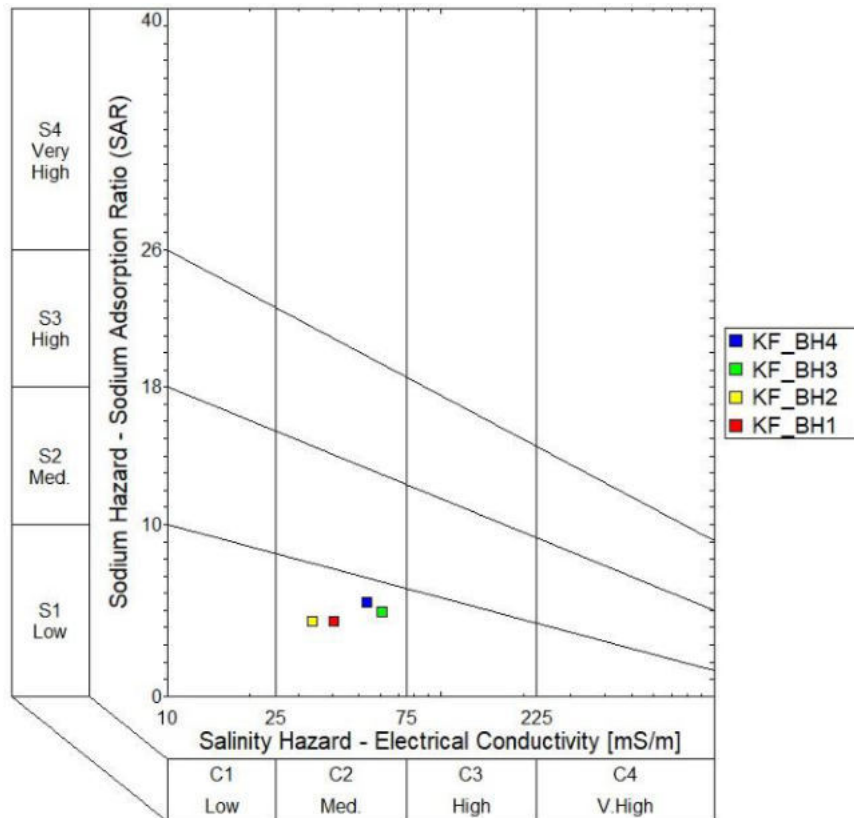
Figure 12: SAR diagram of the groundwater samples.

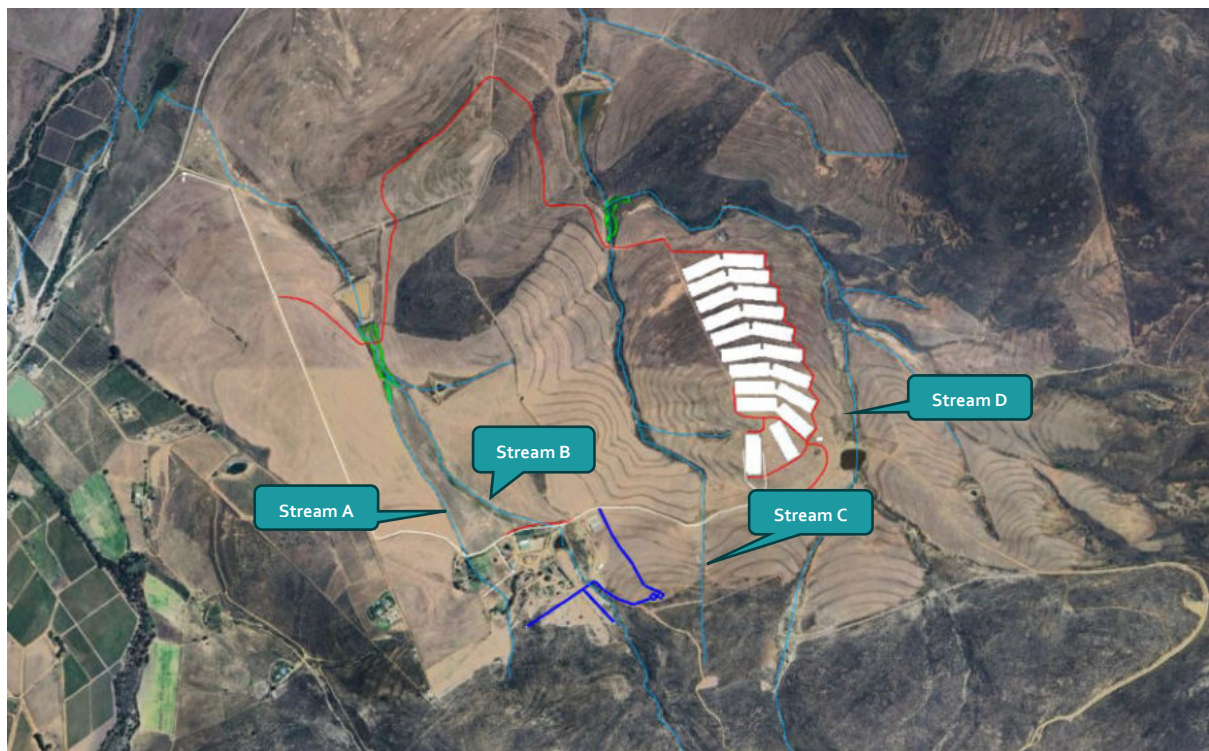
**Figure 8: Satellite imagery indicating the project site with the proposed new roads (red lines), the broiler area (white polygons) as well as the affected streams (blue lines) with their associated wetland areas (green polygons).**
