Routine Water Quality Monitoring Report Steenberg Golf Club

Prepared for: Mr Marius Aker – Estate Manager
Contact Details: Steenberg Estate, Tokai Road, 7945, Cape Town
Date: June 2025

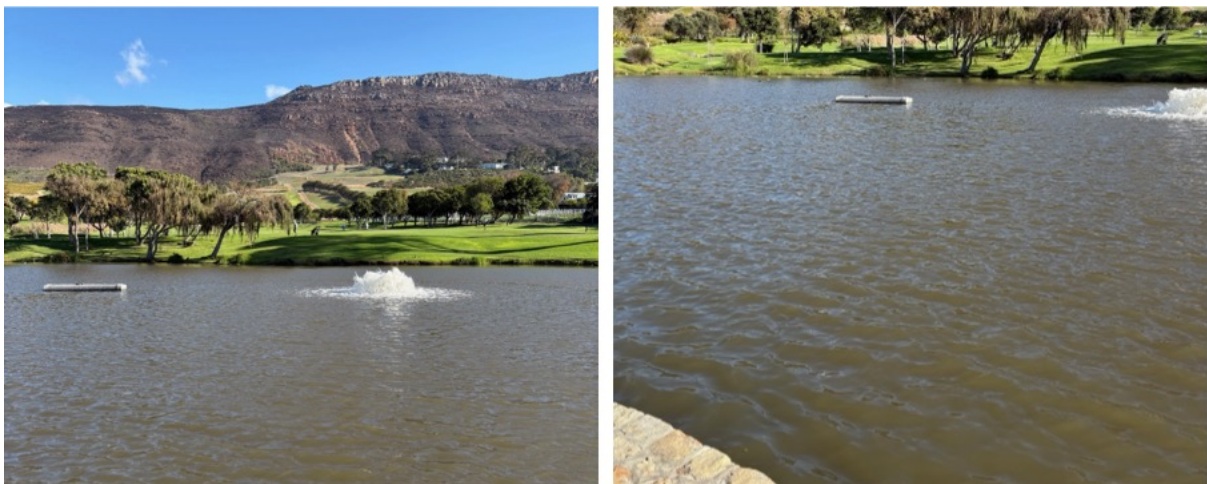
A sample was taken from the main irrigation dam on the left of the 18th tee and from the green surrounding the 7th green on 5 June 2025. The main irrigation dam was full and water was overflowing over the weir. The samples (500 ml) were placed in autoclaved glass bottles and transported to the laboratory for immediate analysis of microbiology and basic chemistry, while samples for ion chromatography for filtered and refrigerated.

Figure 1: Image showing the water level in the main irrigation dam at the time of sampling
