SETBACK LINE STUDY FOR ERF 134 CAPE INFANTA

DRAFT REPORT SUBMITTED FOR COMMENT TO

Doug Jeffery Environmental Consultants (Pty) Ltd, (6 August 2012)

Author : GEOFF. TOMS (Consultant)

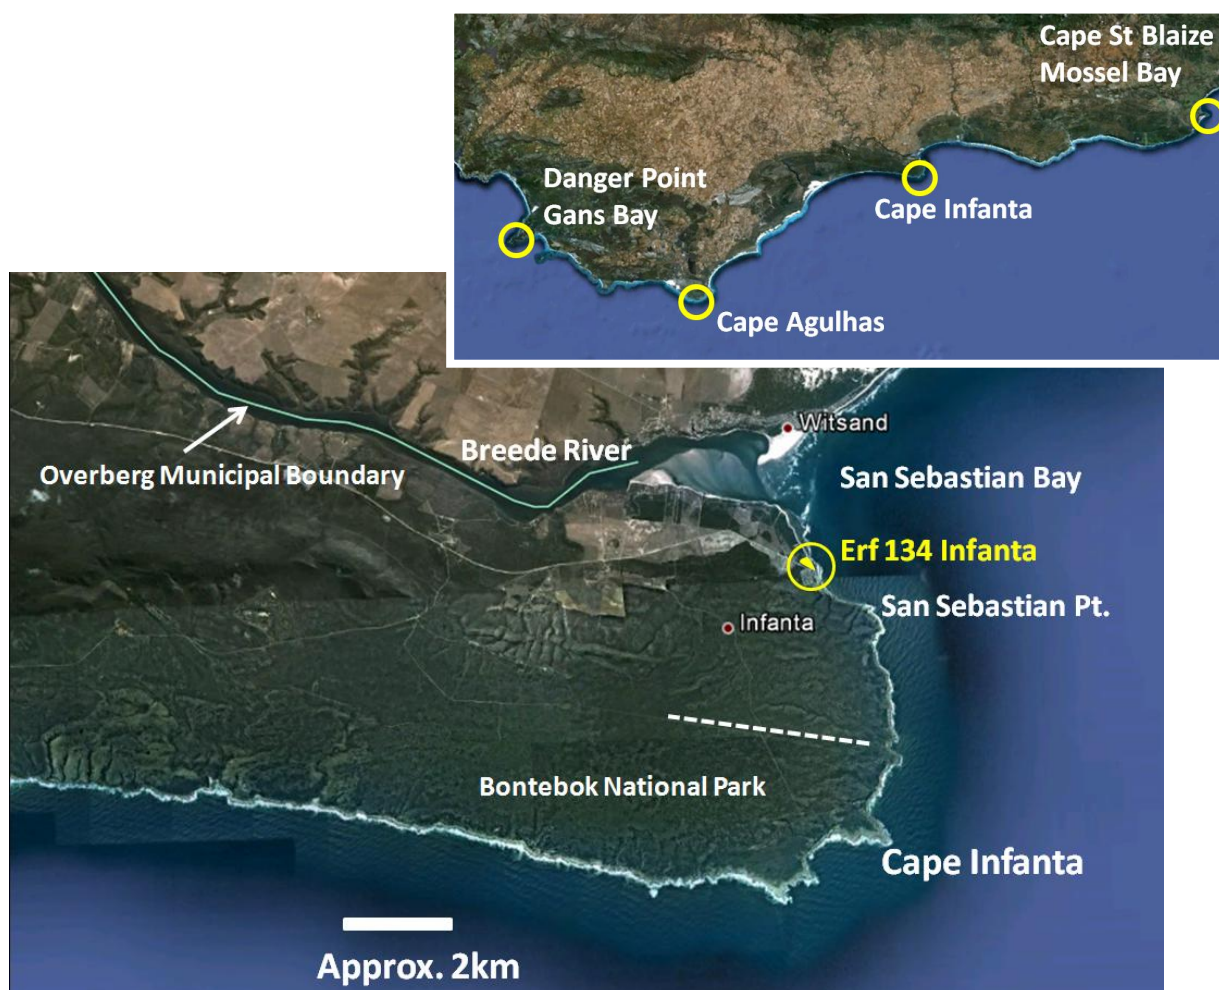
Figure 1 : Location of Infanta and Erf 134

Erf134, located in Infanta, about 8 km east of Cape Infanta, lies on a unique portion of the Cape coast between San Sebastian Point and the Breede River estuary mouth (Figure 1). The Breede River mouth is wide and exhibits a sandbar which protrudes from the Witsand shoreline across most of the mouth of the river as it meanders to sea. In contrast with this mobile and dynamic river mouth area, Cape Infanta and San Sebastian Point provide rocky headlands which shelter a relatively hard and stable shoreline near Infanta.

There are no apparent sediment pathway issues overland which will be disturbed by the development of Erf134. Referring to Figure 1, the plot is located in the lee of Cape Infanta and is not part of a mobile sandy passage of sediment. The examination of aerial photographs from 1943 in PBNS (2010) showed no evidence of sediment pathways in the area prior to development.

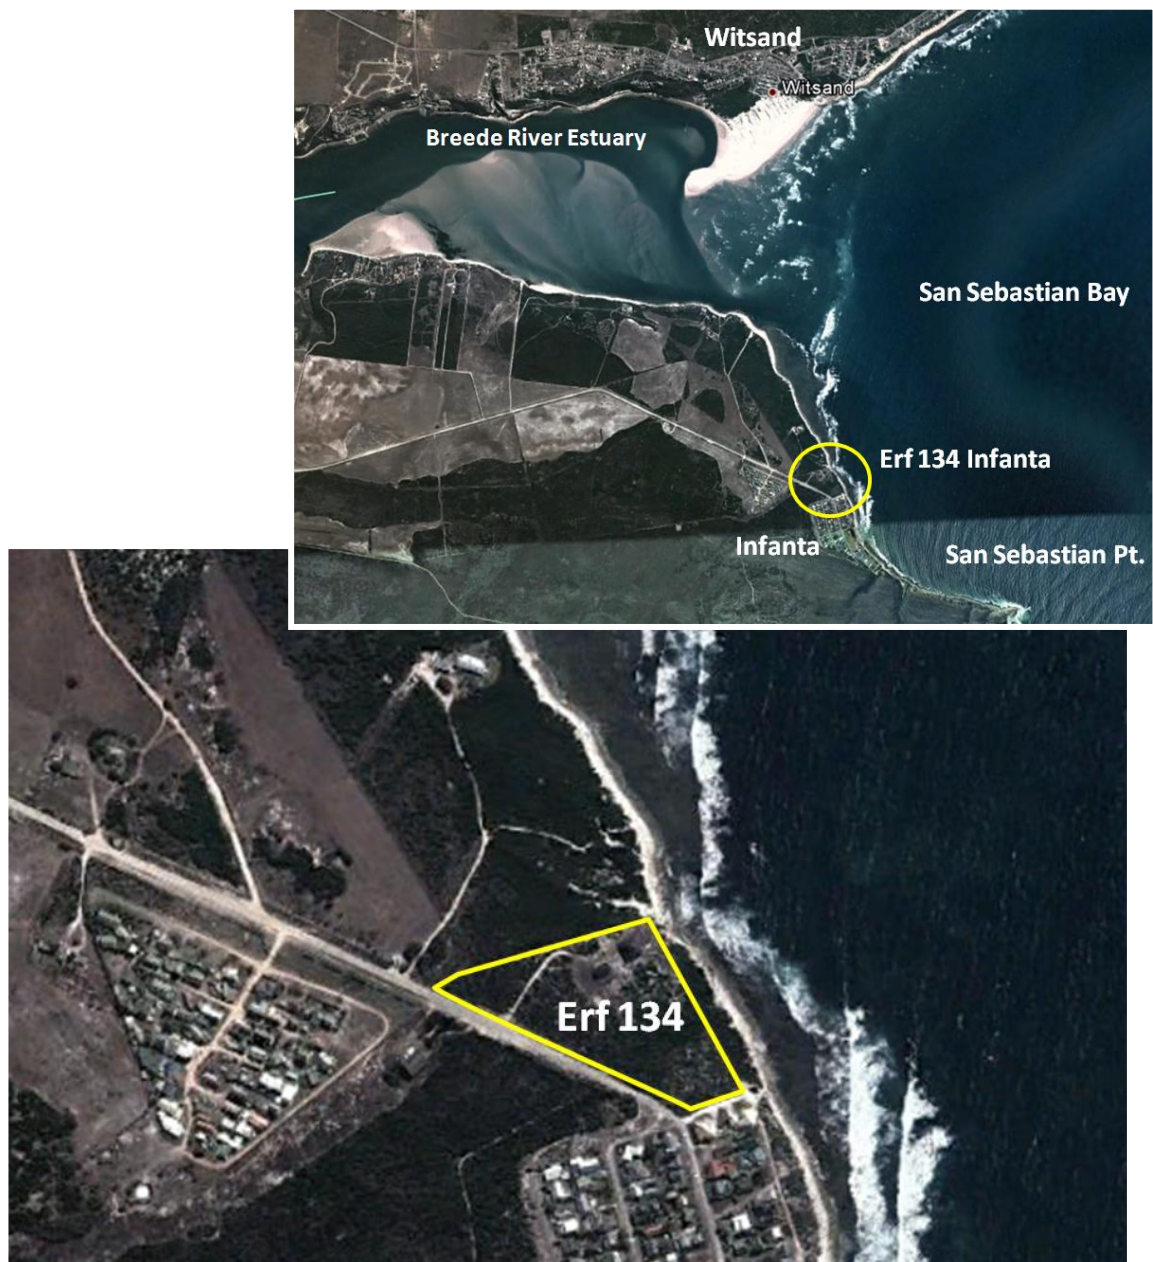
Figure 2 : Erf 134 at Infanta – coastal portion

Erf 134 is 85 hectares and is located just north of developed residential areas at Infanta. The Erf lies about 1km south of the mobile estuary area with its seaward boundary bordering the rocky shoreline (Figure 2). The property is traversed by the main access road into Infanta Village (north west to south east direction). The portion lying east of the main road is the subject of a planning application for a proposed development.

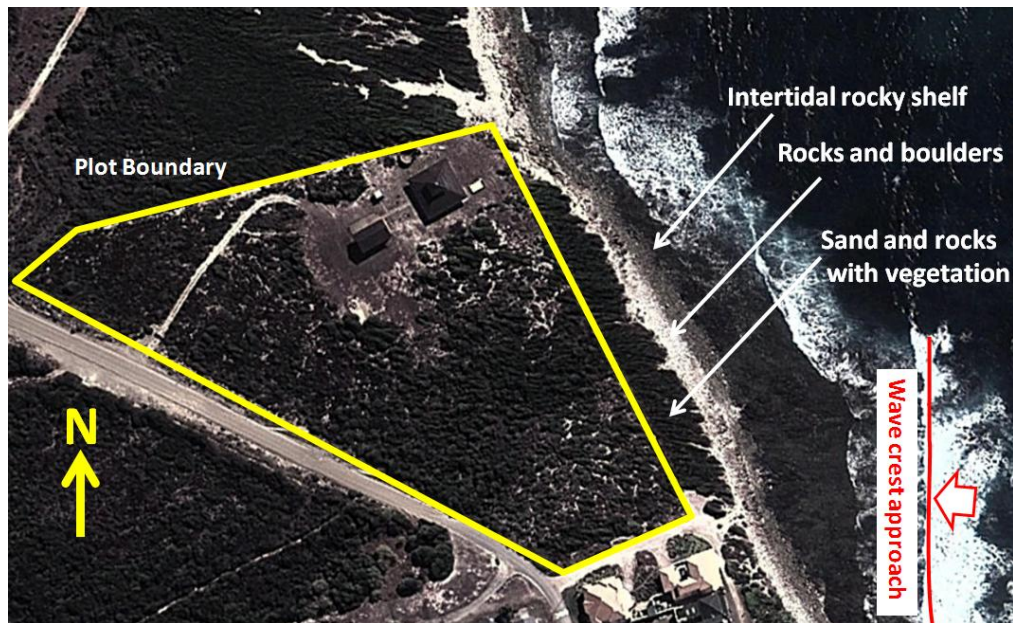
Figure 3a : Erf 134 showing angular wave crest approach and wide rocky intertidal area with vegetation seaward of the plot boundary

In Figures 3a and 3b the site and its seaward edge are shown in more detail. The site is enclosed within a wire fence. On its seaward (eastern) edge the fence is separated from the “vegetation line” (the seaward limit of survival of natural vegetation) by a distance of 20-25m in the south narrowing to almost nothing in the north (in front of the building shown in the Figure). Seaward of the vegetation

line is a small steep slope which falls to a rocky intertidal platform (exposed at low tide and flooded at high tide) which extends at least 50m seaward.

Swell waves approach this local portion of coast at a sharp angle and undergo significant breaking and dissipation of energy on the extensive shallow rocky area as shown in Figure 3b. Beach sand is absent being transported alongshore towards the estuary by the oblique wave attack or blown ashore by ESE onshore winds.

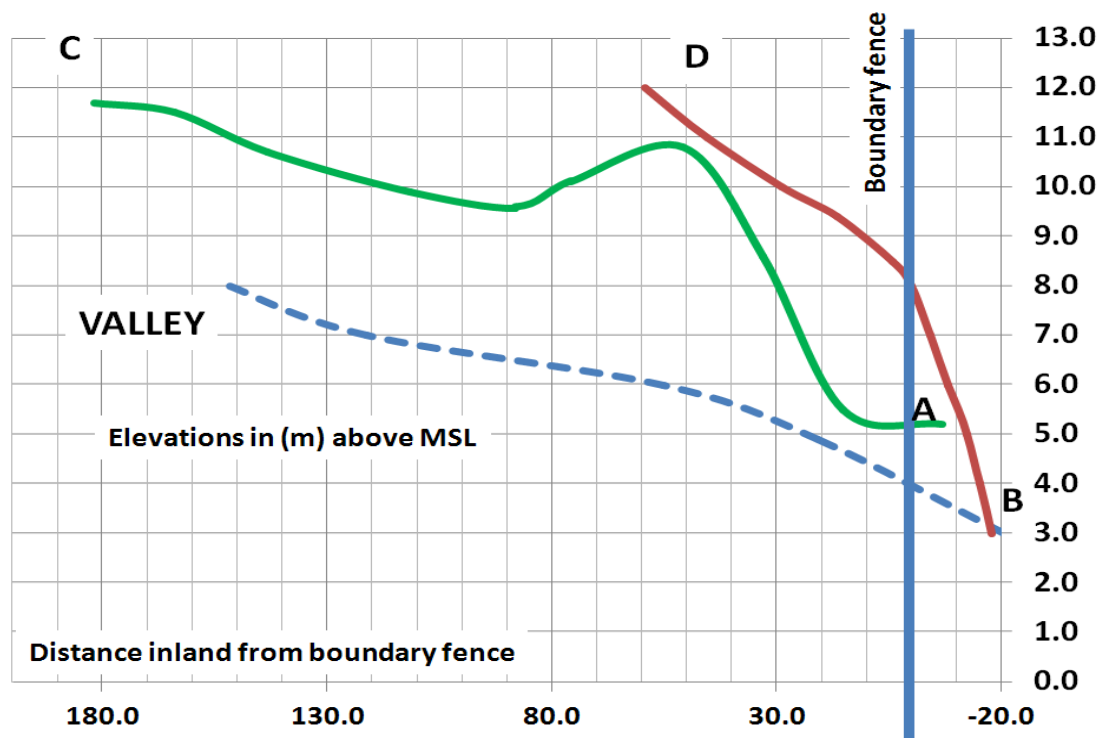
Figure 5 : Cross-section profiles in (m) above MSL (viewed from south with seaward side on the right of the boundary fence)

To assist in visualising the elevations across the site, Figure 5 shows a plot of the elevations along boundaries AC and BD and along the valley shown by the dotted line in Figure 4. The elevations along the seaward boundary are shown in Figure 6.

- The vegetation line coincides well with the +3m elevation contour
- The northern boundary of the plot is 3m lower than the southern boundary at the boundary fence
- There is a valley running through the plot from NE to SW with elevations 3 to 5m lower than the rest of the plot
- The effect of the valley can be seen at the seaward boundary where elevations drop to +4m above MSL (1m above the present vegetation line)

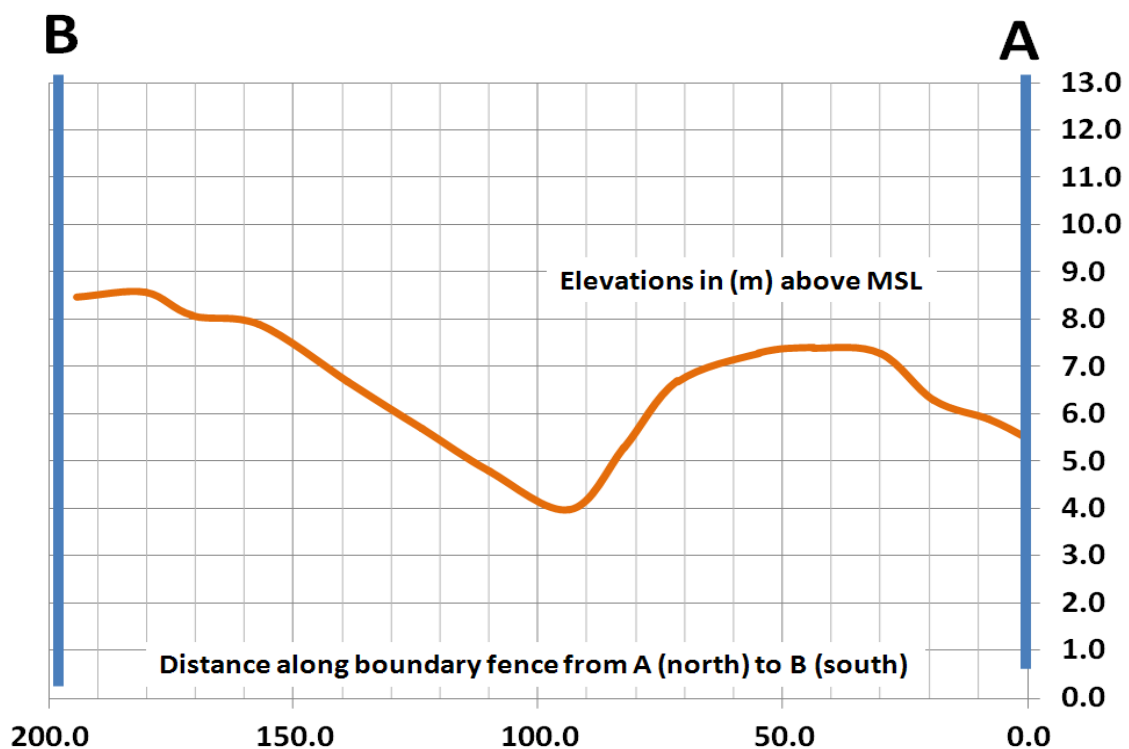
Figure 6 : Longshore profile along the seaward boundary fence in (m) above MSL (viewed from seaward side looking landward)

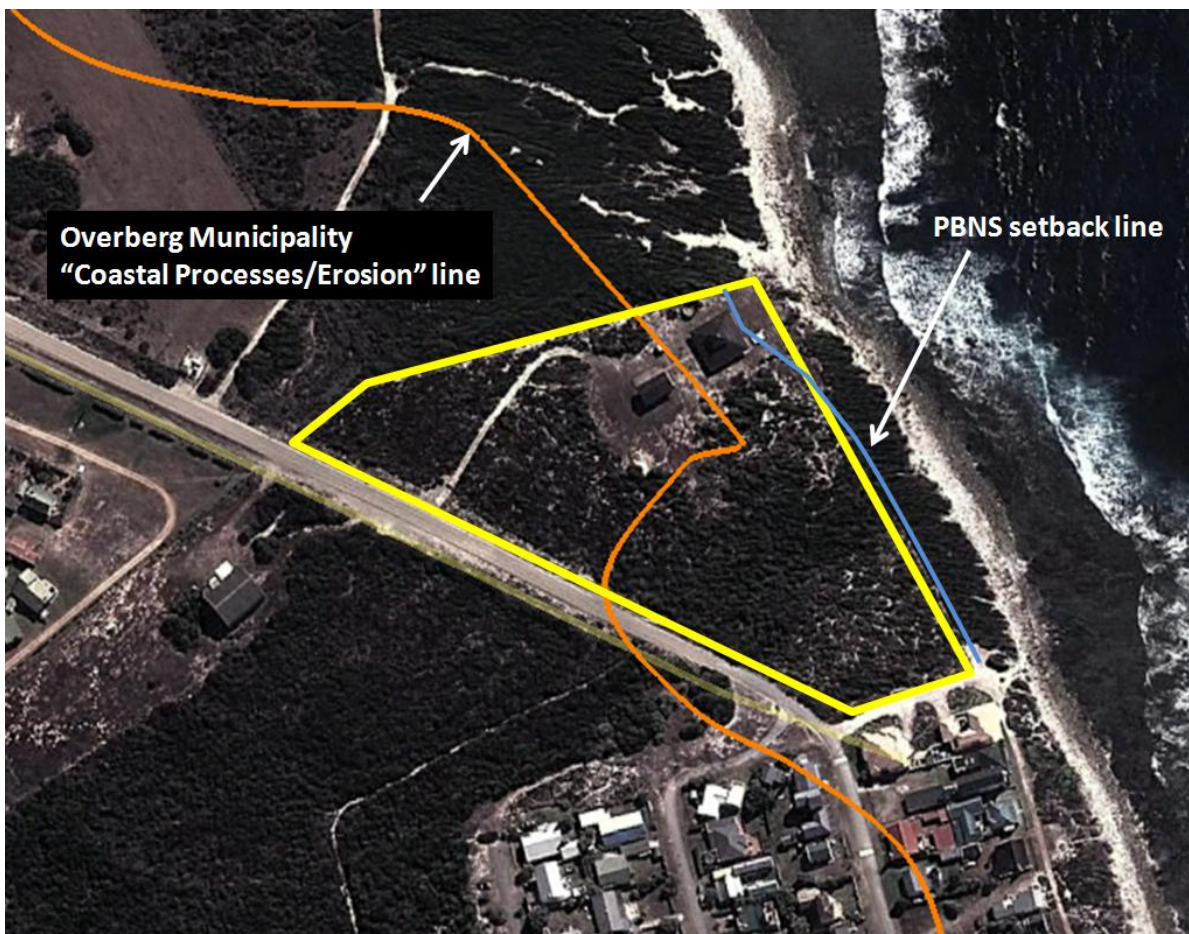
Figure 8 : Showing the Overberg Municipality setback line and the PBNS Setback Line superimposed onto Erf134.

The announced "Coastal Processes / Erosion Line" has been provided by Provincial and District Municipality Authorities but it is not clear what the present statutory or legal status of the line is at the time of writing and it is recommended that this is followed-up with DEA&DP as a matter of urgency. The line is shown in Figure 8.

Also shown on Figure 8 is the PBNS Setback Line which was provided in 2010 by PBNS in a report to DJEC. The PBNS setback line is based on an examination of marine conditions, historic aerial photography and a 25m buffer landward of the vegetation line (seaward limit of survival of land-base vegetation).

The discrepancy between the PBNS line and the Overberg Municipality Line is partly due to the new methodology and partly due to the inclusion of the “Other” factors listed above.

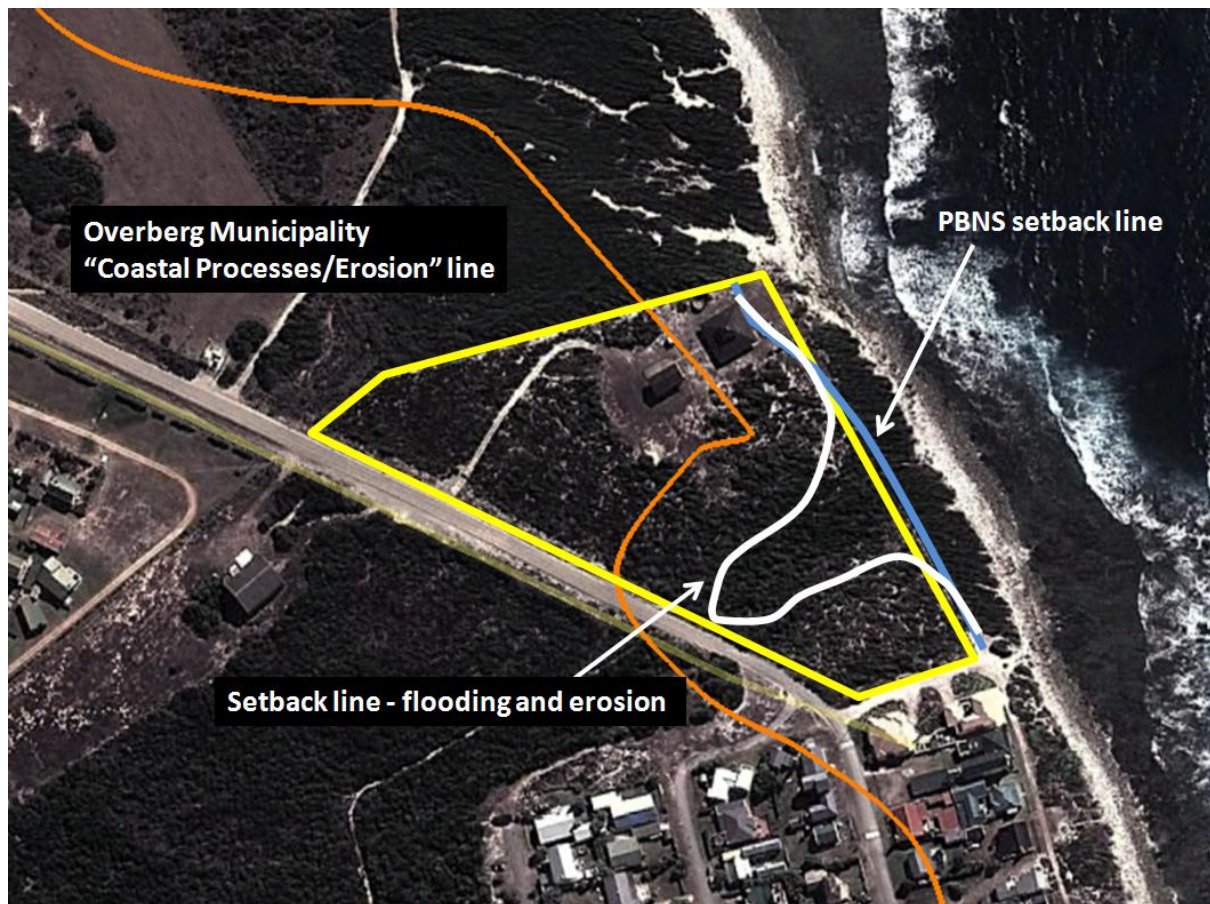
Figure 9 : Erf134 - Composite of setback lines including “Setback line – flooding and erosion”

Compared to the other setback lines this line (shown in white in Figure 9) makes allowance for the “valley” formation which traverses the site and lies between the PBNS and the Provincial lines. The proposed setback line merges at the plot boundaries with the PBNS line. Further there is agreement with the adjacent developed plots to the south which do not extend seaward of the +6m MSL land elevation contour with buildings at higher elevations (approx. +7m MSL).
