# VISUAL IMPACT ASSESSMENT

REDEVELOPMENT OF AN EXISTING RESIDENTIAL HOUSE AND NEW OUTBUILDINGS ON PORTION  
134 OF THE FARM 599; ROOIELS

PHS Consulting

**OCTOBER 2023**

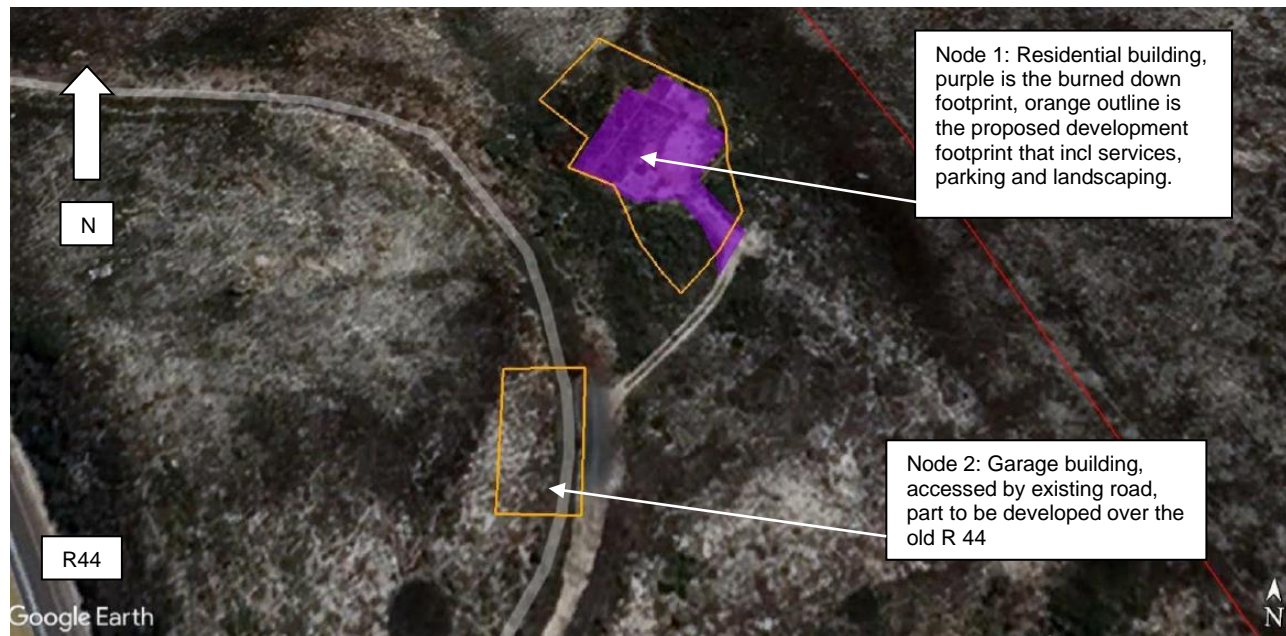
Figure 2: Proposed development nodes 1 & 2 (the site) outlined in orange (direct result of environmental specialist input into the NEMA process.)

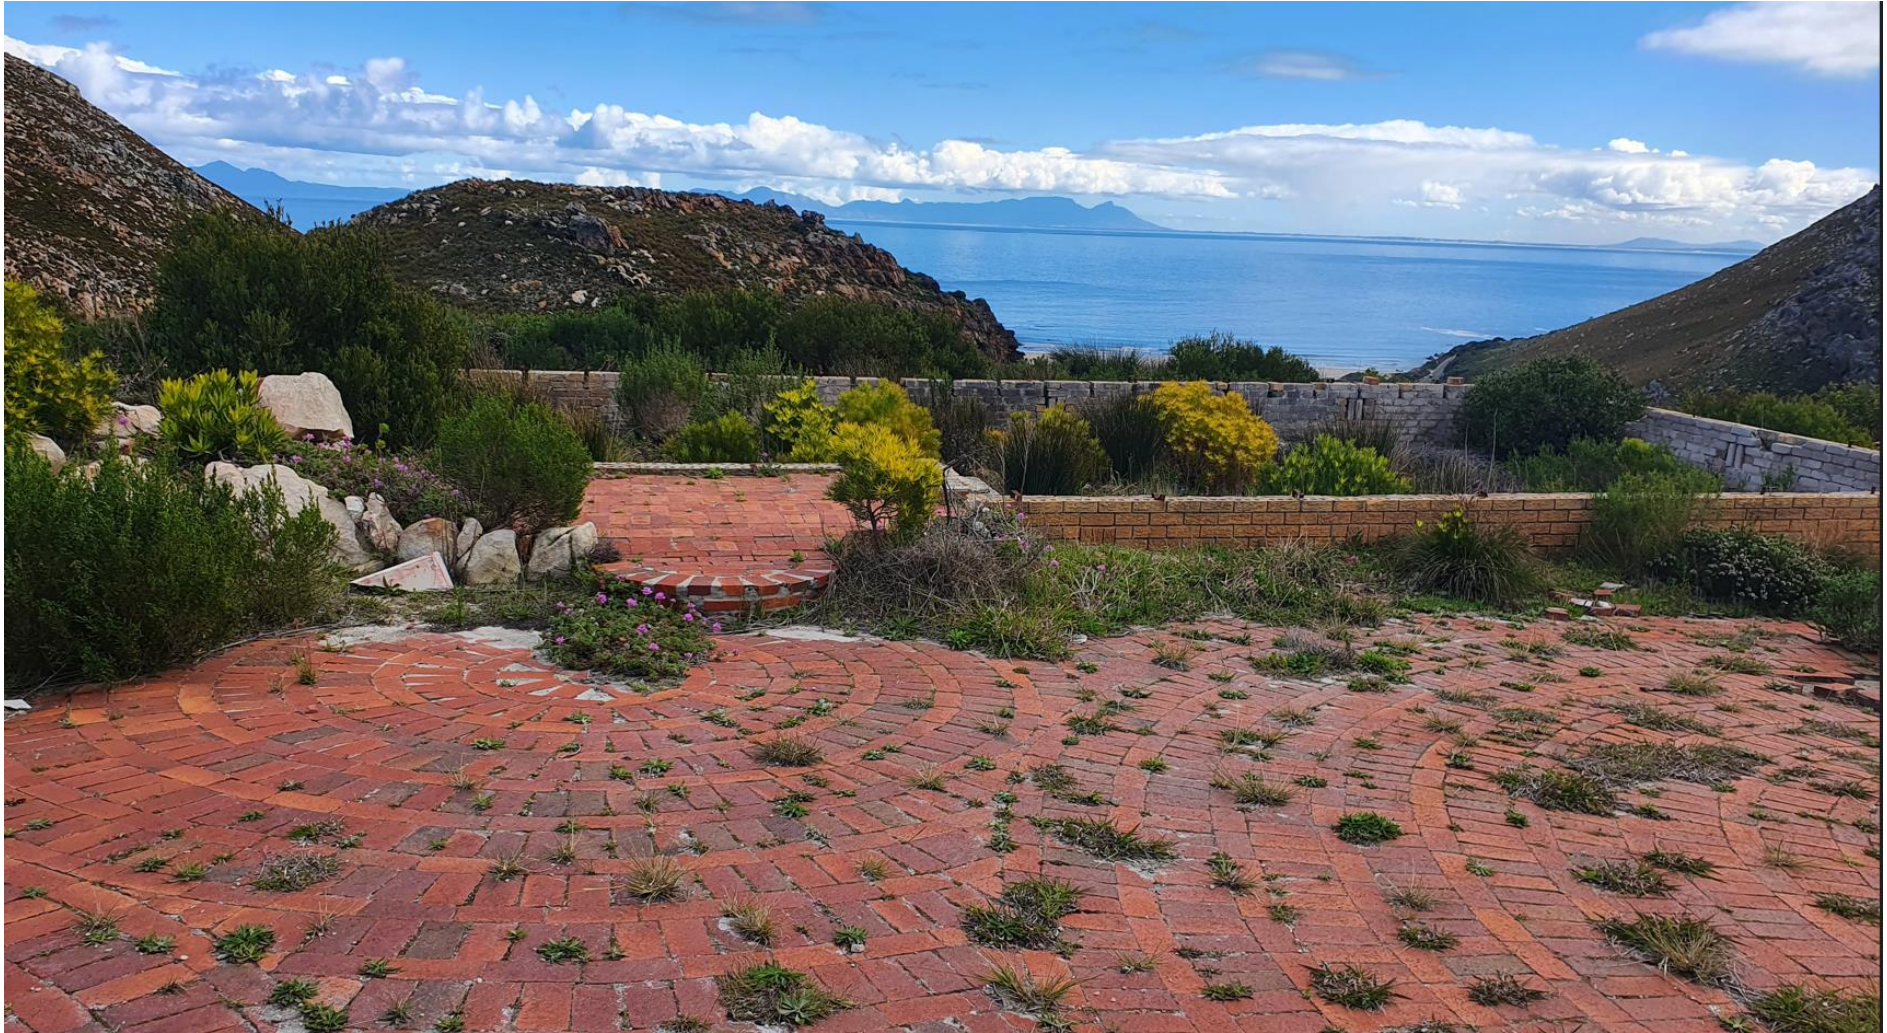
**Slide 1: The original development footprint (node 1).**

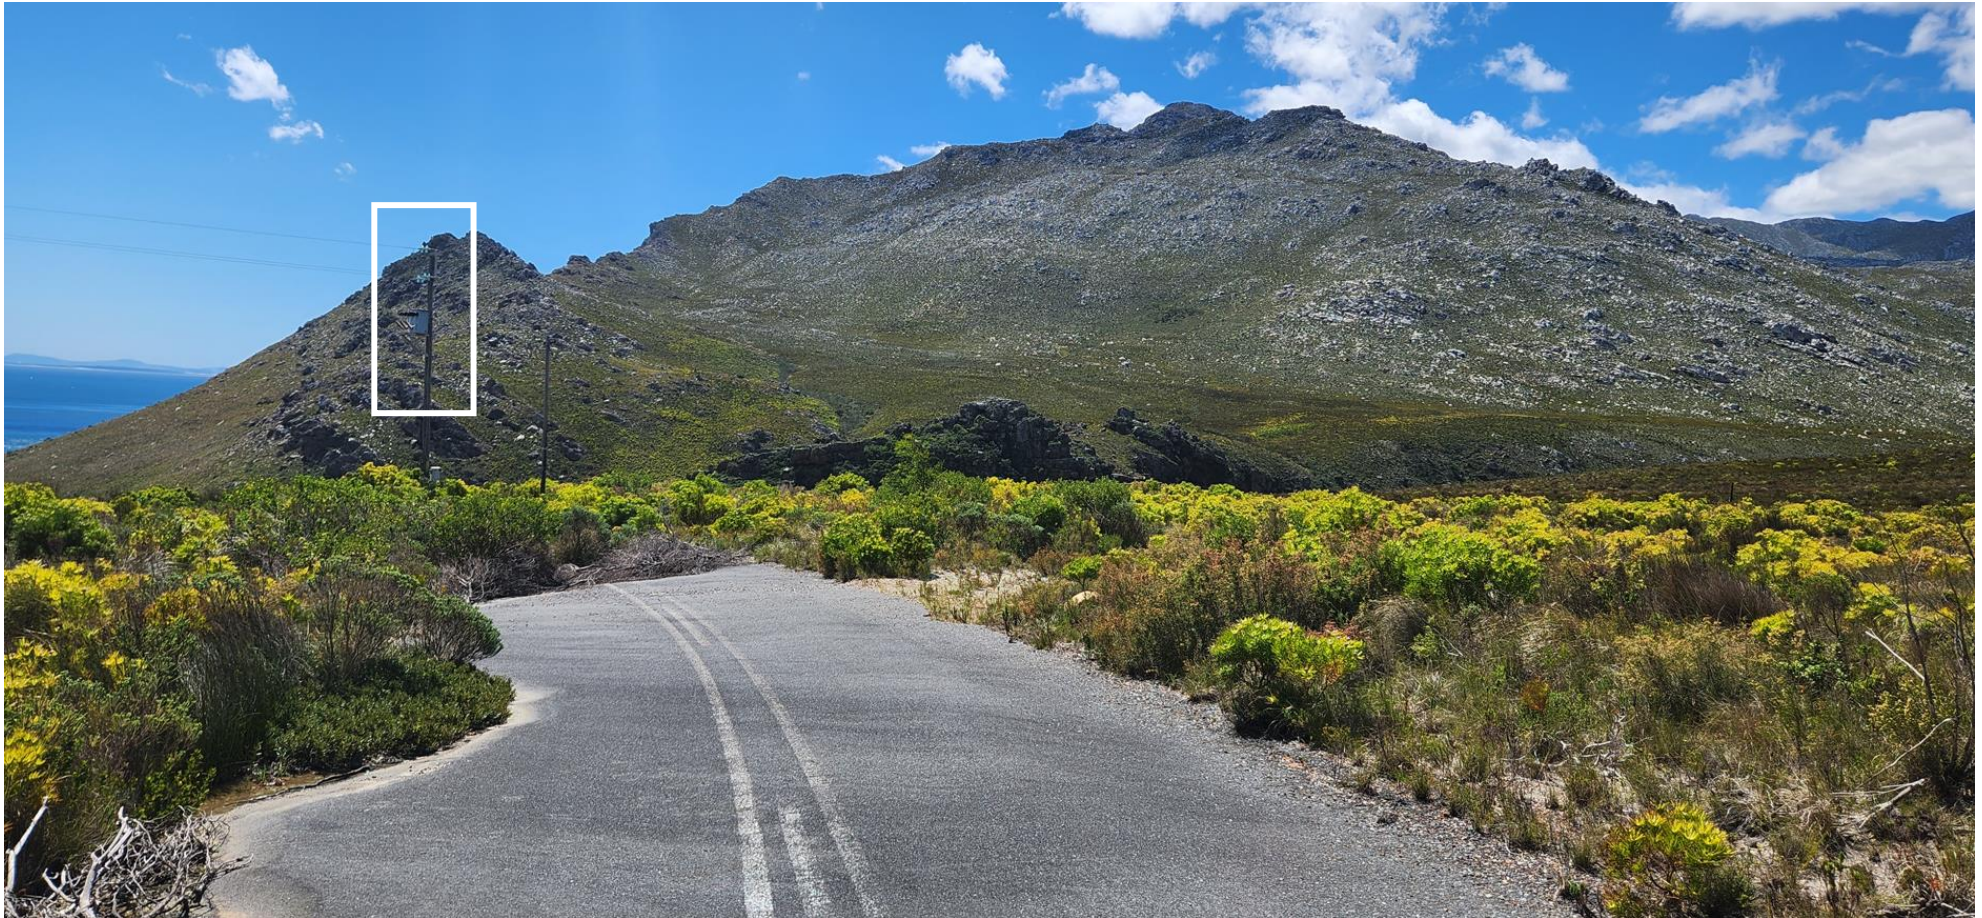
**Slide 2: The location of node 2, halfway on the old R 44 road towards the left. The existing Eskom pole (marked in white) is approx. 11 m high, the visibility of this pole from various vantage points will be relevant throughout this report, with specific reference under the photo section below. Note that the pole consists of a transformer box approx. 2 meters below the top and ceramic anchors on the top.**

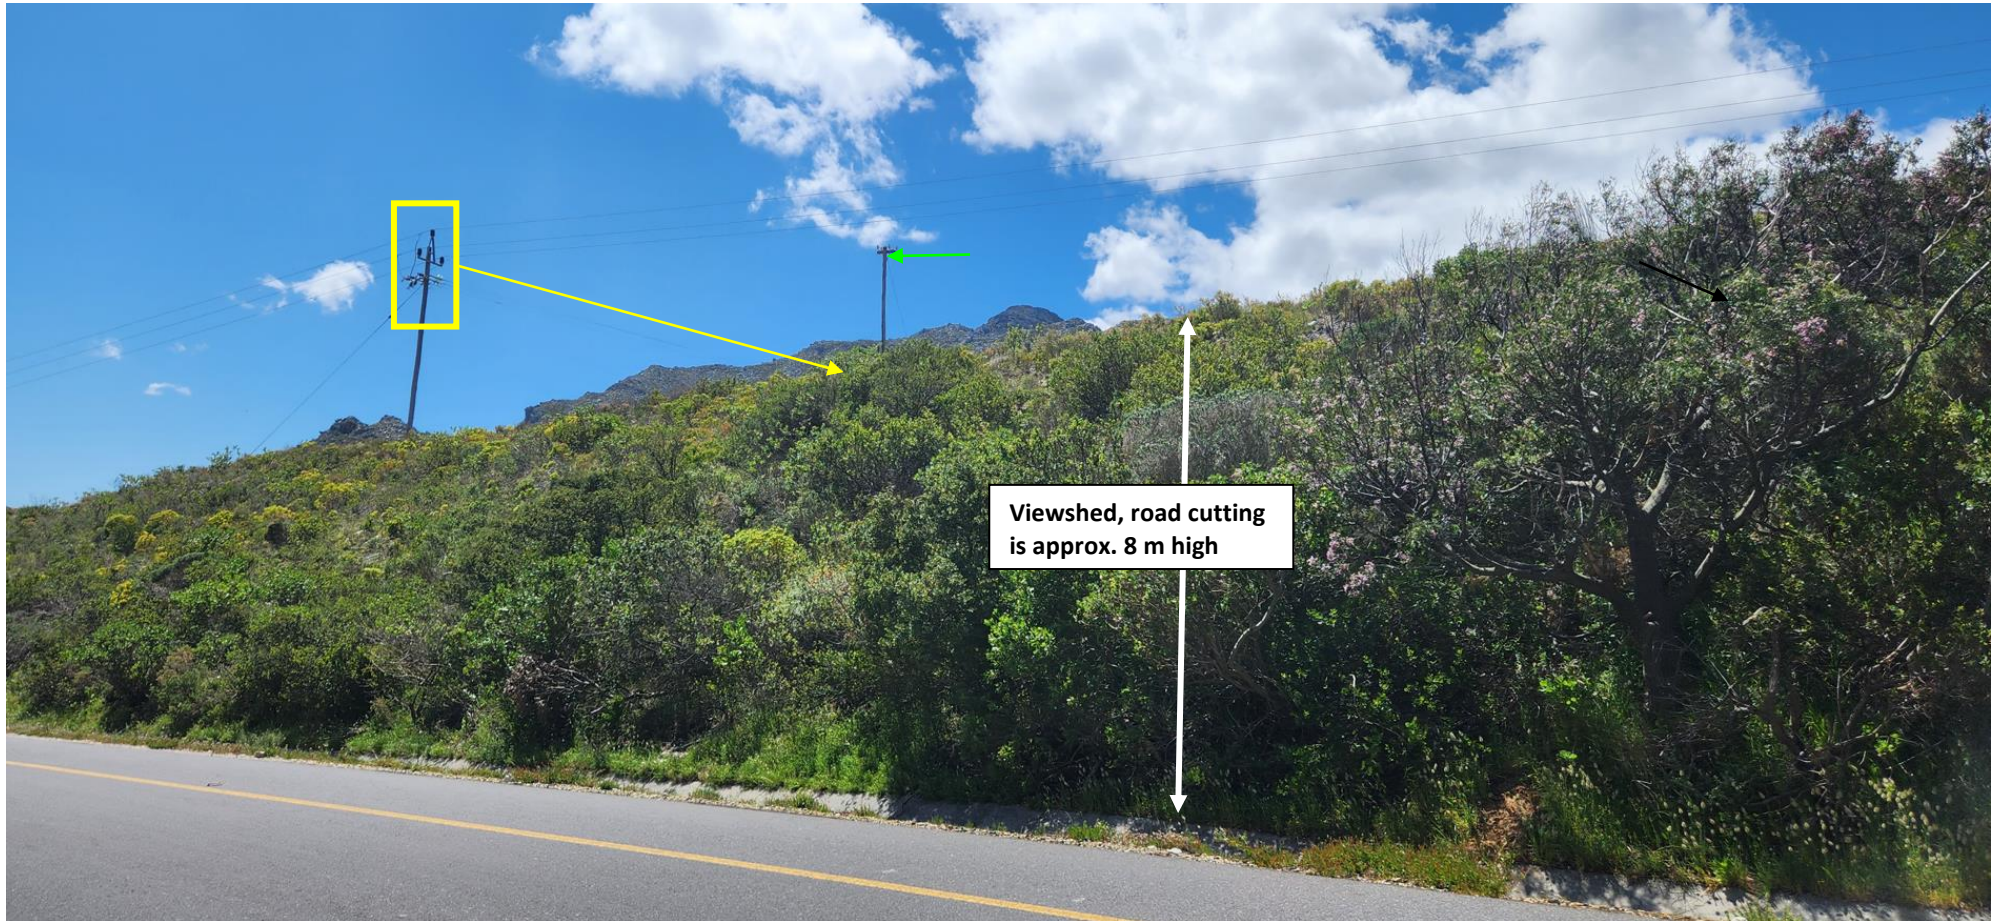
**Photo Position 3: View from the R44, photo taken right opposite the site, the road cutting, and vegetation is approx. 8 m high. Eskom power take-off to the site in yellow, direction and power line to site in yellow arrow clearly drops. The site is not visible and the 11m high Eskom pole on site is not visible either. The telephone pole marked with green arrow is not the power point on the site and doesn't have relevance to this report. Note how the mountain peaks in the background are hidden from this viewpoint.**

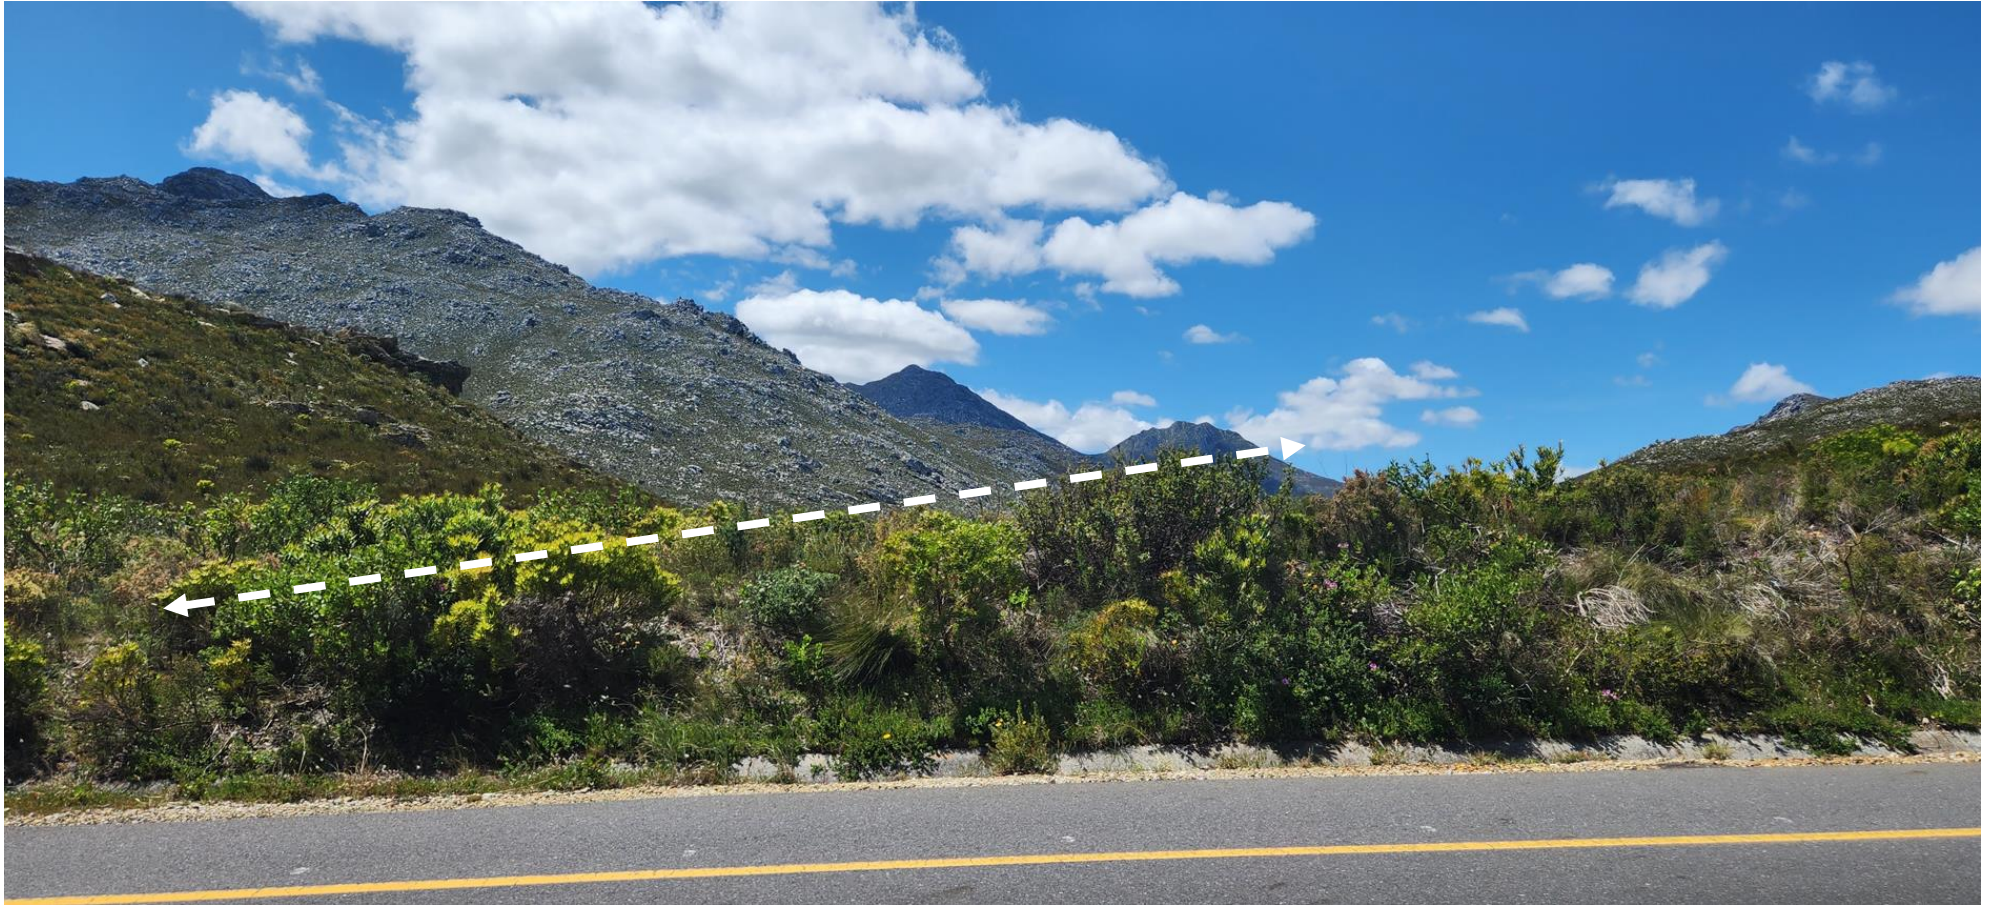
**Photo Position 4: View from the R 44 towards the east, the road verge cutting is now at its lowest. This is on the edge of the narrow view corridor 1, in this photo the Eskom power pole is not visible yet.**

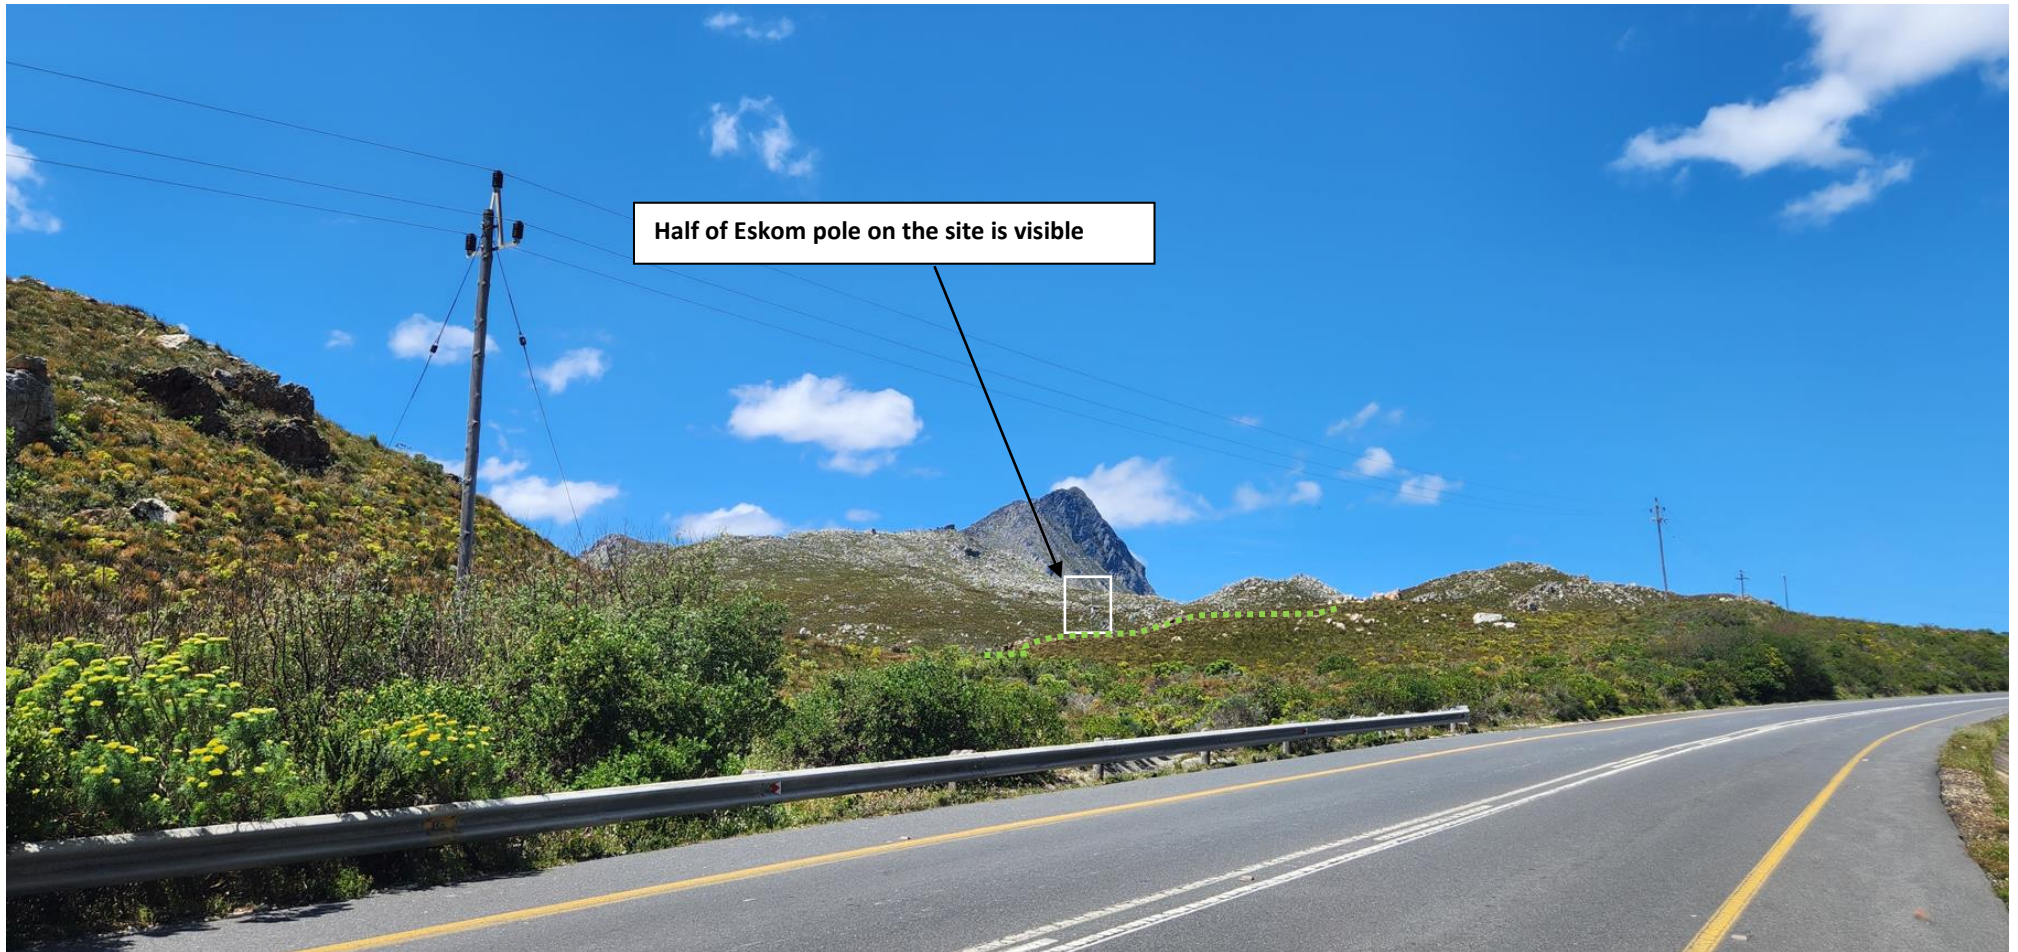
**Photo Position 5: Taken from the R44 towards the east, half of the Eskom pole is visible, due to a secondary viewshed above the old R 44. This photo is inside the view corridor number 1.**

- 1) View corridor 1 (blue); Photo 5, 11b & 12b:** The receptors are traveling at an average speed of 60 – 80 km/h, it's a combination of residents, tourist and business movement in the area. The current experience of road users traveling through Rooiels relate to large residences on the ridgeline and against the mountain slopes consisting of various shapes, sizes and colors resulting in a distinct pattern in the landscape, setting the tone for the receptors overall experience. The site can only be seen when traveling south on the R 44. The approx. distance the road user can possibly see the site is along a 100 m section on the R 44. In the photos it's clear that the site is identifiable when standing still on the side of the road but considering the road is only used for driving vehicles (no stop or viewpoint areas along this section) a view of the site is probably going to be lasting for few seconds. These receptors are driving at high speeds, the embankment is high and primarily shielding views of the site that were developed in the past. When the small window opens only the top part of the new infrastructure will be visible because the bottom part is hidden by a secondary viewshed. Considering all the houses in Rooiels area that have been observed in the landscape, these road users would not likely experience the proposed development as unusual in their view frame.

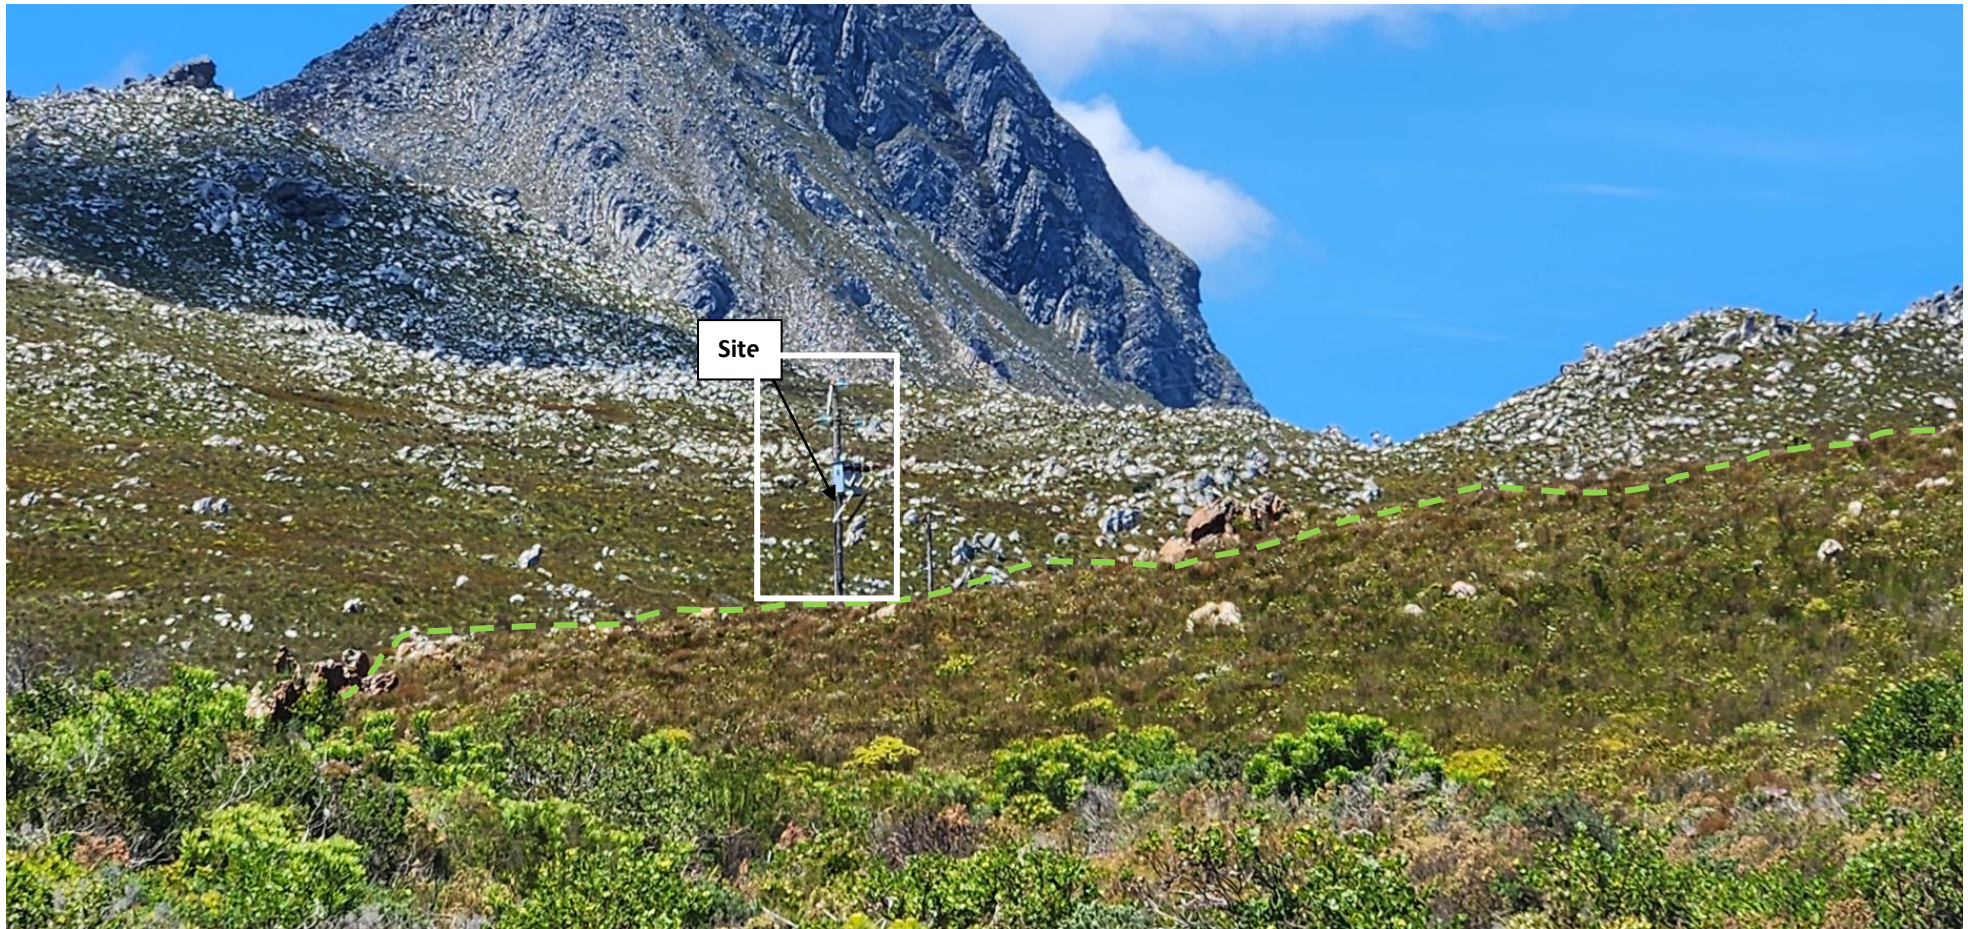
**Photo Position 5: Taken from R44, zoomed in from the same position than the previous photo. Half of the 11m Eskom pole is visible. The site is partly hidden behind secondary viewshed. Therefore 5.5 m is hidden.**

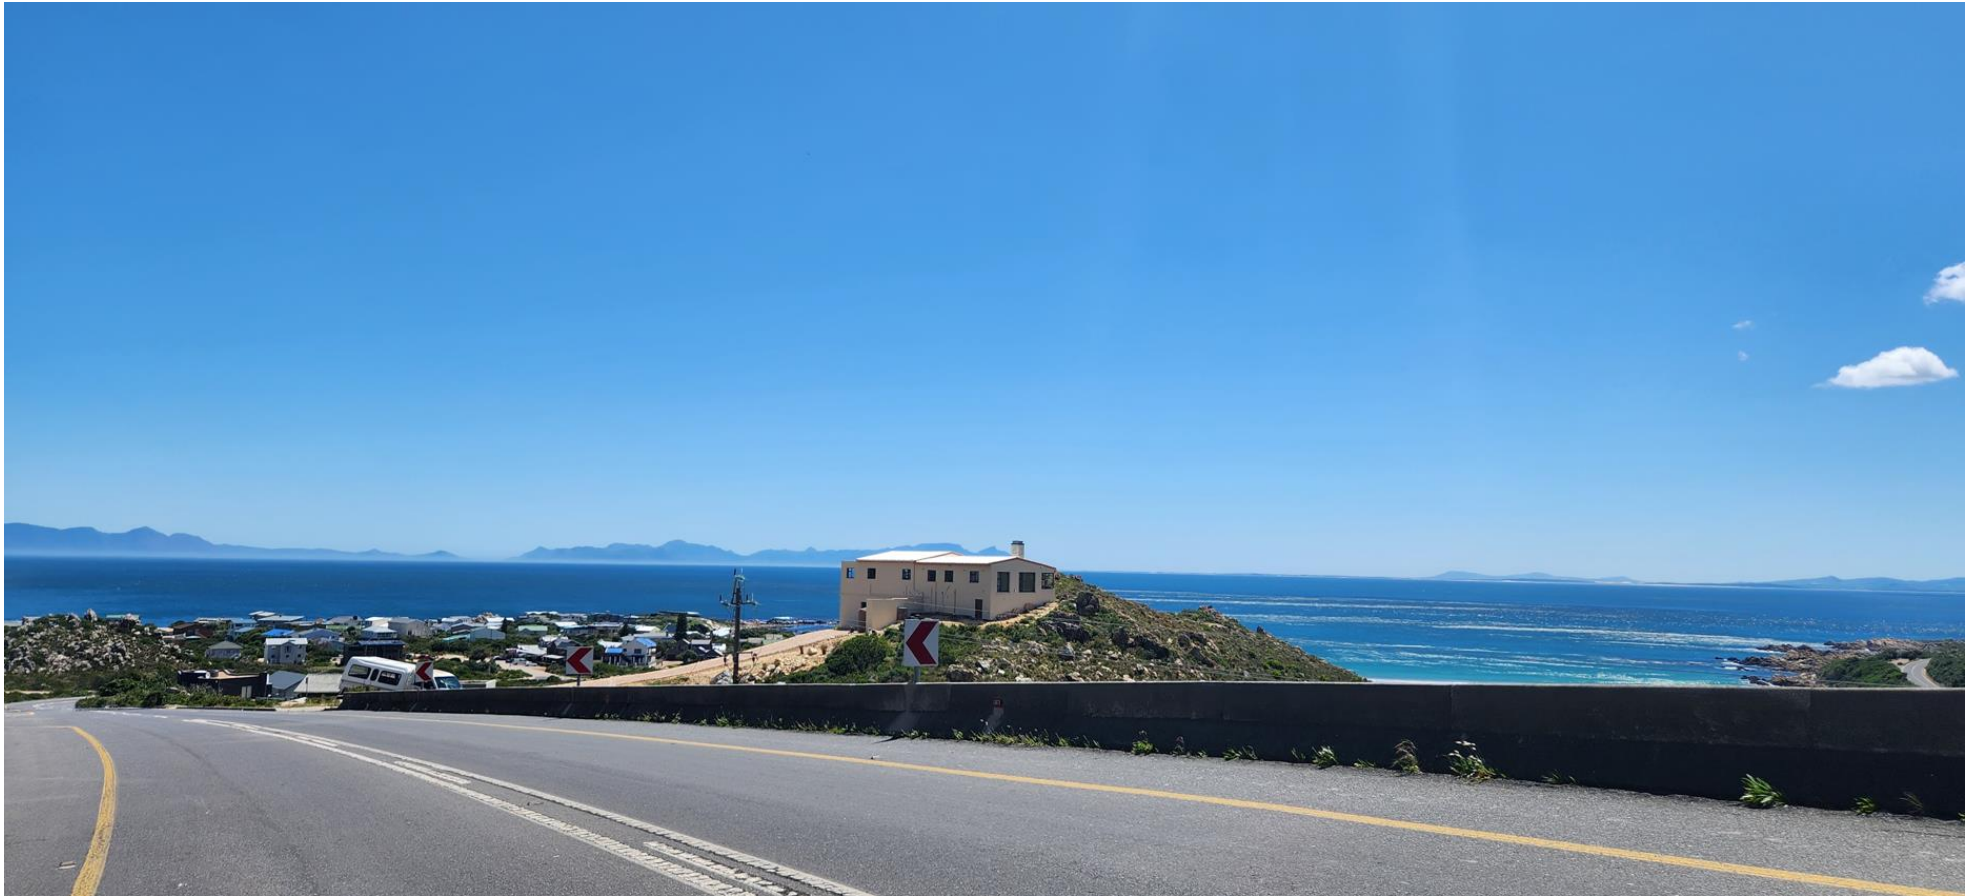
**Photo Position 6: Taken from the R44, 300 m from the site, view towards the northwest. Note the urban landscape and precedent being set of development on the ridgeline.**

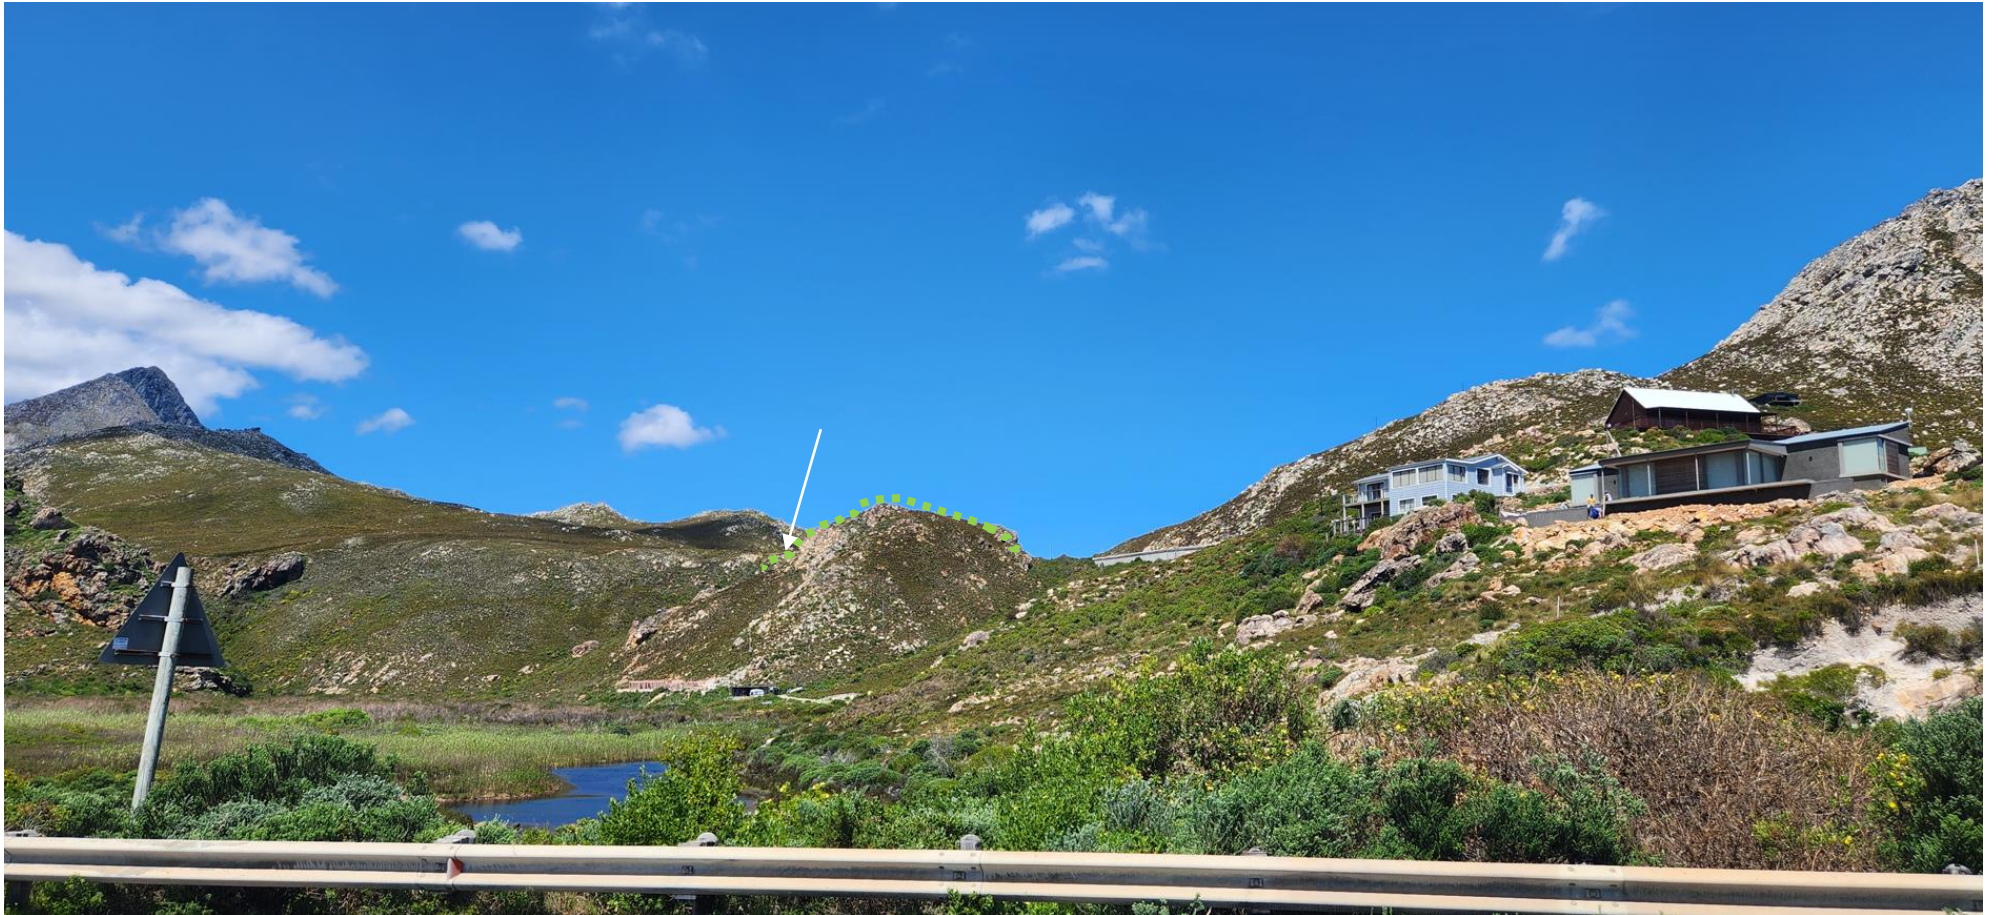
**Photo Position 8:** Photo taken from the R 44, Rooiels river in picture, node 1 partly exposed, but below the ridgeline, node 2 is hidden behind viewshed. Site position pointed by white arrow. View corridor 3 is in picture, primarily natural on the left. The houses on the right can't see the site.

- 2) View corridor 2 (yellow); Photo 8, 11a & 12a:** The receptors are R44 road users traveling south at 7m above sea level. Road users traveling north will not have a view of the site. Views are from 800 m to 1000m, a considerable distance from the site when crossing the Rooiels River bridge entering Rooiels. These road users are traveling 60 to 80 km/h with the entire Rooiels urban landscape opening up in front of them. Existing houses are located on the ridgeline and against steep mountain slopes. The development will be absorbed in this view frame and it will not be seen as new or distracting at this distance and in the

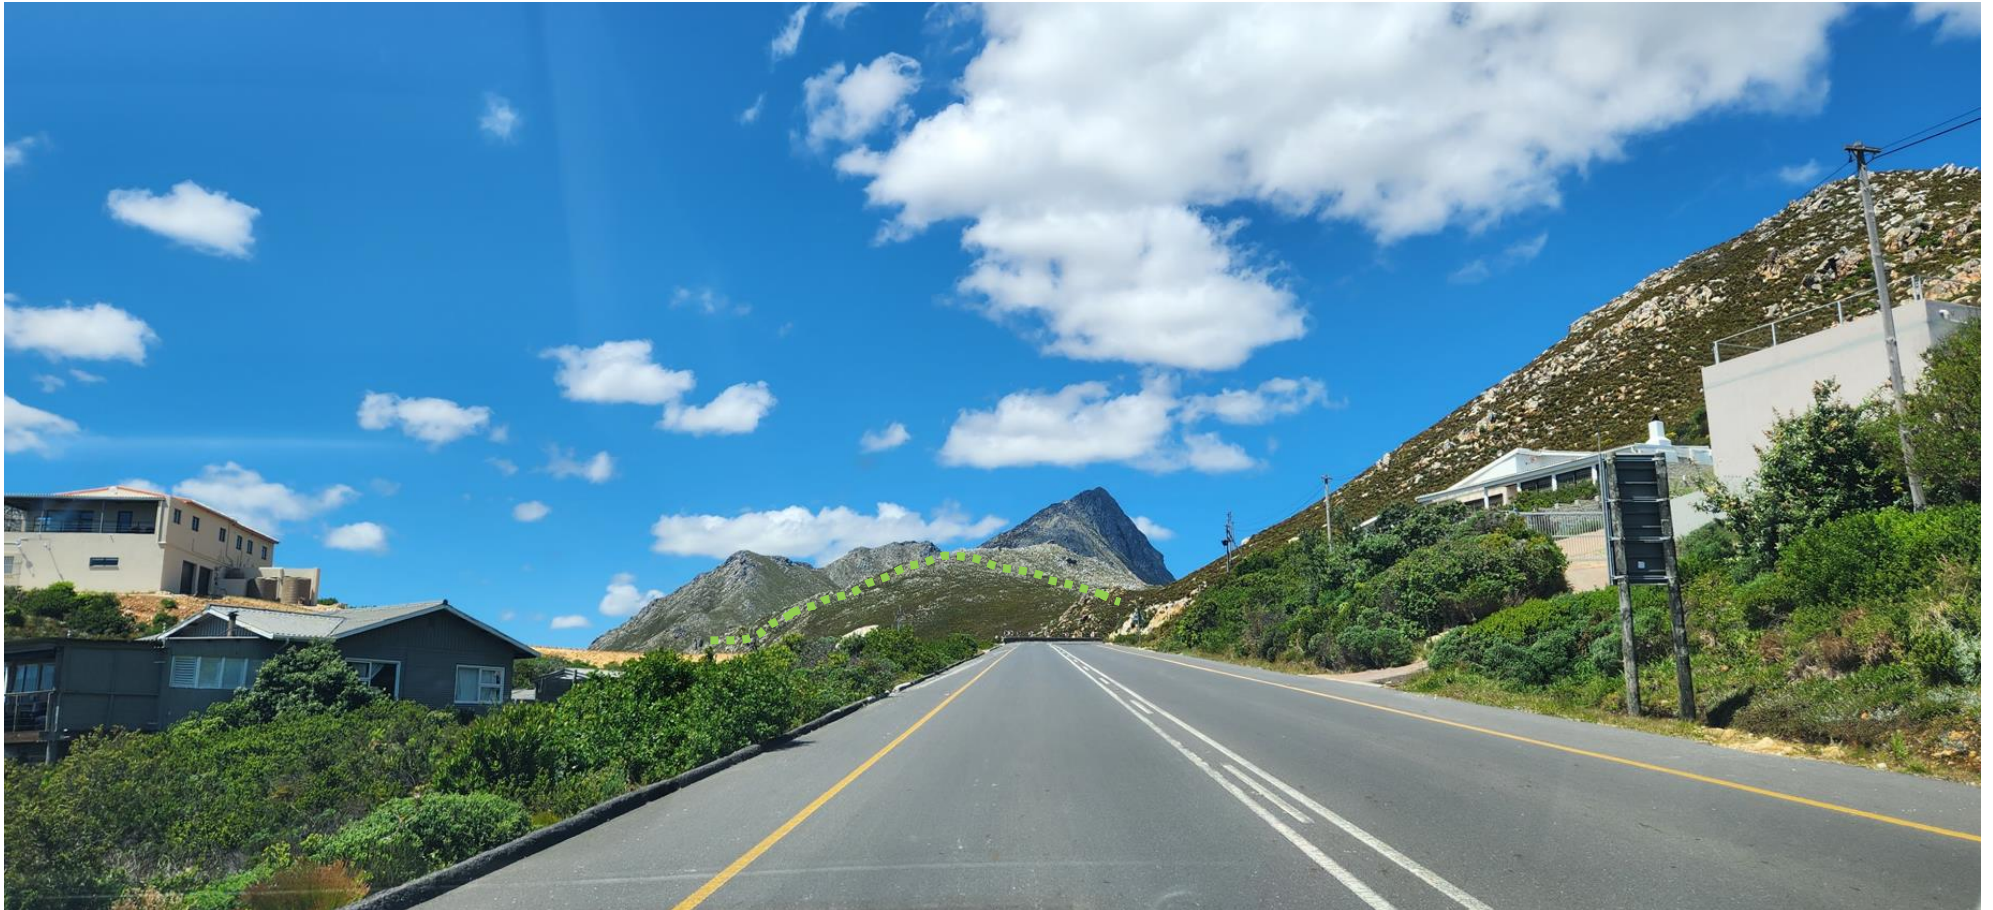
**Photo Position 9: The site is not visible from the R 44 due to viewsheds. Note the visual nature of the houses in the landscape. This photo was taken towards the east. View corridor 1 is in picture, on a short section on the R44 the site is visible (Photo 5), throughout large parts of this corridor receptors views are blocked by secondary viewsheds.**

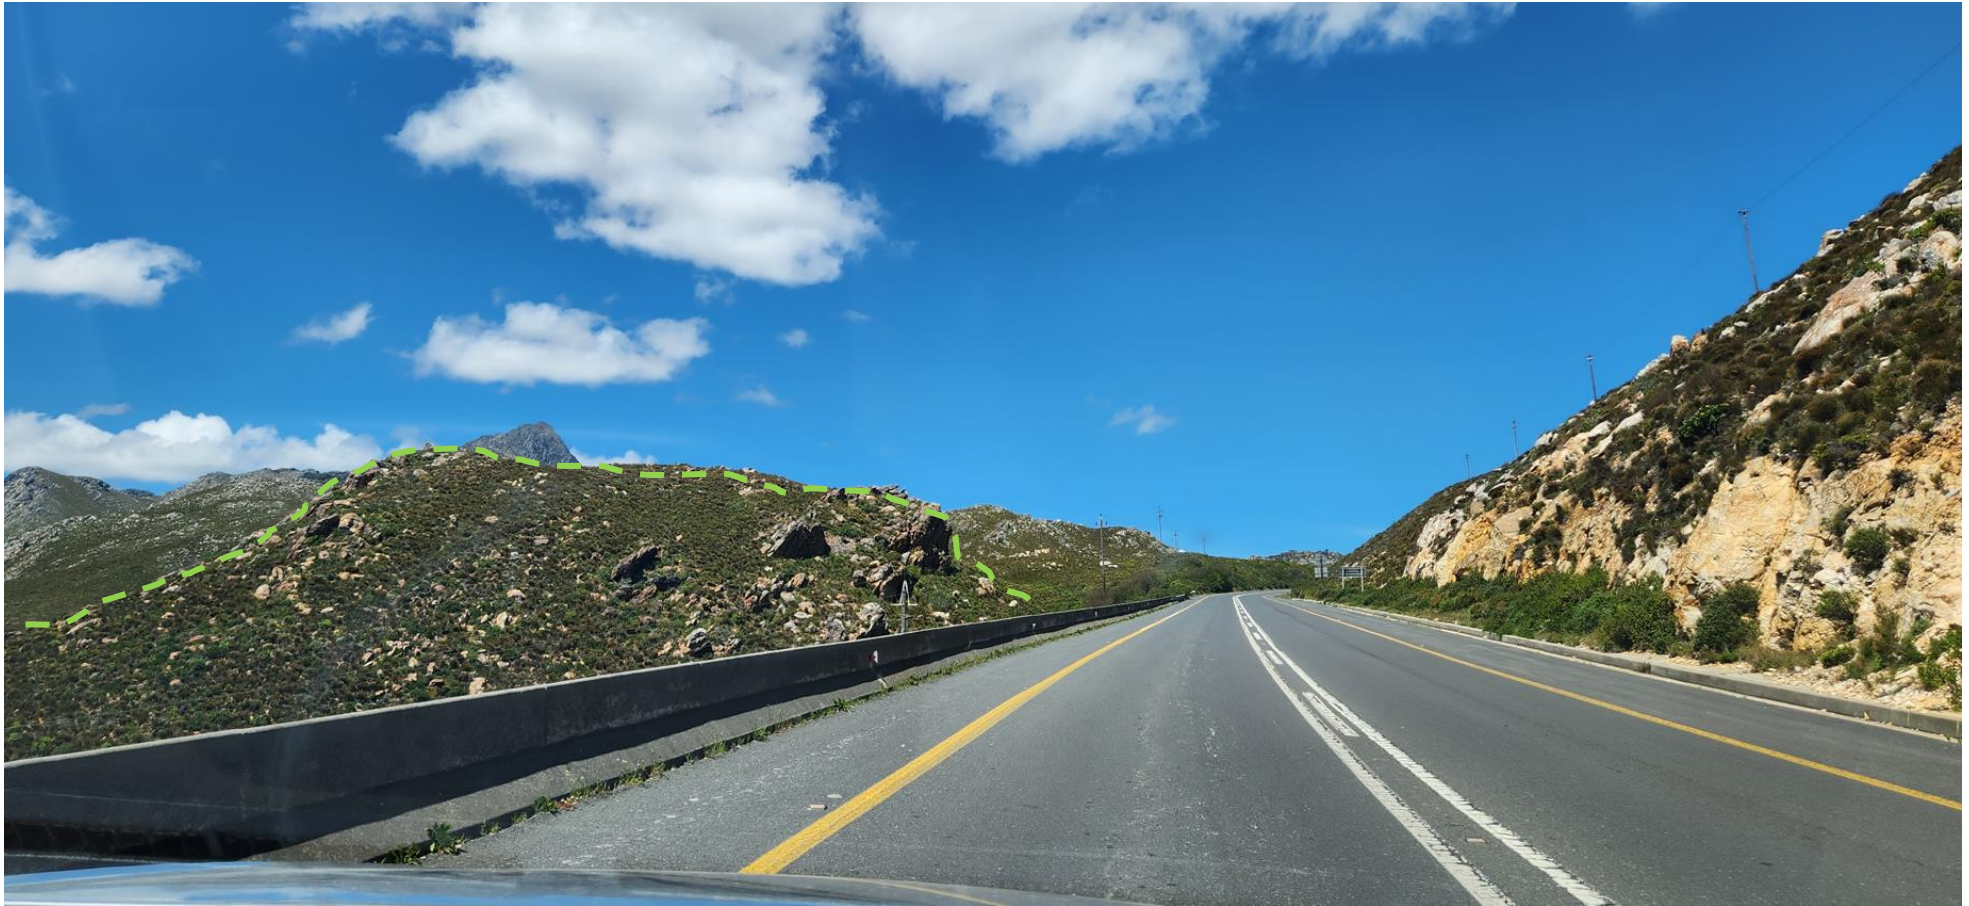
**Photo Position 10: Taken on the R 44 towards the east, site not visible hidden behind viewshed. View corridor 1 is in picture, on a short section on the R 44 the site is visible (Photo 5), throughout large parts of this corridor receptors views are blocked by secondary viewsheds.**

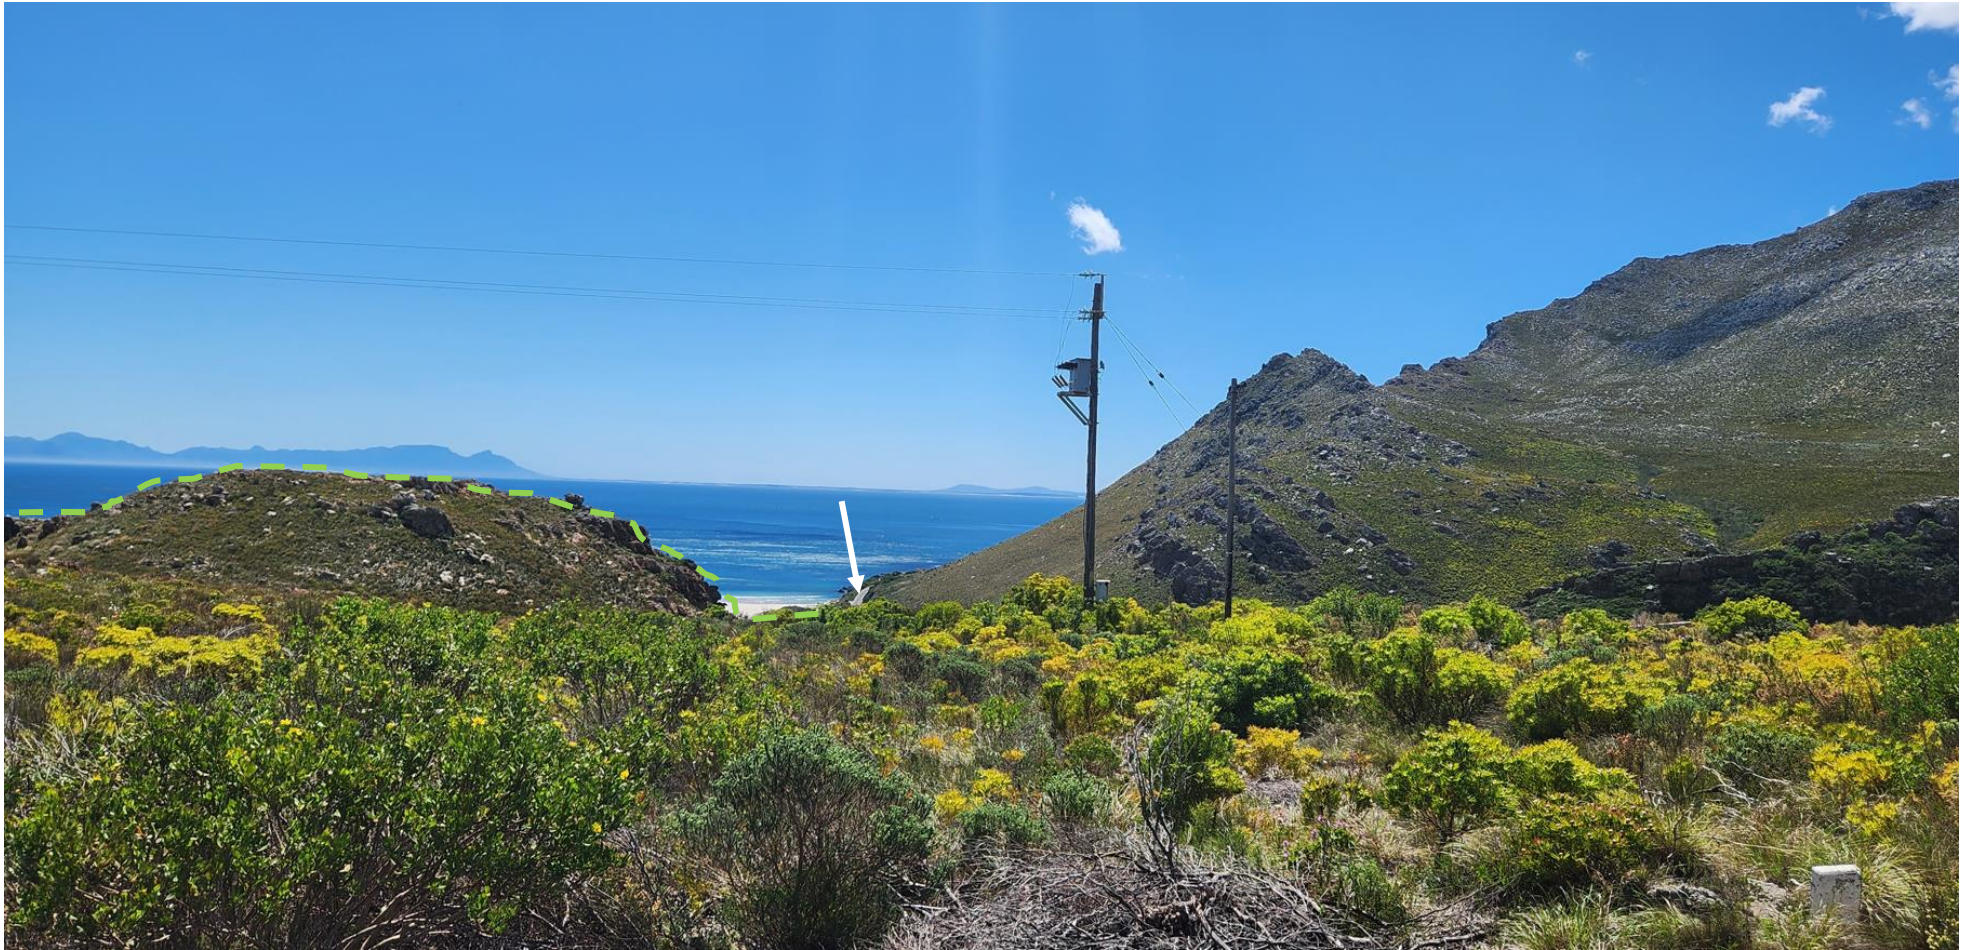
**Photo Position 11a:** Taken from node 2 on site towards the northwest, Rooiels River bridge and residences in town not visible from this node due to viewshed in green dotted line. The R 44 is only visible for a short section, pointed with white arrow. The Eskom power pole used as indicator is in view.
