# VISUAL IMPACT ASSESSMENT

REDEVELOPMENT OF AN EXISTING RESIDENTIAL HOUSE AND NEW OUTBUILDINGS ON PORTION  
134 OF THE FARM 599; ROOIELS

PHS Consulting

**OCTOBER 2023**

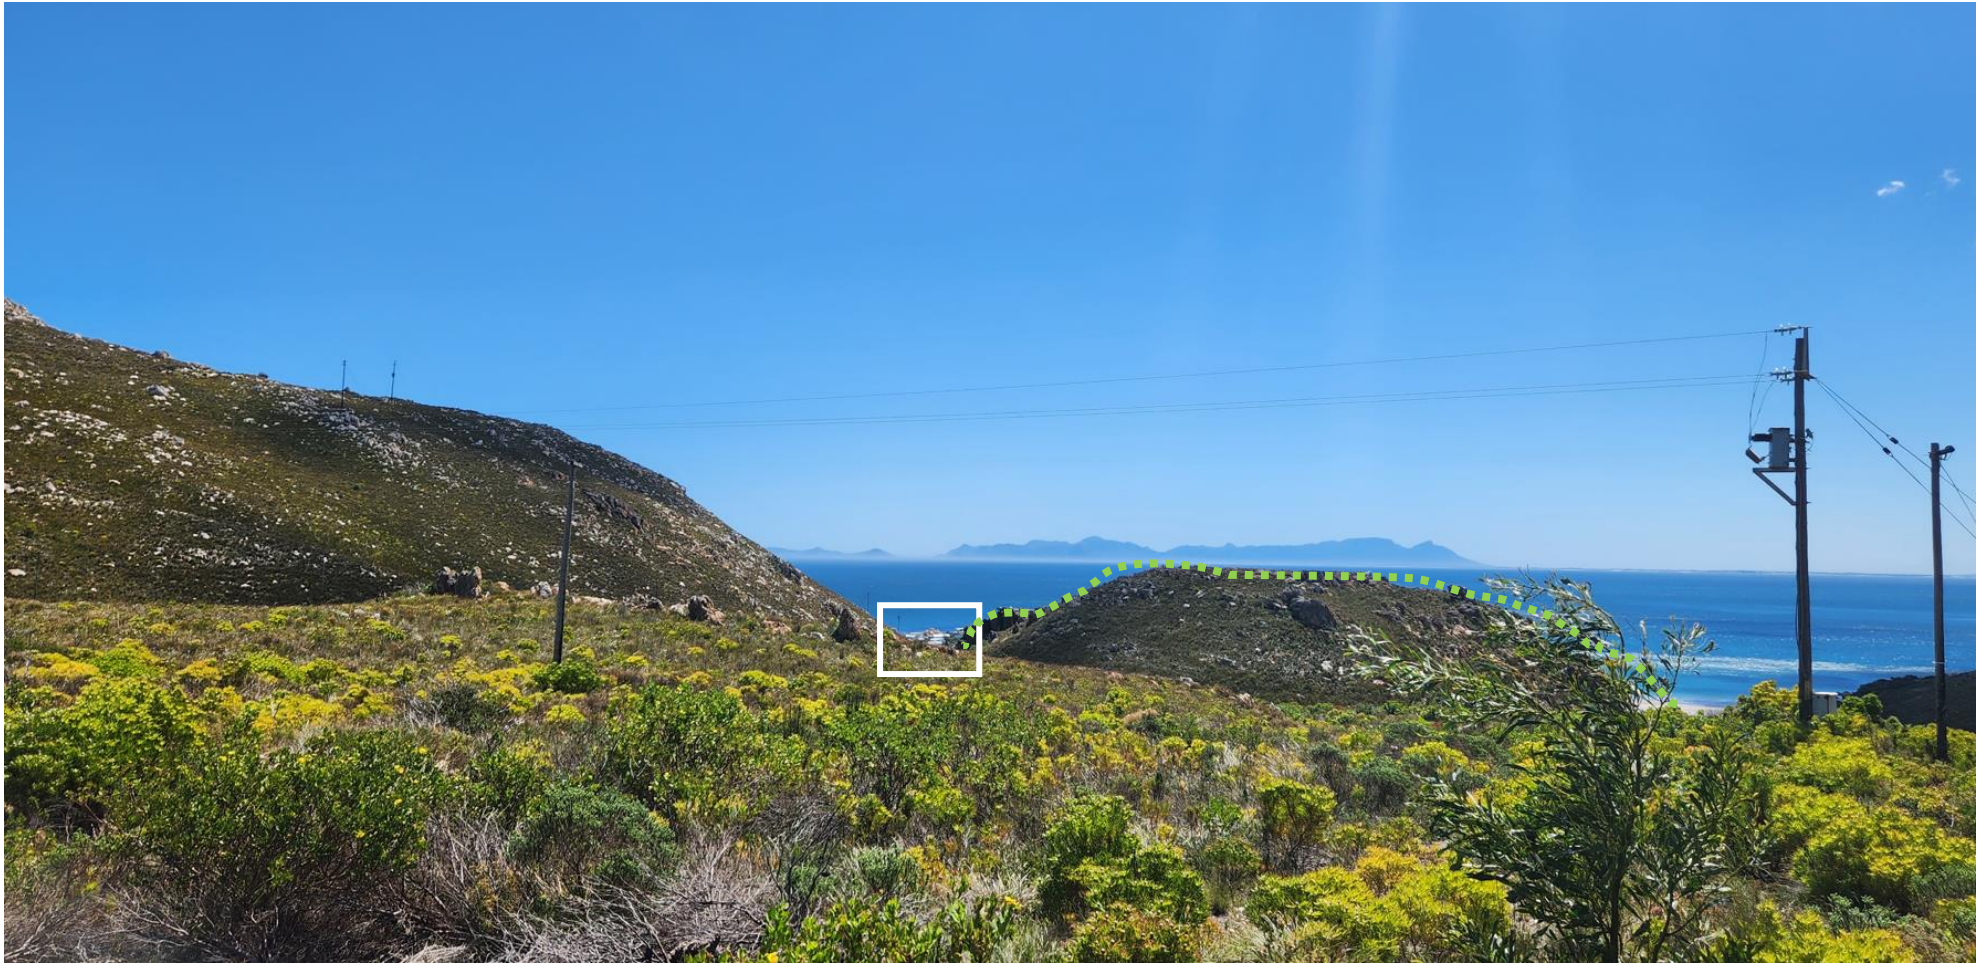
**Photo Position 11b:** Taken on node 2 on site towards the north west, Rooiels River bridge and residences in town are not visible from this node due to viewshed in green dotted line. The R 44 is not visible, neither are vehicles on the road or any road signage. The Rooiels bridge is not visible. Only in the distance roofs of a few houses against the sea are visible, this is on the edge of the 1.5 km zone of visual influence, in view corridor 1. The Eskom power pole used as indicator is in view.

- 1) View corridor 1 (blue); Photo 5, 11b & 12b:** The receptors are traveling at an average speed of 60 – 80 km/h, it's a combination of residents, tourist and business movement in the area. The current experience of road users traveling through Rooiels relate to large residences on the ridgeline and against the mountain slopes consisting of various shapes, sizes and colors resulting in a distinct pattern in the landscape, setting the tone for the receptors overall experience. The site can only be seen when traveling south on the R 44. The approx. distance the road user can possibly see the site is along a 100 m section on the R 44. In the photos it's clear that the site is identifiable when standing still on the side of the road but considering the road is only used for driving vehicles (no stop or viewpoint areas along this section) a view of the site is probably going to be lasting for few seconds. These receptors are driving at high speeds, the embankment is high and primarily shielding views of the site that were developed in the past. When the small window opens only the top part of the new infrastructure will be visible because the bottom part is hidden by a secondary viewshed. Considering all the houses in Rooiels area that have been observed in the landscape, these road users would not likely experience the proposed development as unusual in their view frame.

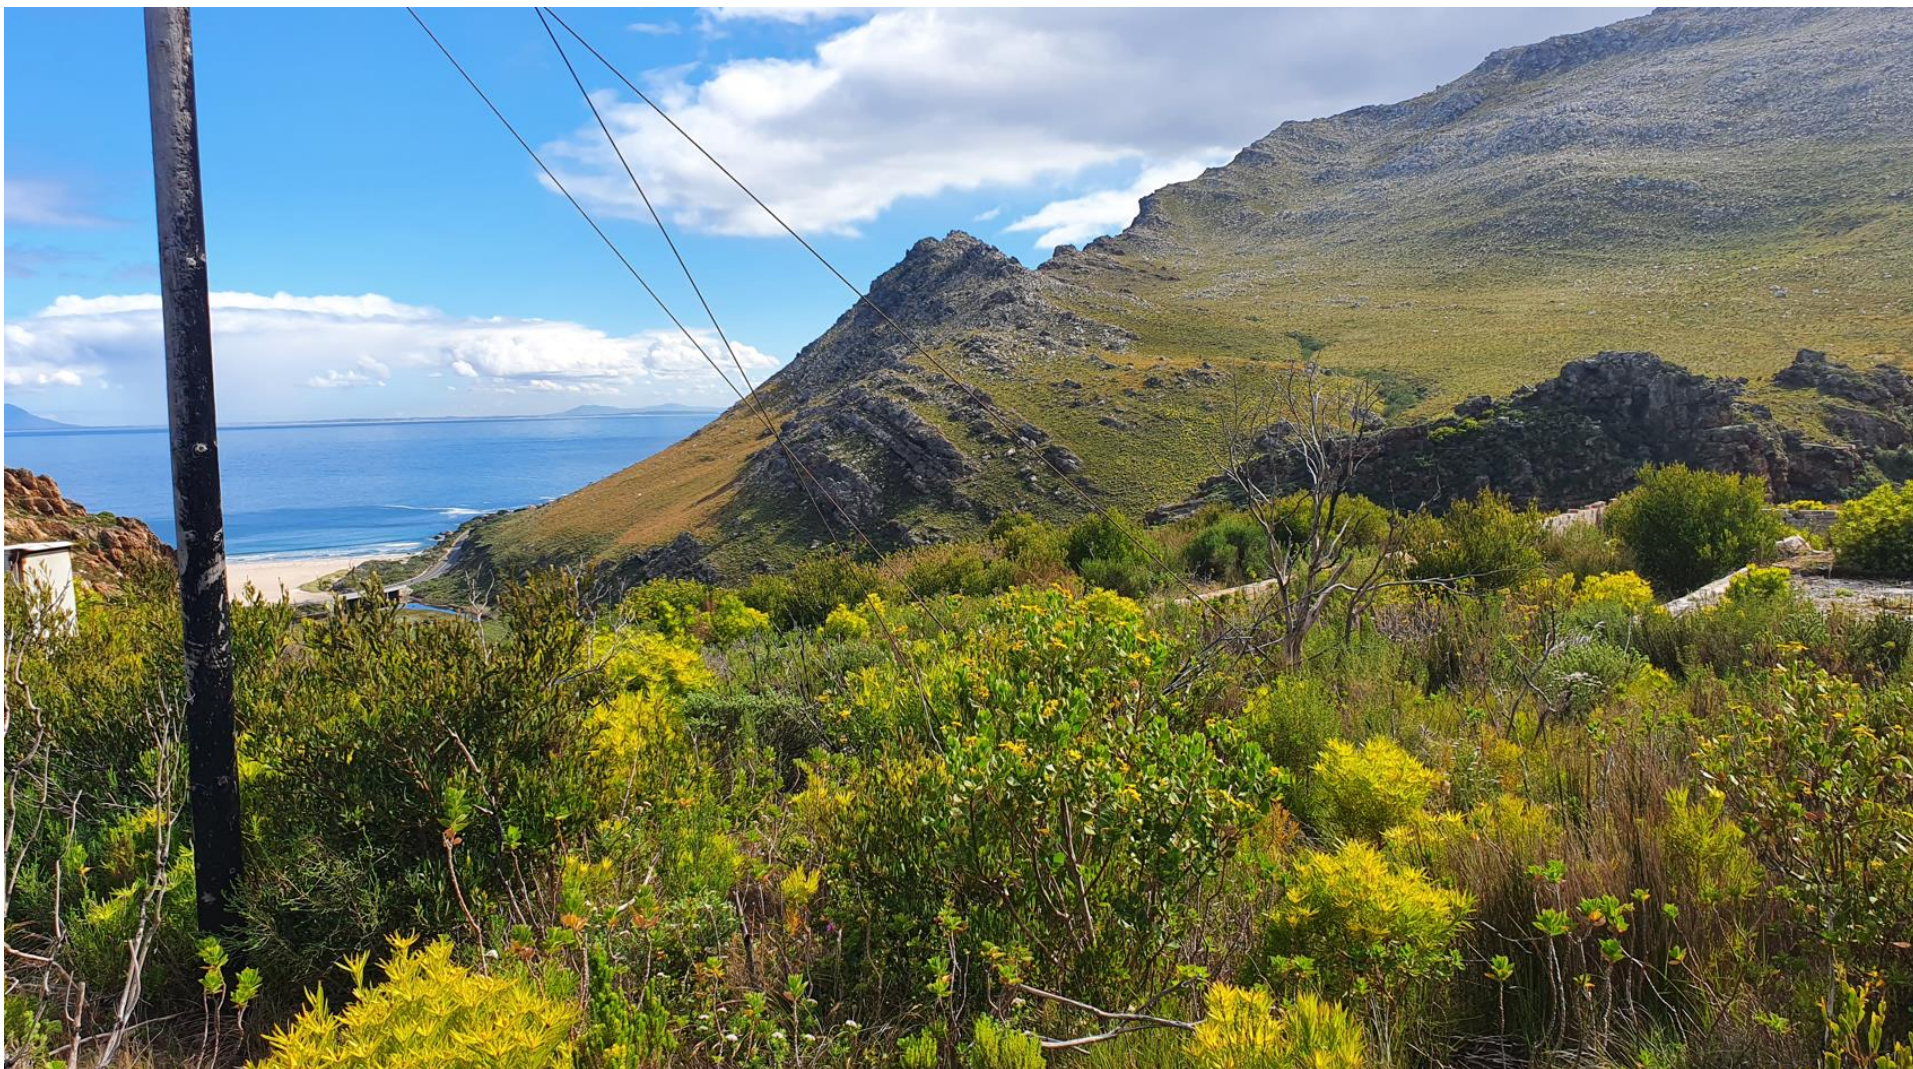
**Photo 12a: Taken from the indicator Eskom pole on site towards the northwest. Node 1 old house site in view on the right. The Rooiels river bridge is visible from this node. View corridor 3 is in picture, primarily natural to the north with limited to no receptors. Only receptors on the R 44 and bridge can see this node.**

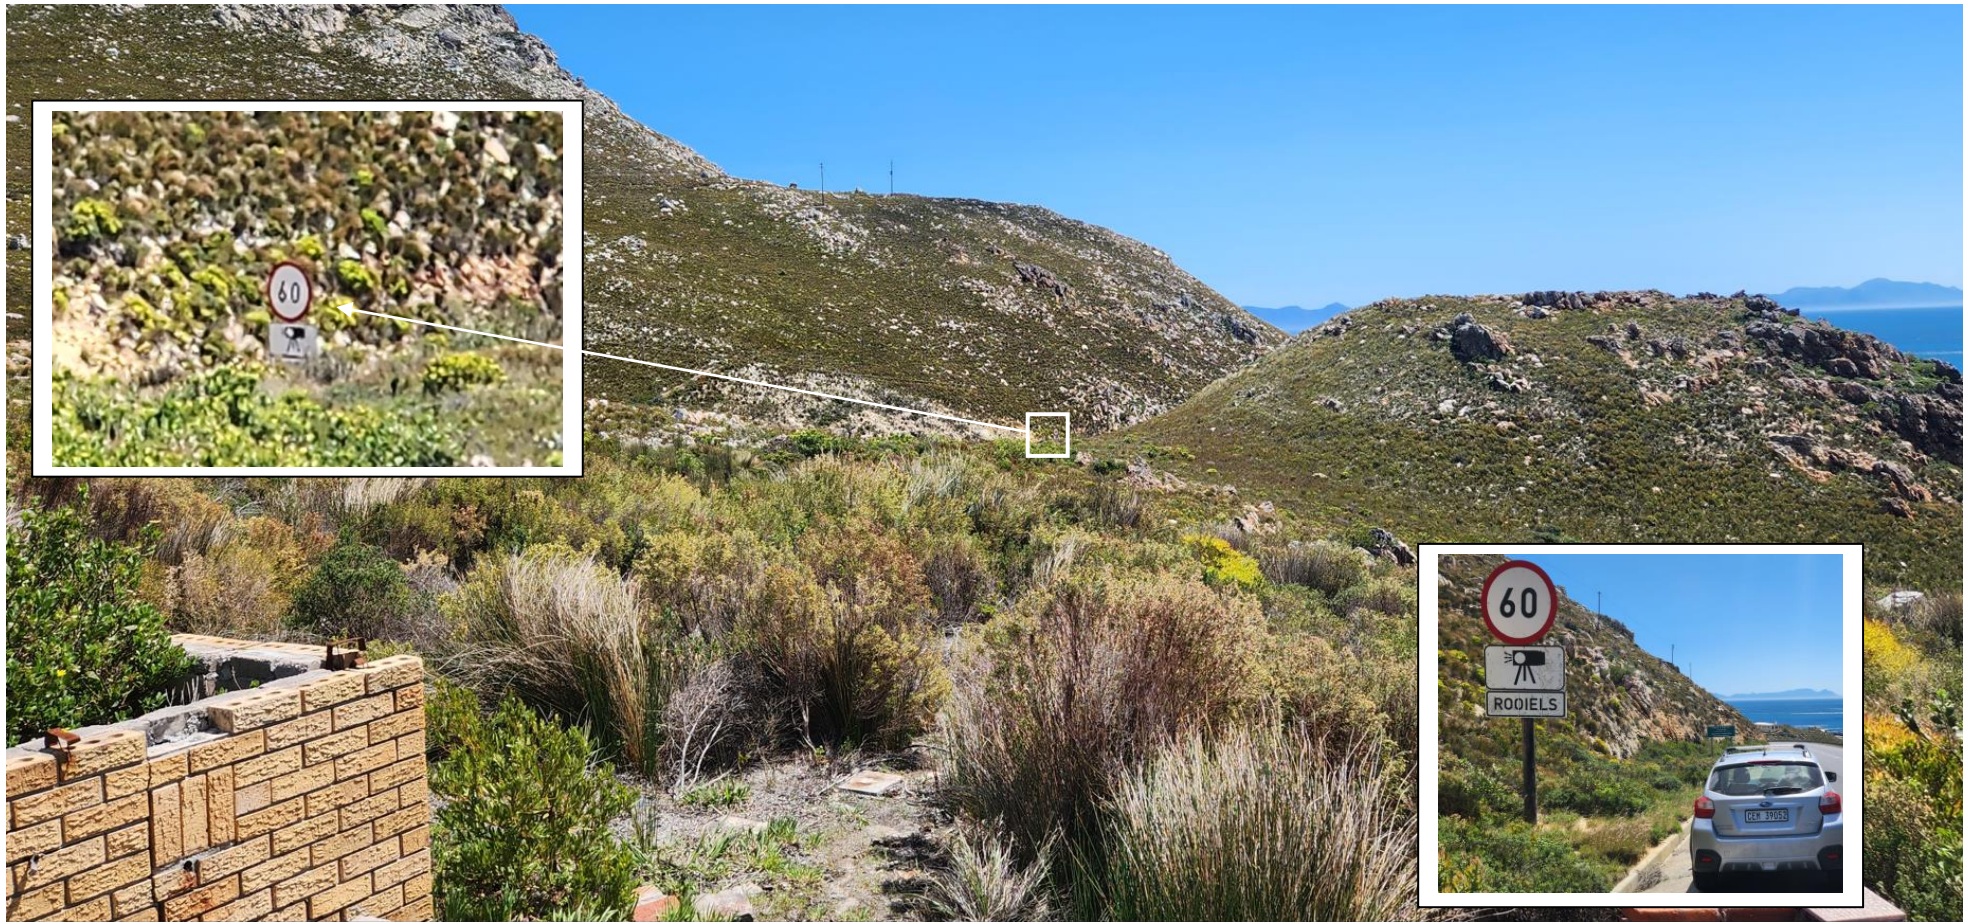
Photo 12b: Taken from Node 1 old house towards the R 44, view corridor 1. The road is not visible, neither are vehicles traveling on the road. This is proven because only the top of a road sign is visible. The insert on the right show that the vehicle is below the part visible from the site.

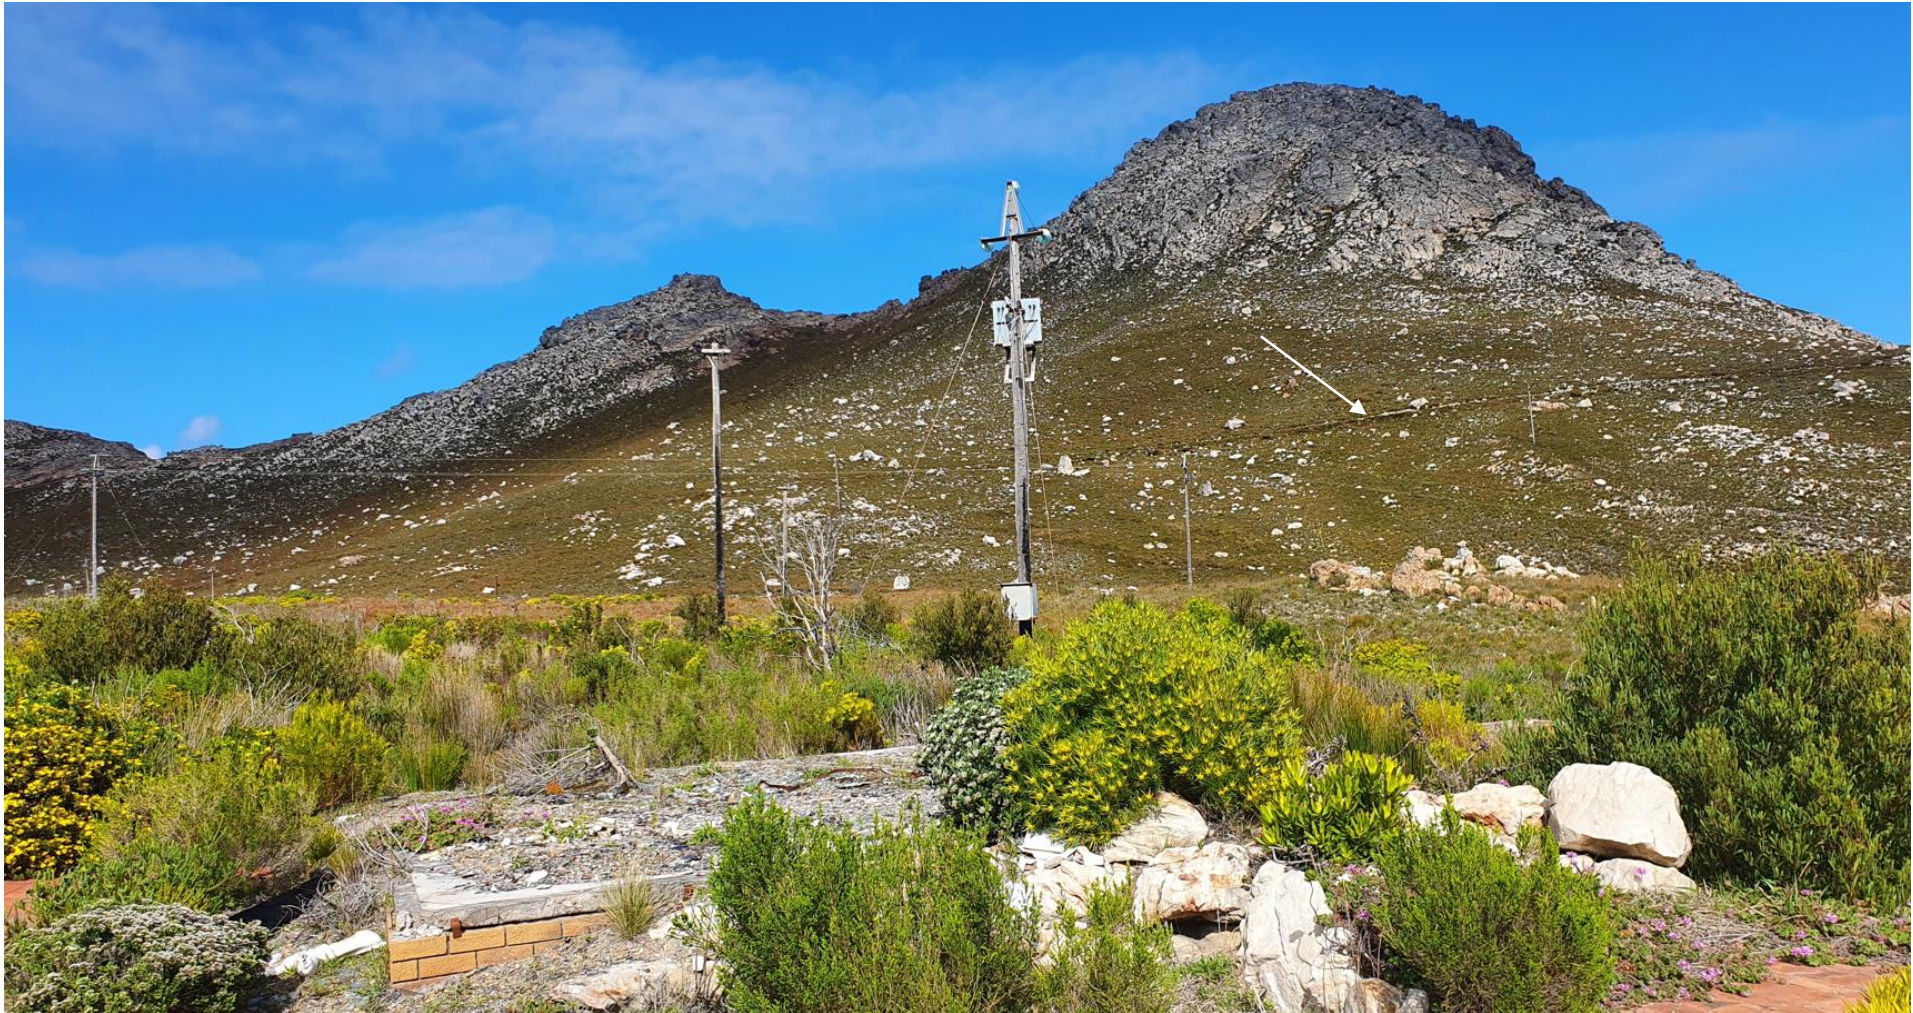
**Photo 13: Taken from the site towards the west, mountainous area part of the farm, with access servitude pointed with white arrow in favour of the neighbour whose house is not visible from the site.**

- 3) View corridor 3 (orange); Photo 13:** The R44 is west of the site but visually separated from the site due to the deep road cutting. The road shoulder, rising contour and vegetation is approx. 8 m high opposite the site. The old R44 road running through the site was also subjected to a road cutting, node 2 is located partly on this old road and node 1 is lower than node 2. The result is a approx. 70 m wide naturally vegetated “berm” separating the receptors on the R 44 from the site, making it highly unlikely to see the proposed development within this corridor. The current R 44 and old R44 is on approx. the same height but separated by the high vegetated berm due to the road cutting. The receptors are limited to the neighbour using a servitude access road to their house. When on this road the user can see the site but the neighbours house its hidden behind a viewshed. The servitude road user lives in a house on the ridgeline overlooking urban Rooiels, considering that the site was previously developed its highly unlikely that the neighbour will experience a deteriorated visual experience while using the road servitude to their house. No receptors exist that will experience visual impact within this view corridor.

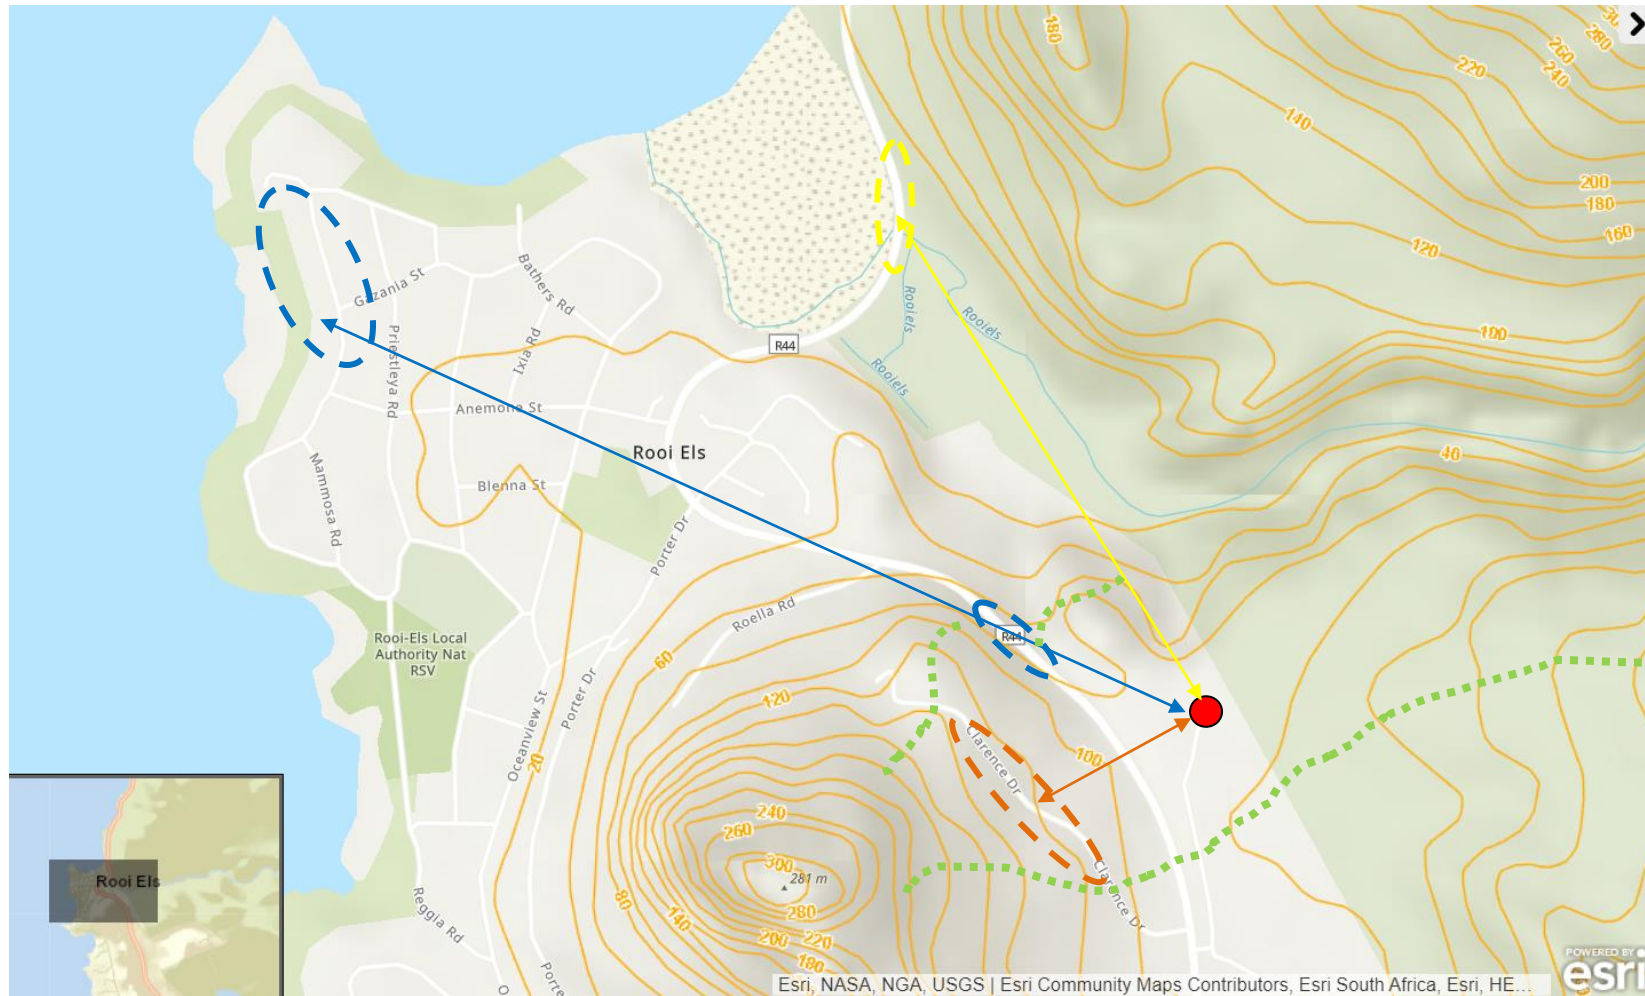
Figure 15: Receptors of potential visual impact. Blue is pinched and distant. Yellow is distant. Organe is a neighbour servitude infrequent use.

- 2) View corridor 2 (yellow); Photo 8, 11a & 12a:** The receptors are R44 road users traveling south at 7m above sea level. Road users traveling north will not have a view of the site. Views are from 800 m to 1000m, a considerable distance from the site when crossing the Rooiels River bridge entering Rooiels. These road users are traveling 60 to 80 km/h with the entire Rooiels urban landscape opening up in front of them. Existing houses are located on the ridgeline and against steep mountain slopes. The development will be absorbed in this view frame and it will not be seen as new or distracting at this distance and in the

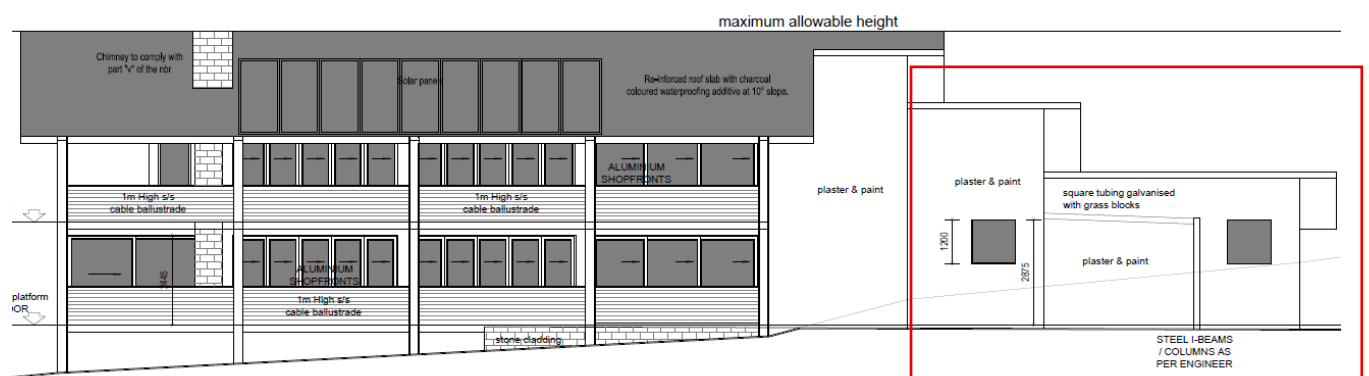
Figure 6: Municipal Approved Main dwelling with New proposed garage extension (indicated by red block outline)

- The site context remains the same as per Oct 2023 VIA.
- Since the proposed expansion is inside the footprint of Node 1 and that the building is lower and behind the approved building, the findings and recommendations of the Oct 2023 VIA pertaining to Node 1, remain the same.
