Borehole Yield and Quality Testing at Elgin Free Range Chickens Agri Operations, Lottershof Farm, Caledon

Prepared by
GEOSS
15 August 2024

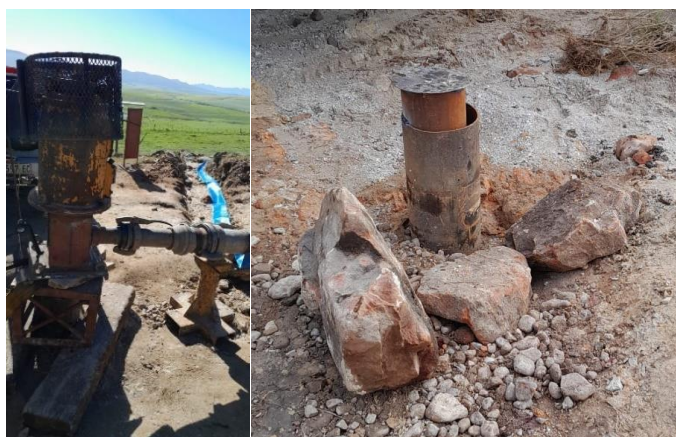
Figure 1: ECA_BH1 during (left) and after (right) testing.

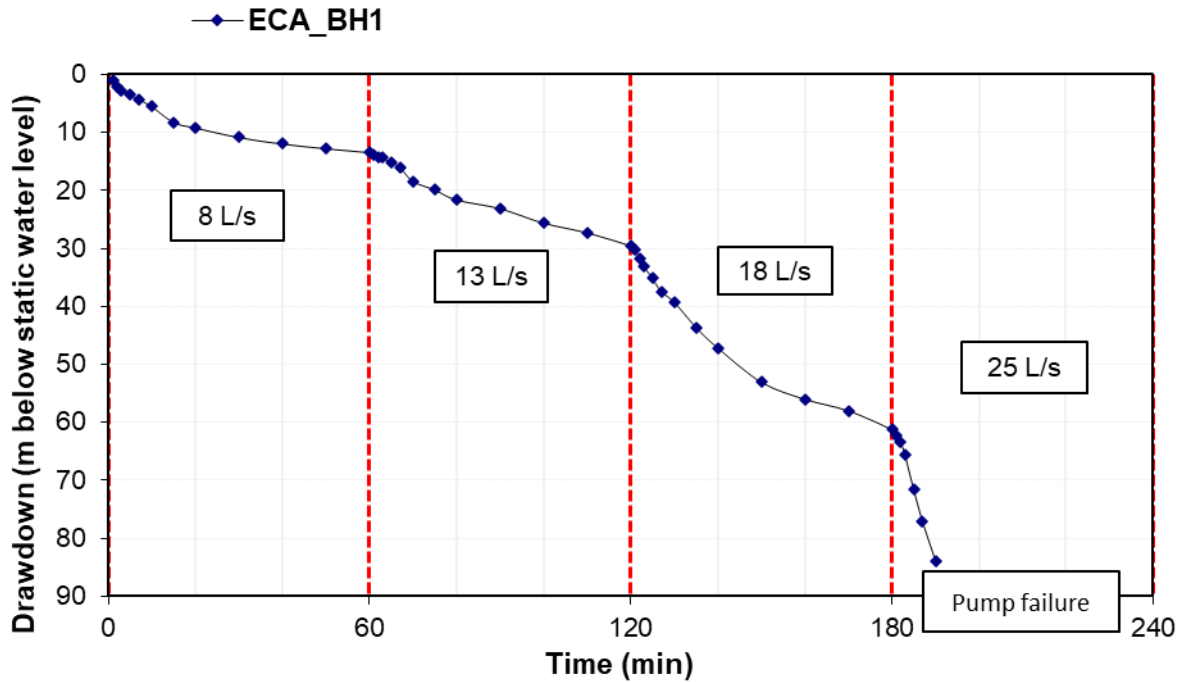
Figure 2: Step Test drawdown data for ECA_BH1.

During the step test, the water level was drawn down 83.86 meters below the rest water level (92.8 mbgl) during the 4th step at a rate of 25 L/s. 10 minutes into the final step the pump broke down due to sand ingress. **Figure 2** shows the time-series drawdown for the Step Test.

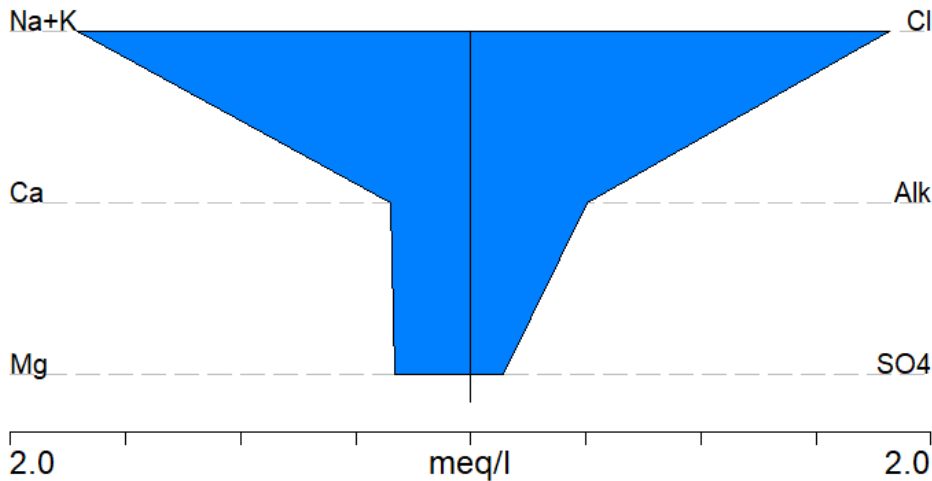
Figure 6: Stiff diagram of the groundwater sample (ECA_BH1).

A number of chemical diagrams have been plotted for the groundwater sample and these are useful for chemical characterisation of the water and illustrate the similarities and differences in the water types. The Stiff Diagram is a graphical representation of the equivalent concentrations of the cations (positive ions) and anions (negative ions). This diagram shows concentrations of cations and anions relative to each other and direct reference can be made to specific salts in the water. From **Figure 6**, ECA_BH1 is classified as a Sodium & Potassium/Chloride hydrofacies. This is expected of groundwater hosted in the sandstone of the Rietvlei formation.

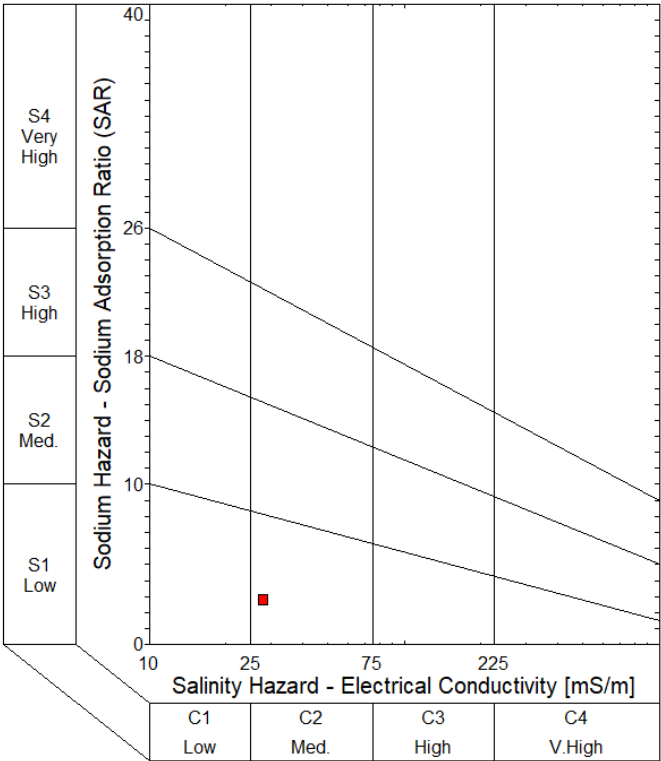
Figure 7: SAR diagram of the groundwater sample (ECA_BH1).

The Sodium Adsorption Ratio (SAR) of the groundwater is plotted in **Figure 7**. ECA_BH1 plots as S1/C2, thus classified as low risk in terms of sodium adsorption and medium risk in terms of salinity hazard. This graph is typically applicable to irrigation, however, is dependent on soil texture and crop type.
