Aquatic Biodiversity Screening: Wetland Confirmation

Portion 91 of the Farm Potteberg Estates No. 516,
Swellendam

Project Reference: Portion 91 of the Farm Potteberg Estates No. 516, Swellendam (DEA&DP Ref: 16/3/3/6/2/E3/10/1489/25)

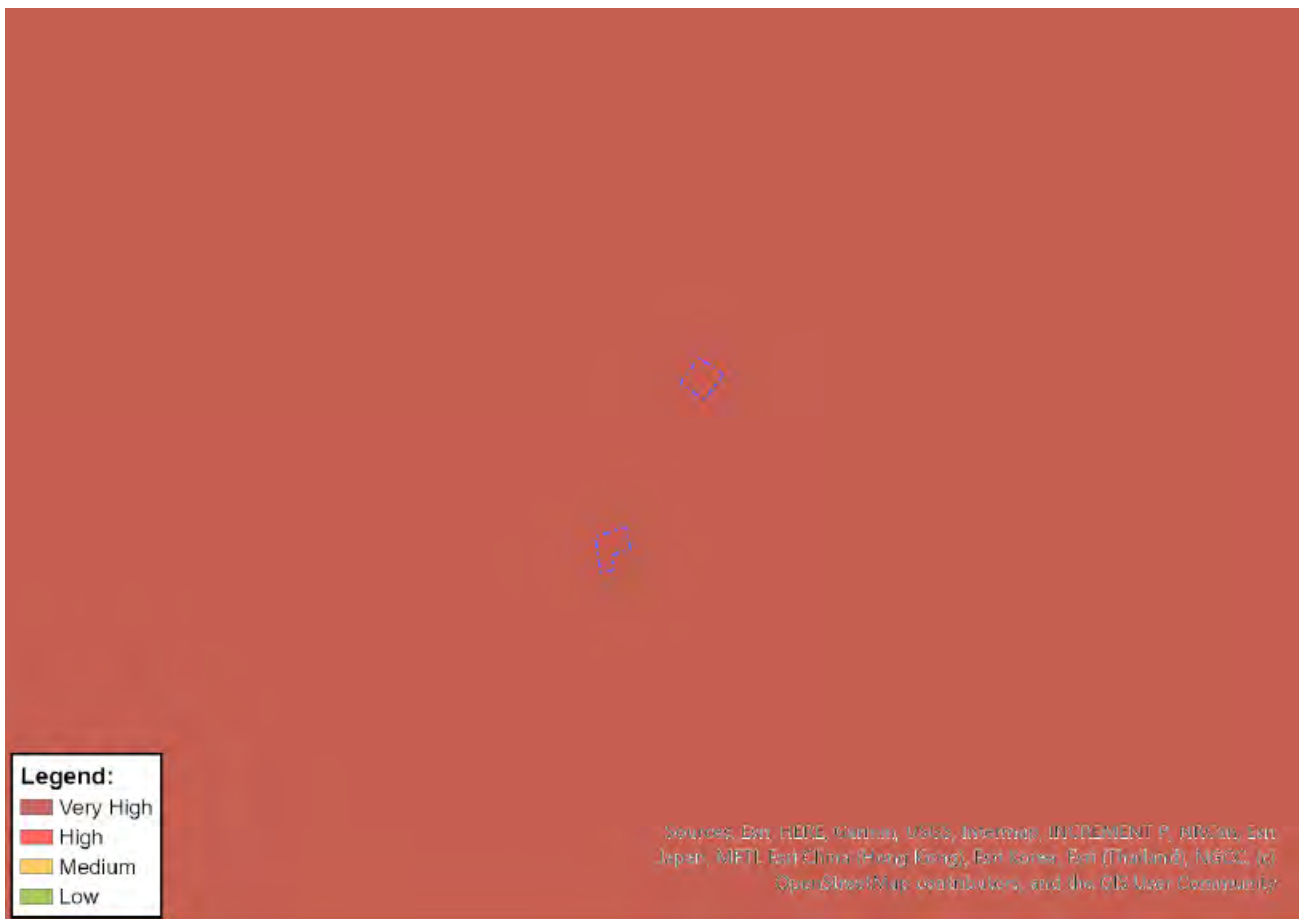
Figure 3: Aquatic Biodiversity Theme.

According to the national web-based environmental screening tool report generated for the proposed site, the Combined Aquatic Biodiversity Theme Sensitivity is classified as “Very High” (DFFE, 2026). The classification trigger is the location of activities within the mapped NWM5 floodplain wetland, as well as within the vicinity of the mapped Breede River Estuary and Aquatic Critical Biodiversity Areas (CBAs). Additionally, the development activities are located within a Freshwater Ecosystem Priority Area (FEPA) sub catchment.

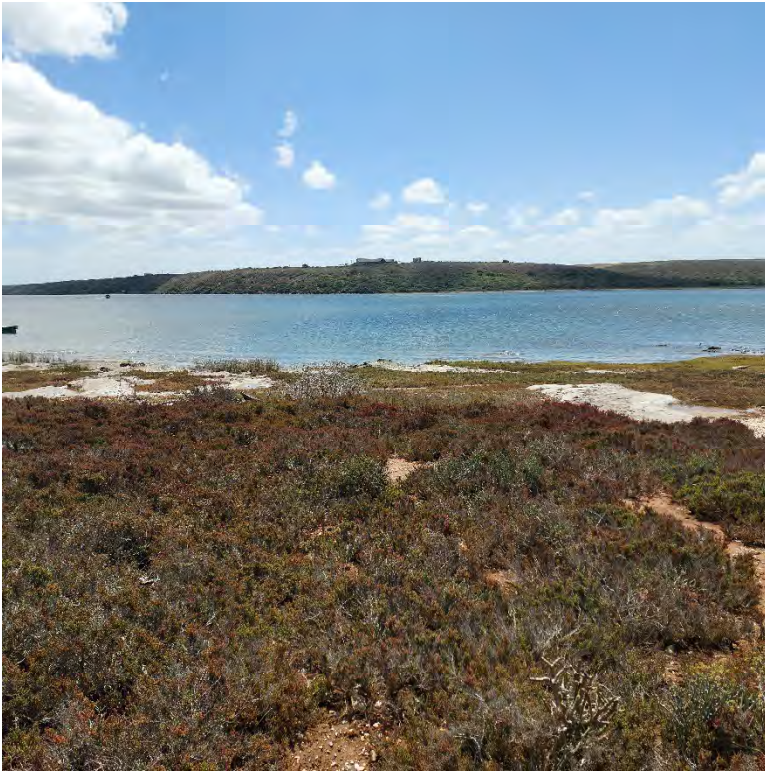
- **Delineation of the Breede River Estuary water resource:** The EFZ was delineated approximately 20 m downslope from the expanded house footprint and 15 m downslope from the proposed road upgrade. The estuary is dominated by *Salicornia mossiana* (Short Glasswort), marking a clear transition from the terrestrial development site to the estuarine environment (**Annexure A**).

Breede River EFZ downslope of the proposed activities.

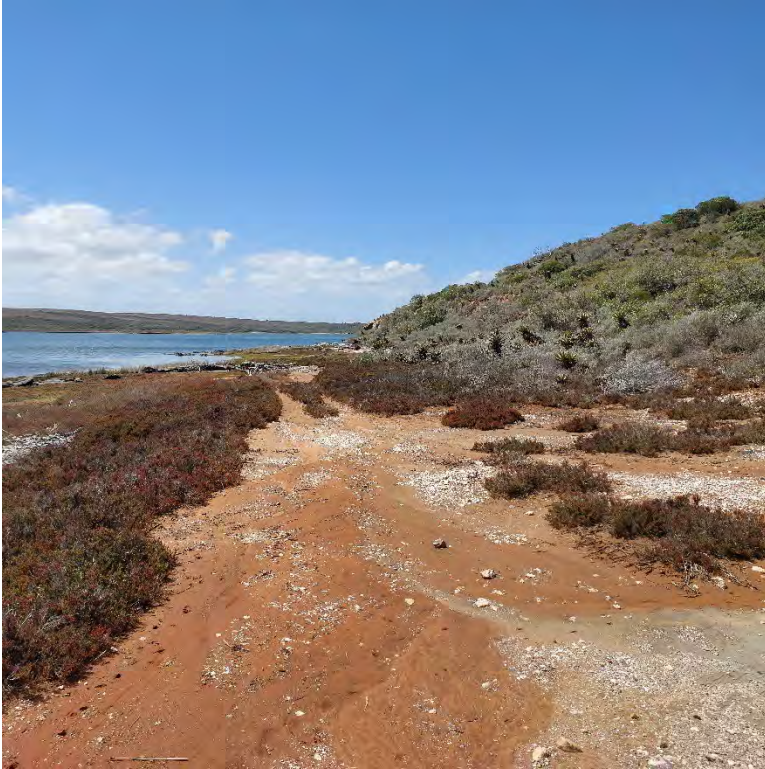
Breede River EFZ downslope of the proposed road upgrade.

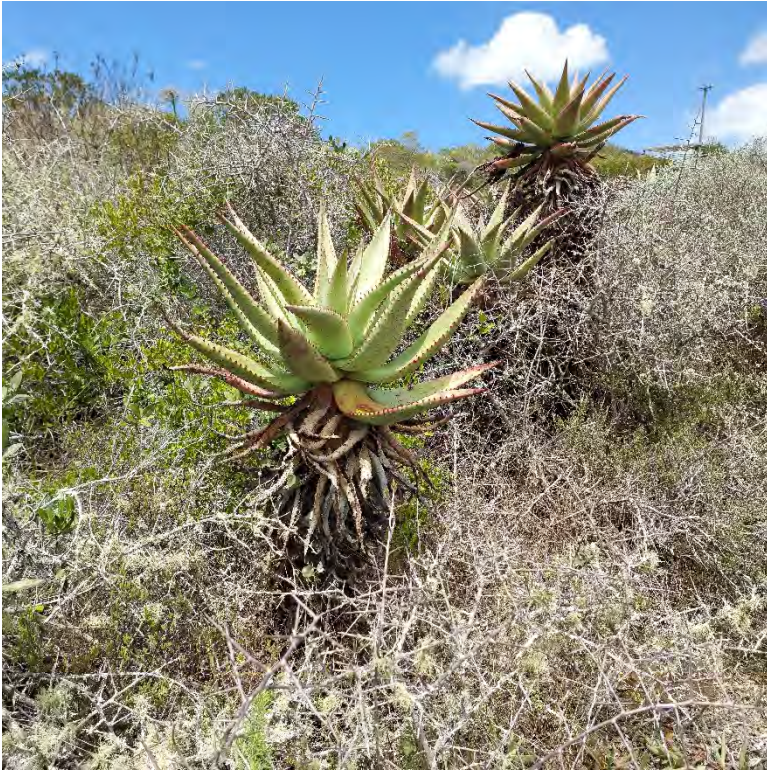
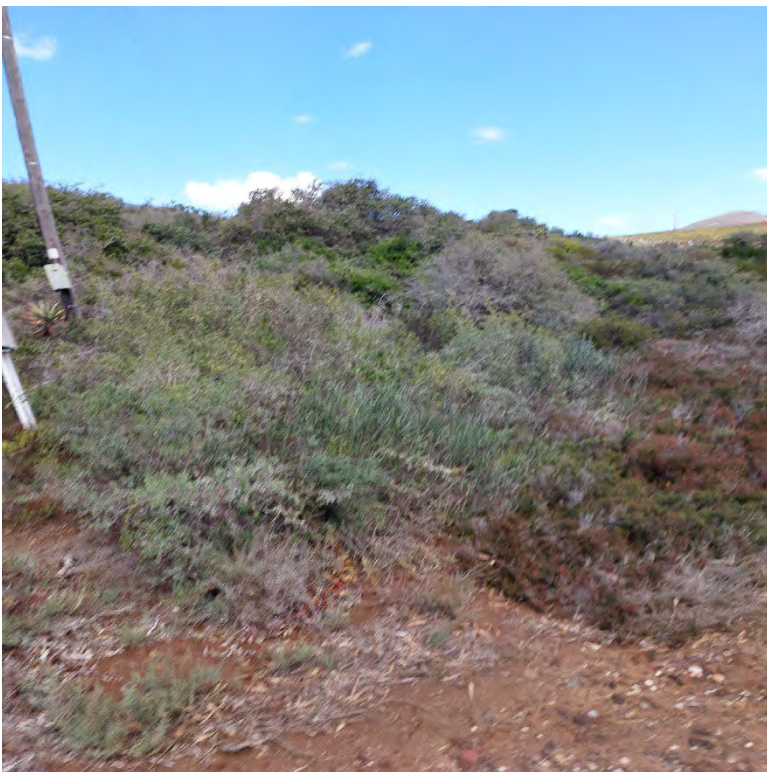
- **Absence of Aquatic Indicators:** No watercourse or wetland indicators were identified within the proposed development areas. The expansion footprints for the residential unit and the "like-for-like" road upgrades are strictly terrestrial in nature (Refer to **Annexure A**).

Location of proposed new farmhouse unit.

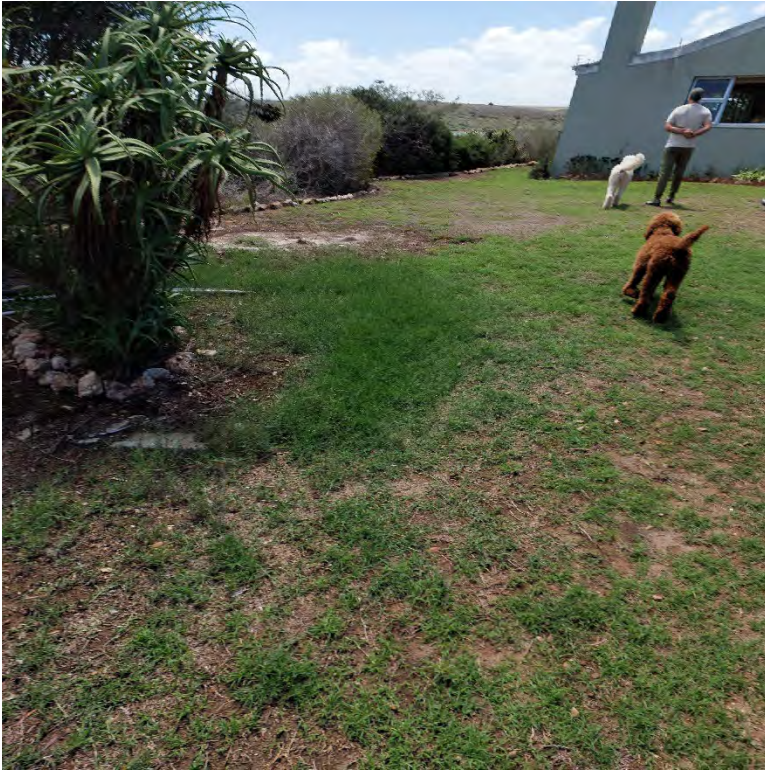
Location of proposed new farmhouse parking.

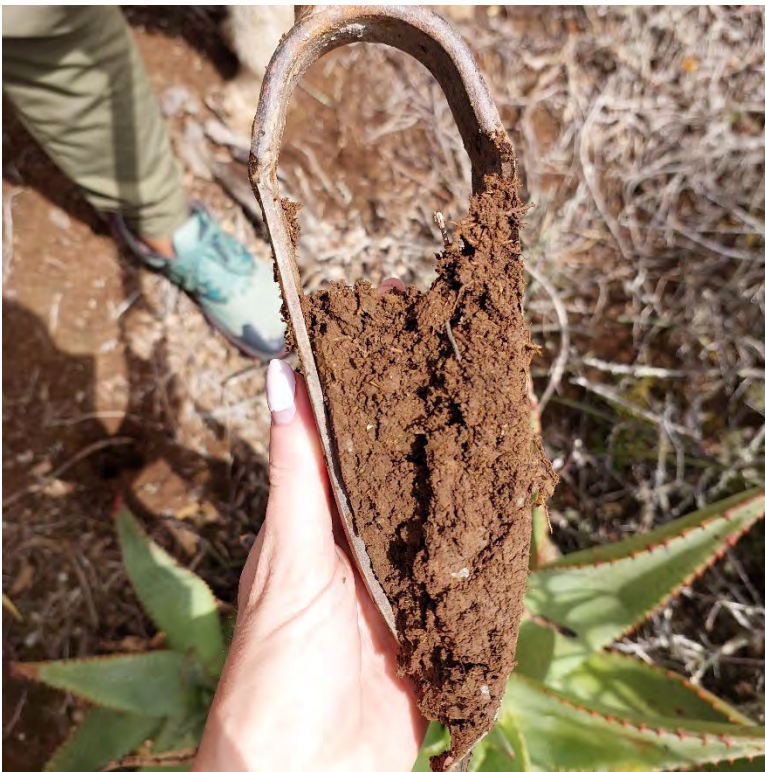
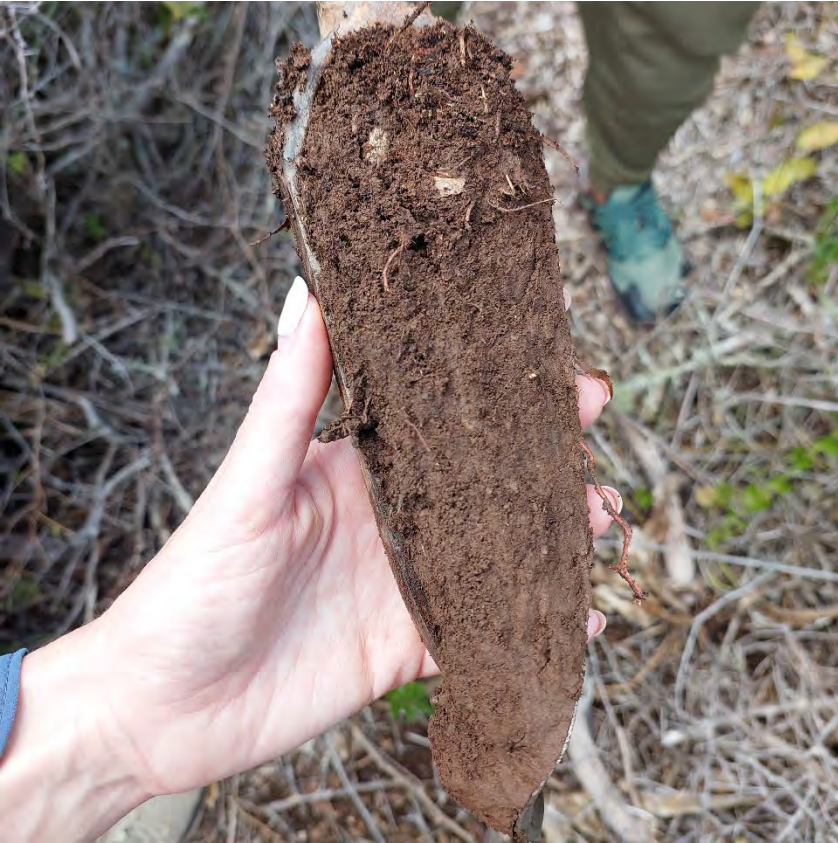
- **Soil Morphology:** Soil analysis further confirms the terrestrial status of the site. Soil samples taken within the development areas consisted of shallow red to orange soils with high clay content, lacking the anaerobic indicators (such as gleying or mottling) typically associated with wetland or saturated conditions.

Terrestrial soils from proposed new farmhouse area.

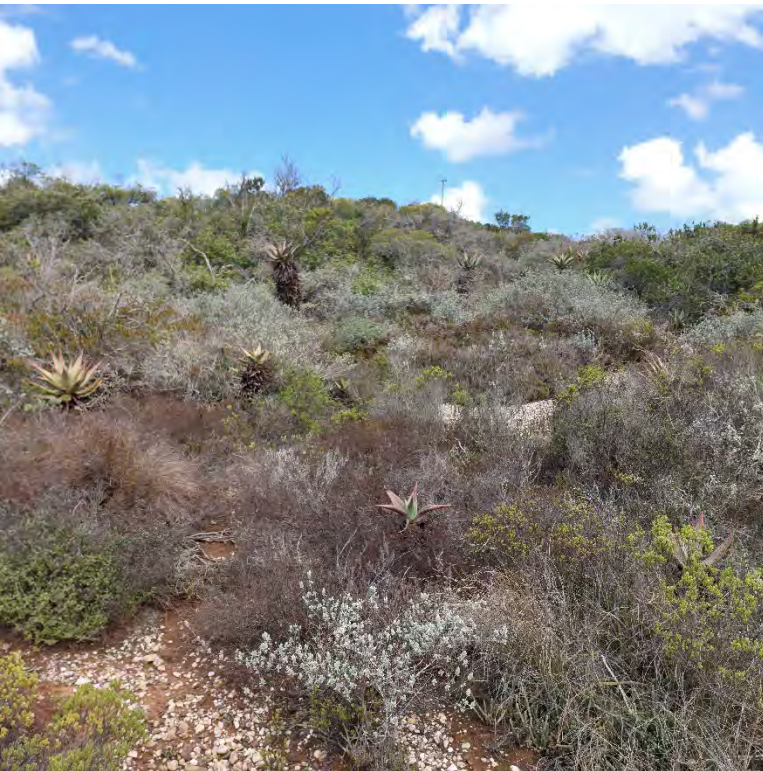
- **Vegetation Profile:** The vegetation within the proposed development area is characteristic of a terrestrial ecosystem, dominated by *Hermannia alnifolia* (Fanleaf Dollsrose), *Searsia glauca* (Blue Kunibush), *Putterlickia pyracantha* (Bastard Spikethorn), *Oedera uniflora* (Limestone Perdekaroo), and *Eriocephalus racemosus* (Kapkap Kapok) (**Annexure A**). These species are typical terrestrial shrubland components of dune Strandveld vegetation and are not associated with aquatic, riparian, or estuarine habitats.

New farmhouses are located on the top of this slope, terrestrial vegetation shown.

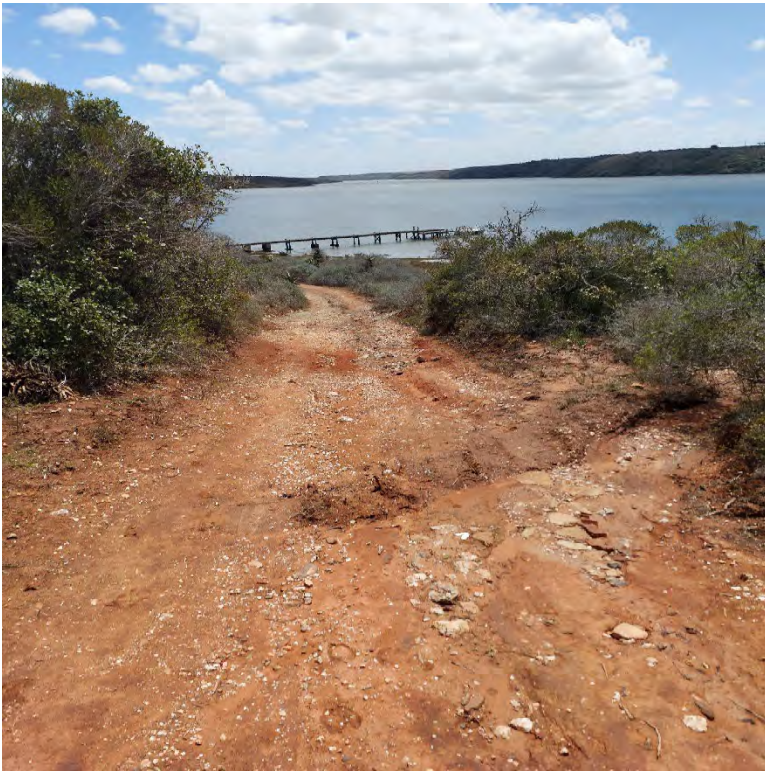
Area where the road upgrade is proposed.

- Road upgrade works must ensure that stormwater runoff from disturbed surfaces is directed through vegetated areas or temporary sediment traps prior to discharge.

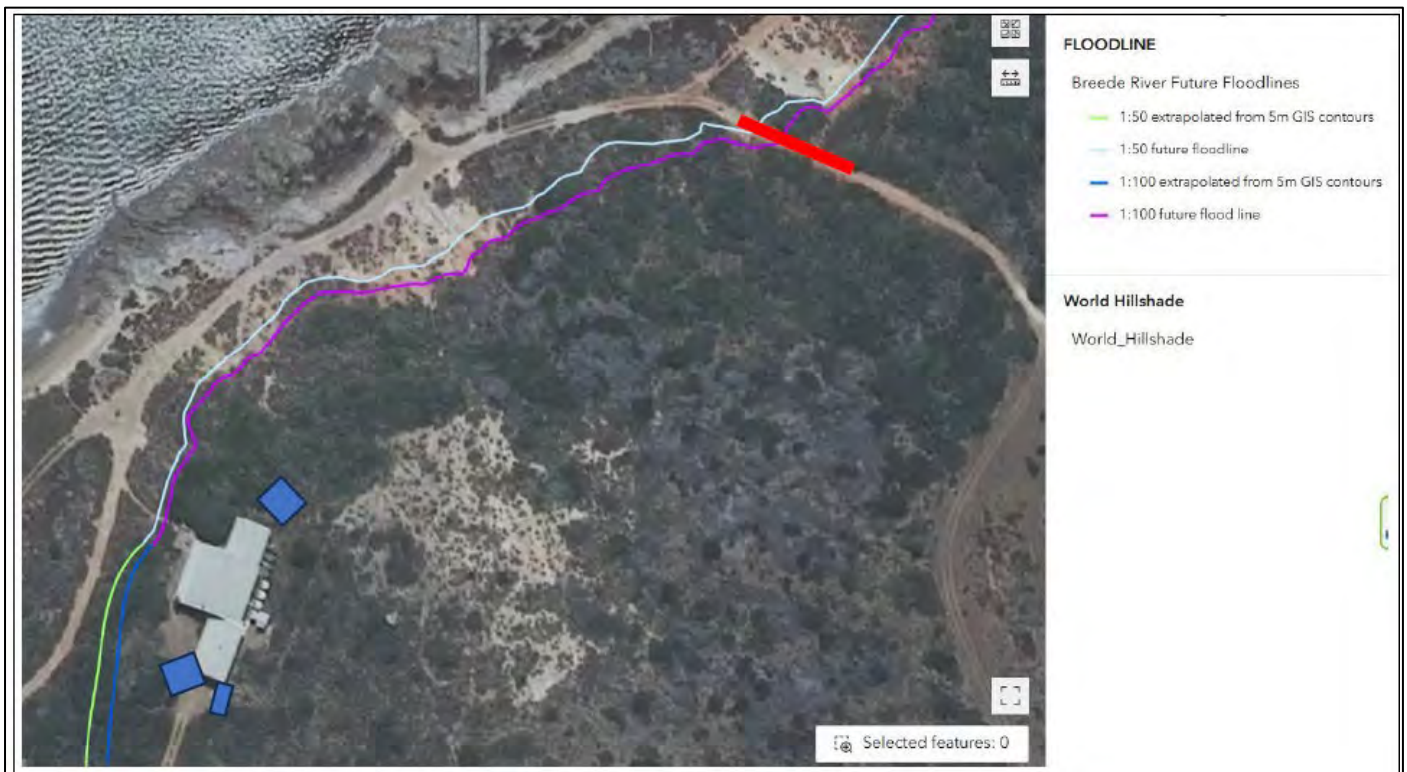
Farmhouse and new footprint is in blue, which is above the flood lines, the road is in red (existing) and works will be like-for-like.
