AQUATIC ECOSYSTEM ASSESSMENT FOR THE ALLEGED  
UNLAWFUL ACTIVITIES ON PORTION 54 OF THE FARM  
POTTEBERG ESTATES NO 516, INFANTA, WESTERN CAPE  
NOVEMBER 2025

(UPDATED MARCH & June 2026)

*Compiled by: Ms. Jeanne Snyman (M.Sc. Env Water Sciences, Pr. Sci. Nat)*

# AQUATIC ECOSYSTEM ASSESSMENT FOR THE ALLEGED UNLAWFUL ACTIVITIES ON PORTION 54 OF THE FARM POTTEBERG ESTATES NO 516, INFANTA, WESTERN CAPE.

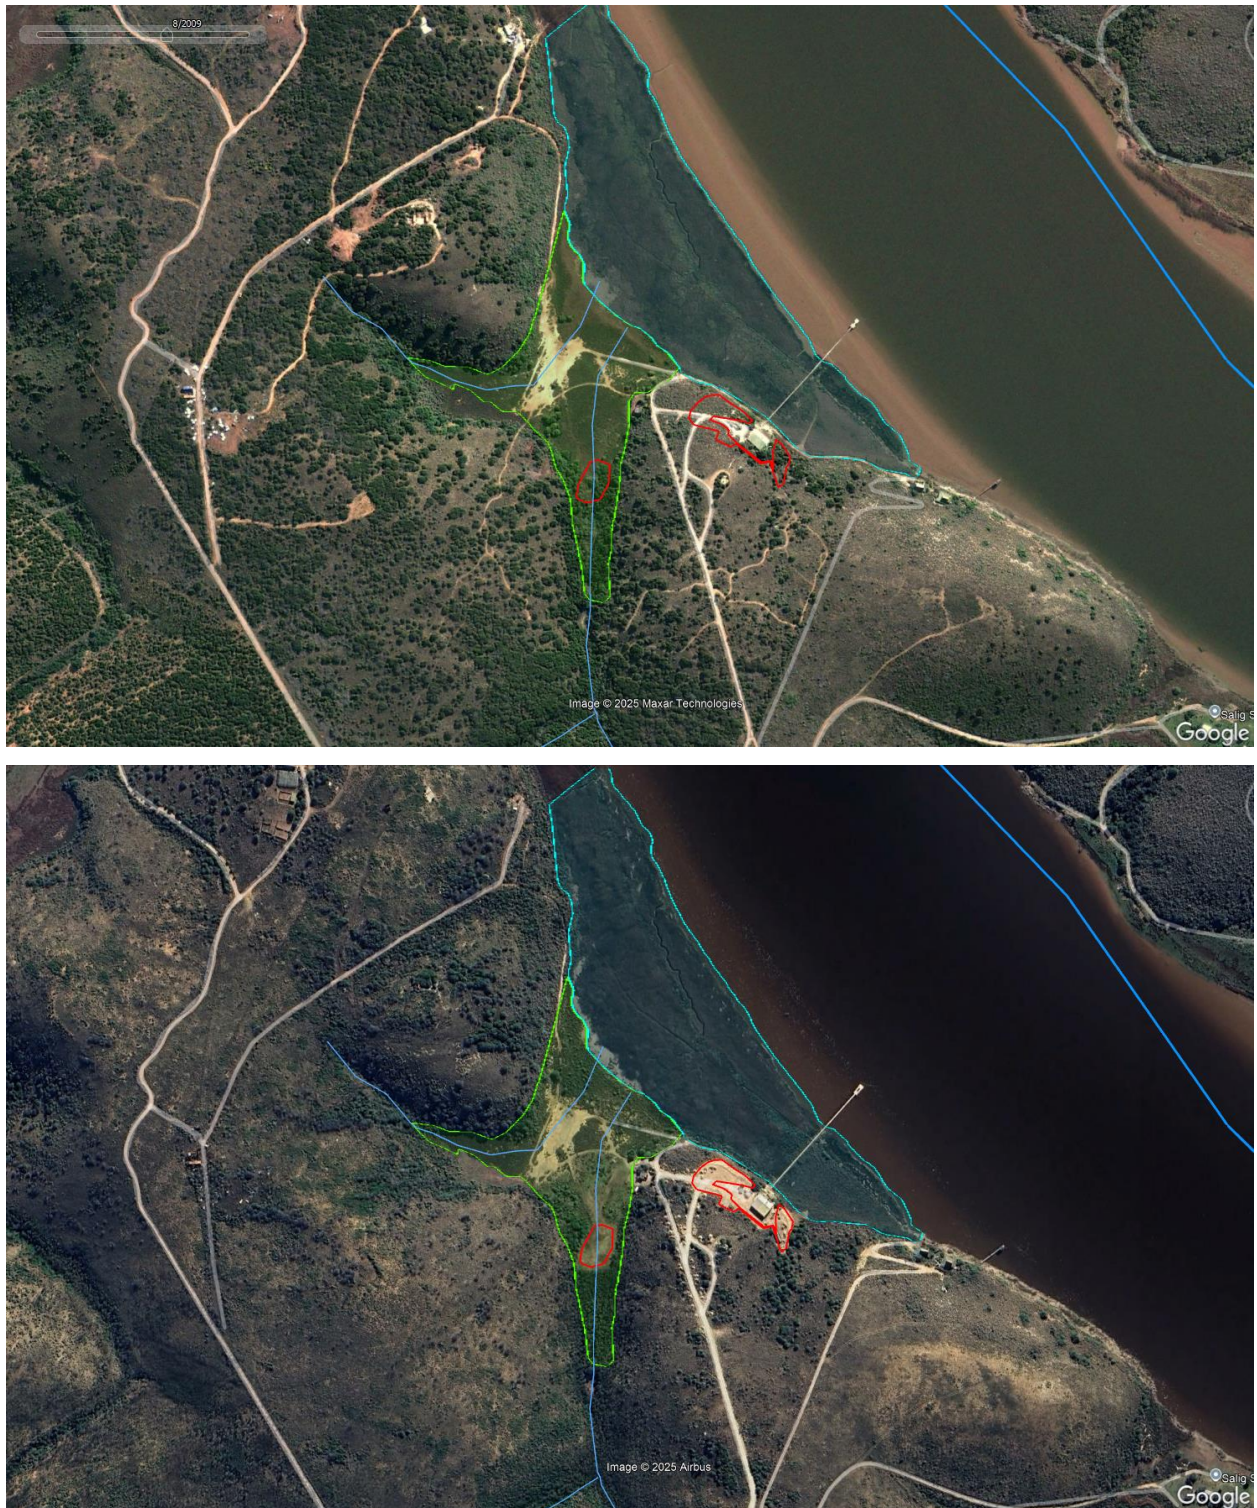
Figure 5: Google Earth imagery of the project site from 2009 (top) and 2024 (bottom). The estuarine wetland area is indicated by the turquoise polygon, while the unchanneled valley-bottom wetland is shown by the green polygon (Google Earth, 2025).

Google Earth's Timeline function was used as a reference (accessed in October 2025) to analyse historical land use and identify any wet areas. The earliest available clear imagery covering the affected areas is from August 2009, and approximately 19 images spanning the period between 2009 and 2024 were reviewed to assess historical land use and determine whether the site had been extensively altered or if significant changes in the catchment's land use occurred. The maps were also used to identify areas where aquatic ecosystems may exist or may have existed.

From these images, it is evident that land use around the property has remained largely consistent over the observed period, being predominantly natural. The property itself has historically been used only for residential purposes. With respect to freshwater features, the Breede River and its associated estuarine wetland areas are situated directly to the north of Disturbed Area 2, while Disturbed Area 1 falls within an unchanneled valley-bottom wetland associated with a small drainage line.

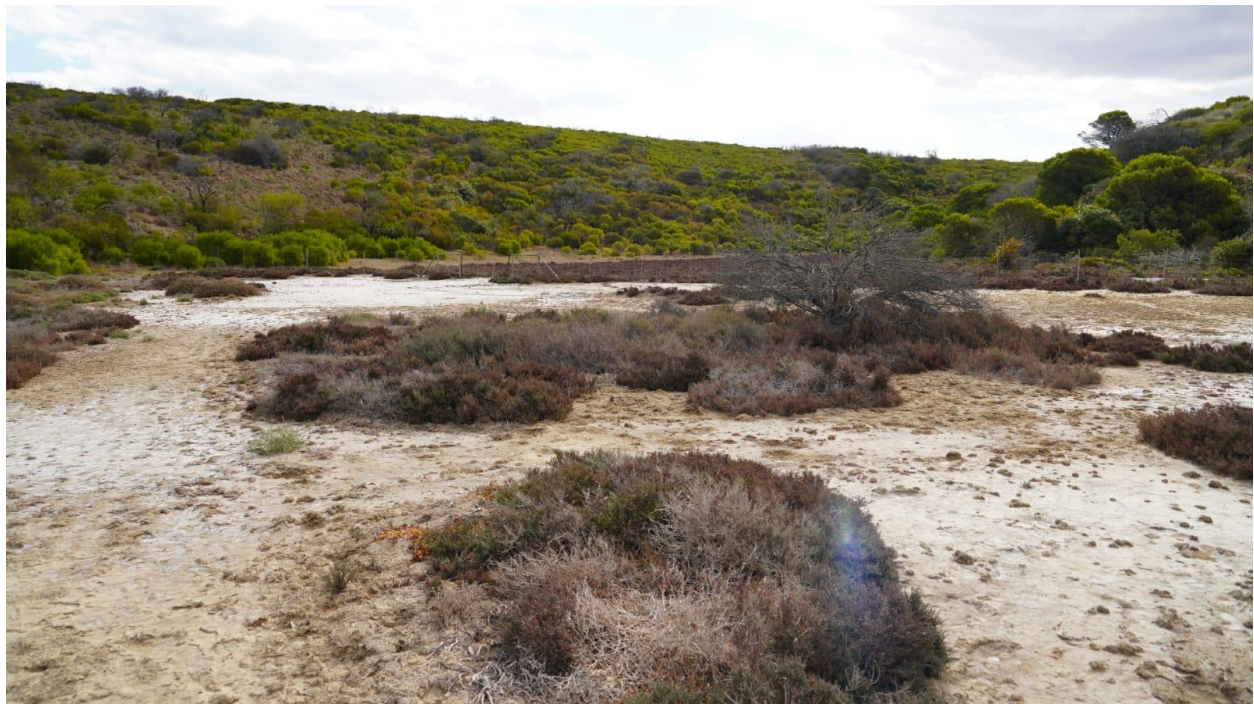
Figure 8: Vegetation found at Cleared Area 1.

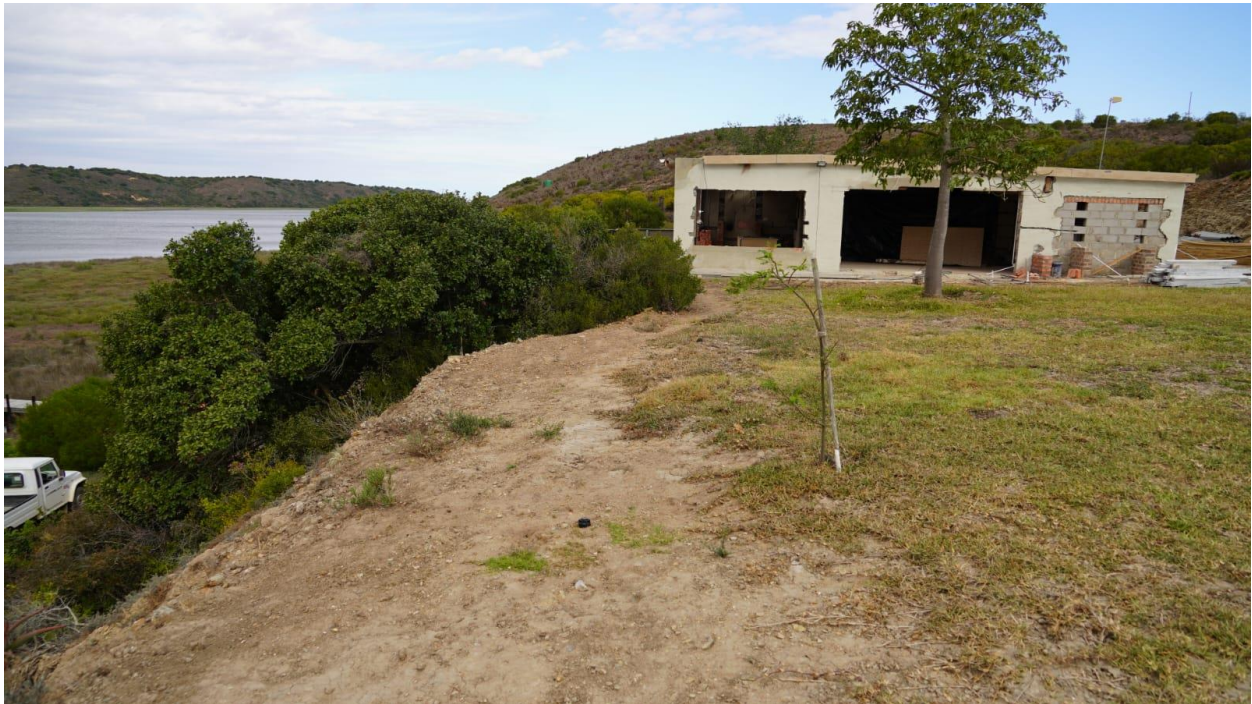
Figure 9: General view over Cleared Area 2.

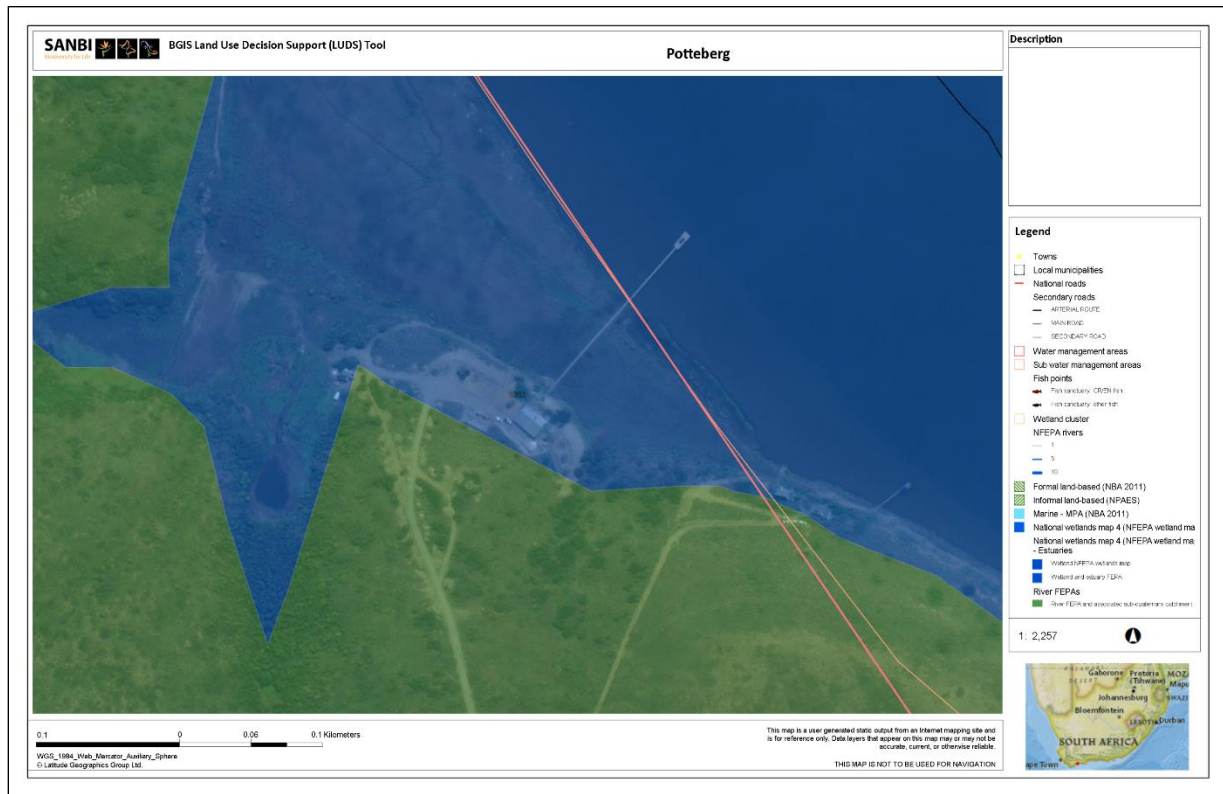
Within the project area, Cleared Area 2 falls within a FEPA wetland classified as Southwest Ferricrete Fynbos – Channelled Valley-Bottom Wetland (Condition C; FEPA Rank 2). The remainder of the disturbed

areas is located within an estuarine wetland. According to the National Wetlands Map, both disturbed areas fall within either the estuarine functional zone, which is considered vulnerable and poorly protected and a floodplain wetland (critically endangered).

**During the field visit, it was once again confirmed that Cleared Area 2 does not fall within any wetland areas.**

Figure 11: NFEPA and NWM5 map for the area (CFM, 2025)

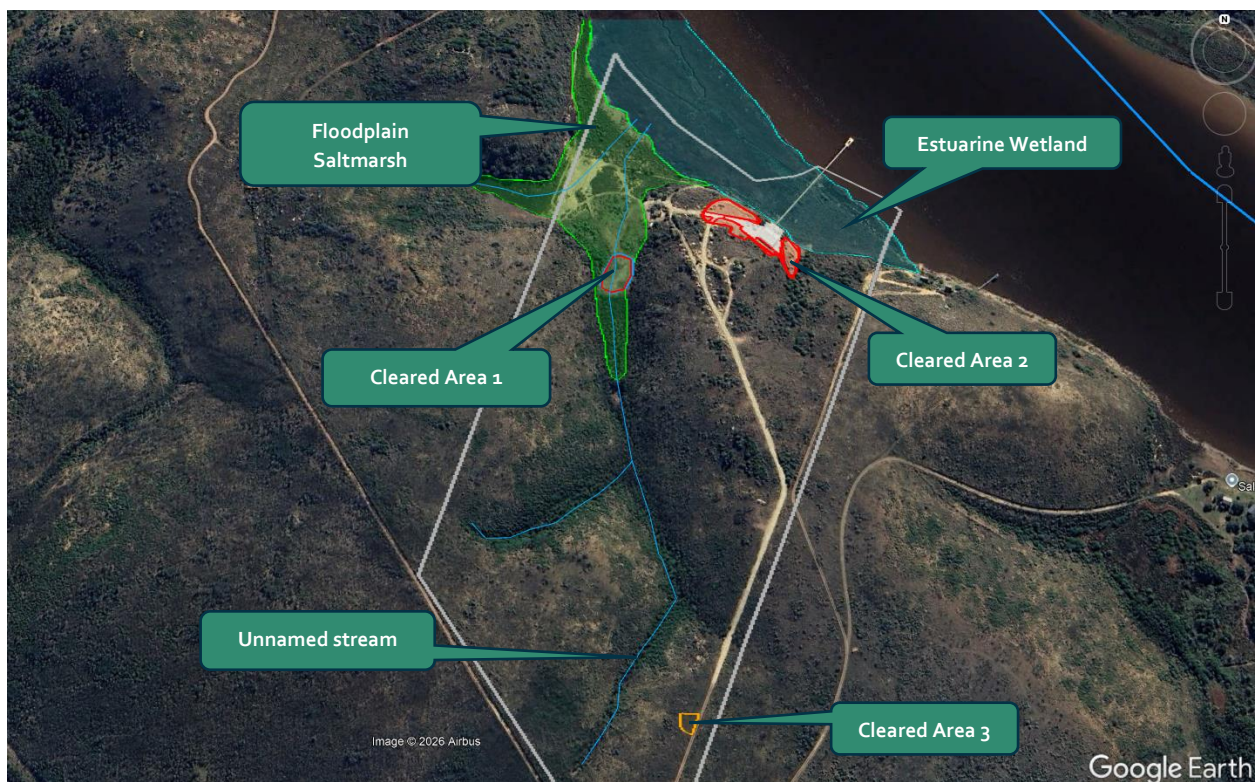
Although Cleared Area 3 lies within 100 m of an Unnamed stream, it is not located within the 1:100year flood line, or associated riparian zone, and thus is not considered to fall within the regulated area of the stream. The Unnamed stream was thus excluded from the freshwater and impact assessment.

Figure 13: Satellite image of the broader area showing surrounding freshwater features, including the Floodplain Saltmarsh (green polygon), the estuarine wetland (turquoise polygon) with the Breede River to the north-east, the Unnamed stream and the three cleared areas(Google Earth, 2025).

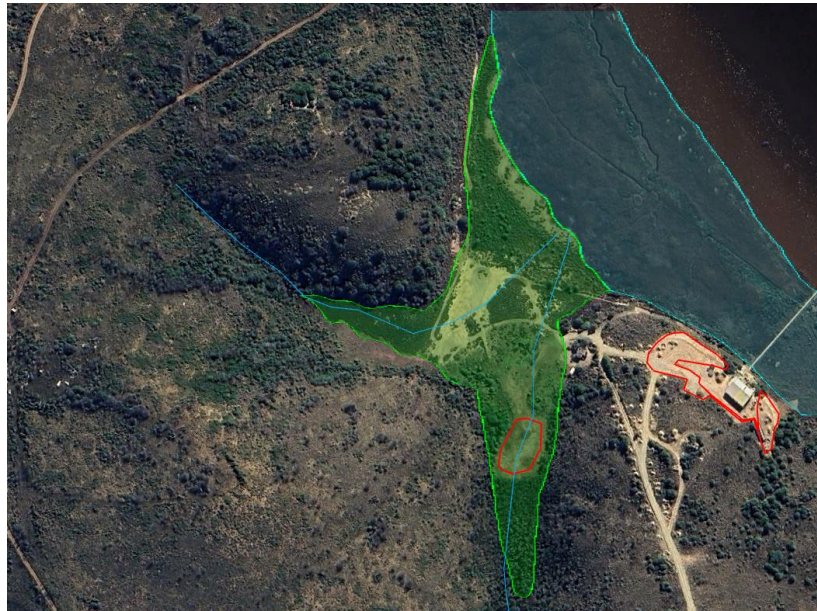
The occurrence of halophytic species such as *Salicornia perennis*, *Atriplex semibaccata* and *Disphyma crassifolium* suggests periodic saline influence. This salinity is likely partly associated with estuarine inundation and groundwater interactions linked to the Breede River Estuary, as well as some contribution from naturally saline runoff associated with local shale-derived soils and the ephemeral tributaries. The wetland therefore exhibits characteristics of both an estuarine-associated floodplain saltmarsh together with freshwater input.

The wetland has experienced progressive vegetation removal over many years, preceding the clearing of Cleared Area 1, which has resulted in significant degradation and the loss of substantial portions of its original extent. The broader area remains heavily infested with *Acacia cyclops* (Rooikrans) and *Acacia saligna* (Port Jackson). A small dam is located upstream of the wetland area within the one drainage line, altering some of the surface flow that might have contributed to a small degree to the health and function of the wetland. These habitats are considered critical for the maintenance of bait organism populations.

Figure 14: Satellite imagery showing the Floodplain Saltmarsh (filled green polygon) with the cleared areas (red polygon) (Google Earth, 2025)

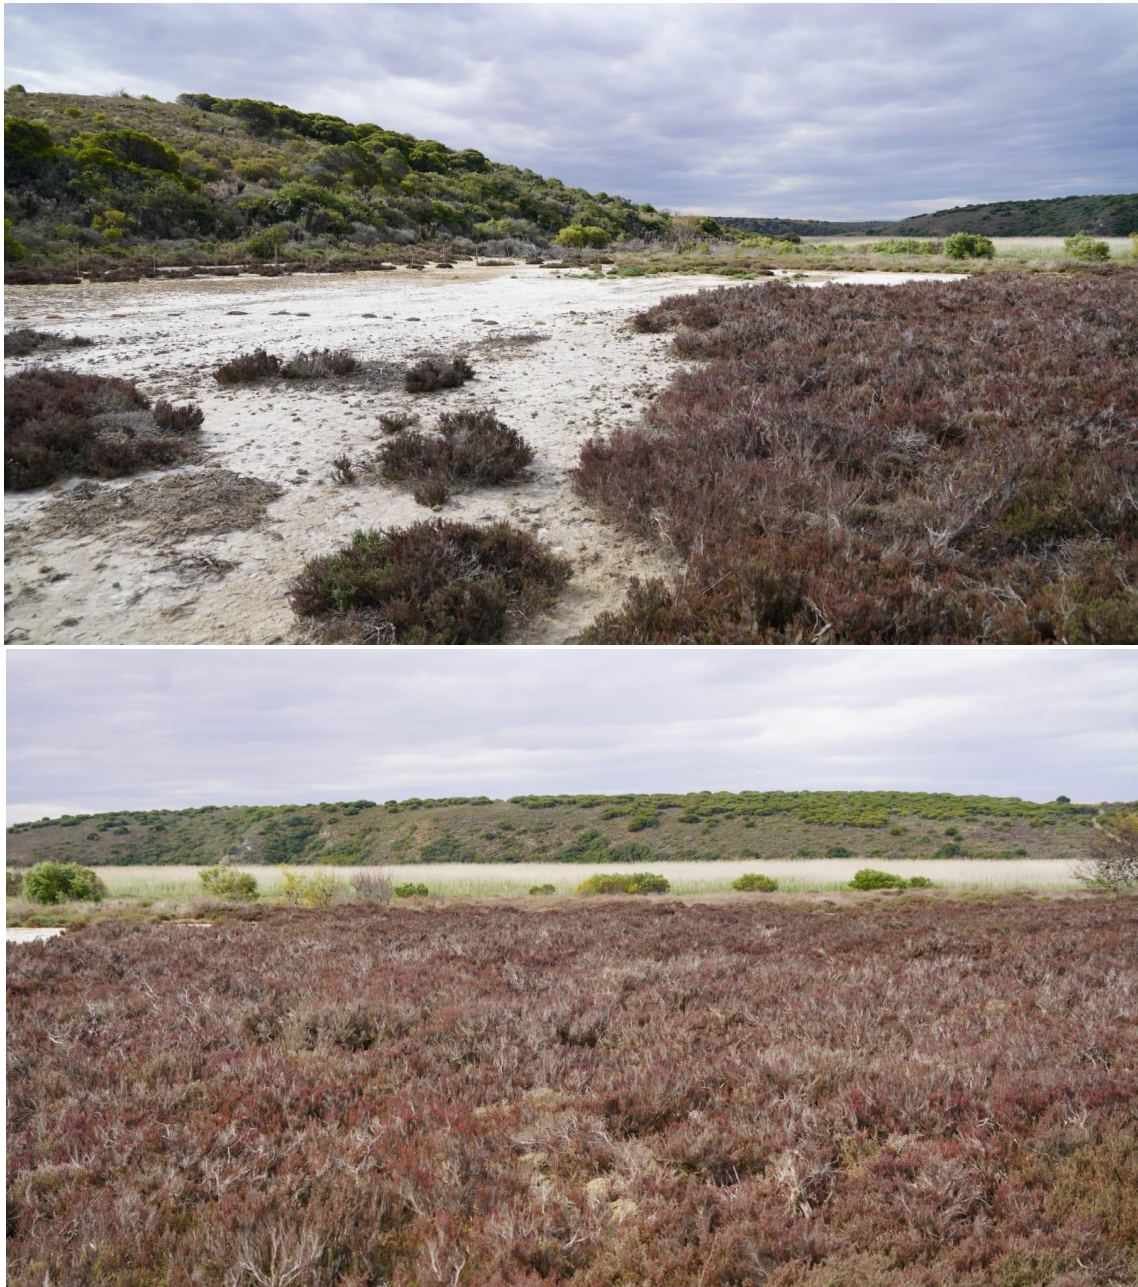
Figure 15: Views over Cleared Area 1 showing the open patches (top) and the remainder of the wetland towards the Breede River (bottom).

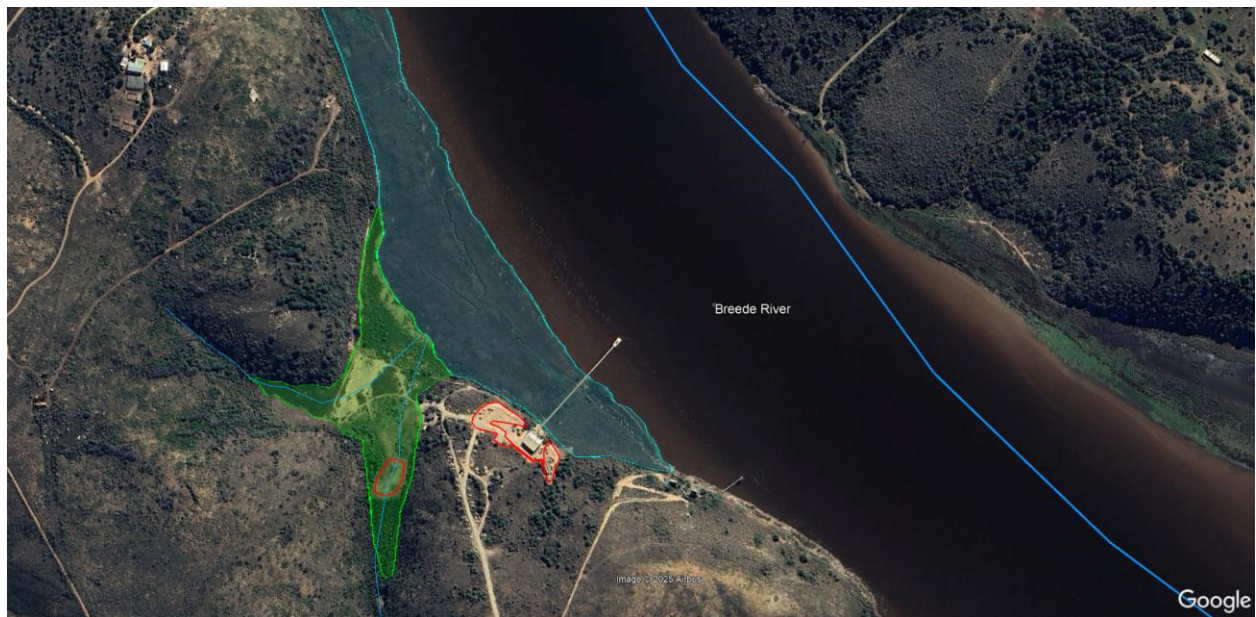
Although the unauthorised clearing activities did not directly affect the Breede River channel or the majority of the mapped EFZ, Cleared Area 1 occurred within floodplain saltmarsh habitat that forms part of the broader estuarine transition zone associated with the Breede River Estuary. Consequently, the ecological functioning and habitat characteristics of both the floodplain saltmarsh and adjoining estuarine habitats were considered during the assessment.

Figure 16: Satellite imagery showing the Breede River and its Estuarine Functional Zone (turquoise polygon) located directly adjacent to the study area. (Google Earth, 2025)

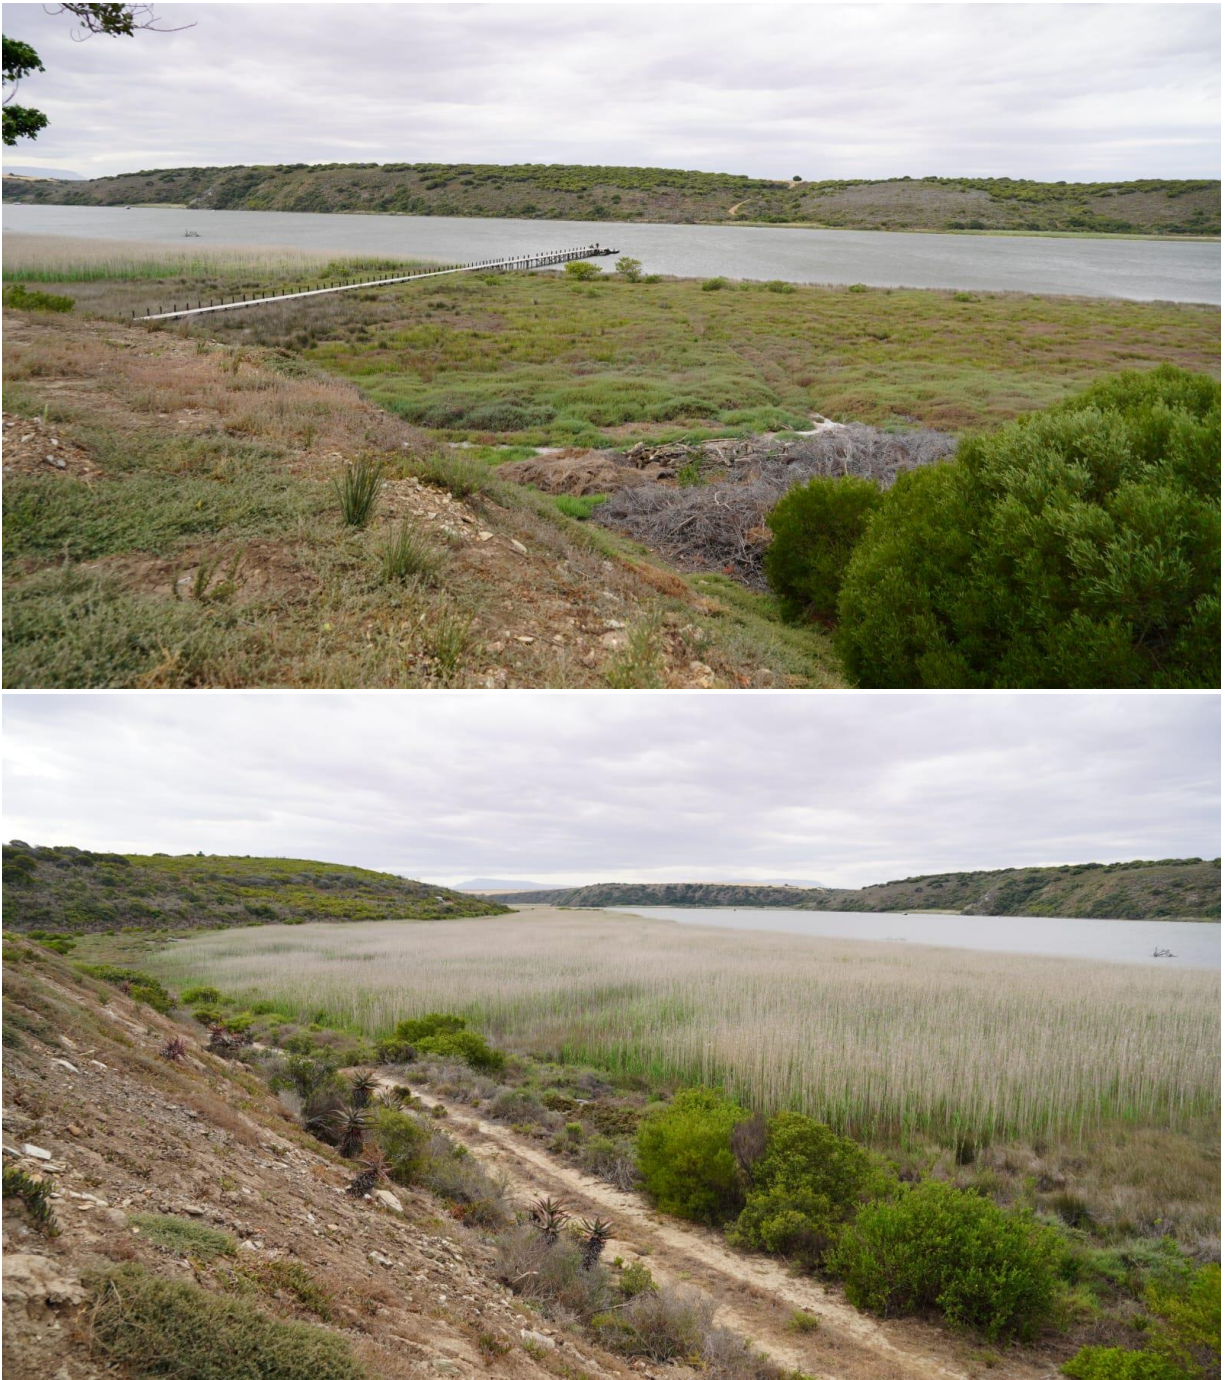
Figure 17: Views over the Breede Rivers' Estuarine Functional Zone situated below Cleared Area 2.

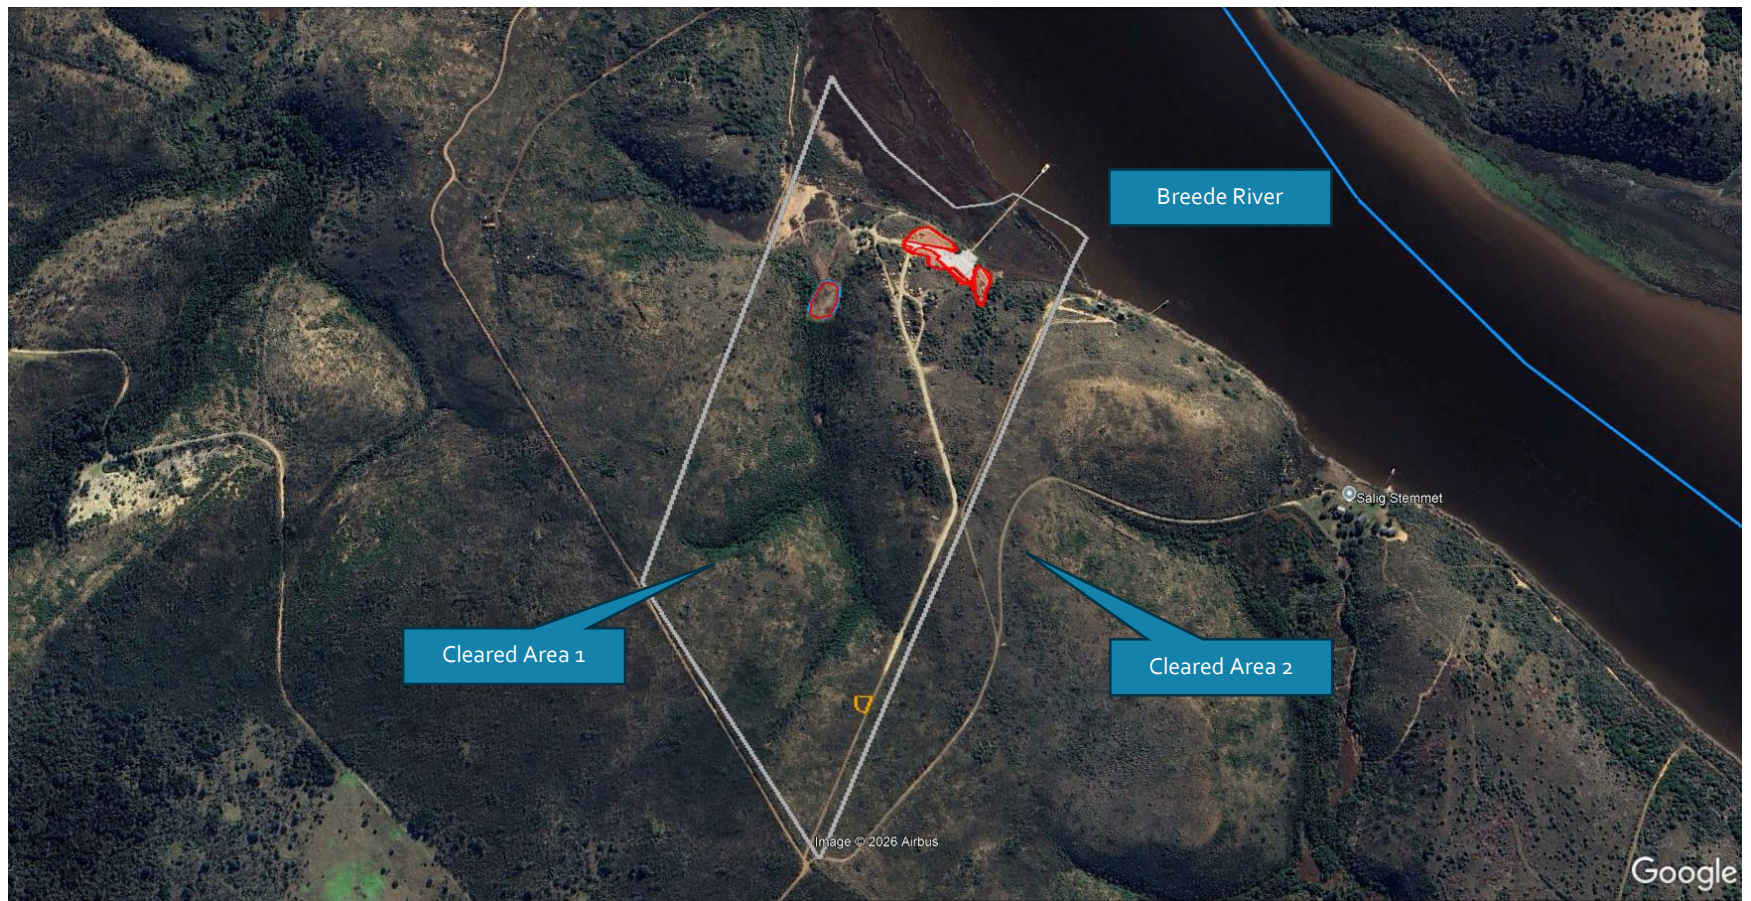
Figure D-2: A satellite image showing the property boundary (grey polygon), as well as the cleared areas (red and orange polygons). (Google Earth, 2025)

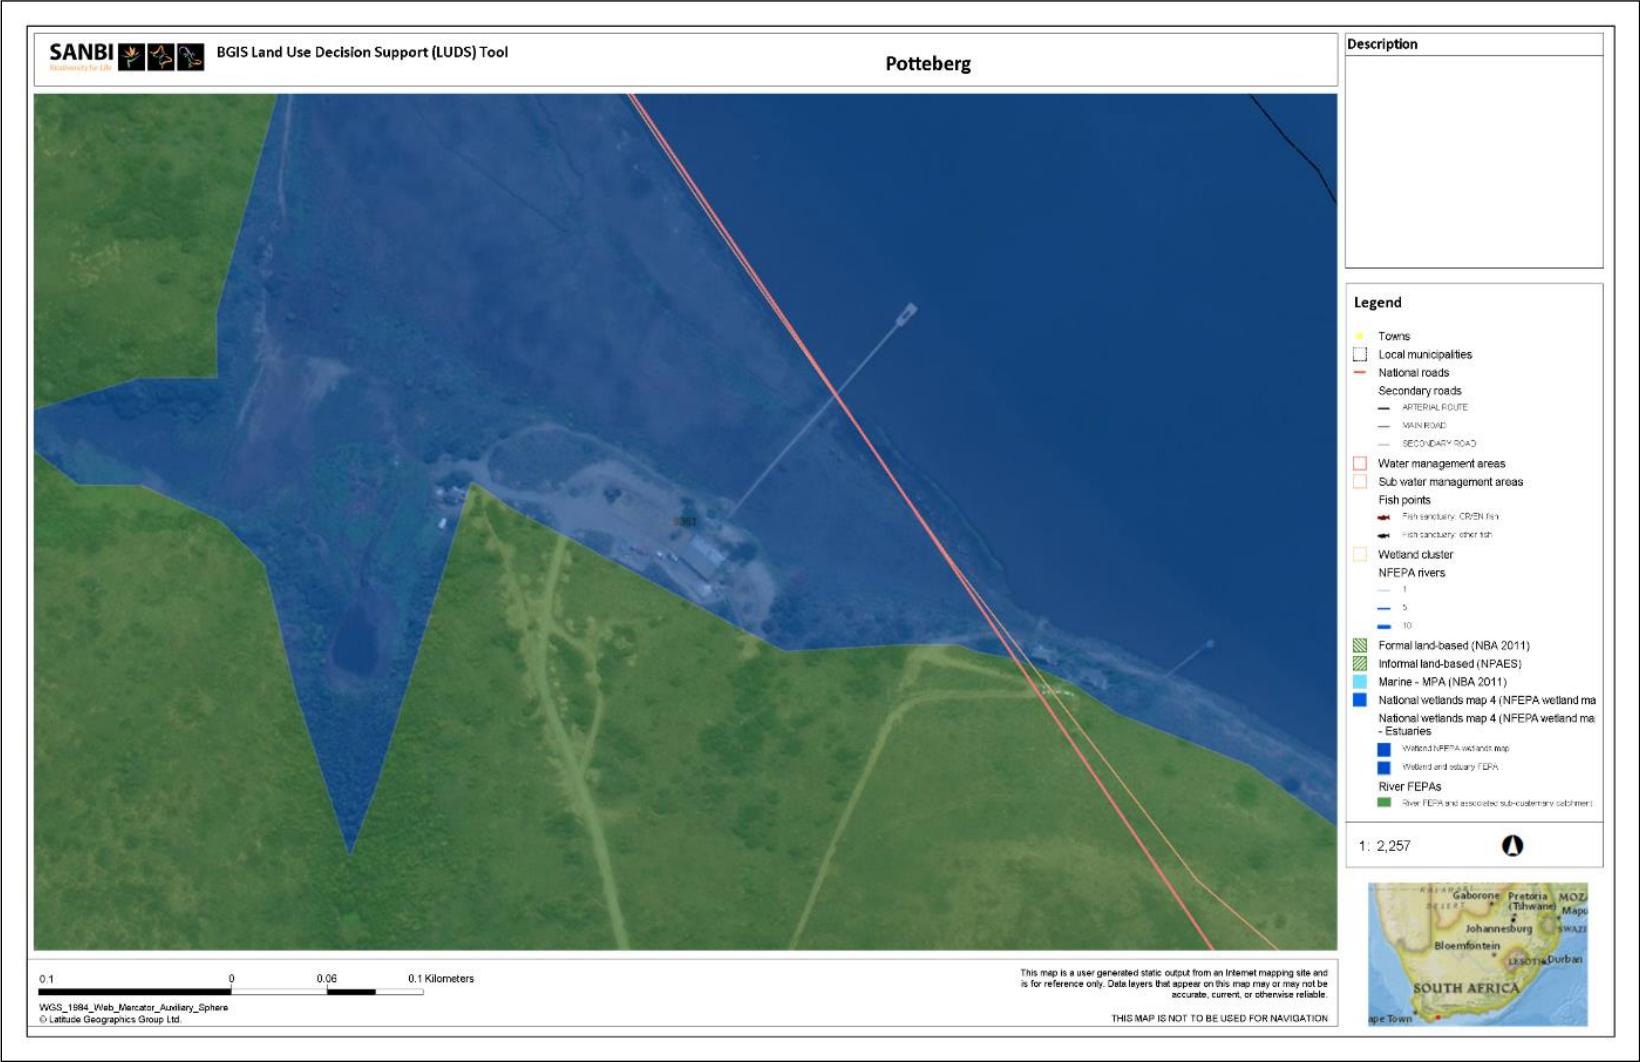
Figure D-5: NFEPA and NWM5 map for the area (CFM, 2025)

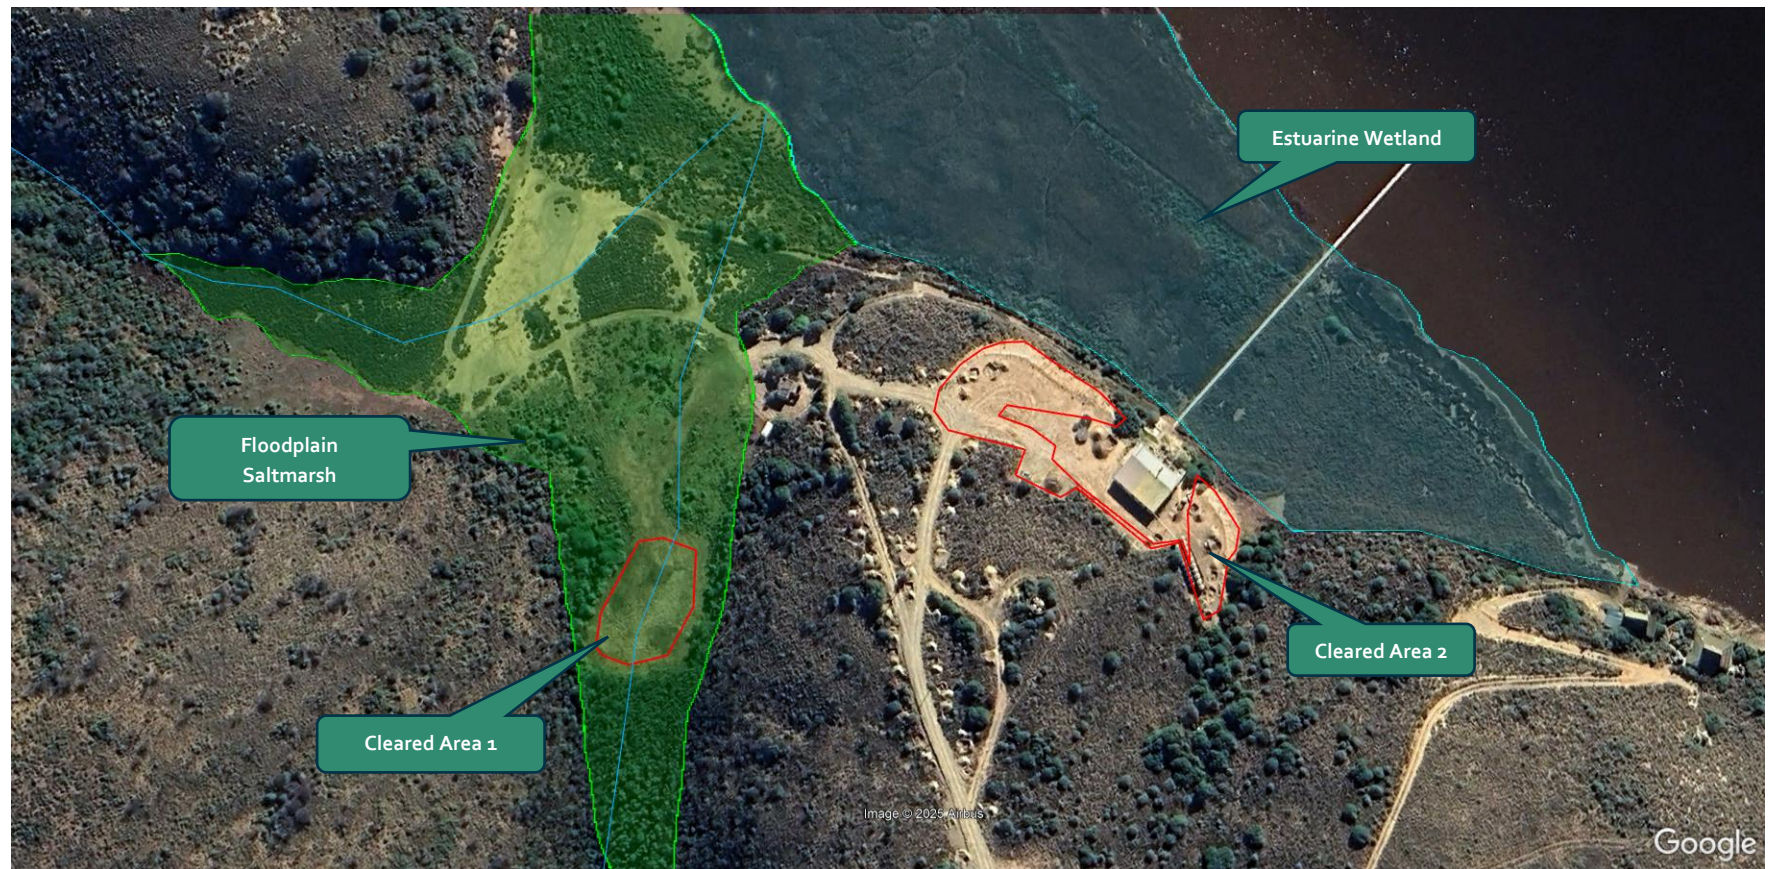
Figure D-6: Satellite image of the broader area showing surrounding freshwater features, including the Floodplain Saltmarsh (green polygon), the estuarine wetland (turquoise polygon) with the Breede River to the north-east, and the two cleared areas (red polygons) (Google Earth, 2025).
