APPENDIX M2 – SITE SENSITIVITY VERIFICATION REPORT

SITE SENSITIVITY VERIFICATION REPORT:
**UNAUTHORIZED INDIGENOUS VEGETATION CLEARING,
EXCAVATION AND DEVELOPMENT ON PORTION 54 OF
FARM 516, THE POTTEBERG ESTATES, INFANTA**

Date: February 2026

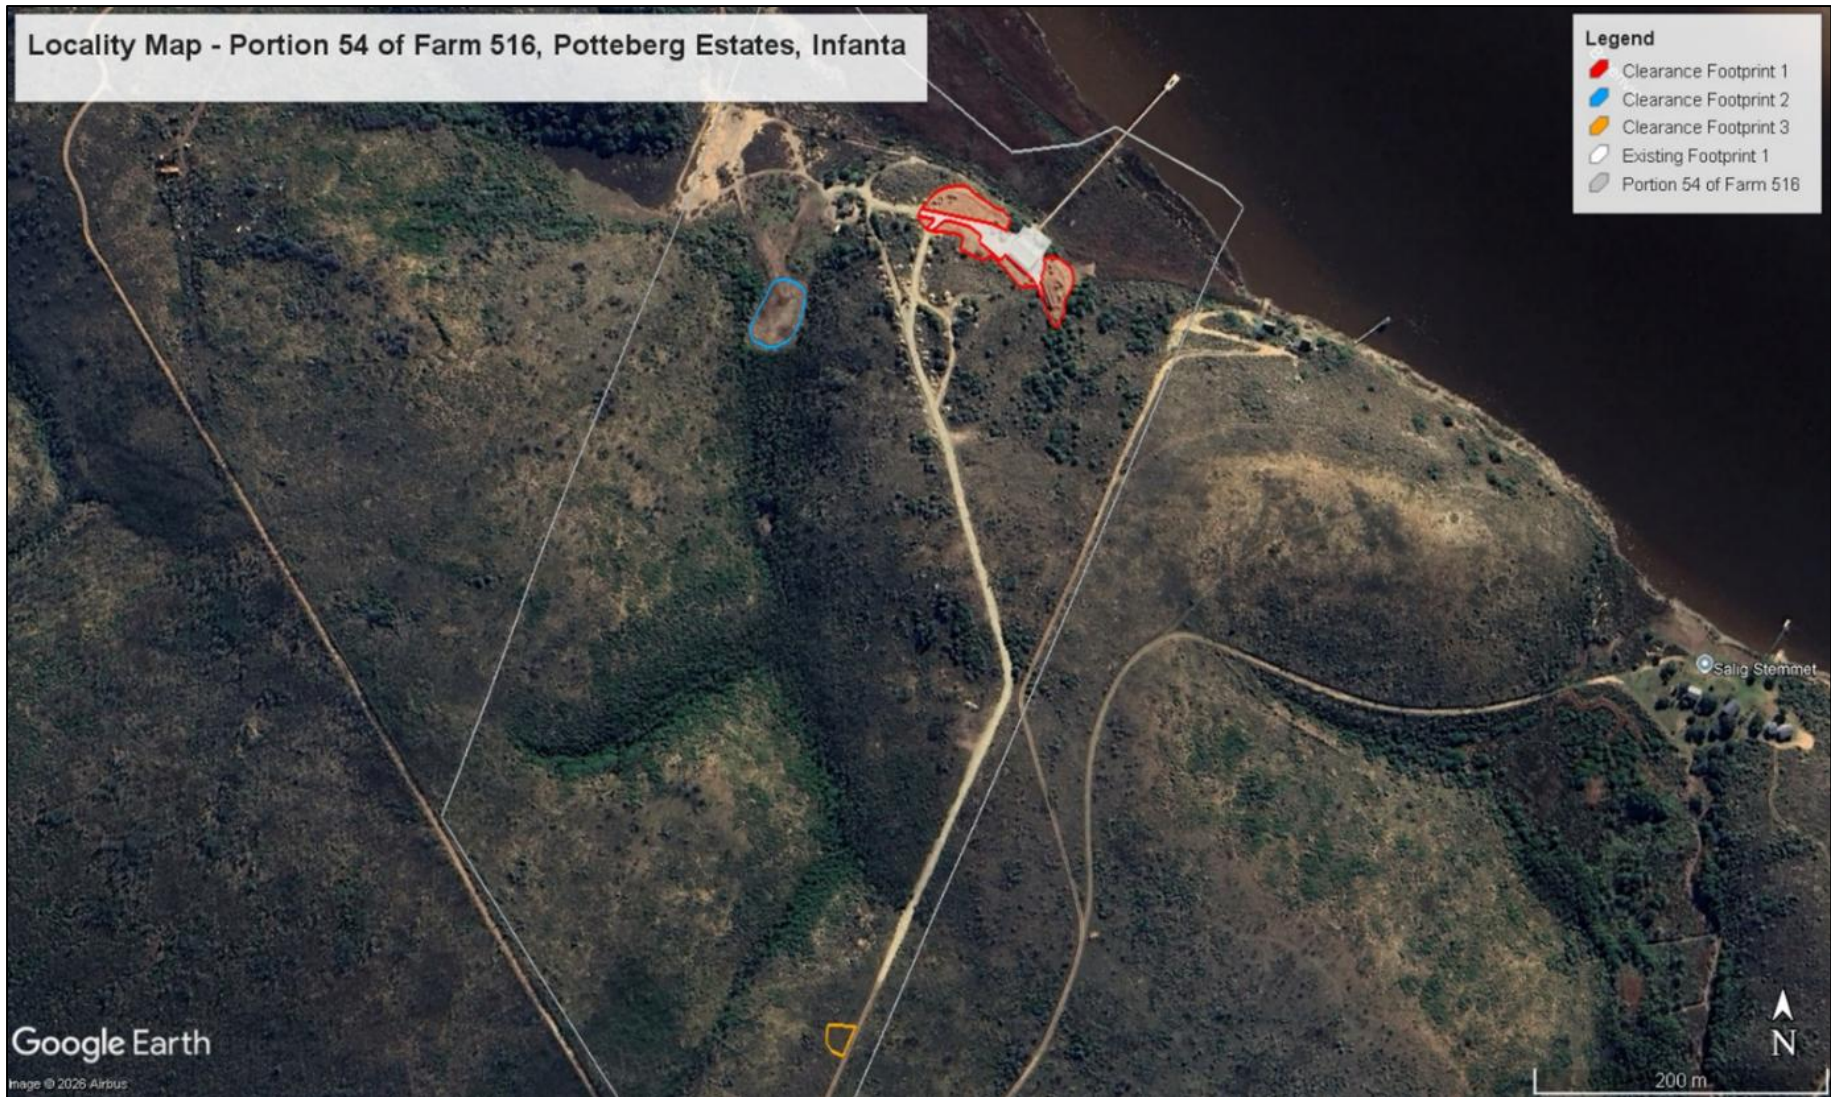
Figure 1: Locality Map – Unlawful clearance within Portion 54 of Farm 516, Infanta

In February 2024 unlawful clearing of indigenous vegetation, excavation and development took place onsite. In total, approximately 0.4 ha of vegetation was removed across three disturbance footprints (Figure 1).

- Unlawful clearing and levelling of approximately 0.24 ha around the existing main dwelling (Footprint 1) – *to be retained*.
- Unlawful clearing and soil removal of approximately 0.12 ha within the floodplain saltmarsh (Footprint 2) – *to be rehabilitated*.
- Unlawful clearing of approximately 0.02 ha in the southern portion of the property adjacent to the access road (Footprint 3) – *200m² to be retained*.
- Construction of an approximately 64 m² double garage within Footprint 1 – *to be retained*.
- Construction of an approximately 8 m² pumproom within Footprint 1 – *to be retained*.
- Construction of an approximately 36 m² caretaker's cottage within Footprint 3 – *to be retained*.

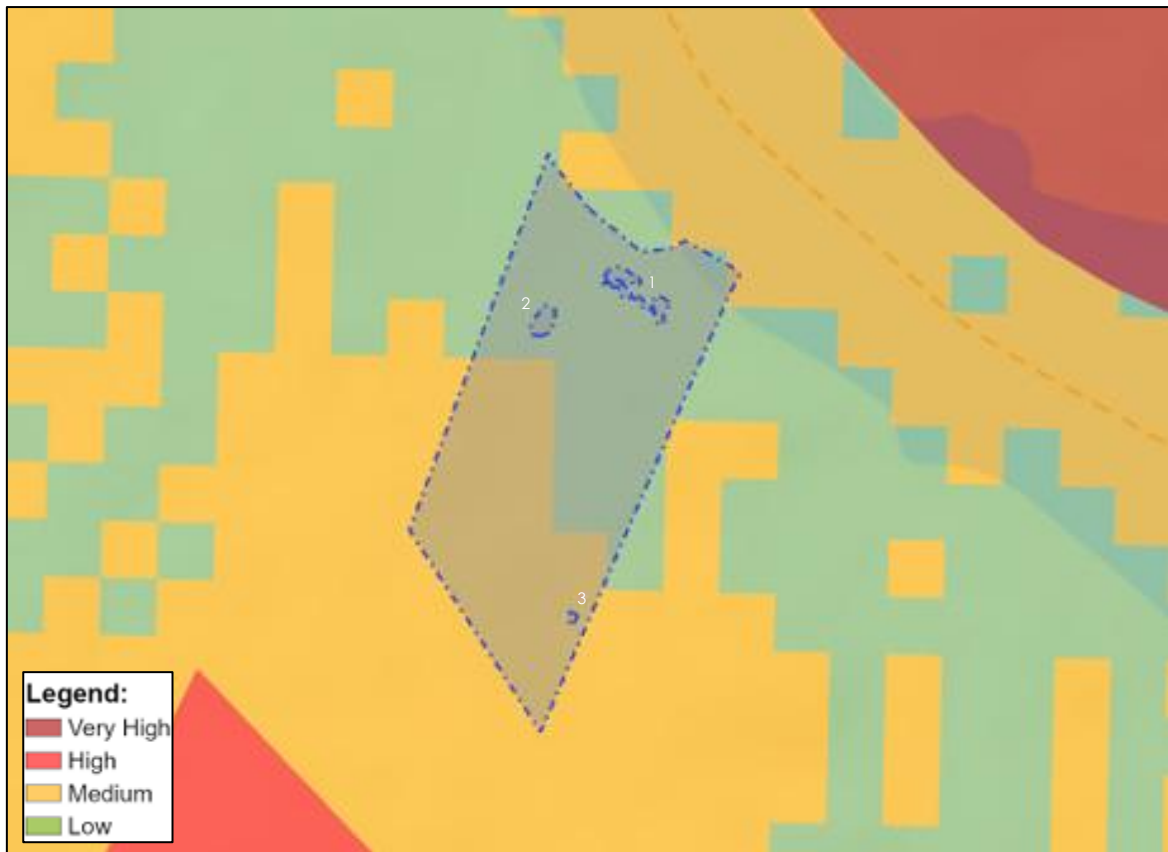
Figure 3: Agricultural Sensitivity. The cleared areas are shown as blue dotted lines within the site boundaries.

The screening tool report generated for the cleared footprints indicates that Footprint 1 and Footprint 2 are classified as having 'low' agricultural sensitivity while Footprint 3 is classified as having 'medium' agricultural sensitivity (**See Figure 3**). The DEA screening tool automatically reverts to the highest sensitivity. The report therefore flags the development footprint as Medium Sensitivity. The reasons listed were:

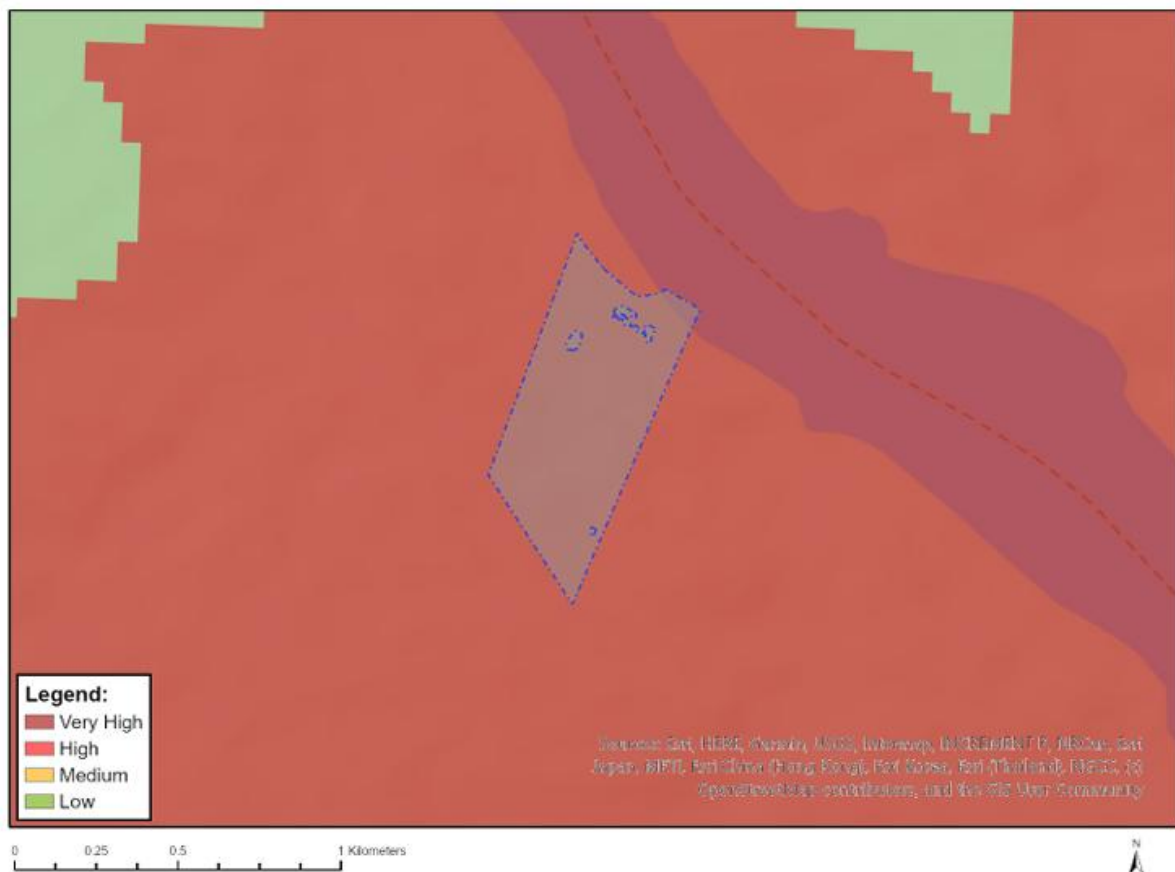
Figure 6: Aquatic Biodiversity Sensitivity. The cleared areas are shown as blue dotted lines within the site boundaries.

The Aquatic Biodiversity theme is identified and mapped as 'very high' sensitivity throughout the property (See Figure 6). This is due to the location of the property within a FEPA sub catchment, the presence of an estuary and rivers onsite as well as the presence of estuary and wetland CBAs onsite.

The property is situated along the southern banks of the Breede River, approximately 13 km upstream of the Breede River mouth. This reach of the river forms part of a known estuarine zone. Given the high aquatic sensitivity and the likely presence of aquatic constraints in the vicinity of the proposed development footprints, an aquatic specialist (Jeanne Snyman of everWater Freshwater Consulting Services) was appointed to undertake a specialist assessment.

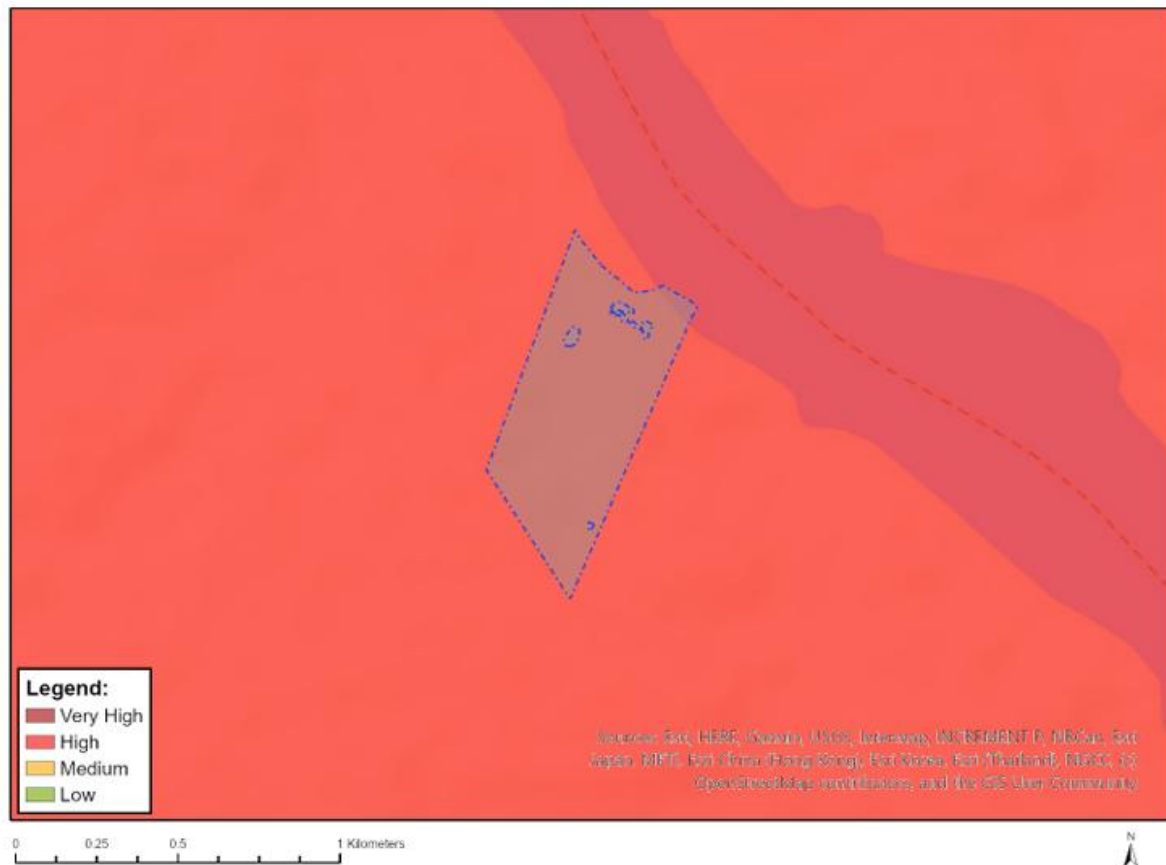
Figure 8: Civil Aviation Sensitivity. The cleared areas are shown as blue dotted lines within the site boundaries.

This theme is identified as 'high' due to the following: 'Dangerous and restricted airspace as demarcated '(See Figure 8). The development will however not introduce any structures or activities that could interfere with aviation operations, flight paths, or airspace safety. Given the nature of the development activities, no aviation-related impacts are anticipated, and as such no further assessment or specialist input is considered necessary.
