# **Planned Expansion of Cultivated Fields on Portion 3 of Farm Aan de Valsch Rivier 186 and Farm Horeb 149, Riversdale, Western Cape.**

Scoping Report - Aquatic Biodiversity

**Prepared For:** PH Consulting  
**Author:** Dr. J.M. Dabrowski (PhD)  
Confluent Environmental Pty (Ltd)  
7 St. Johns Street,  
Dormehlsdrift,  
George, 6529  
**SACNASP:** Pr. Sci. Nat. (Water Resources) – 114084  
**Date:** 2 December 2024  
**Version:** Draft Final

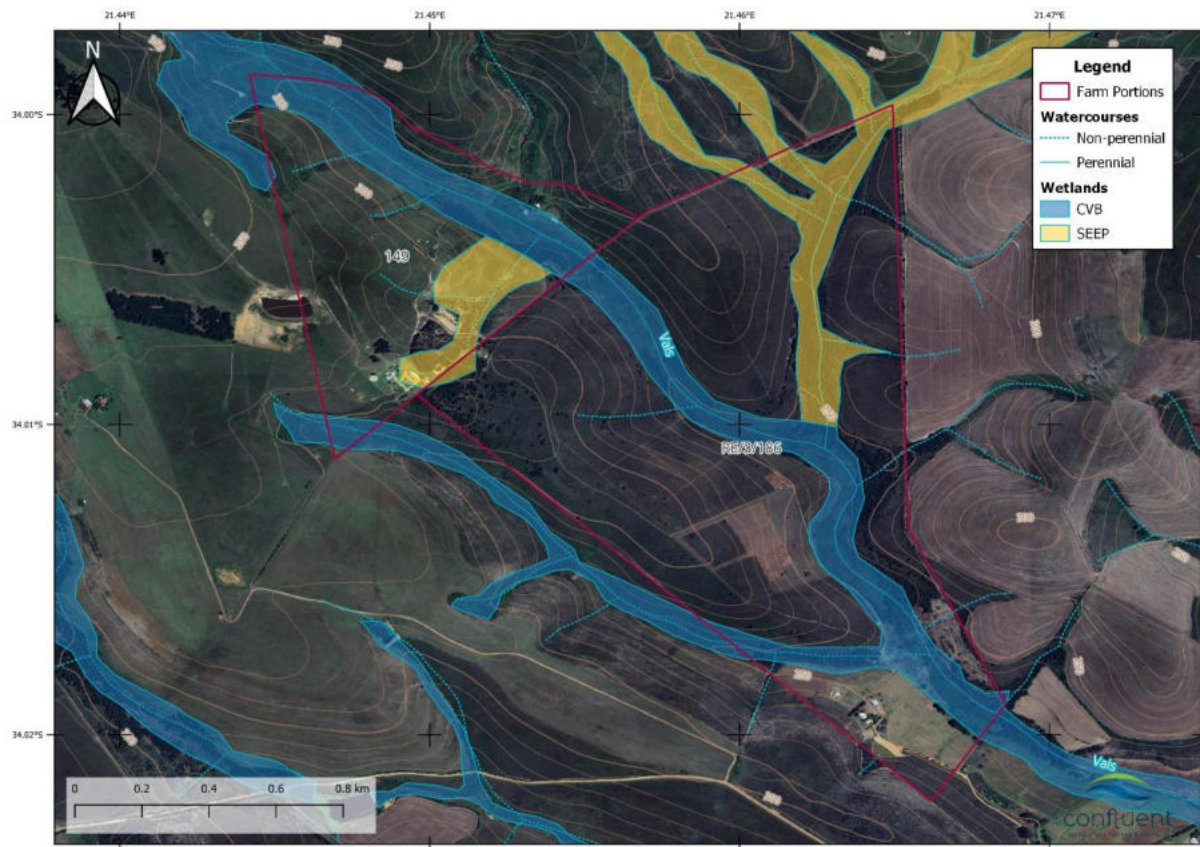
Watercourses mapped within the property boundaries include the Vals River and its tributaries which run along confined, low gradient valleys and are mapped as channelled valley-bottom wetlands (Figure 2). A hillslope seep wetland and non-perennial drainage lines are mapped along the east facing slopes of Farm 149 and several non-perennial streams drain the west facing slopes of Portion 3 of Farm 186. An extensive seep wetland network drains the mountains to the north and meets the Vals River in the north-eastern corner of Portion 3 of Farm 186.

Figure 2: Map indicating mapped watercourses associated with the properties.

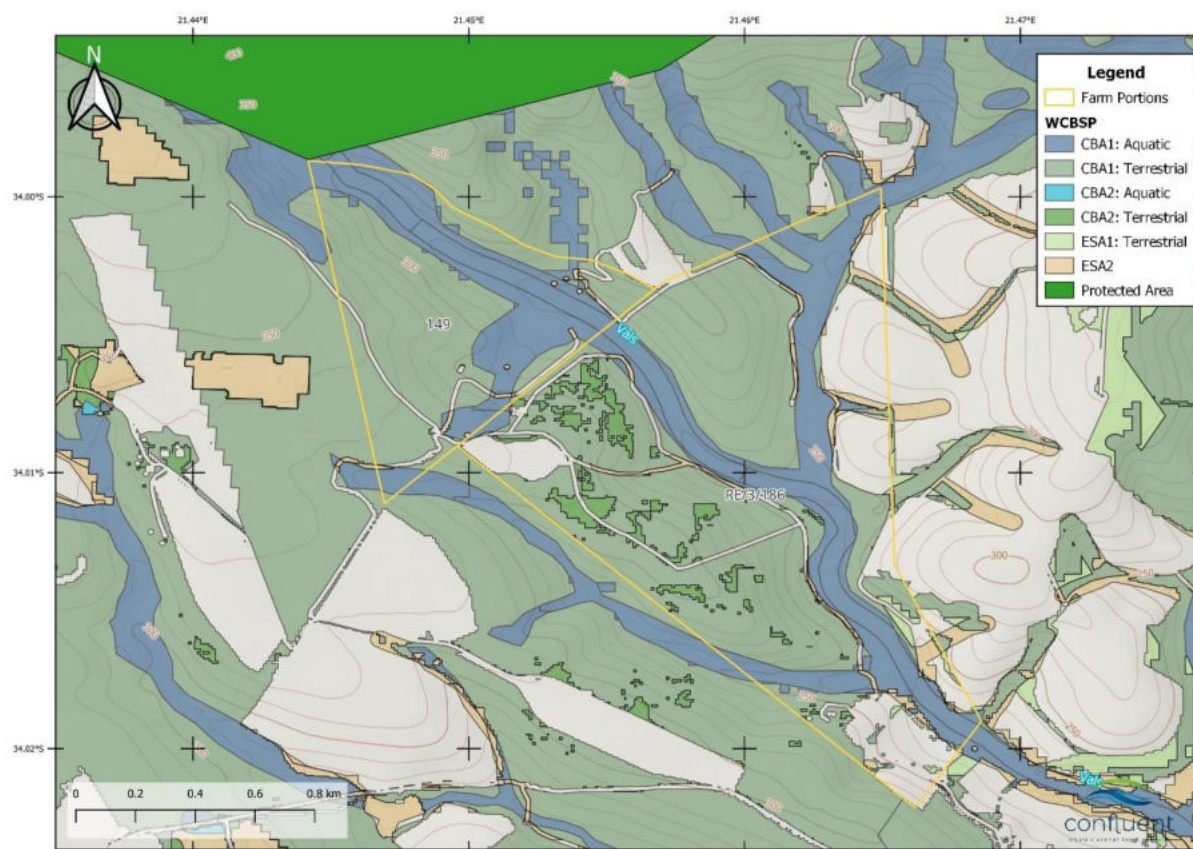
All wetlands indicated to occur within each of the property boundaries have been mapped as aquatic CBA1 (Figure 4). These are wetlands that are considered to be in a relatively natural condition and are important for meeting provincial biodiversity targets. Management objectives require minimal, low impact development so that the natural state of the watercourses are maintained (Table 1). Adjacent terrestrial areas have been largely mapped as terrestrial CBA1.

Figure 4: Map of the dams and road crossings in relation to the Western Cape Biodiversity Spatial Plan (WCBSP).

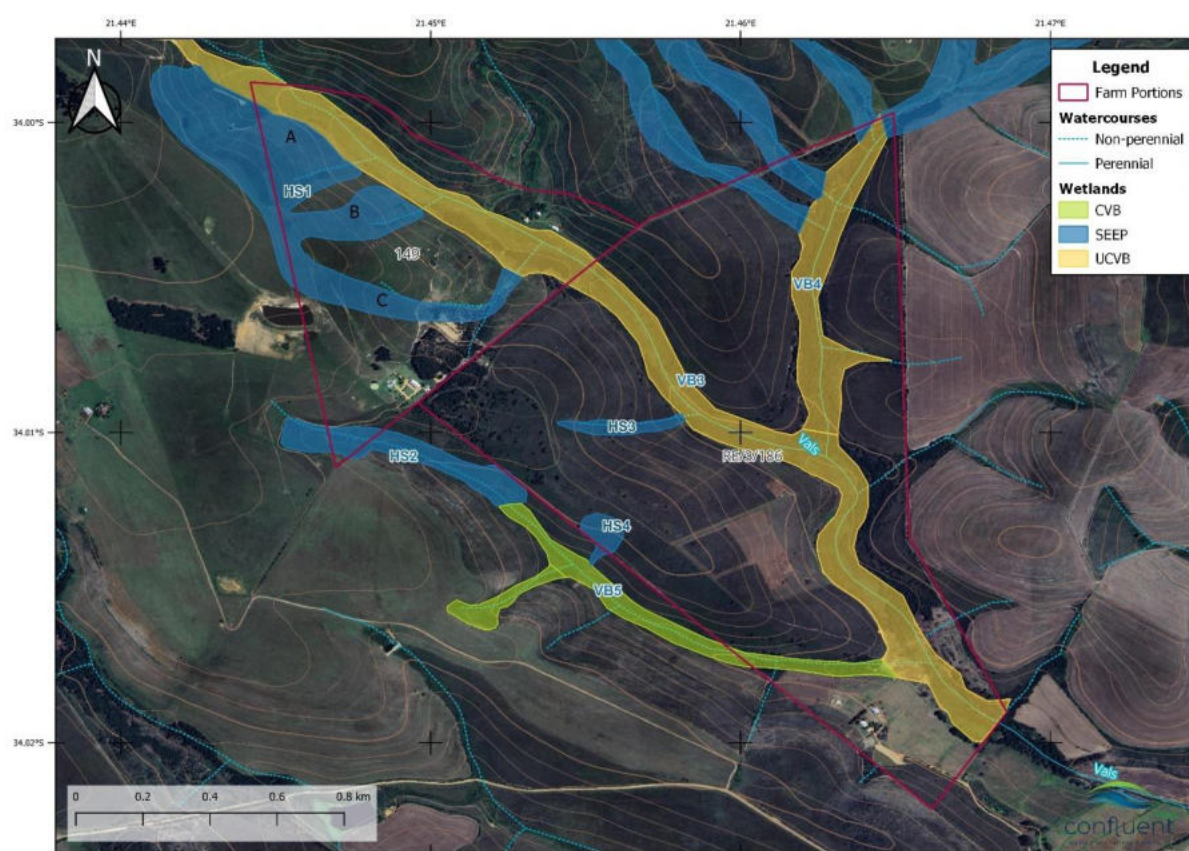
Figure 5: Map showing wetlands delineated and classified on Portion 3 of Farm Aan de Valsch Rivier 186 and Farm Horeb 149.

As the name implies, these wetlands are located along the valley bottoms of both properties. VB3 follows the Vals River and is the most prominent HGM (Figure 5). It is an unchannelled valley-bottom wetland located along a low gradient valley, which favours diffuse (as opposed to channelled) streamflow, ultimately resulting in prolonged saturation levels and deposition of high levels of organic matter and sediment. VB3, is broad and well vegetated by a variety of wetland plant species that include *Carpha glomerata*, *Watsonia angusta* and *Elegia capensis*.

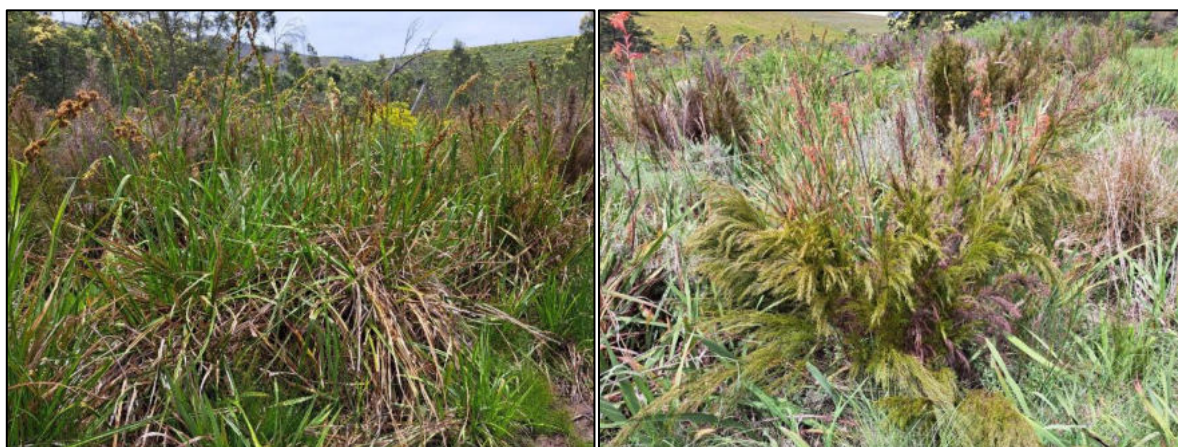
Figure 6: Examples of wetland common wetland plant species observed including *Carpha glomerata* (left) and *Eligia capensis* and *Watsonia angusta* (right).

(Figure 6) While the wetland is heavily invaded by Black Wattle (*Acacia mearnsii*) in some sections, most of the wetland remains free of invasion.

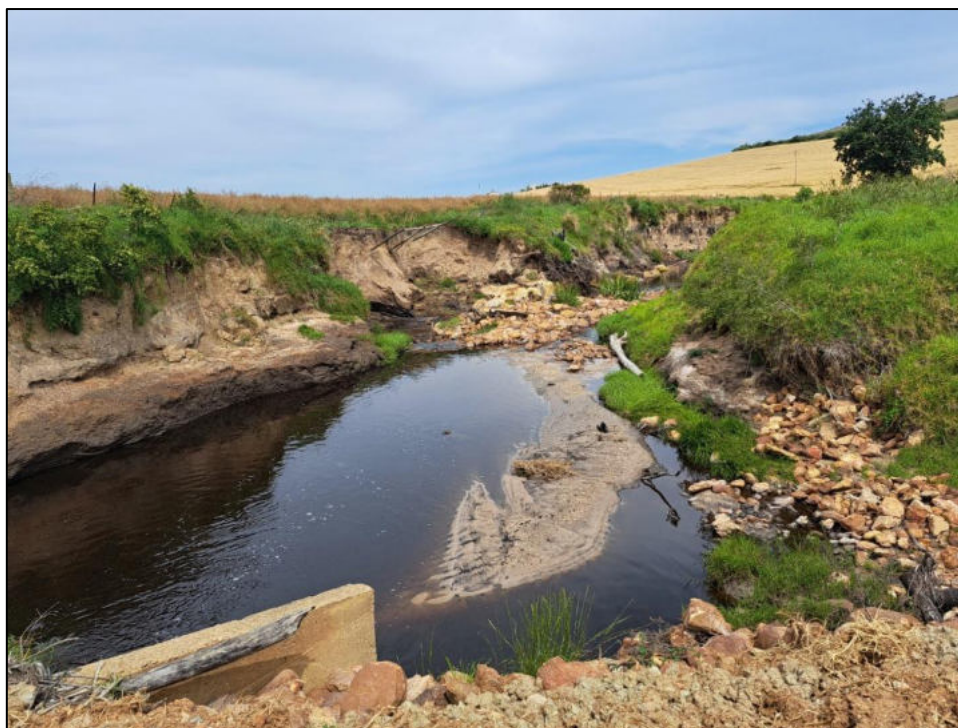
Immediately downstream of the boundary of Portion 3 of Farm 186, the condition of VB3 wetland deteriorates rapidly and has become severely eroded, leading to the formation of a deep, heavily incised channel with banks actively collapsing into the river. This headcut erosion has moved upstream into the lower reaches of the Vals River on Portion 3 of Farm 186, leading to loss of wetland habitat (Figure 8). This erosion has potentially serious consequences for the wetland. Channelisation of the wetland will result in the localised drawdown of water levels leading to a drop in the water table and gradual loss of wetland habitat adjacent to the channel.

Figure 7: Photograph showing severe streambank and channel erosion downstream of Portion 3 of Farm 186.

- Main impacts to VB3 are associated with roads and road crossings and invasion by *A. mearnsii*. Road crossings are currently unprotected low-level crossings along the river bed. While these cause a localised disturbance across the wetland, the main diffuse flow characteristics of the wetland are maintained and no erosion or channelisation of the wetland has occurred as a result of these crossings. Invasion by *A. mearnsii*, is relatively limited to isolated patches and much of the natural extent of the wetland remains uninvaded. As described above, the lower most reach of the wetland is eroding in the neighbouring Portion 2 of Farm 186 and in more recent times, this erosion has extended into the wetland within Portion 3 of Farm 186. This erosion presents a serious threat to the remaining extent of the wetland and rehabilitation of the seep with a view to limiting further headcut erosion is highly recommended. The PES is **B (Largely Natural)** - Table 6).

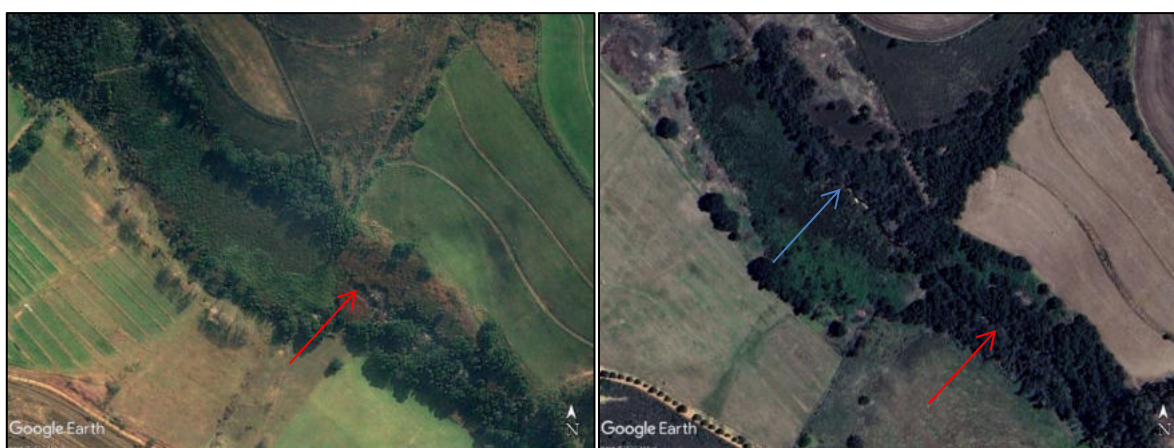
Figure 8: Google Earth images indicating the start of the headcut erosion in 2009 (left – red arrow) and the start of the headcut erosion in 2024 (right – blue arrow, with red arrow indicating initial 2009 start).

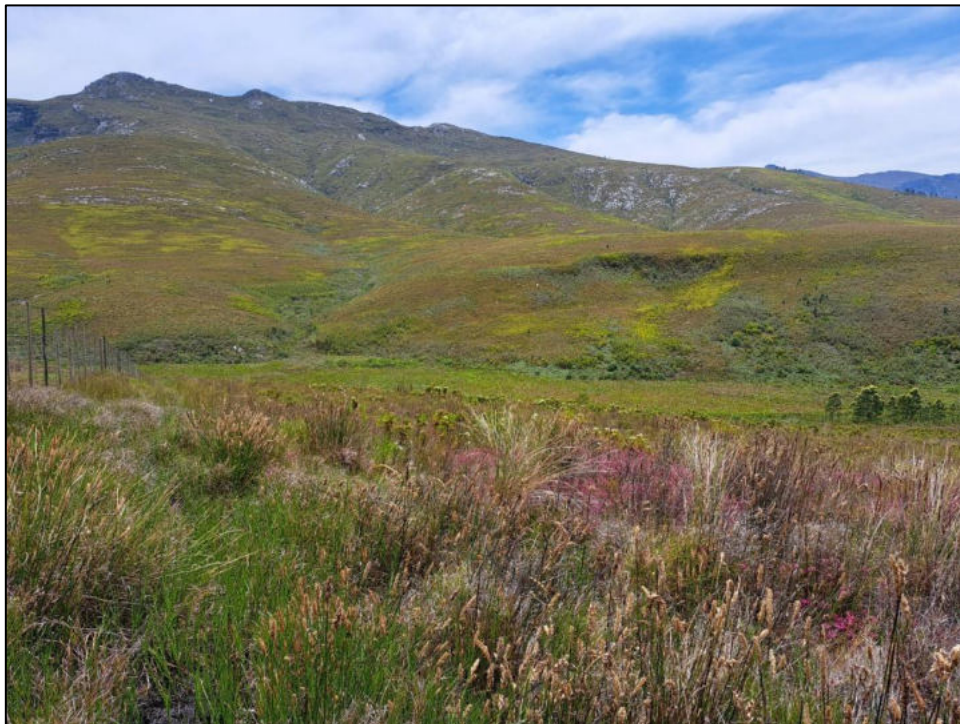
A large hillslope seep wetland was confirmed along the eastern slopes of Farm 149. Water was actively seeping down the slope, feeding the unchannelled valley bottom wetland (VB3) below. For ease of reference discrete sections of the wetland have been labelled from A to C (Figure 5). Section C is a prominent section of the wetland characterised by higher levels of saturation and a diverse assemblage of fynbos species on the upper slopes. Steeper small valleys within the larger seep, where saturation is more pronounced, comprised a number of typical obligate wetland species that included *Utricularia bisquamata*, *Elegia capensis*, *Cliffortia strobilifera* and *Berzelia galpinii* (which frequently occurs in extensive stands in high altitude wetlands along the Langeberg mountains). *Erica cubica* and *Penaea cneorum* were common around the margins of these areas. Soil auger samples from these areas indicated

Figure 9: View of the HS1 seep in the foreground, leading down to VB3.

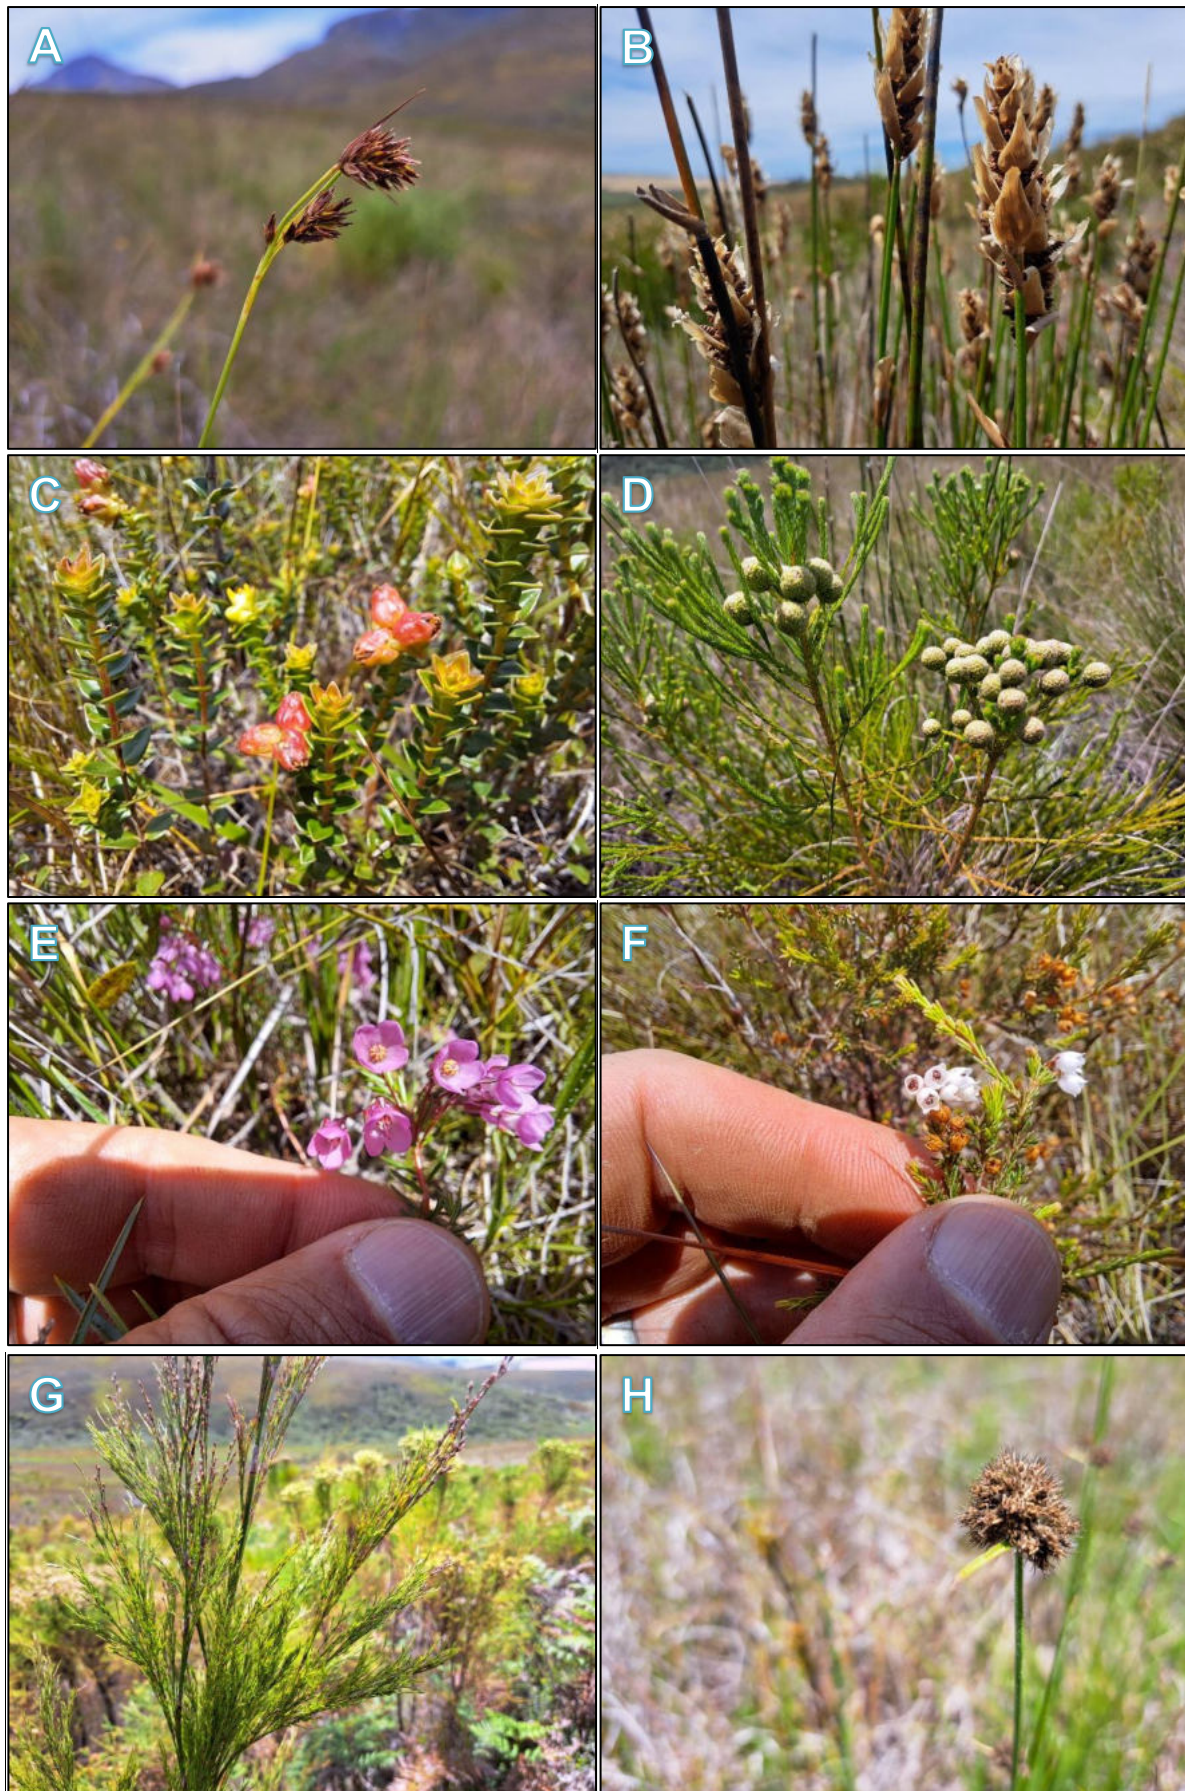
Figure 10: Typical wetland plant species observed in Section A and B of HS1, including *Caryx* sp. (A); *Eligia* cf. *fistulosa* (B); *Penaea cneorum* (C); *Berzelia galpinii* (D); *Erica* cf. *cubica* (E); *Erica* cf. *quadrangularis* (F); *Eligia capensis* (G) and *Fuirena hirsuta* (H).

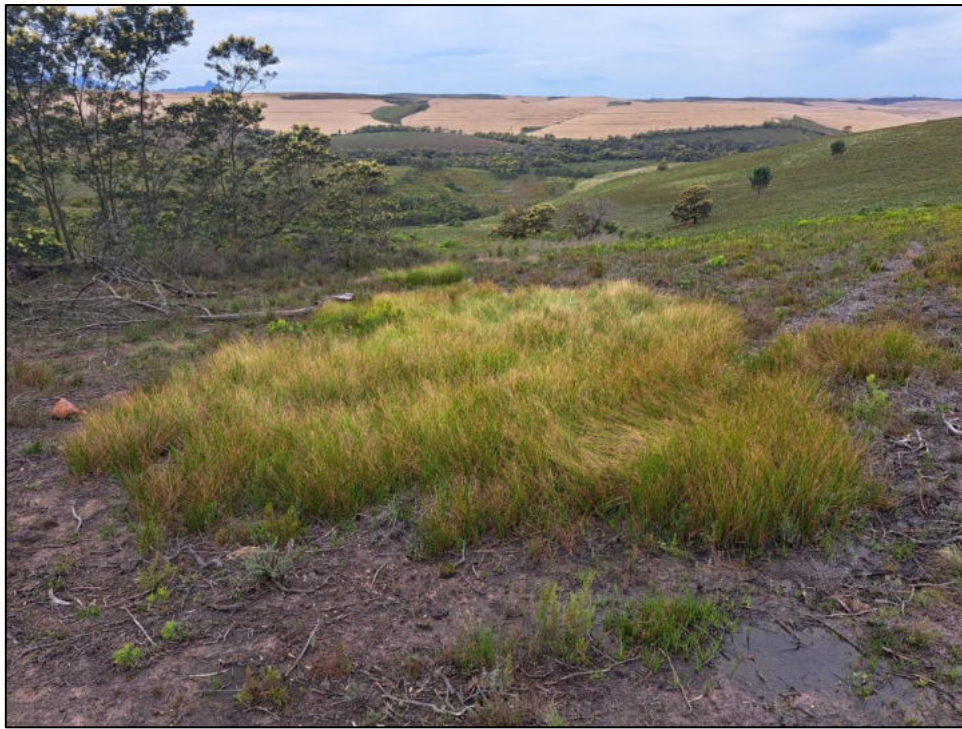
- HS2 was identified and delineated by Day (2020) and forms the source zone of VB5.
- HS3 is a narrow seep wetland that extends down the east facing slope of the property. This seep occurs adjacent to an area that was actively farmed. Water was actively seeping from the top of the seep during the site visit (Figure 12). Vegetation along the seep was not as dense as observed elsewhere on the property and soil is more exposed (and thus vulnerable to erosion). The seep would benefit from the establishment of a protective buffer that would allow typical wetland species to re-establish

Figure 12: View of HS3 from its source down to the valley below.

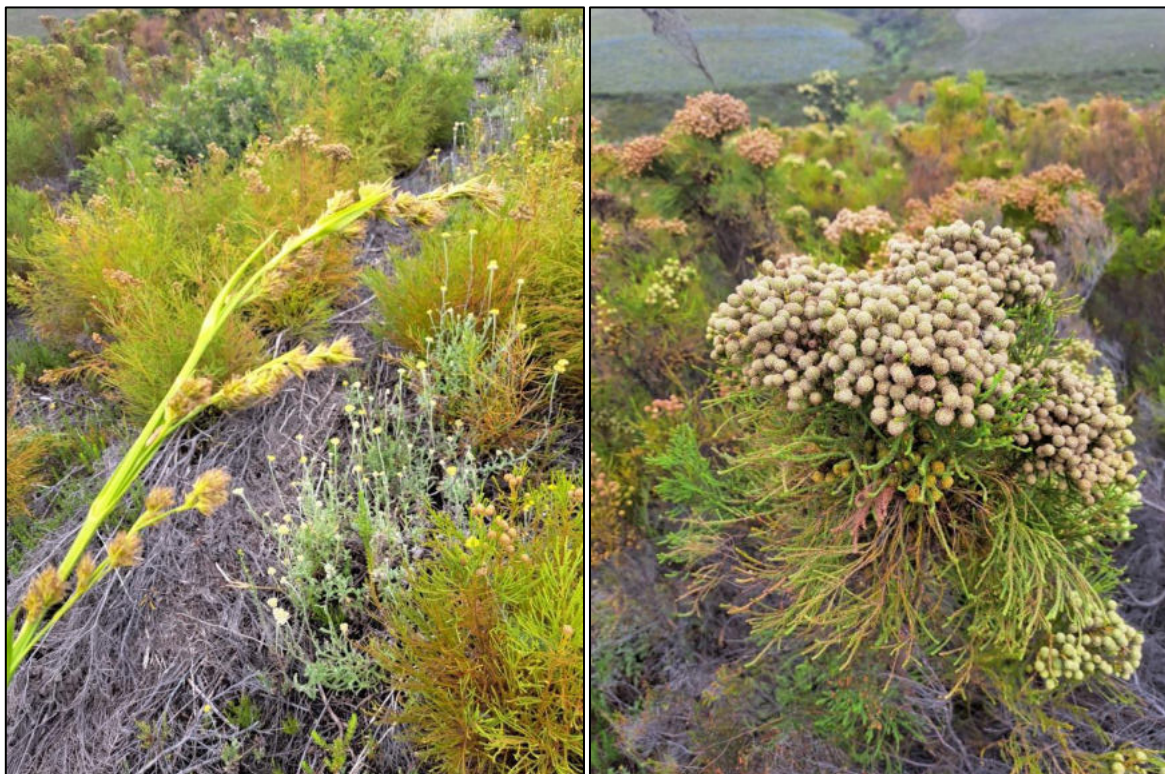
Figure 13: Wetland plant species observed in HS4, including *Carpha glomerata*, *Helichrysum cymosum* (left) and *Berzelia galpinii* (right).
