# Freshwater Ecological Assessment

## PROPOSED CONSTRUCTION OF A MIXED USE DEVELOPMENT IN MANDALAY, CAPE TOWN

July 2008

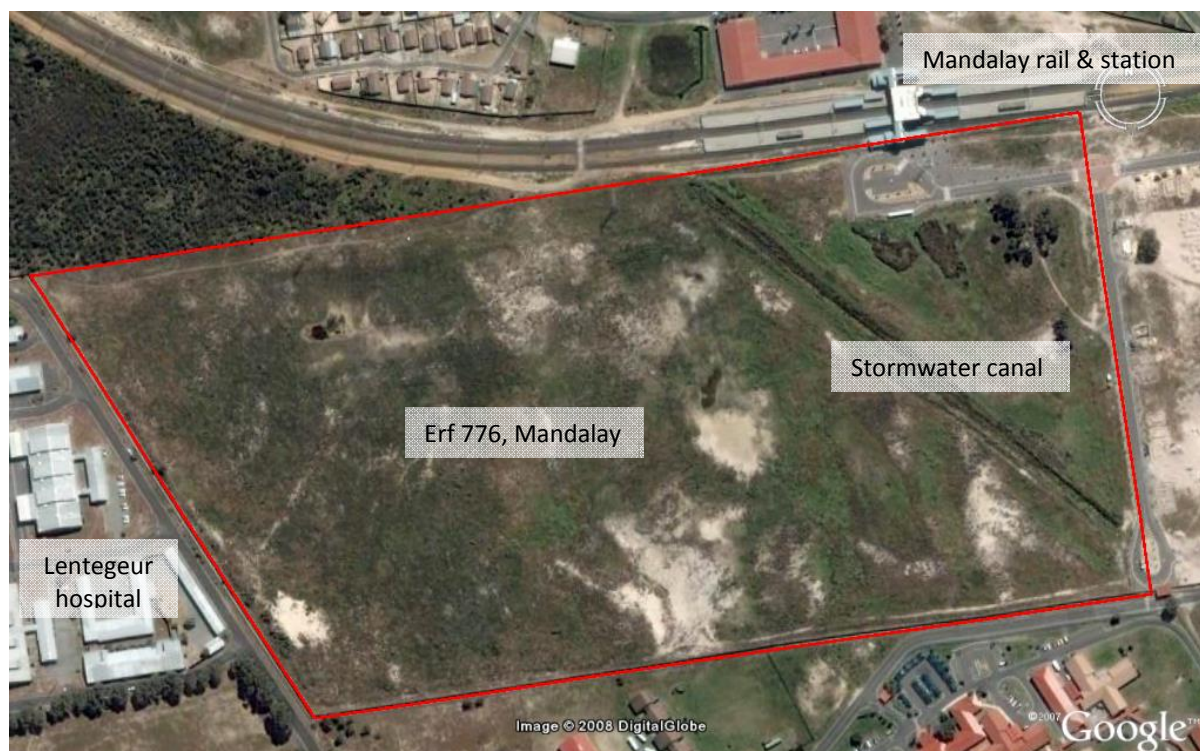
Figure 1. Aerial view of the proposed development site near Mandalay

Erf 776, the proposed development site, is situated in Mandalay in the greater Mitchell's Plain area. The site (Figure 1) is approximately 23.5 hectares in extent and forms part of a larger piece of land (54.48 hectares), which was purchased by Communicare during 1987/1988. It is bordered by the Mandalay station and railway line to north, Lentegour Psychiatric Hospital to the south and west, and residential areas to the east. The site is currently vacant with only an existing Eskom powerline servitude crossing the northern boundary and a stormwater channel which runs from the north to the south east corner of the site.

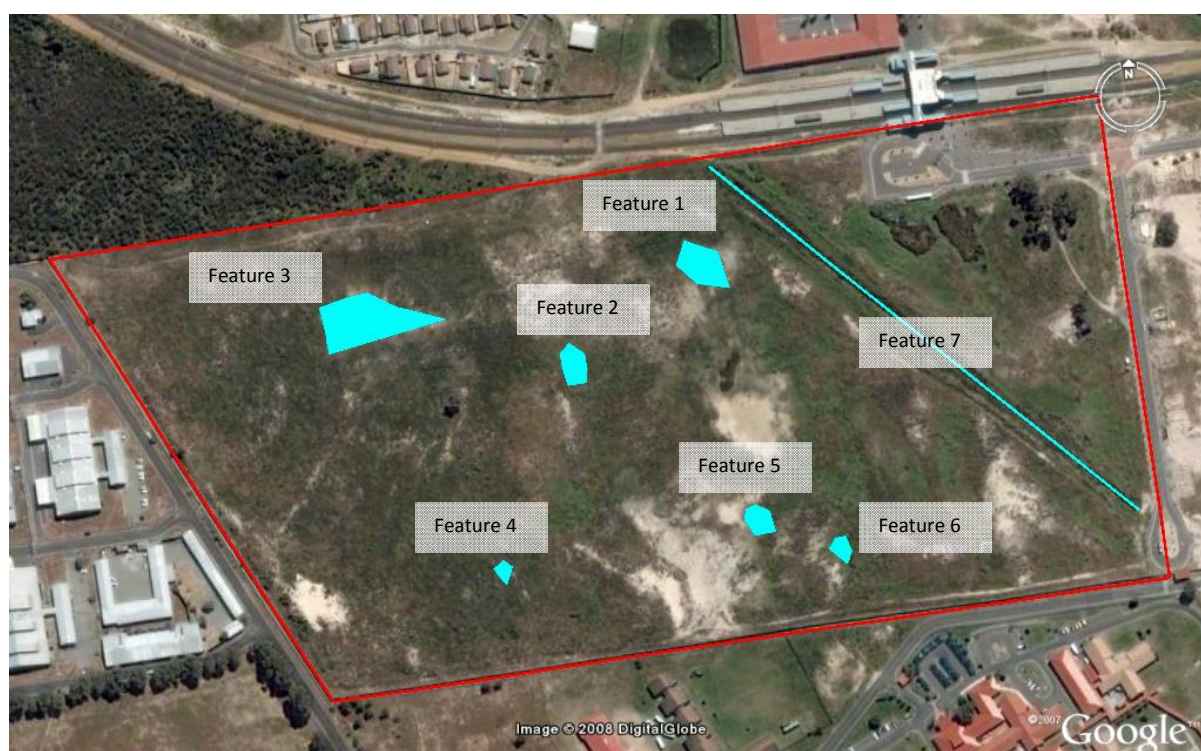
Figure 4. Mapped wetland features

A summary table (Table 6) follows which indicates the value of each of the wetlands shown on Figure 4

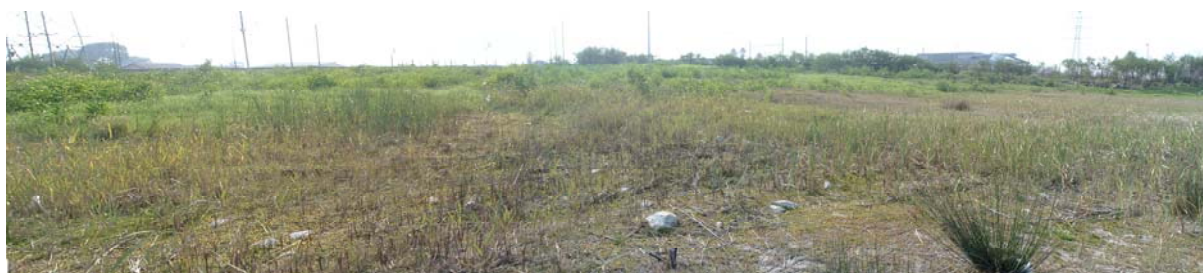
Figure 5. Wetland feature 1

Generally the study area is characterised by wetlands due to the associated wetland type vegetation with low dunes in between. These wetland features are thus formed largely as a result of the

topography of the site and are mostly dependent on sub-surface water, as well as an accumulation of surface water. The features can therefore be more clearly observed during higher rainfall periods.

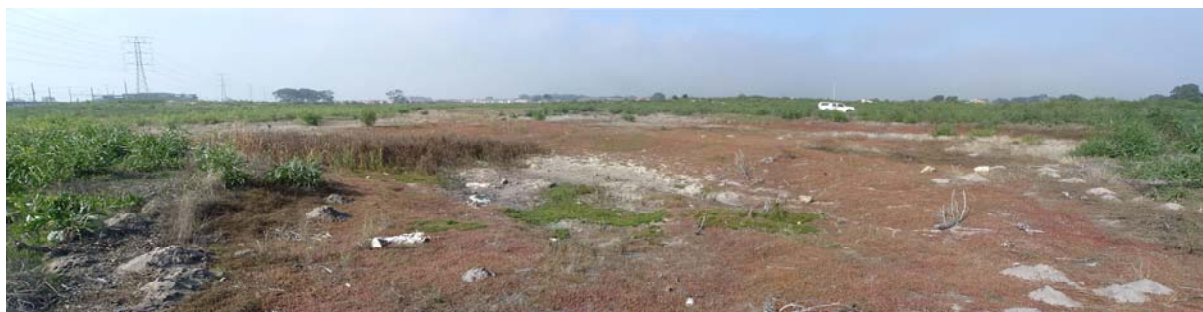
Figure 6. Wetland feature 3

| Wetland feature | Conservation Importance | |
|---|---|---|
| Wetland Area 3:<br>Seasonally inundated<br>reed/ <i>Sarcocornia</i><br>wetland | Moderate | It may support red data species and it representative of regionally threatened habitat type |

Proposed mitigation: It is proposed that should the botanical assessment support the importance of retaining the wetland feature of concern (feature 3) that the proposed subdivision for the development be reworked such that the wetland area can form part of the proposed public open spaces. It is however important that should this mitigation measure be taken that the uniqueness of this wetland habitat be retained by:

1. Proper management of the impacts of the development activities during the construction phase;
2. Allocating an adequate buffer zone (minimum of 30m) to the wetland area to protect it from surrounding impacts such as stormwater runoff, dumping of waste, trampling;
3. If possible maintaining a corridor to the private open space that will be maintained for the Eskom powerlines to ensure that the hydrodynamics the maintains the wetland character is not interfered with; and
4. Maintaining an invasive alien plant removal programme.

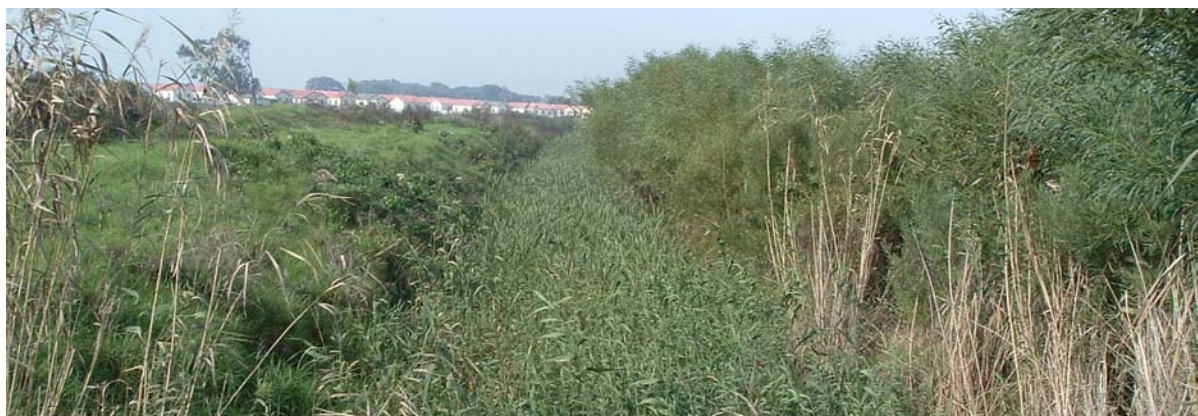
Figure 8. Wetland feature 7

The wetland features due to their small size and slightly degraded state do not provide significant goods and services. The wetland feature that has been artificially created to manage stormwater is provided the most goods and services due to its contribution to the stormwater management in the area.

The maintenance of wetland feature 7 is supported. One could however improve the goods and services that this wetland feature is able to provide if the habitat were better landscaped through increasing the sinuosity of the channel and increasing the habitat diversity. Removal of invasive alien plants along the banks of the feature should also take place.
