GROUNDWATER IMPACT ASSESSMENT FOR THE PROPOSED CAPE WINELANDS AIRPORT, FISANTEKRAAL, WESTERN CAPE

Groundwater Impact Assessment for the Proposed Cape Winelands Airport, Fisantekraal, Western Cape

Prepared by
GEOSS
28 February 2025

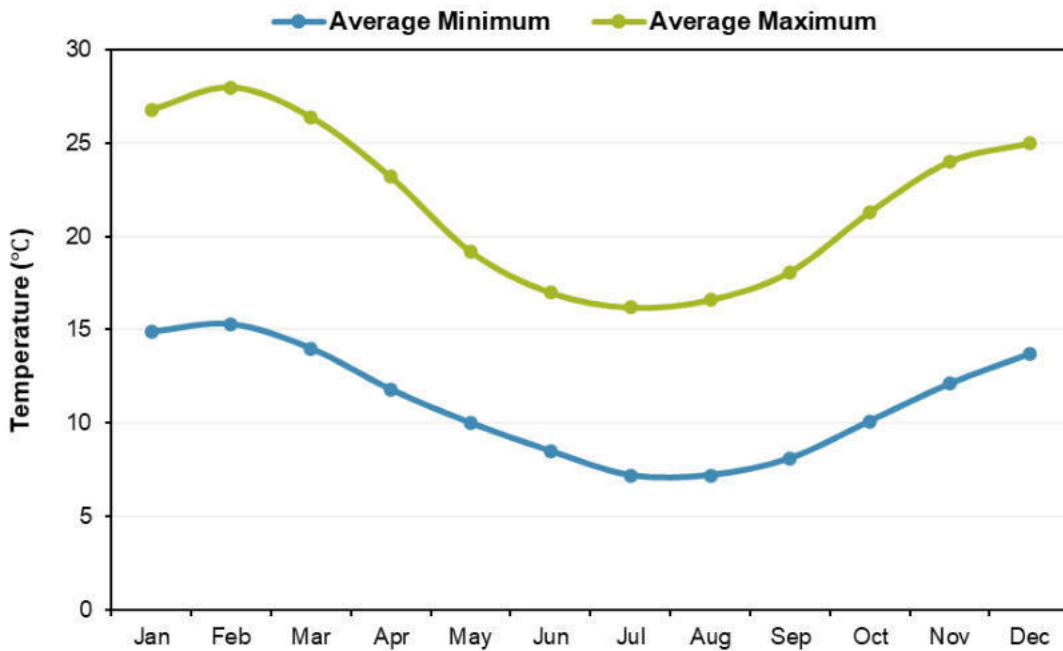
Figure 1: Monthly average minimum and maximum air temperatures for the study area (Schulze, 2009).

The Fisantekraal area experiences a Mediterranean climate with mild, wet winters and warm, dry summers. **Figure 1** shows the monthly average air temperature and **Figure 2** shows the monthly median rainfall and evaporation distribution for the Fisantekraal area (Schulze, 2009). The long term (1950 – 2000) mean annual precipitation for the Strand area is 532 mm/a. The rainfall typically exceeds evaporation rates in the winter months between May and August.

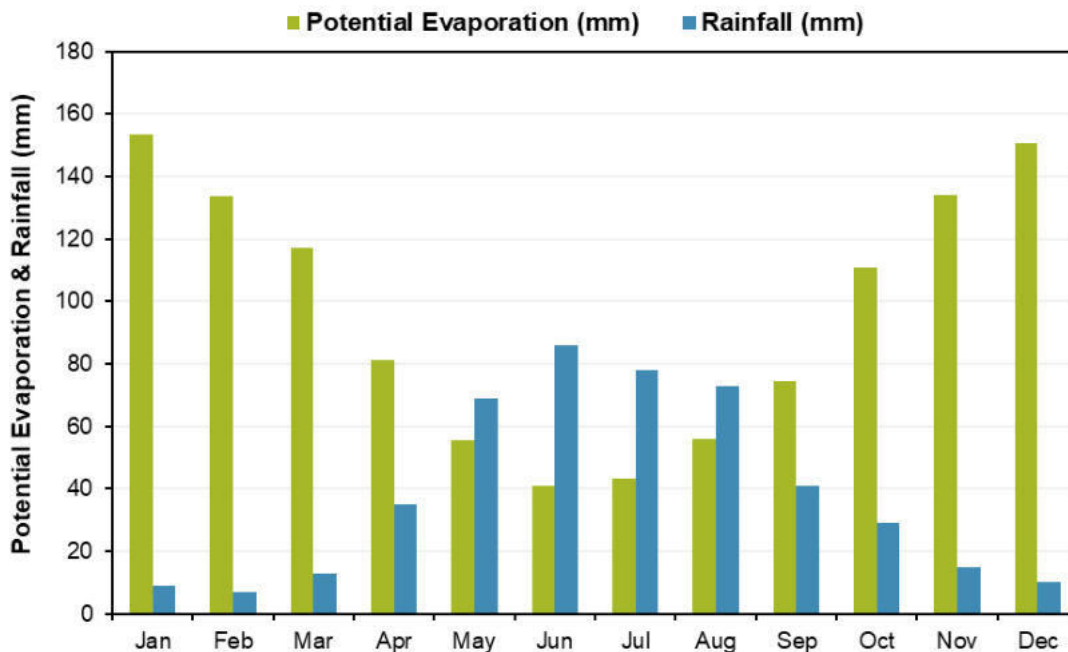
Figure 2: Monthly average rainfall and evaporation distribution for the study area (Schulze, 2009).

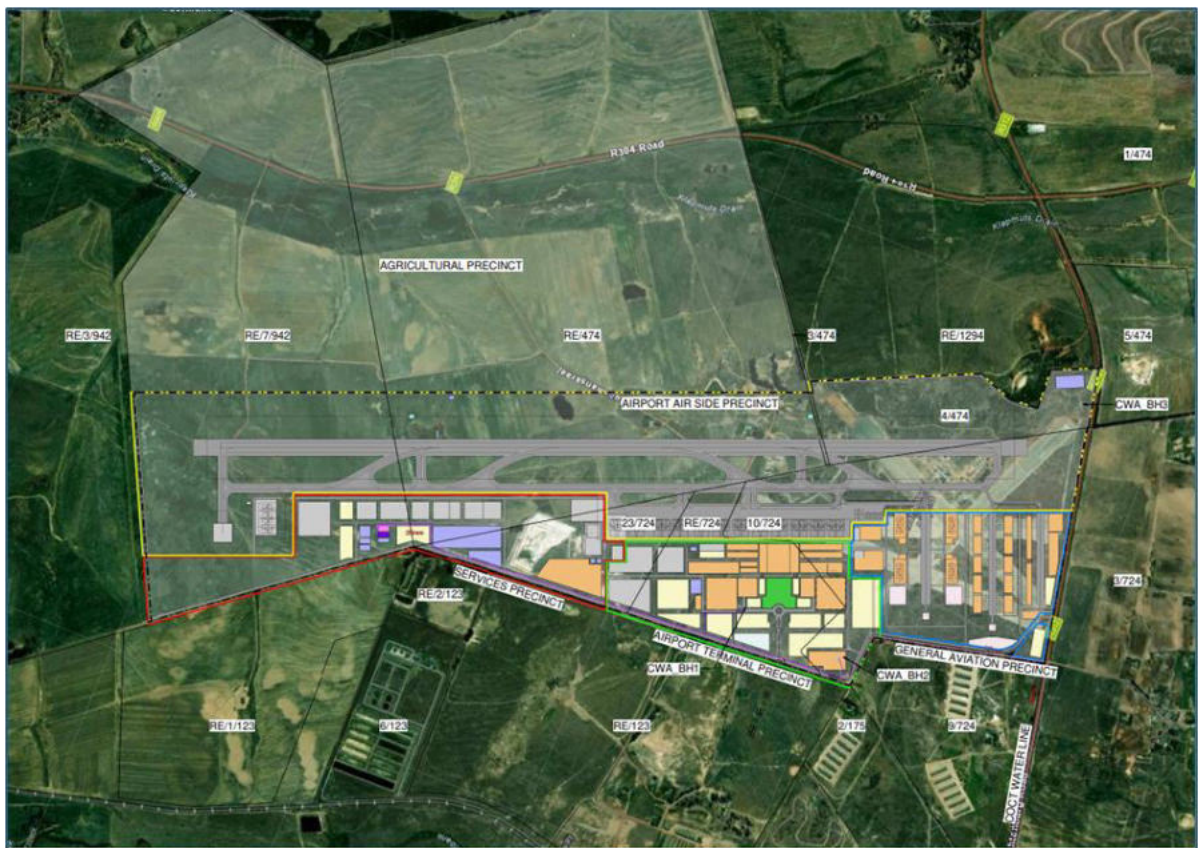
Figure 9: Figure 10: New Preferred Development Option (Phase 2) for the CWA (CWA Ltd, January 2025).

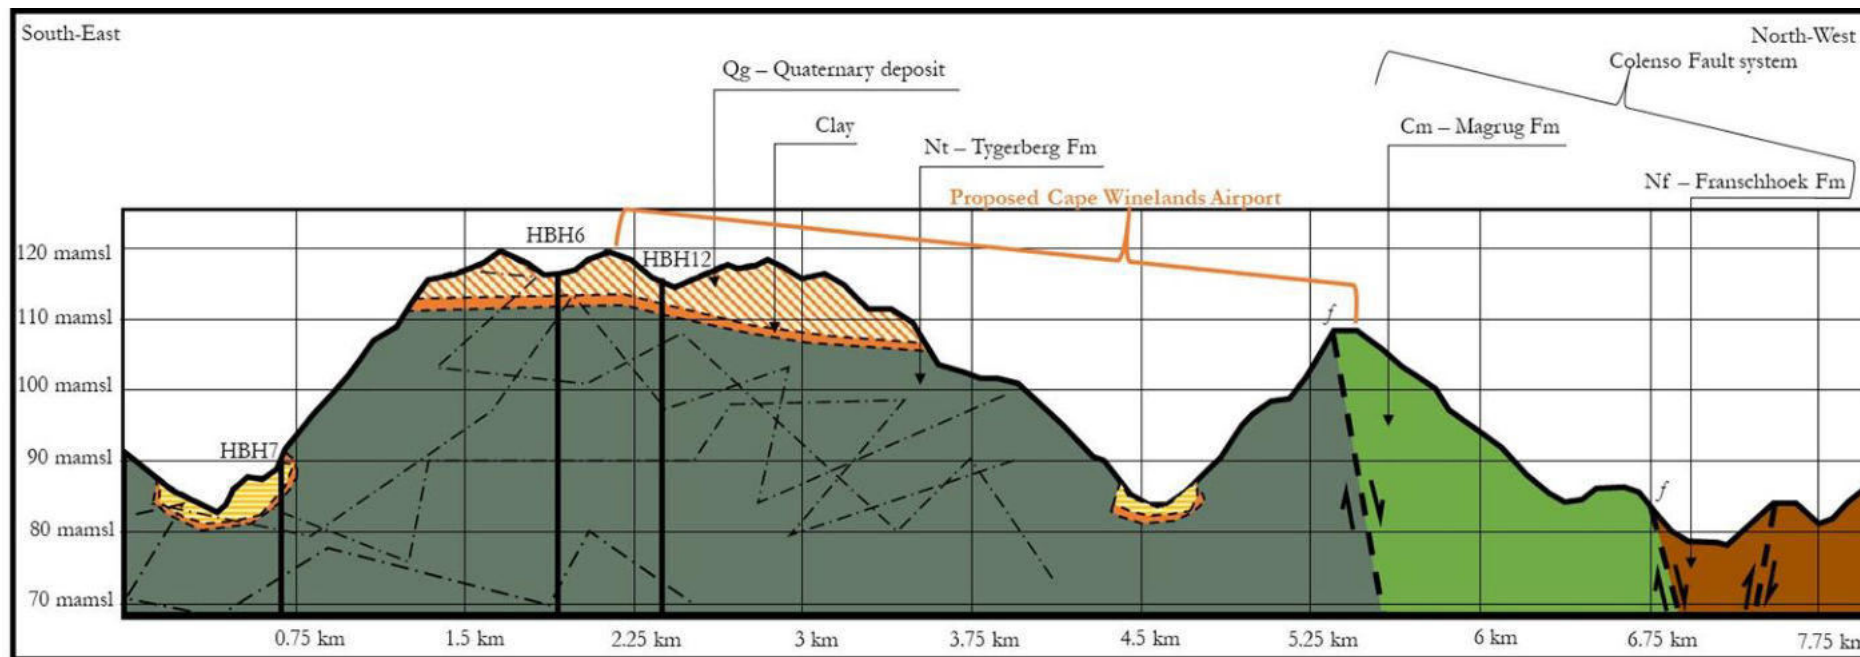
Figure 11: Schematic and conceptual southeast to northwest cross section.

Based on drilling information in the surrounding area, it has been observed that boreholes in the surrounding area had a general geological log that started with overburden and clay between 0 – 40 m, followed by weathered bedrock between 40 – 60 m), followed by bedrock (shale, sandstone, greywacke, phyllite).

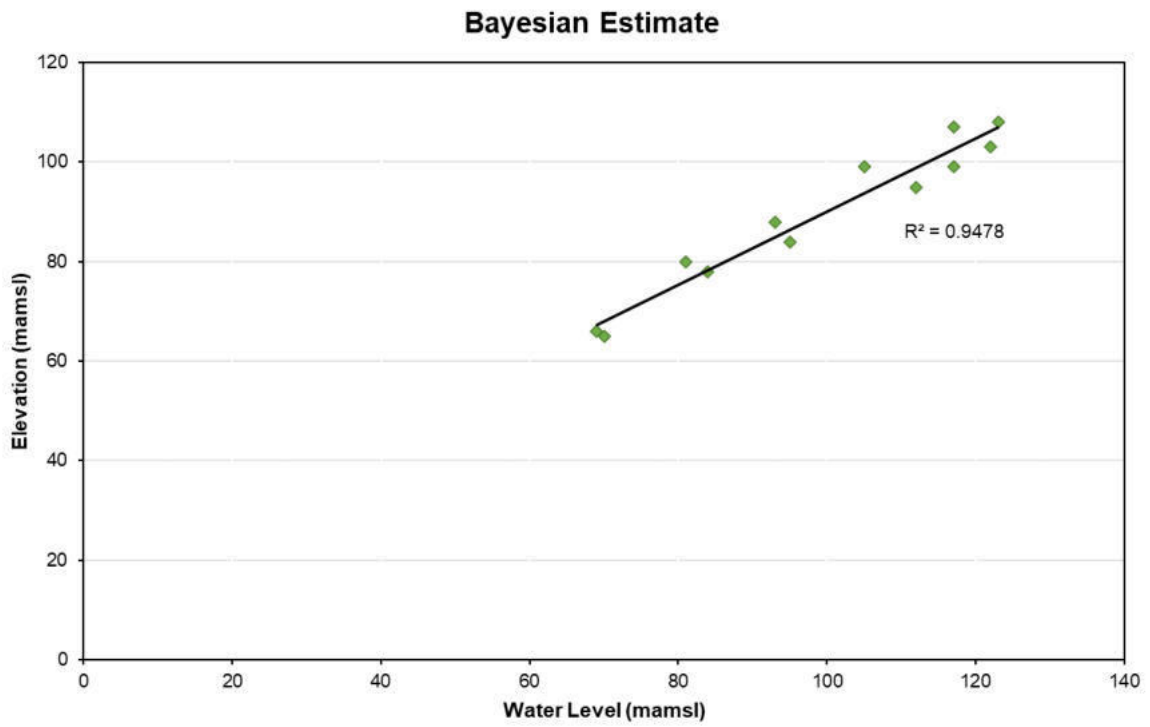
Figure 12: Correlation between surface topography and groundwater elevation for the boreholes proximal to the study site.

Groundwater flow generally follows surface topography, flowing from areas of high elevation to areas of lower elevation. In order to evaluate the relationship between groundwater levels and topography, the surface elevations and water table elevations are plotted relative to each other to assess the applicability of an interpolation technique. Where close correlation between surface elevations and water table elevations exist, interpolation techniques are an appropriate method to estimate values for areas with limited data.

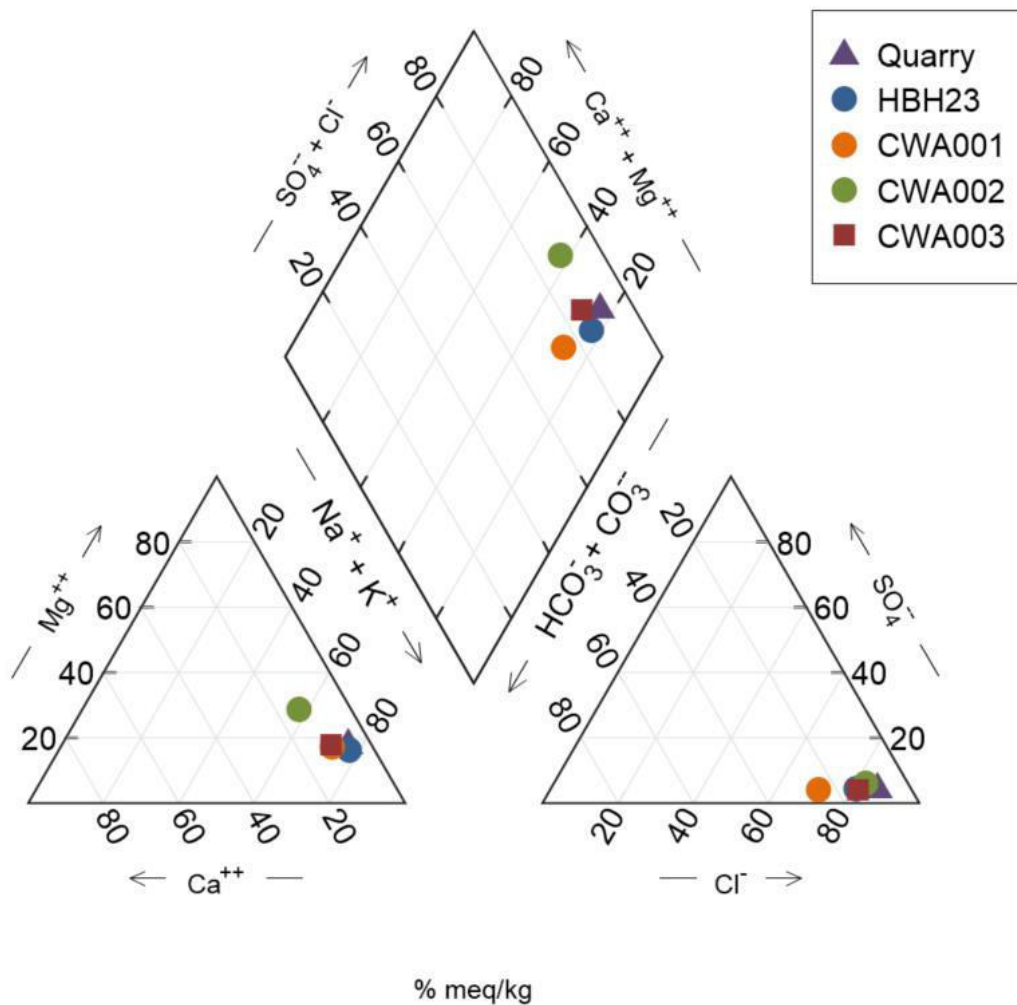
Figure 13: Piper diagram for the collected samples.

A number of chemical diagrams have been plotted for the quarry water sample and the groundwater samples and these are useful for chemical characterisation of the water and illustrate the differences in the water types. The chemistry of the samples has been plotted on a trilinear diagram known as a Piper Diagram. This diagram indicates the distribution of cations and anions in separate triangles and then a combination of the chemistry in the central diamond. From **Figure 13** (central diamond), it is evident that both the quarry and the borehole samples are of a similar sodium-chloride hydrofacies type, indicating that the water has likely originated/evolved in a similar geological environment

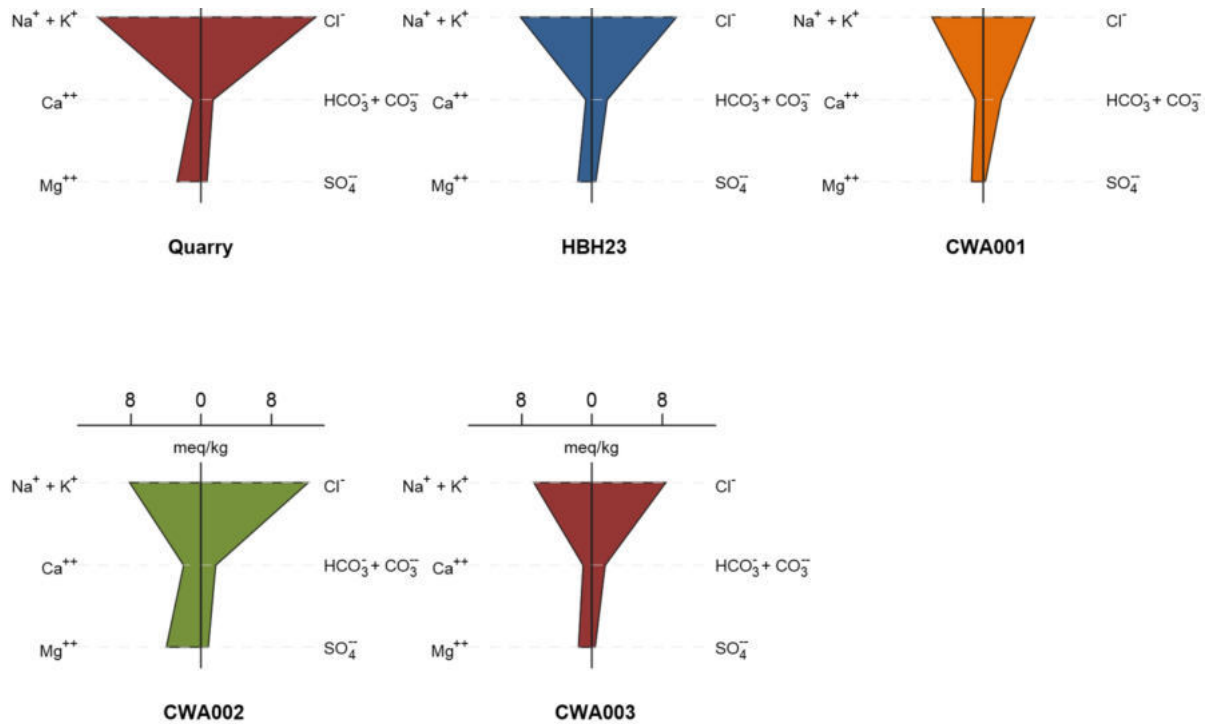
Figure 14: Stiff diagrams for the collected samples.

The Stiff Diagram is a graphical representation of the relative concentrations of the cations (positive ions) and anions (negative ions). This diagram shows concentrations of cations and anions relative to each other and direct reference can be made to specific salts in the water. The Stiff Diagram for the samples from the boreholes and quarry is shown in **Figure 14**. It is clear that the groundwater and quarry water samples collected, is dominated by sodium and chloride. This corresponds to what was observed in the Piper Diagram.

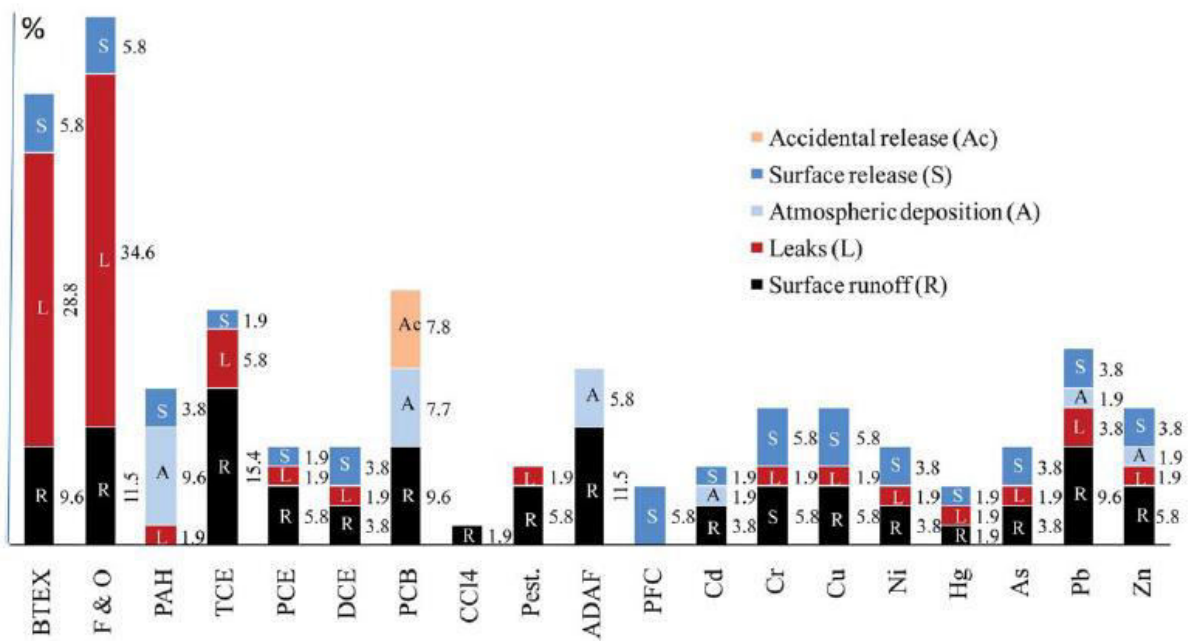
Figure 15: Reported frequency of contaminants for several origins (Nunes et al., 2011). F & O: fuels and Oils; ADAF: anti-icing and de-icing fluids; PFC: perfluorochemicals.

Origins, operations and locations for contamination at civil airport sites around the globe as per Nunes et al. (2011), along with other potential contaminant sources have been summarised in Table 11. Where the origin refers to the process of transporting the contaminant to the groundwater, the location indicates the physical place where the contaminants are generated/released; and the operation indicates the activity during which the contaminant is released into the environment. Nunes et al. (2011) compiled information from reports on airports where contamination had taken place. 19 contaminants were assessed and divided into several origins (Figure 15). The origins included accidental release (Ac), surface release (S), atmospheric deposition (A), leaks (L), and surface runoff (R). It is clear that surface runoff appears to be the most widespread origin (reported for 17 of the contaminants), followed by surface releases (reported for 15 of the contaminants), and leaks (reported for 14 of the contaminants) (Figure 15).

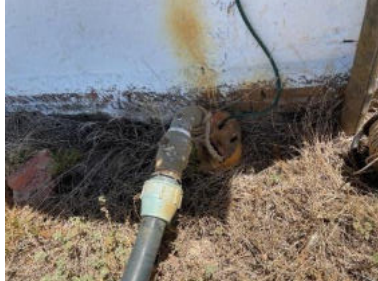
HBH3	83.2	40.87	2.2	EC: 145 mS/m TDS: 710 mg/L pH: 6.2	Used for livestock.

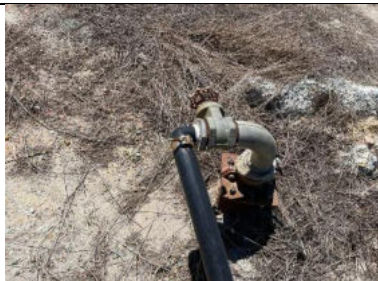
HBH4	-	19	-	EC: 132 mS/m TDS: 650 mg/L pH: 6.7	Livestock watering, BH in use.

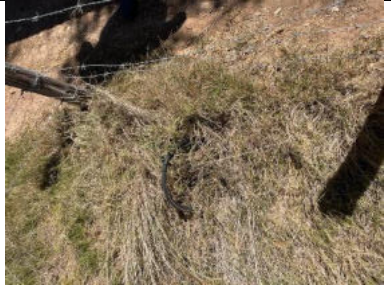
ID	Depth (m)	Water Level (mbgl)	Yield (L/s)	Field Chemistry	Comment	Photo
HBH5	-	-	5	EC: 152 mS/m TDS: 750 mg/L pH: 6.7	Domestic use and garden irrigation. Borehole overgrown.

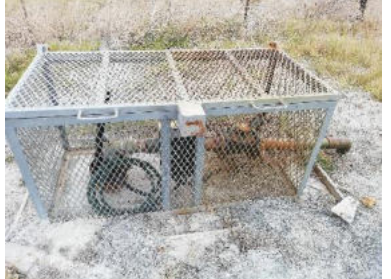
HBH6	102	17.8	8.3	EC: 201.7 mS/m TDS: 1210 mg/L pH: 7.1	County Fair production borehole. 2024 comment on behalf of CF indicates that the borehole is now dry and no longer in use.

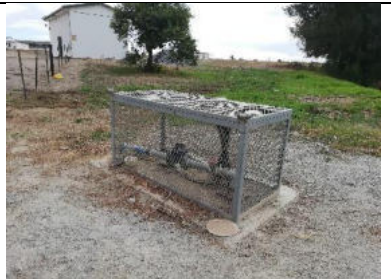
HBH7	90	11.27	5	EC: 284.7 mS/m TDS: 1708 mg/L pH: 7.9	County Fair production borehole

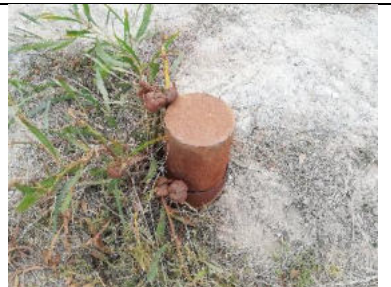
HBH8	-	-	-		County Fair borehole. BH welded shut. Not in use. 2024 comment on behalf of CF indicates that the borehole is now dry.

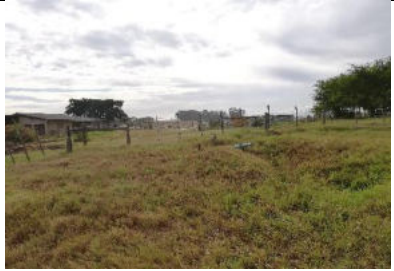
ID	Depth (m)	Water Level (mbgl)	Yield (L/s)	Field Chemistry	Comment	Photo
HBH9	-	-	-		Borehole used for household supply.

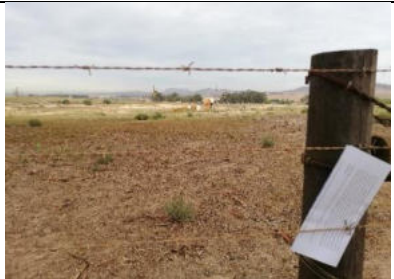
HBH10	-	-	-		Tanks concentrated with red staining, likely groundwater use.

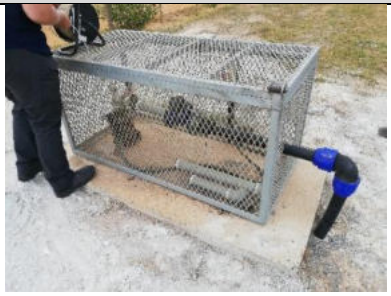
ID	Depth (m)	Water Level (mbgl)	Yield (L/s)	Field Chemistry	Comment	Photo
HBH13	200	15	3	EC: 138.7 mS/m TDS: 832 mg/L pH: 7.5	County Fair production borehole.

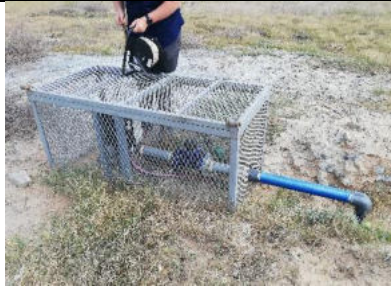
HBH14	156	5.5	5.3	EC: 19.7 mS/m TDS: 118 mg/L pH: 8.7	County Fair production borehole.

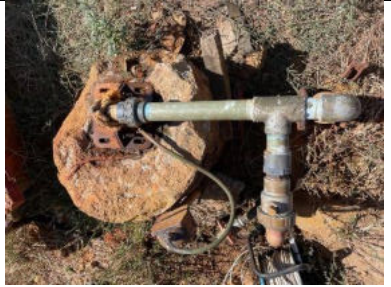
HBH15	-	-	-		Used for garden irrigation, iron staining on walls.	No photo taken
HBH16	30	42.2	0.2	EC: 167 mS/m TDS: 830 mg/L pH: 6.4	Livestock and domestic use.
