# Aquatic Biodiversity Screening: Wetland Confirmation

Portion 91 of the Farm Potteberg Estates No. 516,  
Swellendam

**Project Reference:** Portion 91 of the Farm Potteberg Estates No. 516, Swellendam (DEA&DP Ref: 16/3/3/6/2/E3/10/1489/25)

**Date:** 5 March 2026

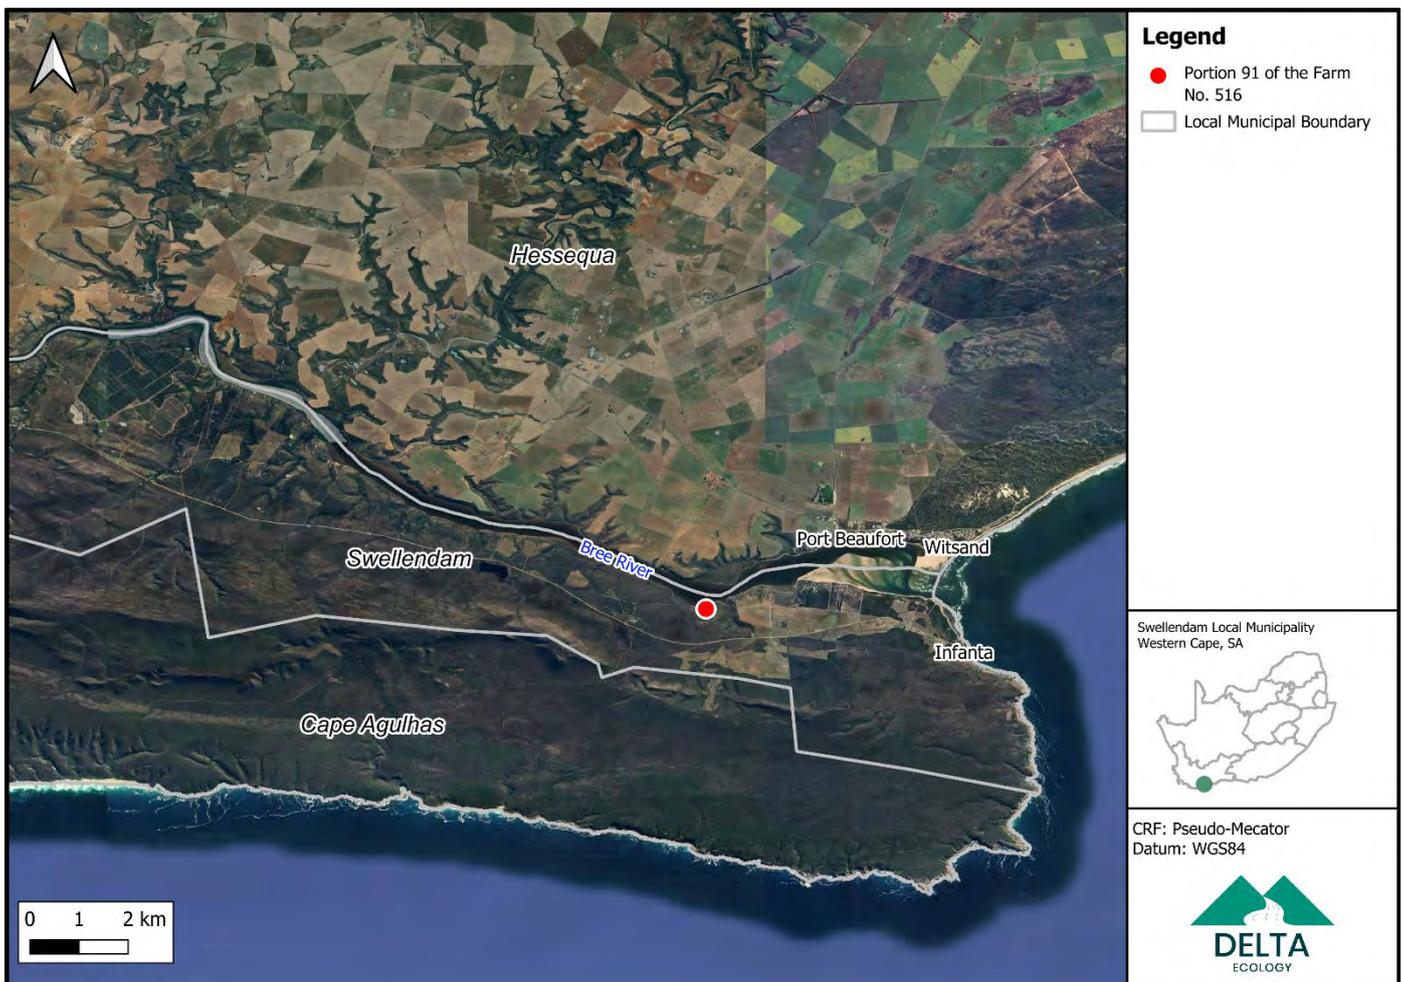
**Figure 1: Location of the site.**

This letter provides the findings of the aquatic screening and Site Sensitivity Verification (SSV) conducted for the proposed Set Back Line (SBL) for the expansion of the existing farmhouse and road upgrade on Portion 91 of Farm 516, Swellendam (**Figure 1-1** and **Figure 1-2**). The primary objective was to verify the "Very High" aquatic biodiversity sensitivity rating identified by the National Department of Forestry, Fisheries, and the Environment (DFFE) Web-Based Environmental Screening Tool.

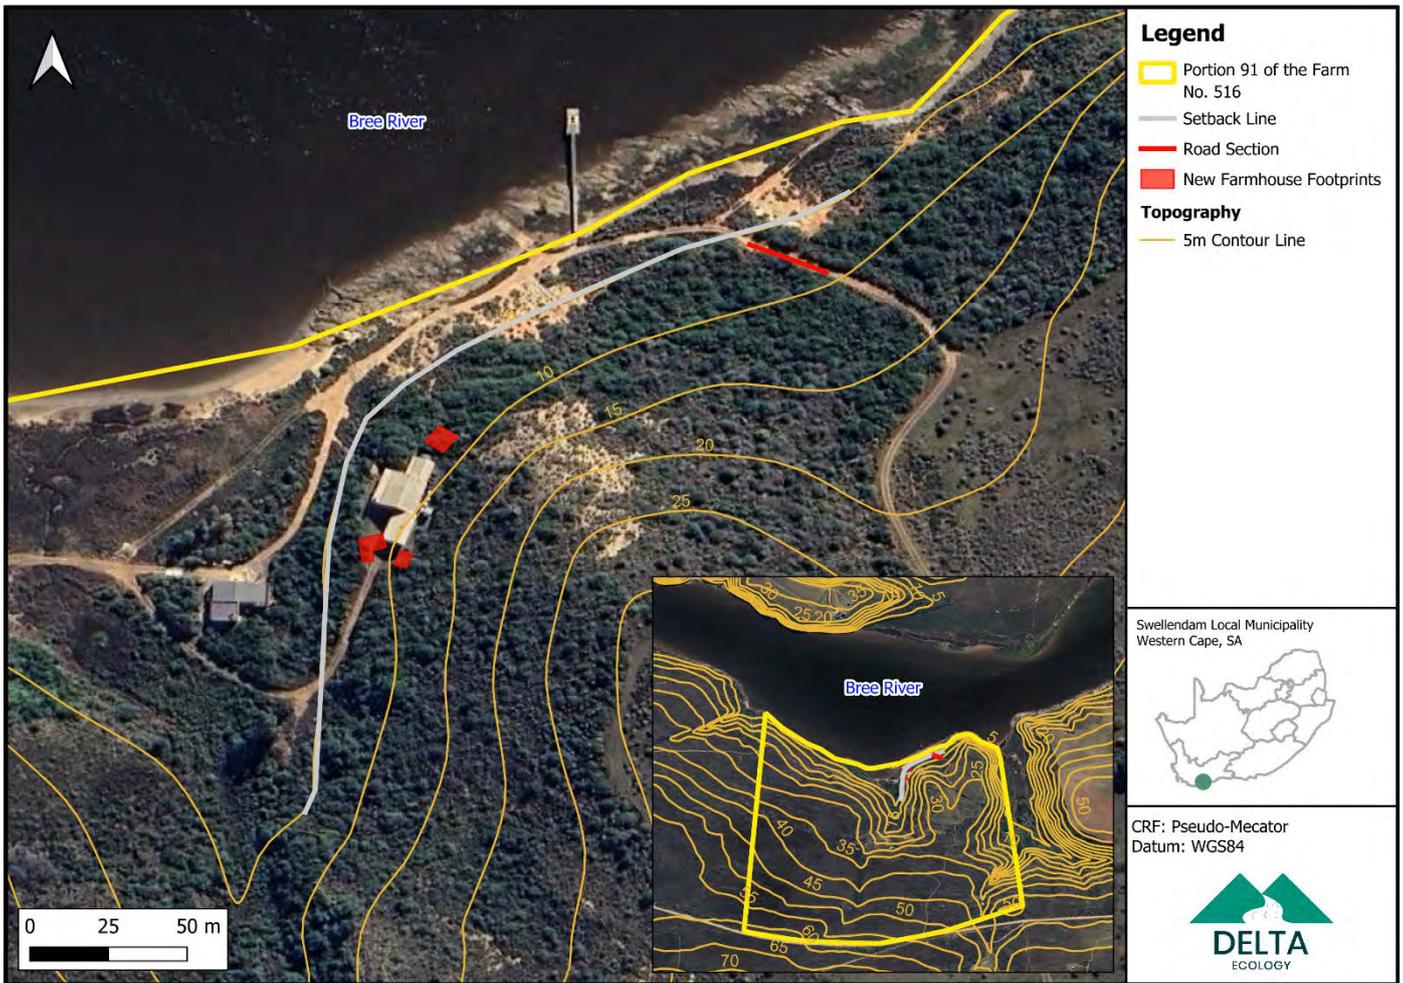
**Figure 2: Proposed development areas.**

The screening focused on the development footprint, which involves adding two small residential units to the existing house envelope along with a parking area, and a "like-for-like" upgrade of an existing road section. The scope included confirming whether these activities are located within a mapped National Wetland Map Version 5 (NWM5) floodplain wetland and verify the location of onsite watercourses.

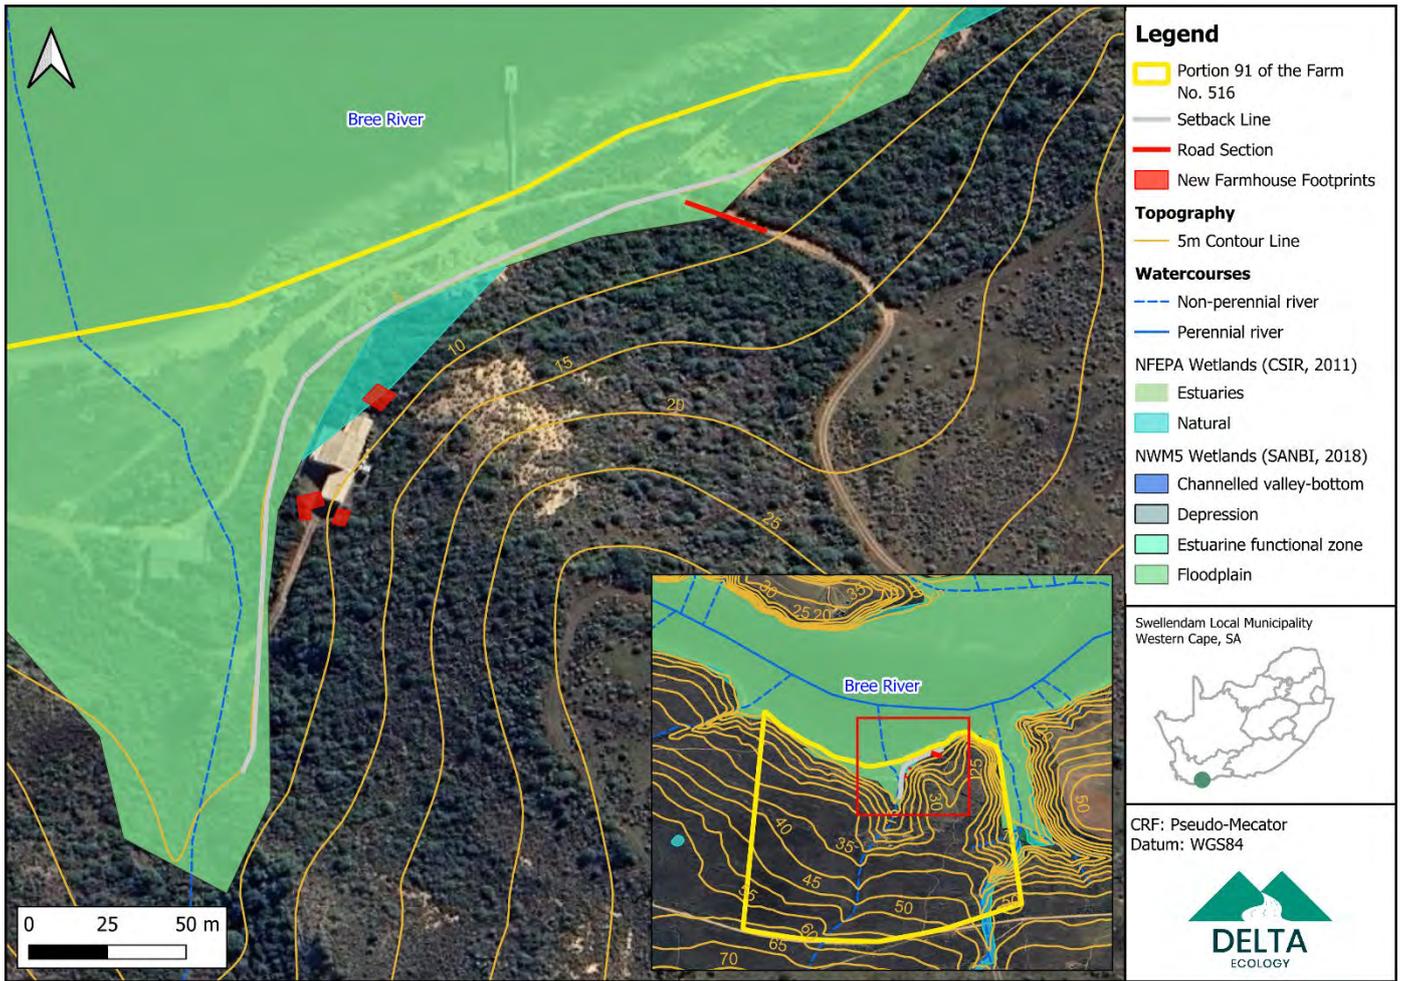
Figure 5: Watercourses indicated by NWM5.

According to the NFEPA and NWM5 datasets, portions of the proposed development area are located within mapped aquatic features (CSIR, 2011; NWM5, 2018) (**Figure 5**). The majority of the proposed SBL and the proposed road upgrade area are located within the mapped estuarine functional zone of the Breede River. A portion of Unit 1 overlays a mapped floodplain wetland and natural wetland according to both the NFEPA and NWM5 datasets. Unit 2 does not directly overlay mapped wetlands; however, it is located in close proximity to the estuarine functional zone and floodplain wetland, and portions of the SBL intersect these mapped features.

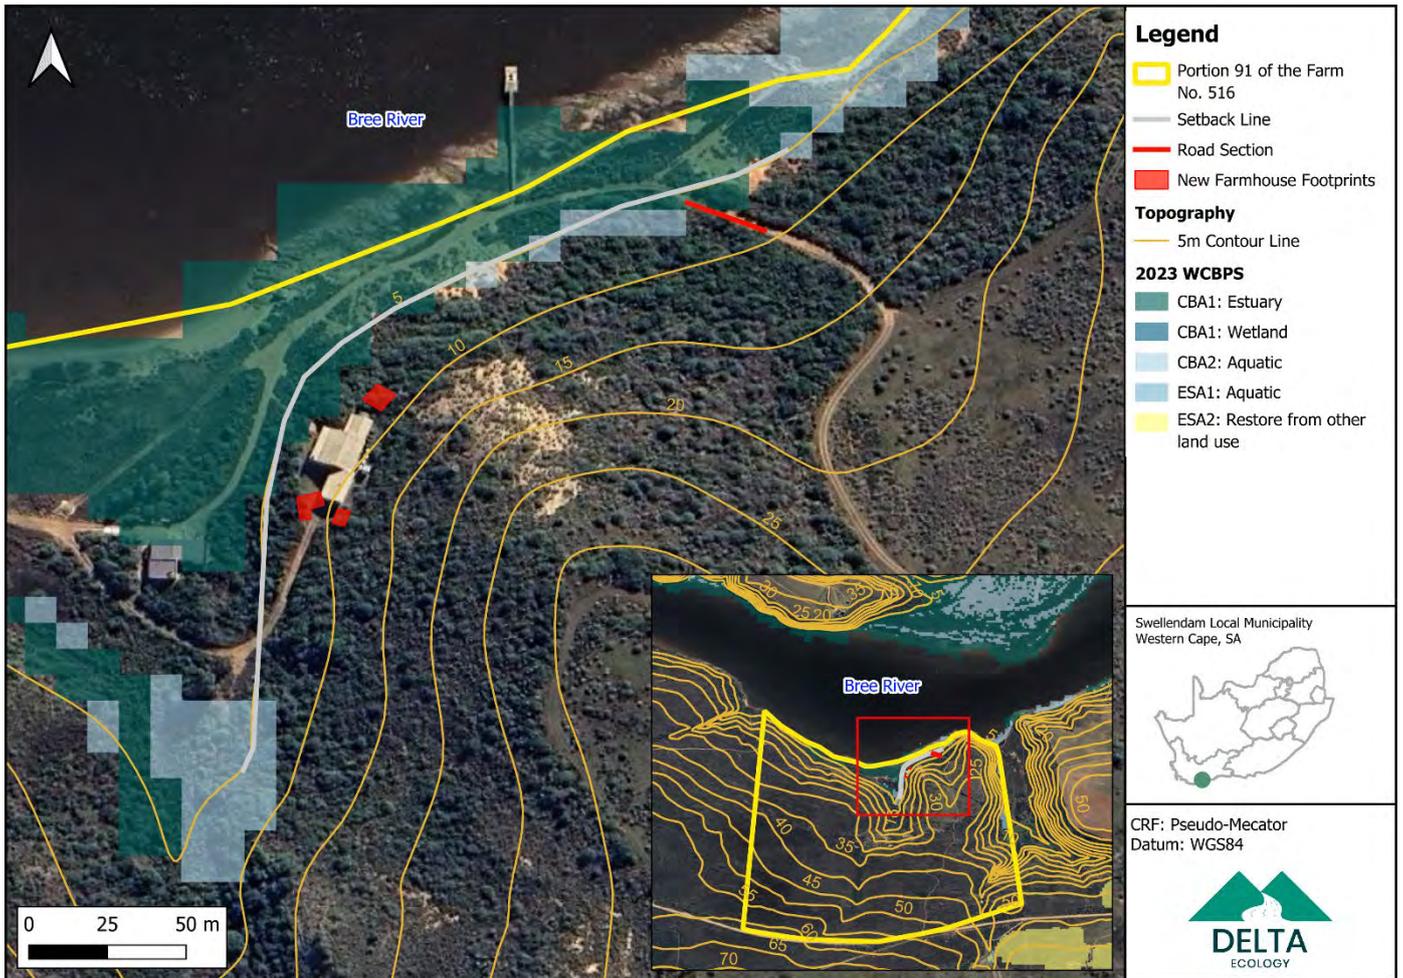
Figure 6: Western Cape Biodiversity Spatial Plan.

According to the Western Cape Biodiversity Spatial Plan (WCBS, 2023), the proposed development units do not fall directly within mapped aquatic Critical Biodiversity Areas (CBAs), however the proposed SBL does fall within this CBA. A terrestrial CBA occurs over the proposed SBL and unit 1, however does not overlap unit 2 (**Figure 6**). Small portions of aquatic and terrestrial Ecological Support Areas (ESAs) occur south of the study area, approximately 870 m and 945 m from the development area respectively.

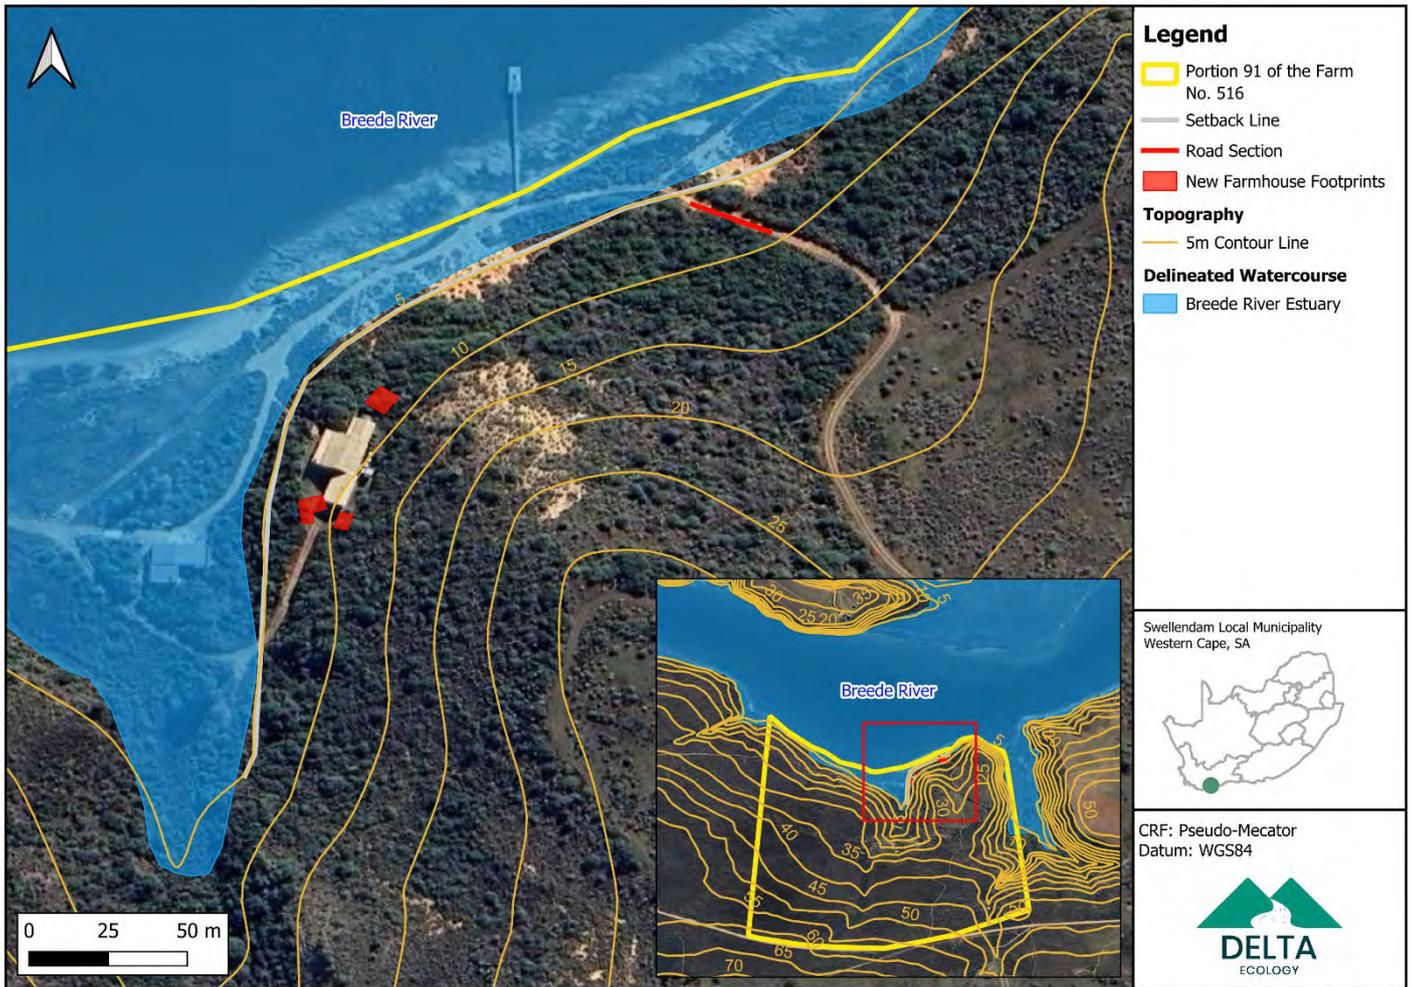
**Figure 7: Delineation Map.**

- **Delineation of the Breede River Estuary:** The Estuarine Functional Zone (EFZ) was delineated approximately 20 m downslope from the expanded house footprint and 15 m downslope from the proposed road upgrade. The estuary is dominated by *Salicornia mossiana* (Short Glasswort), marking a clear transition from the terrestrial development site to the estuarine environment (**Annexure A**).

The proposed works are located above the delineated watercourses and are separated from these features by dense natural vegetation. In addition, the development footprint is situated above both the Coastal Management Line and the future 1:100-year flood line. The proposed activities will involve less than 300 m<sup>2</sup> of indigenous vegetation clearance and comprise like-for-like upgrades associated with the road improvement. As a result, the aquatic biodiversity sensitivity of the development footprint is verified as **“Low”**.

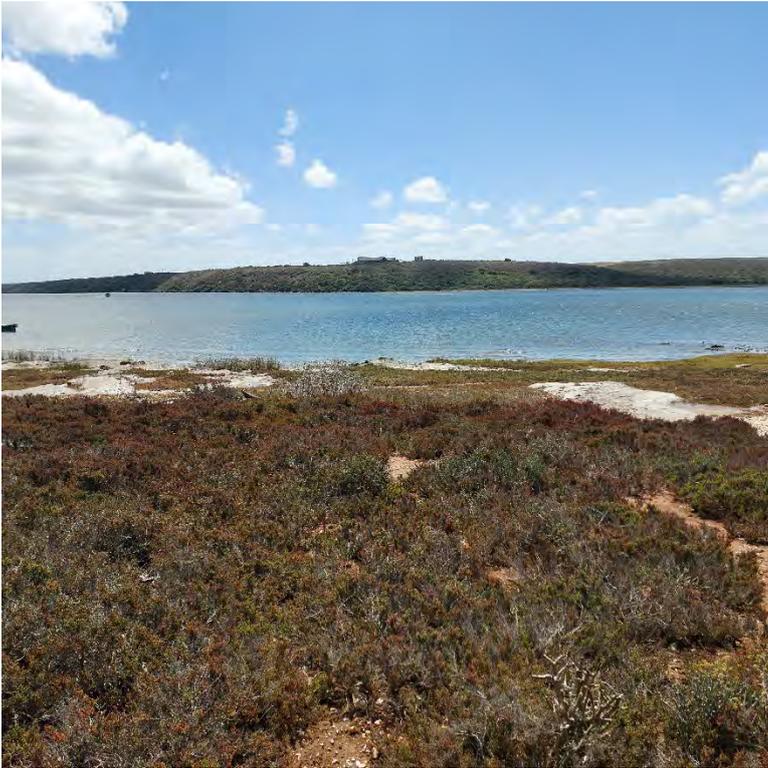
**Breede River Estuary downslope of the proposed activities.**

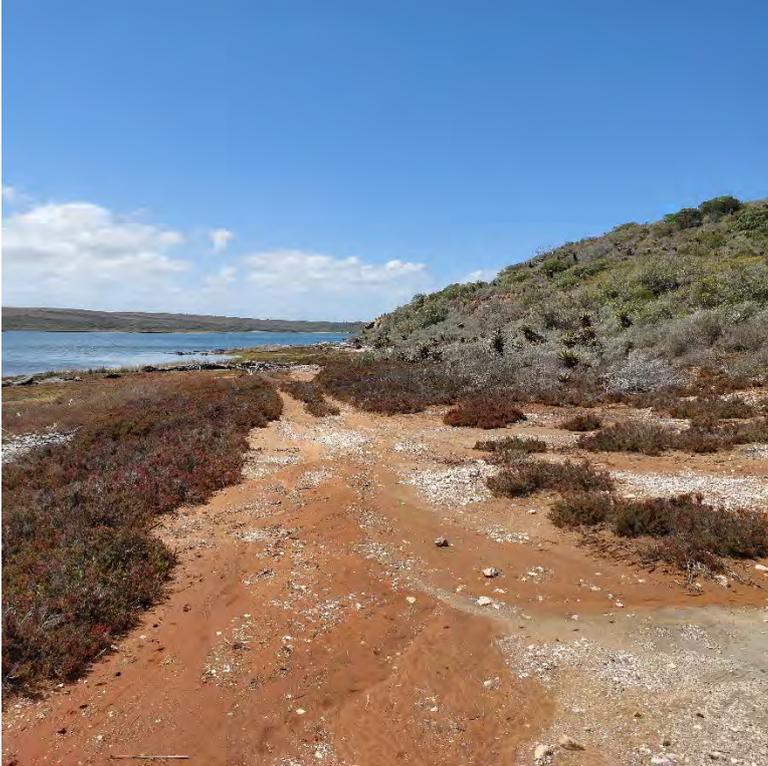
**Breede River Estuary downslope of the proposed road upgrade.**

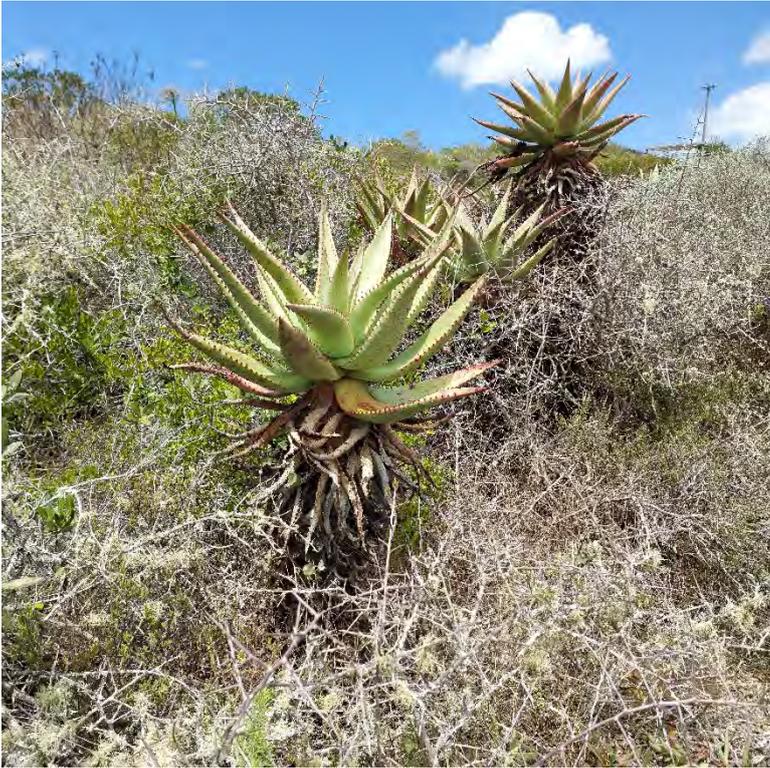
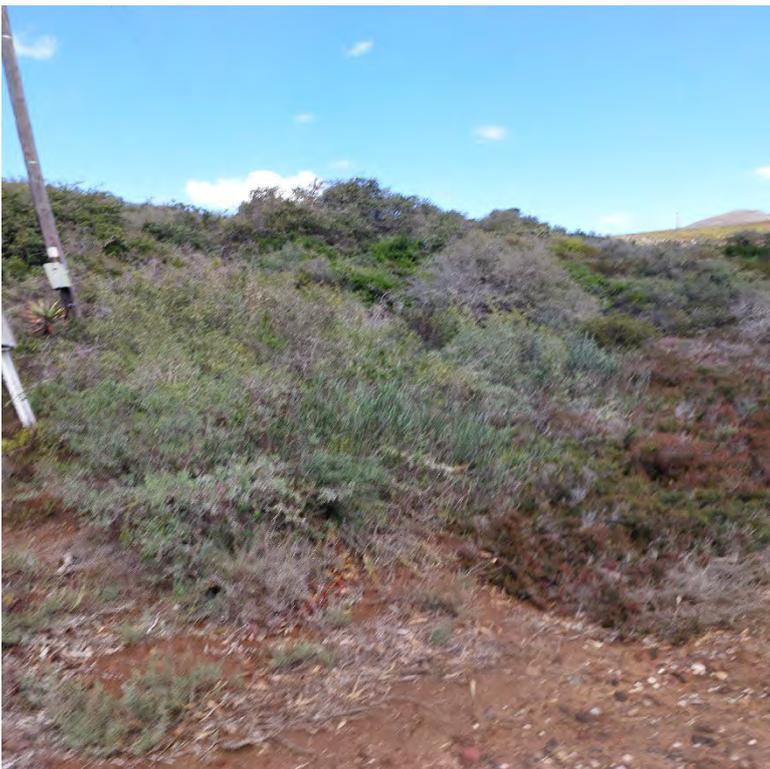
- **Absence of Aquatic Indicators:** No watercourse or wetland indicators were identified within the proposed development areas. The expansion footprints for the residential unit and the "like-for-like" road upgrades are strictly terrestrial in nature (Refer to **Annexure A**).

**Location of proposed new farmhouse unit.**

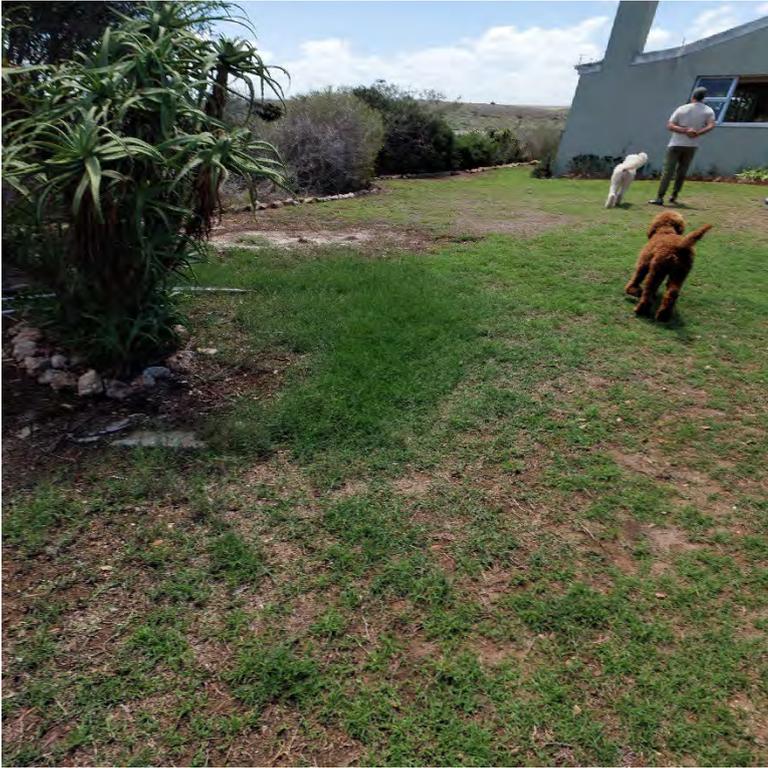
**Location of proposed new farmhouse parking.**

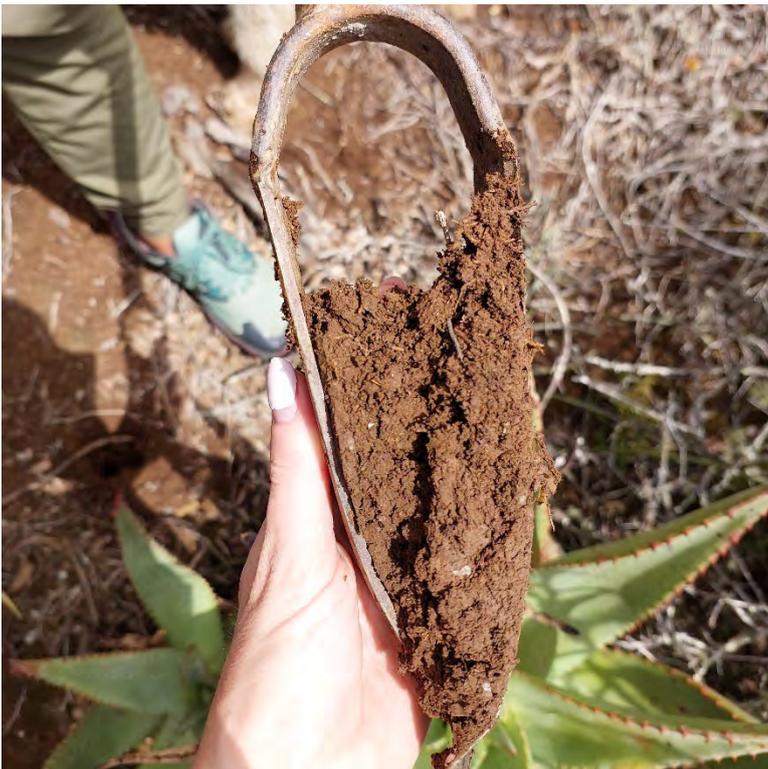
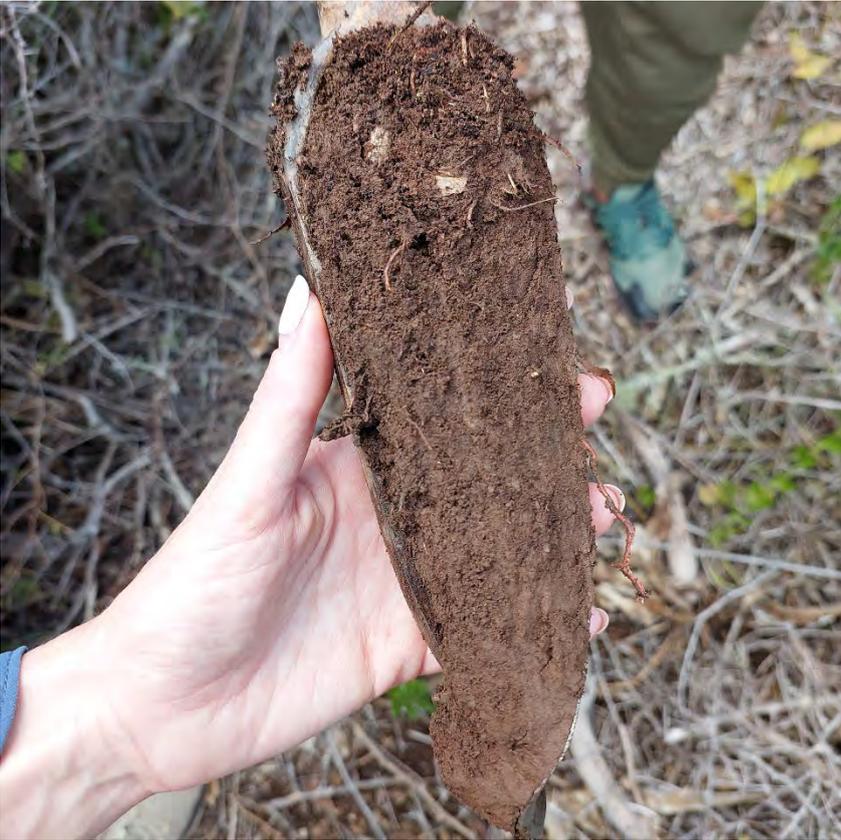
- **Soil Morphology:** Soil analysis further confirms the terrestrial status of the site. Soil samples taken within the development areas consisted of shallow red to orange soils with high clay content, lacking the anaerobic indicators (such as gleying or mottling) typically associated with wetland or saturated conditions.

**Terrestrial soils from proposed new farmhouse area.**

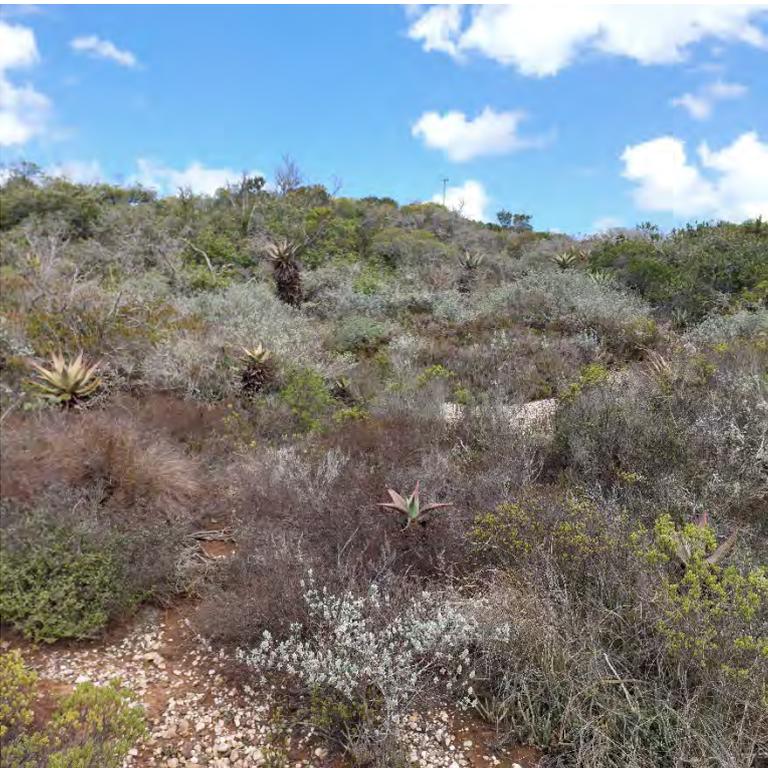
- **Vegetation Profile:** The vegetation within the proposed development area is characteristic of a terrestrial ecosystem, dominated by *Hermannia alnifolia* (Fanleaf Dollsrose), *Searsia glauca* (Blue Kunibush), *Putterlickia pyracantha* (Bastard Spikethorn), *Oedera uniflora* (Limestone Perdekaroo), and *Eriocephalus racemosus* (Kapkap Kapok) (**Annexure A**). These species are typical terrestrial shrubland components of dune Strandveld vegetation and are not associated with aquatic, riparian, or estuarine habitats.

**New farmhouses are located on the top of this slope, terrestrial vegetation shown.**

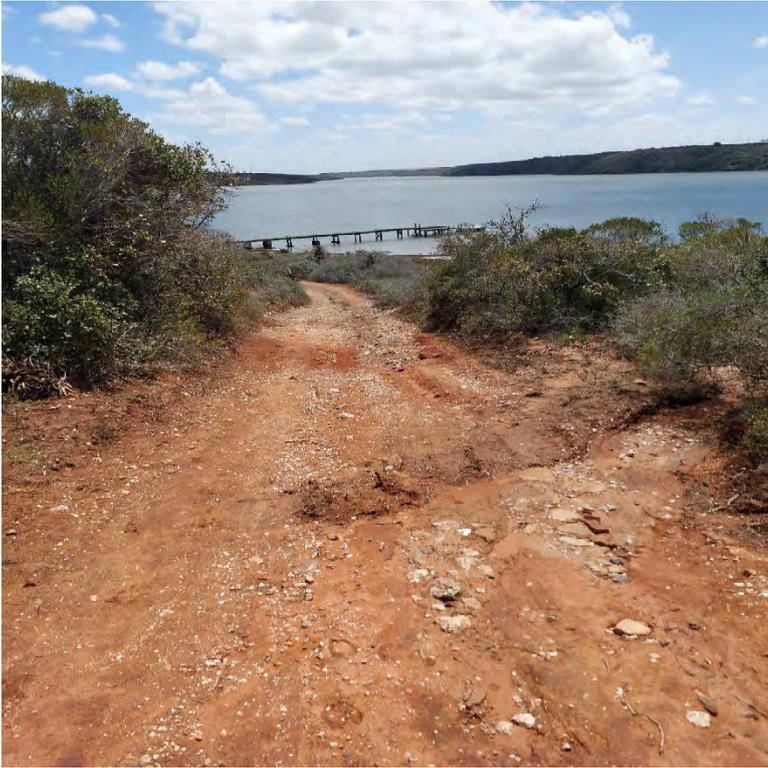
Area where the road upgrade is proposed.

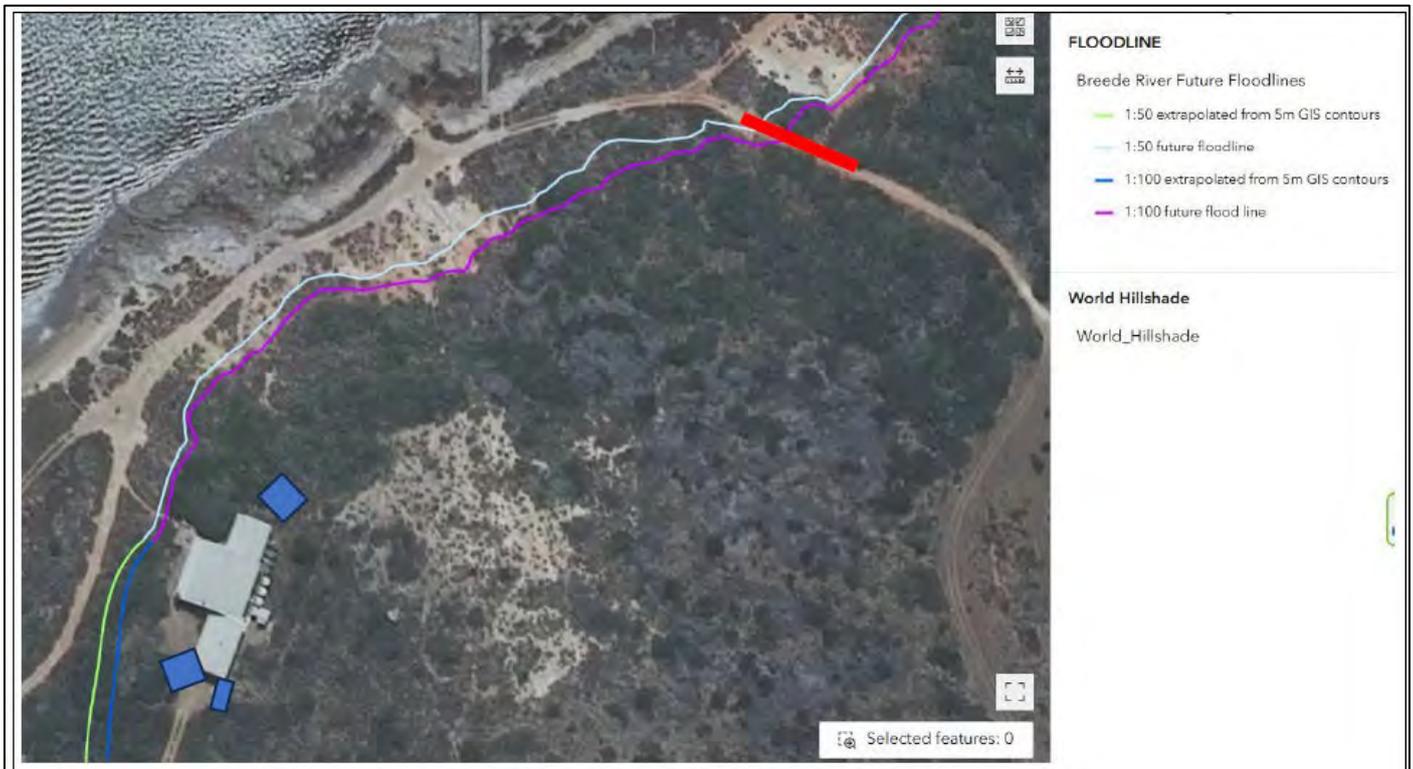
## Annexure B: Flood Lines

Farmhouse and new footprint is in blue, which is above the flood lines, the road is in red (existing) and works will be like for like.

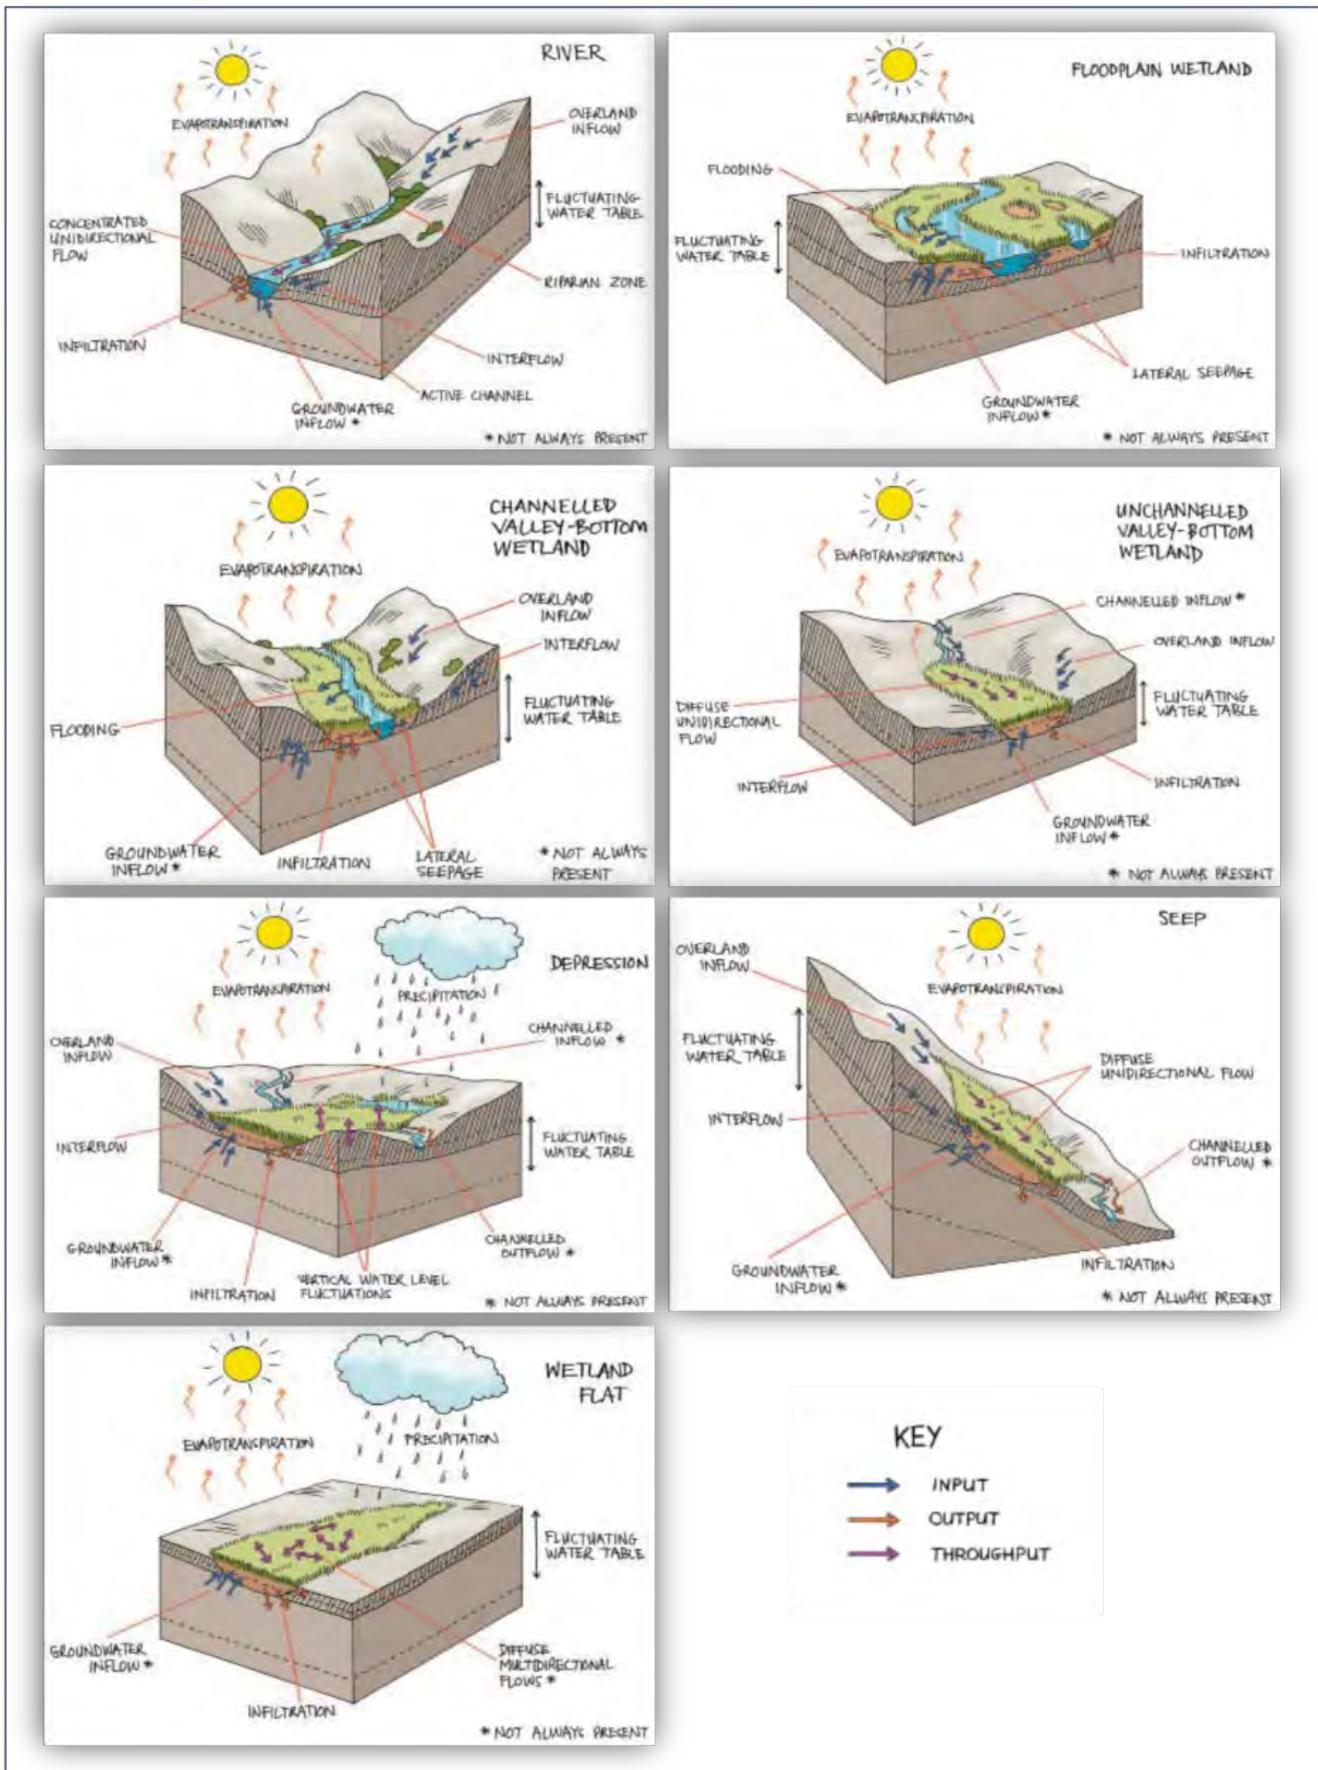
The Ollis *et al* (2013) Classification System for Wetlands and Other Aquatic Ecosystems in South Africa, as used in this assessment, is a tiered structured classification system that provides a uniform description of wetland types based on their hydrogeomorphic characteristics. This classification system categorises wetlands into 7 distinct hydrogeomorphic units described in **Figure 3-1**.

Figure 3-1: Wetland Hydrogeomorphic Types as defined in the Classification System for Wetlands and Other Aquatic Ecosystems in South Africa (Ollis et al., 2013).
